## Research Article

# Stability Control Mechanism of High-Stress Roadway Surrounding Rock by Roof Fracturing and Rock Mass Filling

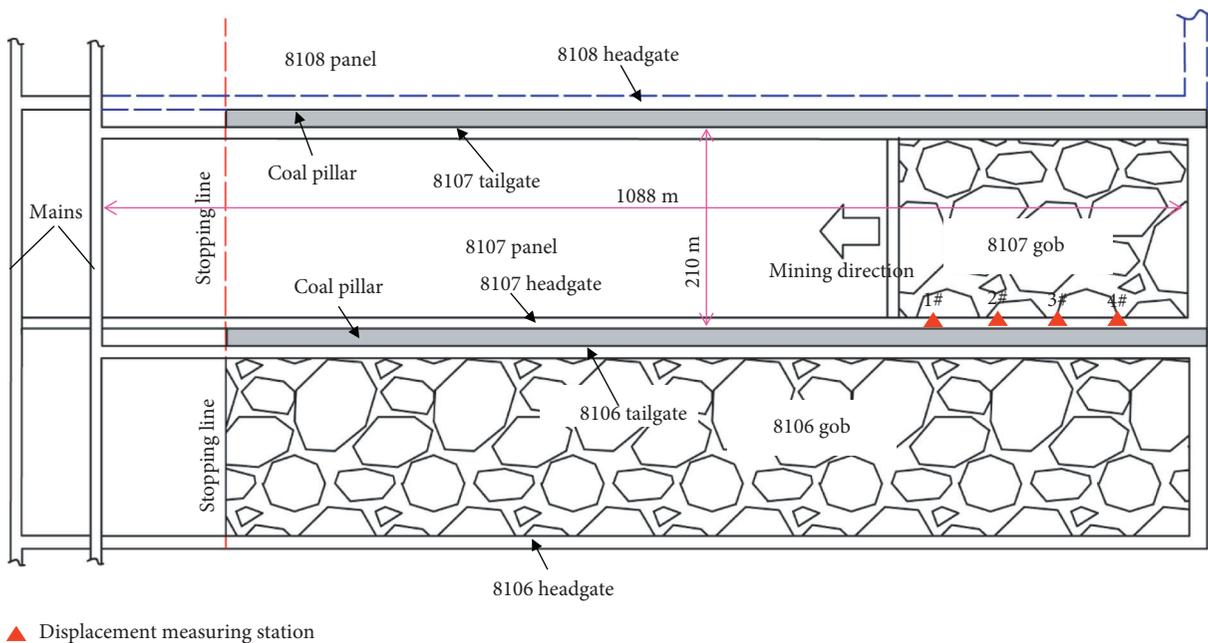
FIGURE 2: Panels and roadway layout.

thickness of the coal seam at the study site are 300 m and 4 m, respectively. Panels 8106, 8107, and 8108 are located in mining area #8 of the deep coal mine (Figure 2), which has a strike length of 1088 m and a dip length of 210 m. The 8106 panel is located south of the 8107 panel and has been mined. The 8108 panel is located north of the 8107 panel and has not been mined. The 8107 headgate is excavated along the 8107 panel (Figure 2), and a 10 m width is adopted for the coal pillar. The roadway roof strata mainly include mudstone (3.6 m), siltstone (7.8 m), and sandy mudstone (6.4 m), and the roadway floor strata mainly include mudstone (4.2 m), fine sandstone (6.4 m), and siltstone (4.5 m). A detailed stratigraphic column is shown in Figure 3.

The section of the 8107 headgate is rectangular, with a width of 5 m and a height of 3.5 m. Four deformation measurement stations were installed 50 m from the front of the 8107 headgate (Figure 2). In the process of excavation and panel retreat, deformation of the roof, floor, and two roadway ribs was observed. The pins (blue solid circle in Figure 4(a)) were fixed to the corresponding regions of the roadway at each measurement station. The pins between the roof and floor were installed at the middle position of the roof, and the pins for the coal rib were installed 1.7 m from the roof. The measurements of the deformation and internal conditions of the rock mass were carried out with a digital measuring instrument (JSS30A-30) and rock layer detection recorder (YTJ20), respectively, as shown in Figure 4(b). The measuring range of the digital deformation instrument is 0.5–30 m, and the accuracy is 0.01 mm. During the displacement observation, a digital deformation instrument was used with the pins fixed in the position of the roadway rock mass. The image of the rock layer detection recorder is accurate to 1.5 million pixels and can identify 0.1 mm rock cracks. Thus, the rock layer detection recorder can characterize fissures at different rock depths.

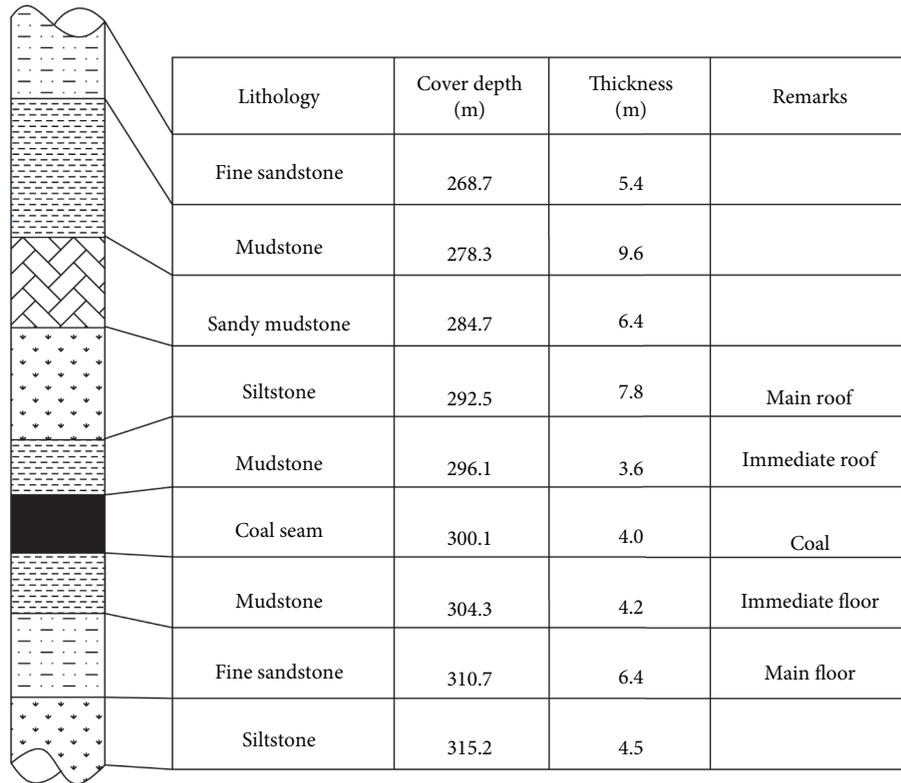
FIGURE 3: Rock histogram of the study site.

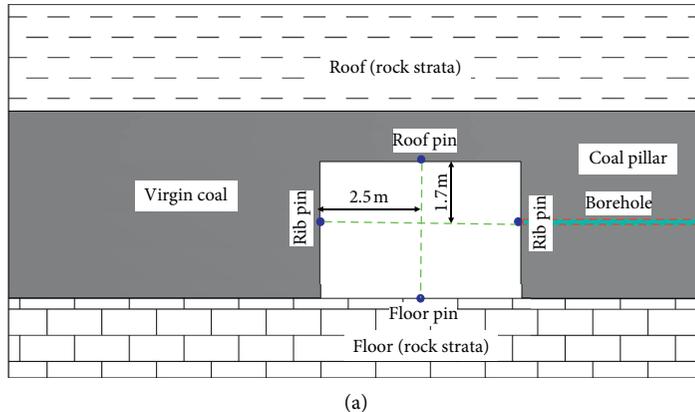
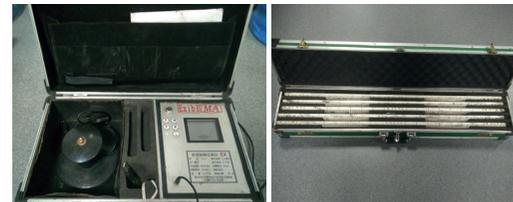
Rock layer detection recorder

Digital measuring instrument

FIGURE 4: Schematic diagram for roadway measurements. (a) Cross section of the measurement station. (b) Measurement devices.

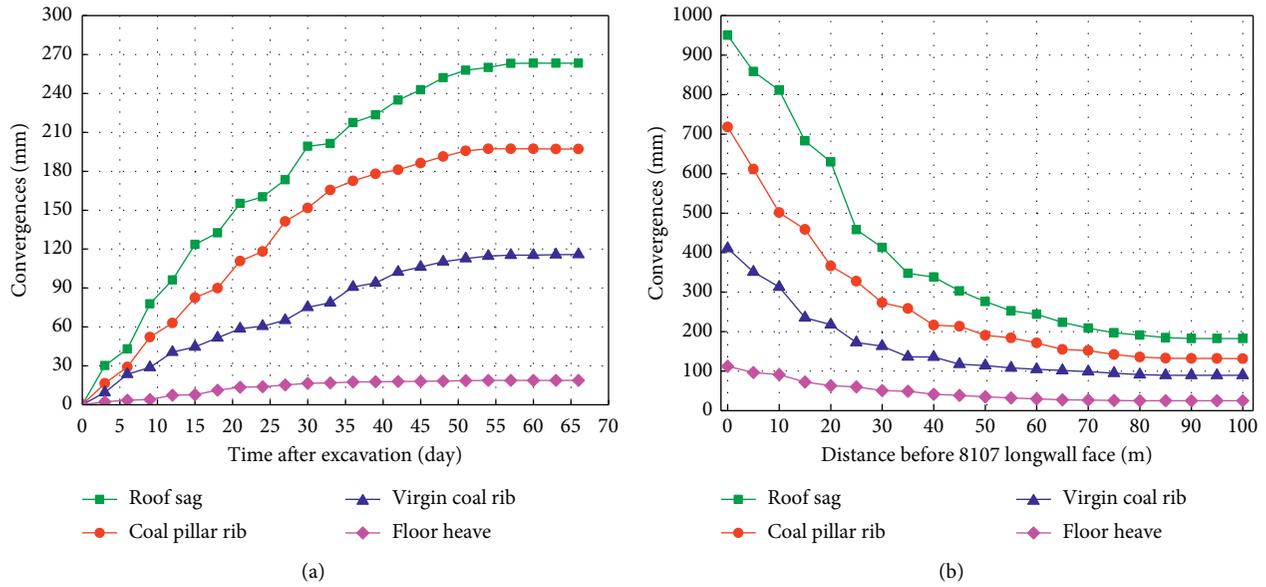
FIGURE 5: Measured convergences in the 8107 headgate. (a) During the 8107 headgate excavation. (b) During the 8107 panel retreat.

Figure 5 shows the convergence of the 8107 headgate during the excavation and panel retreat stages. After the 58<sup>th</sup> day of excavation, the deformation tended to keep steady, with a rate of deformation close to zero (Figure 5(a)). The total convergences for the roof, coal pillar rib, and virgin coal rib were 263 mm, 197 mm, and 115 mm, respectively. As shown in Figure 5(b), compared with the convergence during roadway excavation, the displacement of the roadway grew rapidly during panel retreat. The convergence of the roadway roof increased to 952 mm and the coal pillar rib and virgin coal rib convergence reached 718 mm and 410 mm, respectively. More than 80% of the roadway deformation occurred in a location before the working face 45 m. Displacement laws show that the deformation of the roof is larger than that of the two ribs in the roadway. The floor heave was considerably smaller than that of the roadway roof and the two ribs. The deformation failure of the 8107 headgate is shown in Figure 6. The immediate roof and two ribs of the 8107 headgate were located in the coal seam with low strength, and the floor was located in mudstone with relatively high strength. This special geological condition and high stress led to considerable deformation of the roof and the two ribs with roadway excavation and panel retreat.

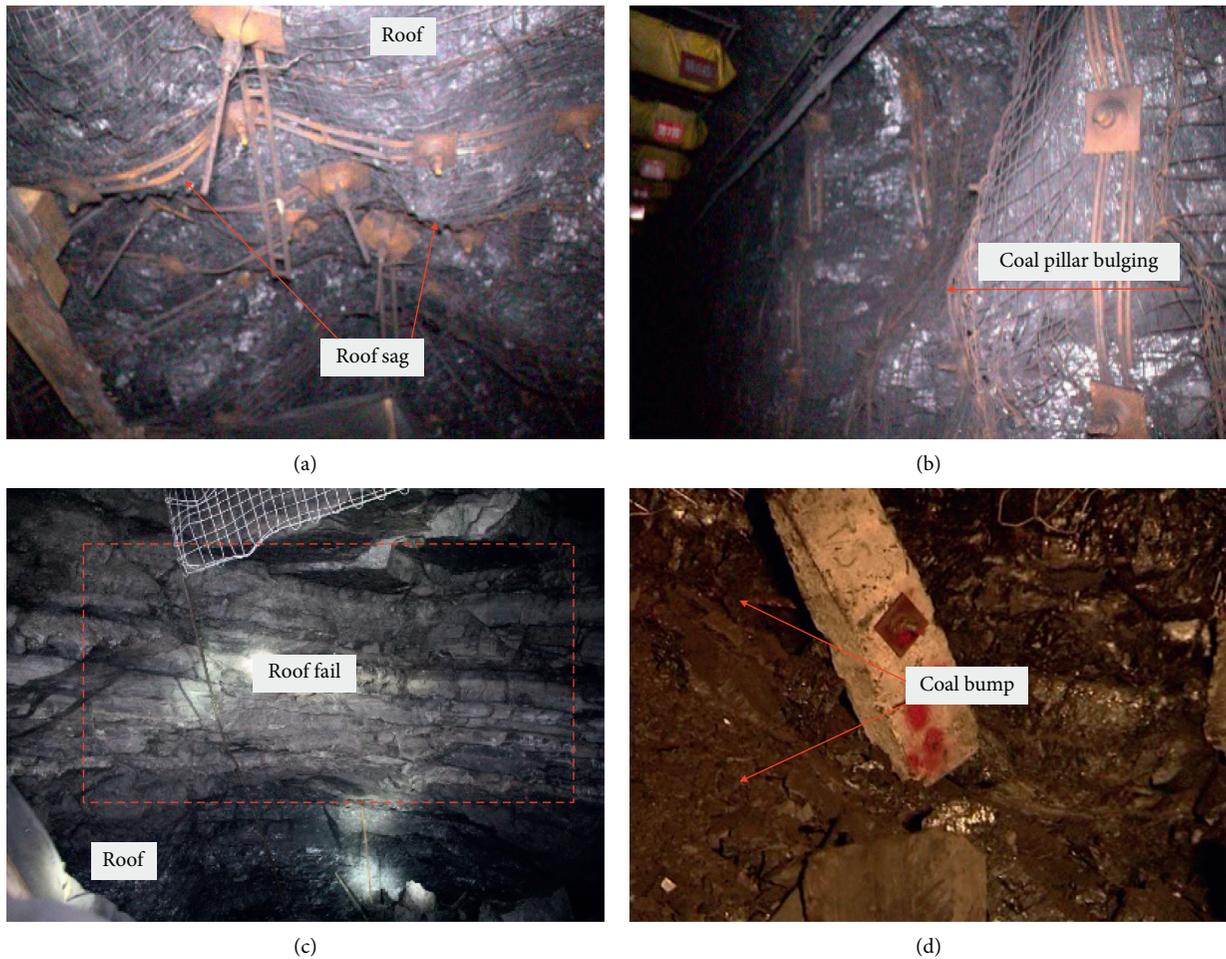
FIGURE 6: The deformation failure of the 8107 headgate. (a) Roof sag. (b) Coal pillar bulging. (c) Roof fail. (d) Coal bump.

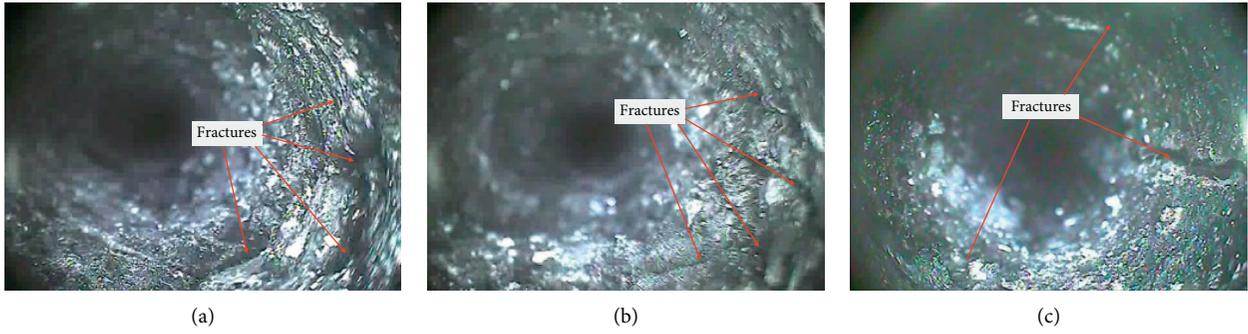
FIGURE 7: Photographs of a coal pillar with different borehole depths obtained by a rock layer detection recorder. (a) Borehole depth of 2 (m). (b) Borehole depth of 4 m. (c) Borehole depth of 6 m.

Figure 7 shows photographs obtained by the rock layer detection recorder of the coal pillar at measurement station

2#. It can be seen from Figure 7(a) that the shallow area of the coal pillar is seriously damaged. A large number of massive fractures are present. Under the influence of high stress, the coal pillar has been entirely crushed and is in a yielded state. It is very likely that the failure of this coal pillar will lead to the collapse of the roadway.

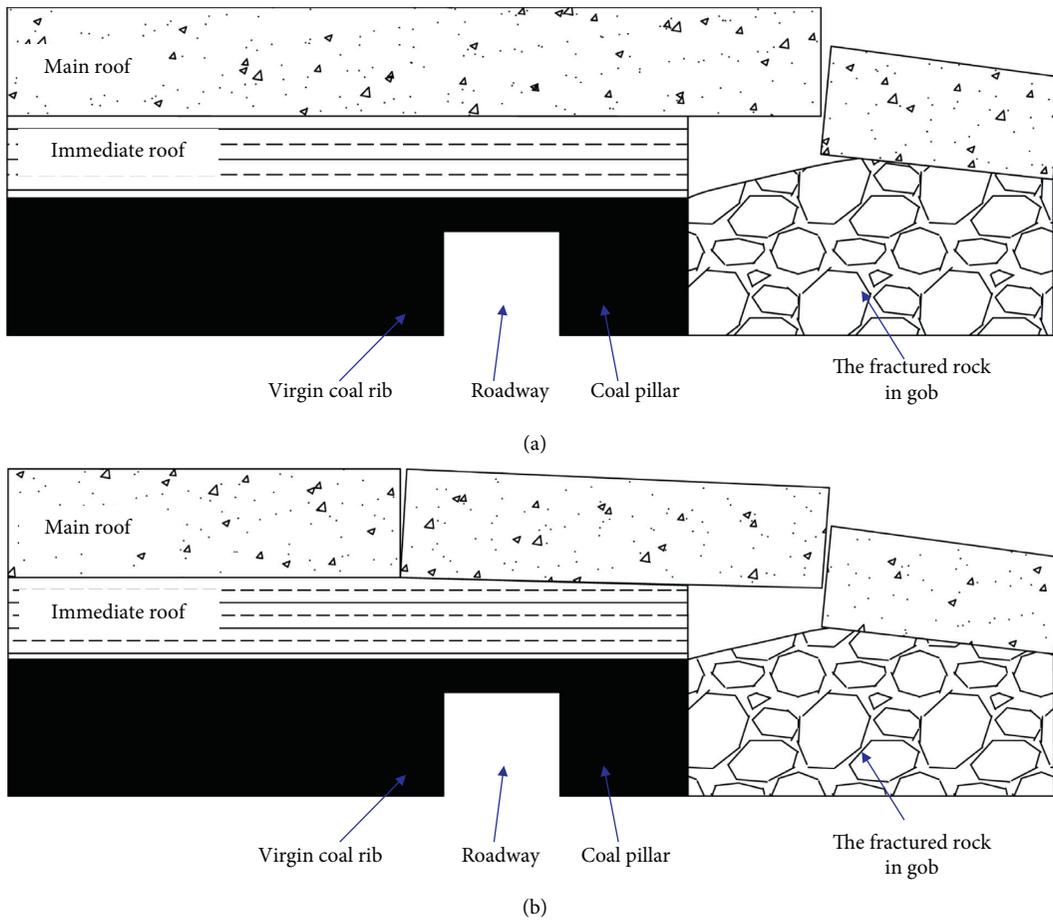
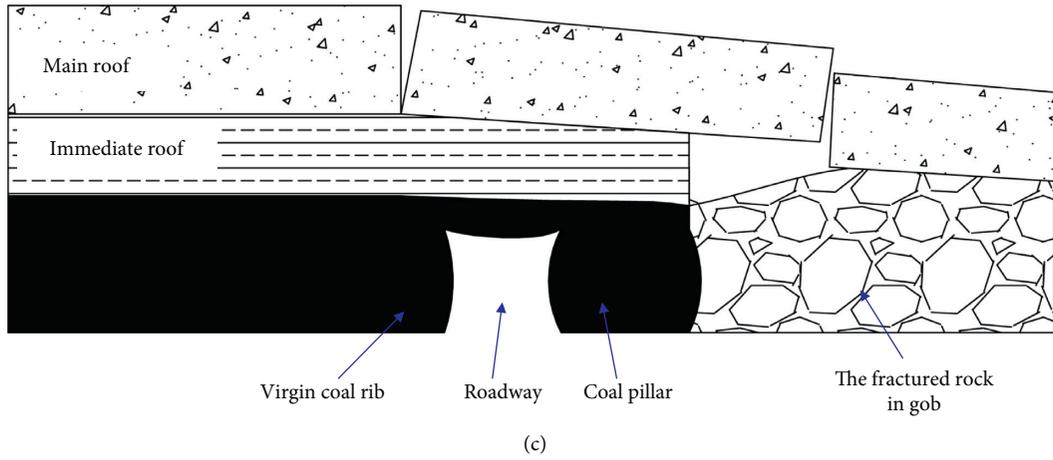
FIGURE 8: The movement process of roadway roof strata. (a) Initial movement of the strata. (b) Fracturing of the strata. (c) Rotation of the strata.

2.2.1. Movement of Roadway Roof Strata. After adjacent panel retreat, the roadway roof strata movement can be divided into three stages—the initial movement, the fracture, and the rotation of the strata—as shown in Figure 8. In the

initial movement stage, the caving of the immediate roof occurs instantly after coal seam mining (Figure 8(a)). In the fracture stage, the main roof fractures, as shown in Figure 8(b). The roof and pillar begin to deform, and the overlying strata load is transferred to the virgin coal rib. Meanwhile, there is a crushing zone in the virgin rib edge. In the rotation stage, the main and immediate roofs rotate, with the fracture site as the axis of rotational motion (Figure 8(c)). Moreover, the stress from the roof strata is shifted gradually from the virgin coal rib to the coal pillar. Coal pillar failure will directly lead to a loss of stability in the roadway surrounding rock when the coal pillar is not strong enough to withstand the overlying strata load.

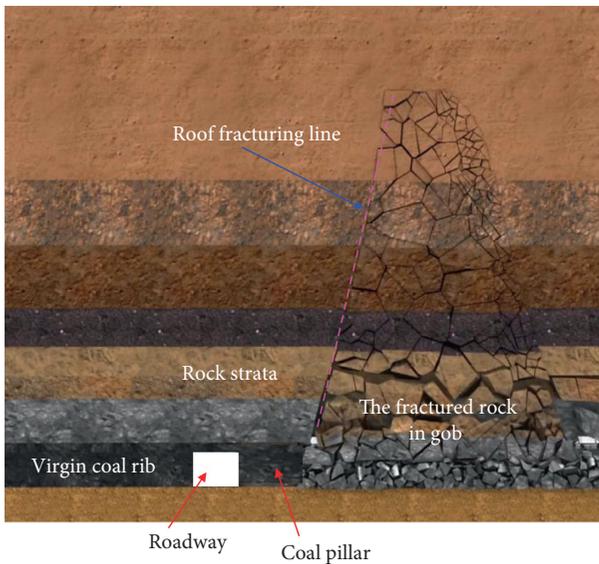
FIGURE 9: A novel approach for improving the stress environment of the roadway.

Since the movements of the roadway and gob roofs are closely related, the rotary subsidence of roof strata is the main reason for the high stress and deformation of the roadway. Hence, a novel approach has been proposed that can improve the stability of surrounding rock by interrupting the stress transmission. As shown in Figure 9, by adopting a directional fracturing line to cut off the gob roof, the stress propagating from there can be interrupted, relieving the high stress of the roadway roof. In addition, due to the rock mass gravity action, the gob roof strata collapse rapidly along the fracturing line. The rock masses rotate, come into contact in the process of collapse, and are broken into smaller rock masses (Figure 9). The rock masses in the

broken state increase and fill the gob. The broken rock masses in the gob are compressed to form a wedge accumulation structure that bears the overburden pressure, which effectively alleviates the stress concentration on the two ribs of the roadway.

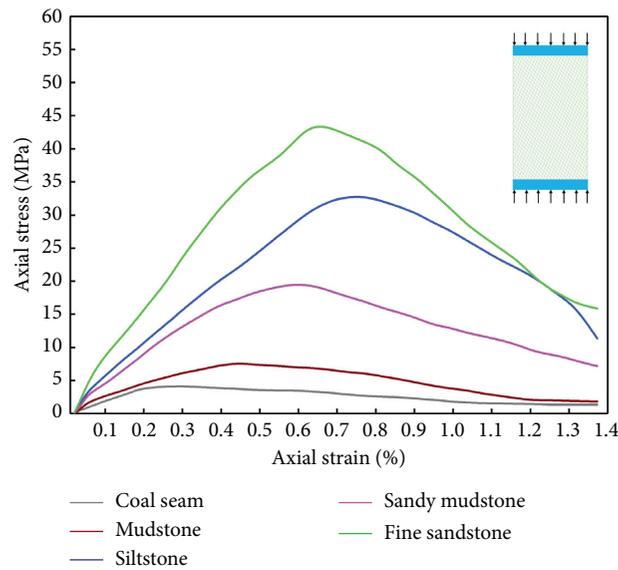
FIGURE 10: Axial stress-strain curves of the synthetic rock specimens.

A fitting method adopted in previous related studies was used to acquire block contacts data [24, 25]. To obtain the mechanical parameters of block contacts, many simulated uniaxial compression tests on synthetic rock specimens were adopted in this paper, as shown in Figure 10. To eliminate the influence of mesh size, each type of calibrated model had an identical block mesh size which corresponded to the rock mass of the full model when the calibration was performed. Moreover, the calibrated model kept the height-to-width ratio constant during the calibration process. To ensure the reliability of the parameters, simulations were repeatedly checked until the modelling results matched the main properties of the field rock mass (uniaxial compressive strength and elasticity modulus). The target and simulated elasticity modulus and compressive strengths are compared in Table 3. These comparisons show that the simulated elasticity modulus and compressive strength are consistent with the target values. Table 4 lists the mechanical parameters of the rock mass used in the UDEC model. Therefore, the parameters listed in Table 4 could be applied to the simulations of the surrounding rock along roadways because the mechanical behaviour of the blocks was consistent with those of the field rock mass.

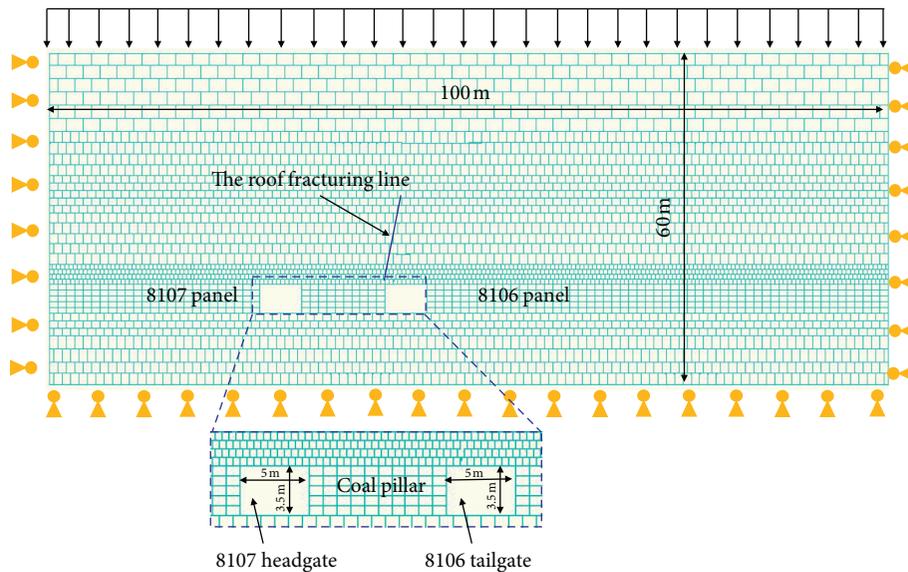
FIGURE 11: The UDEC numerical model.

**3.3. Model Establishment and Simulation Scheme.** The main aim of this study is to investigate the stability of roadways under the influence of roof fracturing. A UDEC numerical model was established, and its dimensions were 100 m × 60 m (Figure 11). The model consisted of the 8106 and 8107 panels and the roadway systems between them.

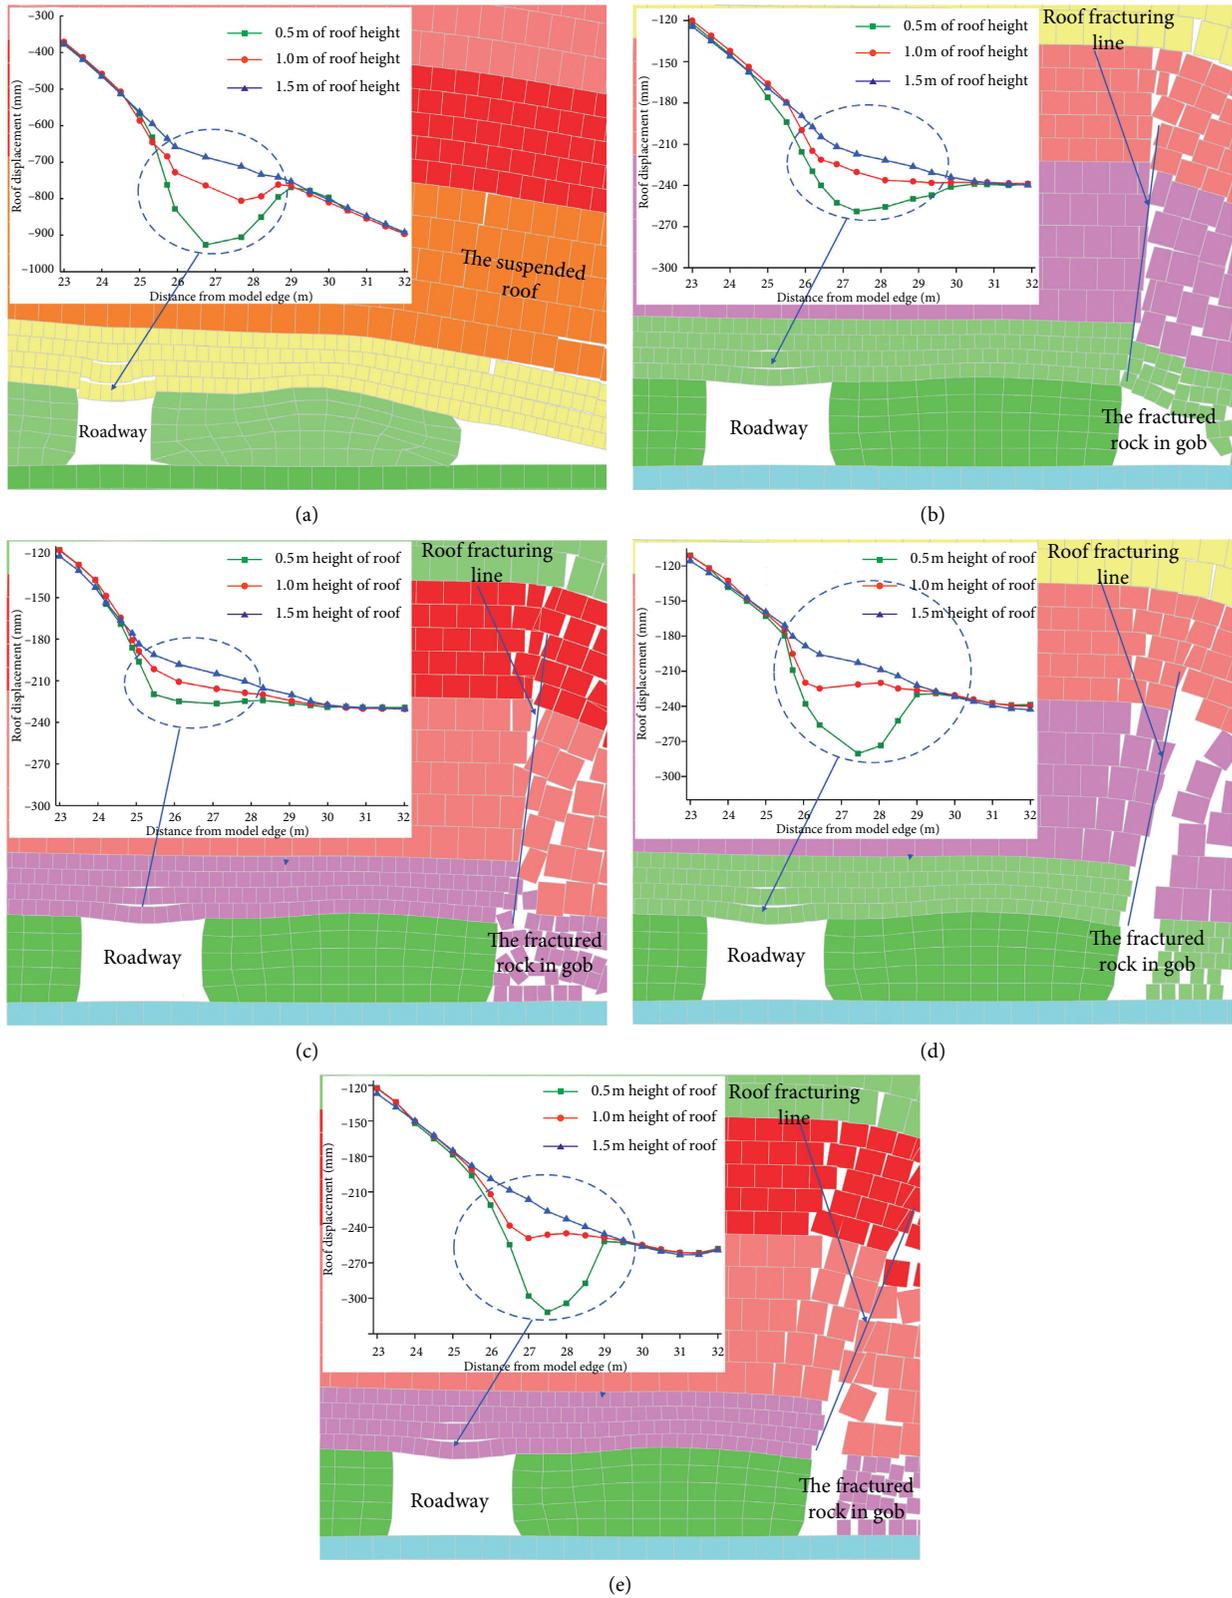
FIGURE 12: The deformation rules and fracture characteristics of roof strata under different roof fracturing conditions. (a) Nonfracturing roof. (b) 5° roof fracturing angle. (c) 10° roof fracturing angle. (d) 15° roof fracturing angle. (e) 20° roof fracturing angle.

As illustrated in Figure 12(a), when the roof was not fractured, a large separation zone appeared in the roadway roof, and a distinct suspended roof structure formed above the roadway. The displacements for the roof height of 0.5 m, 1 m, and 1.5 m were 932 mm, 805 mm, and 711 mm, respectively, which easily led to roof rock falling. When the fracturing angle was 5°, the roof strata of the gob could not fully collapse along the fracturing line, which could easily cause dynamic disturbance to the roadway. The displacements of the three corresponding roof heights were 259 mm, 236 mm, and 221 mm. Meanwhile, the separation area of the roof strata was reduced. When the fracturing angle was 10°, the roof strata collapsed along the fracturing line in a timely manner, and the fractured rock filled the gob and supported

the overlying strata. The displacements of the 0.5 m and 1 m roof heights were continuously reduced (Figure 12(c)), and the deformation of roof strata was consistent among the different regions, which further controlled the development of roof strata separation. As the fracturing angle was 15° and 20°, respectively, the range of the suspended roofs above the roadway enhanced with increasing fracturing angle, which led to an increase in the load borne by the roof rock. Compared with the roof deformation conditions of a fracturing angle of 10°, with a greater fracturing angle, the damage scope of the roof rock was enlarged, and the displacement of the roadway roof strata continuously increases (Figures 12(d) and 12(e)), which had a negative effect on maintaining the stability of the roadway surrounding rock.

According to the above discussion, the optimal fracturing angle of the roof strata was determined to be  $10^\circ$ , as shown in Figure 12(c).

The geometry size of 24.5 m was greater than the total width of the roadway and pillar, and the roof above the roadway was suspended. This conclusion was basically consistent with the simulation result (Figure 12(a)). Because of the suspended roof effect, the stress distribution in roadway ribs presented a “double peak” shape (Figure 15(a)), which kept the 8107 headgate in a high-stress state. The upper stratum load exceeded the ultimate coal pillar strength, and the coal pillar experienced yield failure, which made the roadway unstable. Since the roof fracturing approach was adopted to cut off the suspended roof, the high stress of the two roadway ribs could be effectively released, as shown in Figure 15(b). At the same time, the fractured rock filled the gob and was in close contact with the upper rock structure, which limited the rotational deformation of the roadway roof and improved the coal pillar stability. The 8107 headgate was in a state of low stress.

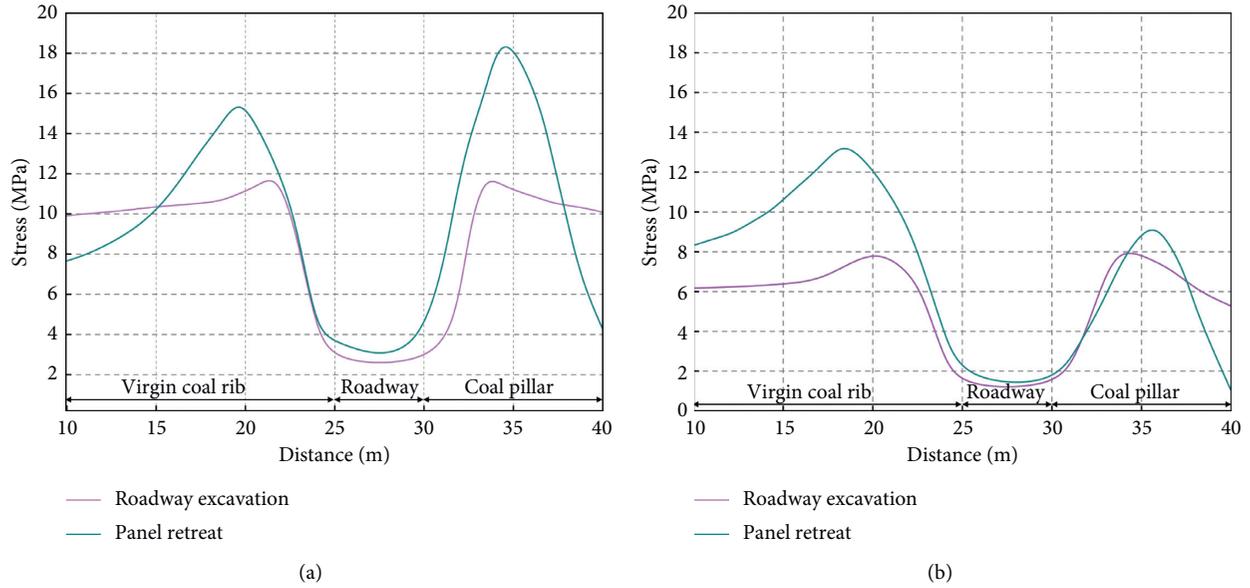
FIGURE 13: Vertical stress distribution of two roadway ribs at different stages. (a) Roof nonfracturing. (b) Roof fracturing.

**4.2. Stress Changes in Two Roadway Ribs.** Figure 13 shows the vertical stress distribution in the two roadway ribs at different stages with and without fracturing roof. It should be noted that the curve data for the right and left ribs were obtained at the midheight of the two ribs in the roadway. The modelling results show that the stress changes in the two roadway ribs are greatly affected by roof fracturing.

As shown in Figure 13(a), without roof fracturing, roadway excavation redistributed the stress in the coal pillar

and virgin coal rib. The vertical stress increased to a peak and then decreased. The vertical stress peaks in the two roadway ribs were equal. In the panel retreat stage, stress concentrated in the two ribs. The vertical stress peak of the coal pillar exceeded the solid rib stress because the roadway roof strata rotated, and the overlying strata load was mainly carried by the coal pillar during the mining process. The roadway was in a state of high stress, which led to severe deformation of the roadway (Figure 6). As shown in Figure 13(b), with roof fracturing, the vertical stress of the two ribs in the roadway changed significantly in the process of panel extraction. As the roof strata stress transfer avenue was cut off, the vertical stress peak of the coal pillar decreased

from 18.3 MPa to 9.3 MPa, while the virgin rib stress decreased from 15.6 MPa to 13.4 MPa. Meanwhile, the bearing capacity of collapsed rock mass in the gob reduced the partial coal pillar pressure. Therefore, the coal pillar stress was clearly lower than that in the solid coal region. The stress environment of the roadway thus was optimized.

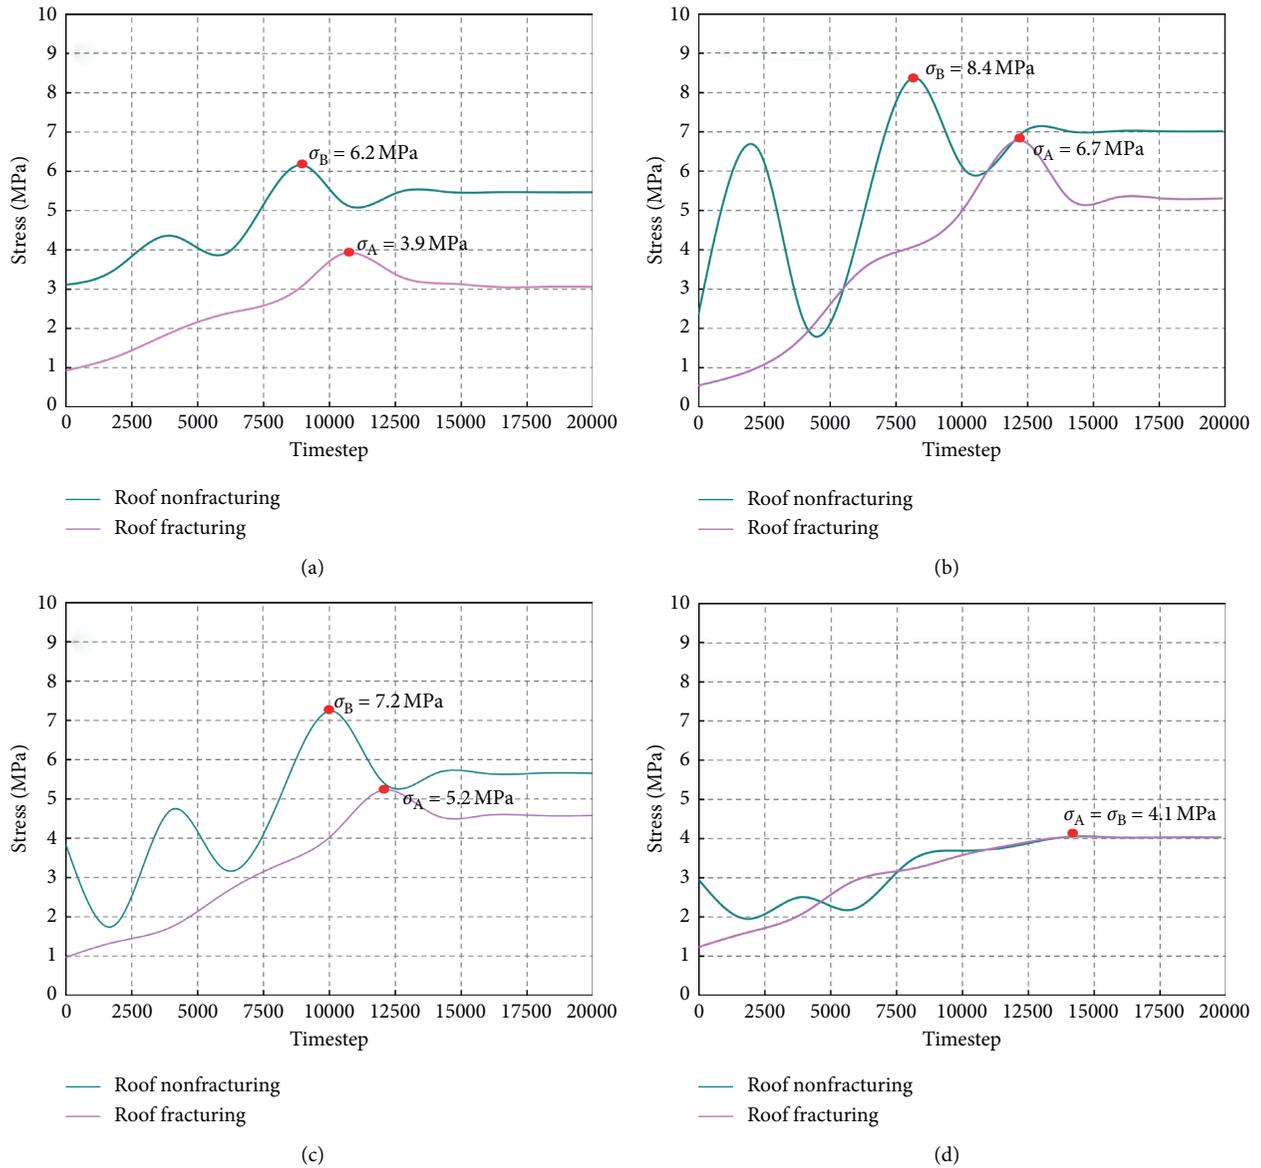
FIGURE 14: The vertical stress variations at different positions of the roof. (a) 5 m. (b) 10 m. (c) 15 m. (d) 20 m.

**4.3. Stress Changes in the Roadway Roof.** During the simulation, the evolution law of the vertical stress in the roadway roof was monitored. The monitoring points were placed 5 m, 10 m, 15 m, and 20 m above the roadway. Figure 14 shows the variations in vertical stress at different roof positions during mining. The vertical stress peaks under roof fracturing and roof nonfracturing conditions are marked by  $\sigma_A$  and  $\sigma_B$ , respectively.

As shown in Figures 14(a) and 14(b), under the influence of roof fracturing, the vertical stresses at 5 m and 10 m above the roadway were much smaller than the corresponding vertical stresses with roof nonfracturing. With the increase in height, the vertical stresses at 15 m and 20 m above the roadway under the condition of roof fracturing gradually approached the vertical stresses without roof fracturing, as shown in Figures 14(c) and 14(d). The simulation results show that, within the range of influence of the roof fracturing, the structural connectivity between the roadway and gob roofs was cut off, and the stress from the gob roof could not be transferred to the roadway roof. In the area far from the roof fracturing line, the roadway and gob roofs formed complete and continuous rock strata, which weakened the influence of roof fracturing on the stress in the upper complete rock mass.

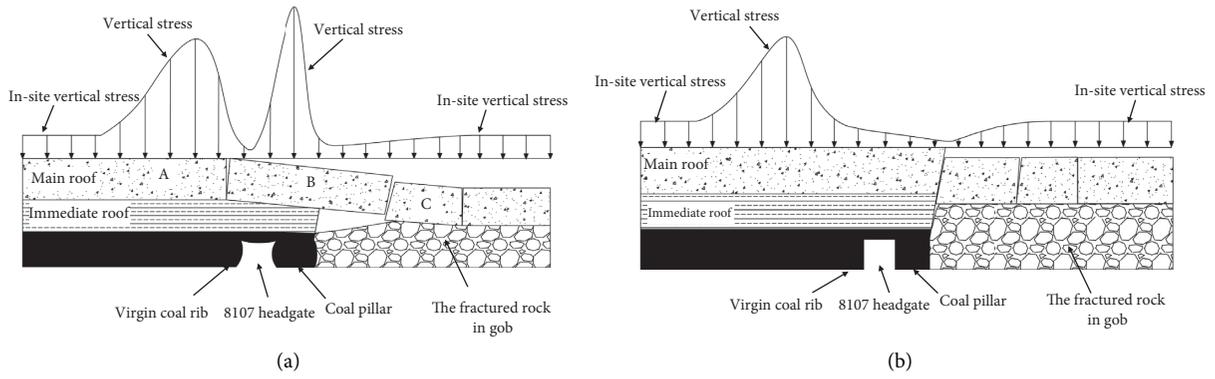
FIGURE 15: Failure analysis of surrounding rock in roadway. (a) Before roof fracturing. (b) After roof fracturing.

**4.4. Discussion of the Roadway Roof Mechanical Behaviour.** After panel retreat, the roof strata structure above the roadway was broken, as shown in Figure 15(a). Rocks A, B, and C

interact, which influences the stability of the 8107 headgate. According to the ultimate balance theory, the rock B geometry size  $l$  can be calculated by the dip length  $S$  of the panel and the periodic fracture length  $L$  of the main roof, as follows [26–28]:

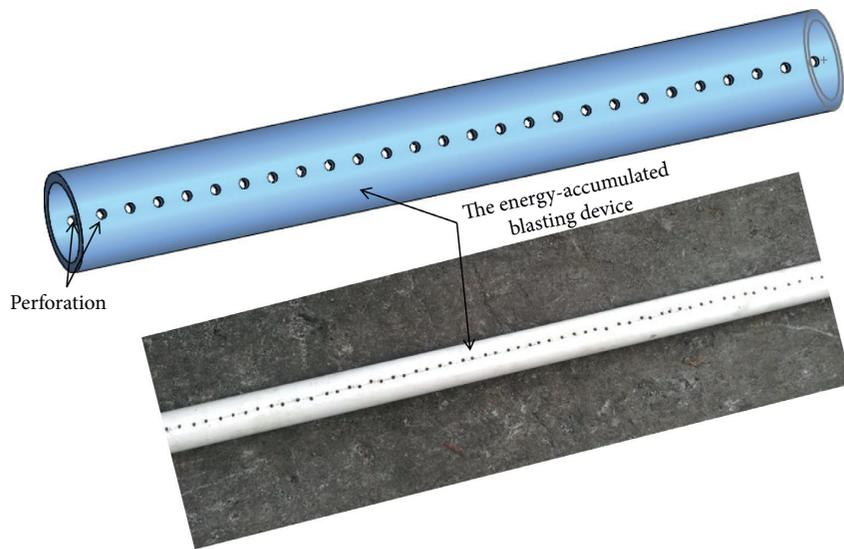
FIGURE 16: The energy-accumulated blasting device.

accumulated blasting device (Figure 16) is used to establish rock fracturing cracks. Through the blasting devices, high-temperature, high-pressure, and high sound velocity gases generated by blasting create a fracture in a predetermined direction of the rock mass, with no damage impact in other directions. Figure 17 shows the fracture propagation due to blasting.

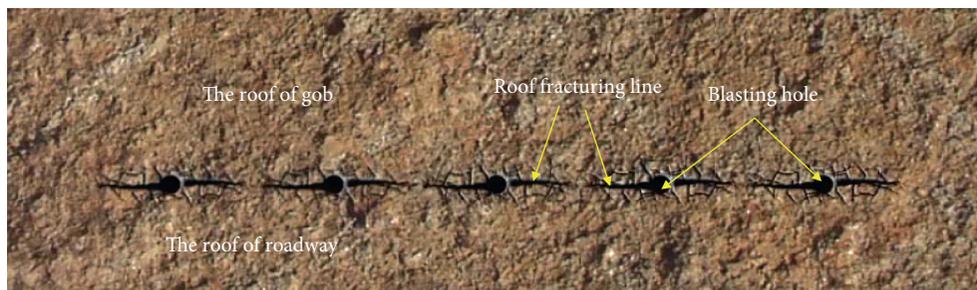
FIGURE 17: Fracture propagation due to blasting.

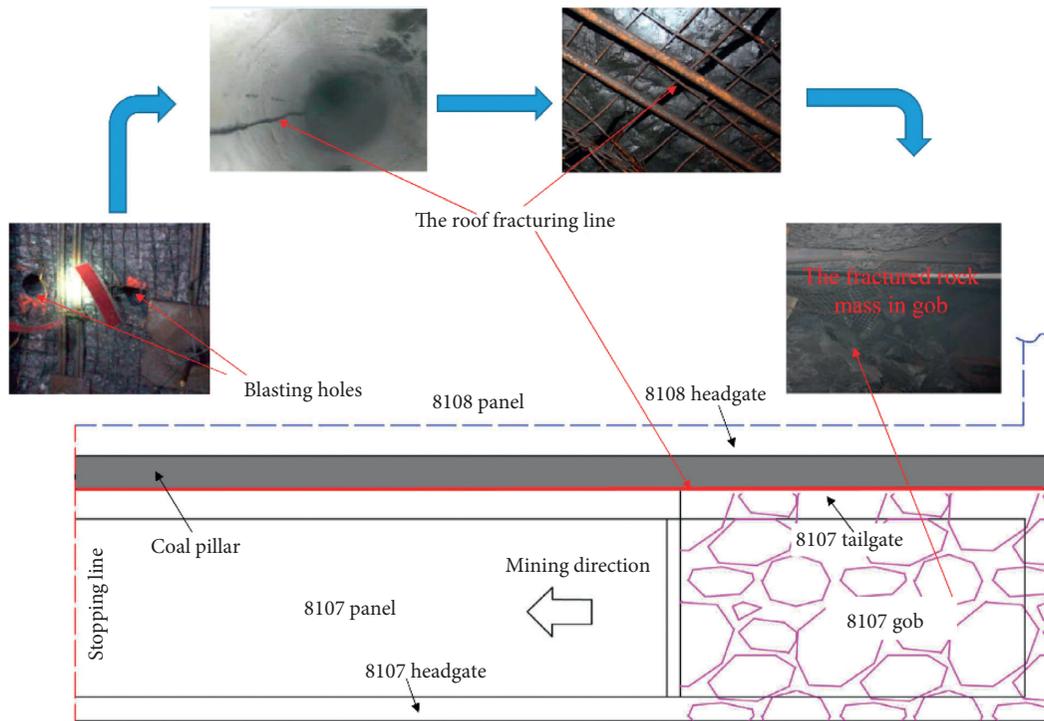
FIGURE 18: Exhibition of roof fracturing and rock mass filling.

To verify the feasibility of roof fracturing for deep high-stress roadways, a field test was carried out. Blasting was undertaken in front of the 8107 tailgate roof to create a fracturing line, as shown in Figure 18. The gob roof strata collapsed quickly along the fracturing line with the retreat of the 8107 panel. The broken rock masses filled the gob and were in contact with the upper strata.

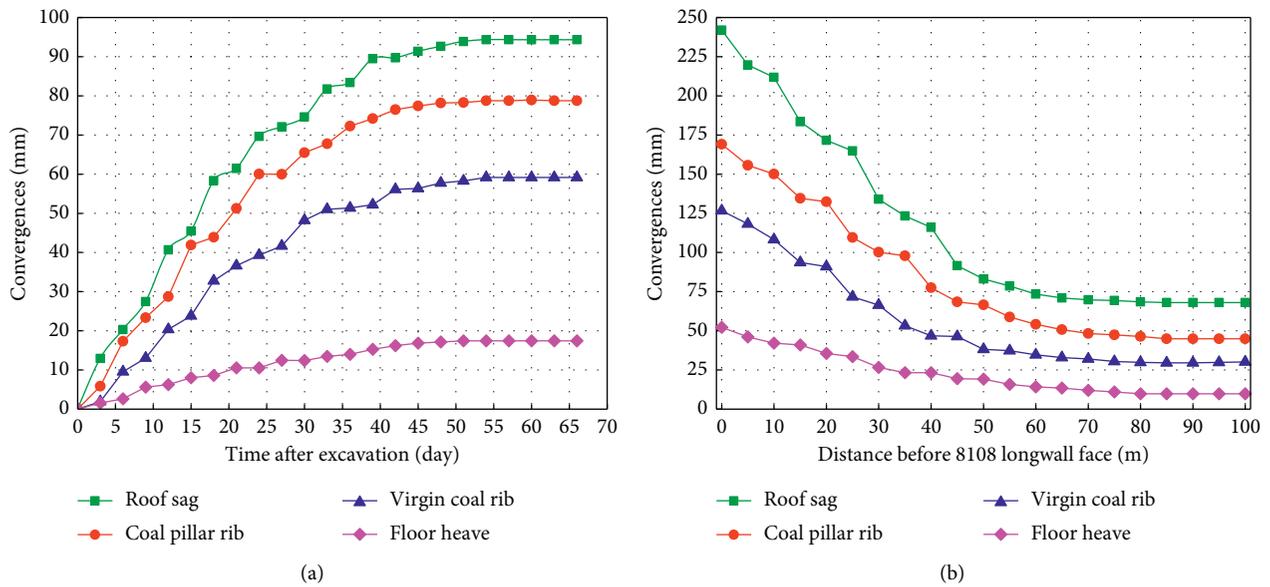
FIGURE 19: Measurement of 8108 headgate deformation. (a) During the 8108 headgate excavation. (b) During the 8108 panel retreat.

excavation of the roadway and panel retreat, as shown in Figures 19(a) and 19(b). Within 50 days of excavation, the deformation of the surrounding rock increased rapidly with the stress adjustment. After 50 days of excavation, the deformation of the roadway gradually decreased and tended to stabilize. The final convergences of the roof, coal pillar rib, and virgin coal rib were 95 mm, 78 mm, and 60 mm, respectively. During the 8108 panel retreat, roadway deformation mainly occurred 60 m in front of the working face; the total convergences of the roof, coal pillar rib, and virgin coal rib reached, respectively, 242 mm, 169 mm, and 126 mm. Compared with the roadway deformation without fracturing roof, the corresponding convergence of the roadway (roof, pillar, and virgin rib) was reduced by 75%, 76%, and 70%, respectively. The stability of the 8108 headgate was obviously improved, as shown in Figure 20. The field measurements indicate that severe roadway

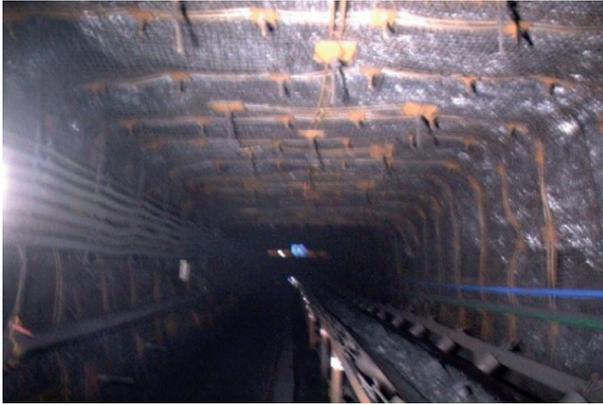
FIGURE 20: The stability of the 8108 headgate.
