Research Article

Research on the Seismic Performance of Straw Panel-Infilled Concrete Frame by Shaking Table Test

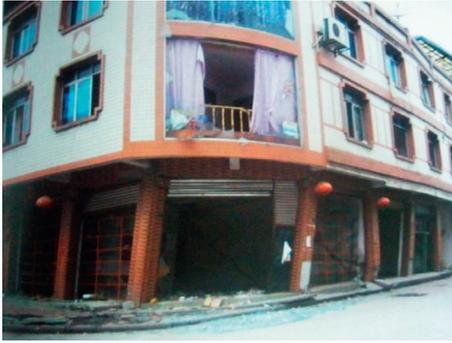
FIGURE 1: Damage of a 3-story frame structure [8].

The current design philosophy poses serious problems, as it did in the case of Wenchuan earthquake. On May 12, 2008, an Ms8.0 earthquake struck Wenchuan area where masonry infill wall is extensively adopted. A 3-story building of frame structure in Beichuan is shown in Figure 1 [8]. To set street shops for the building, few infill walls were set on the ground floor, while many infill walls were arranged on other floors, making the ground floor much weaker than other layers. Finally, all the bottom columns broke at ends,

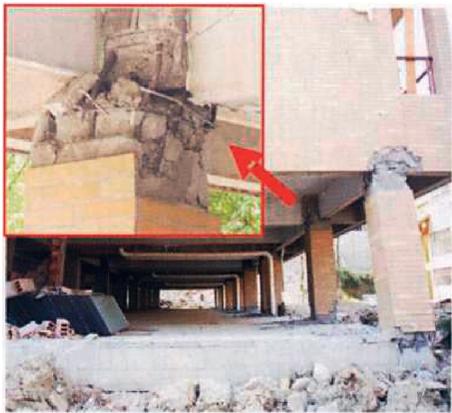
FIGURE 2: Damage of the bottom columns of a 6-story building [9].

and the whole building inclined dramatically. The same type of failure is presented in Figure 2 [9]. It is a damaged column of a 6-story building in Dujiangyan city. Its ground floor acted as a garage with no walls. Infill walls on the upper floors made the stiffness vary greatly between the first and second story, so the damage of bottom columns occurred.

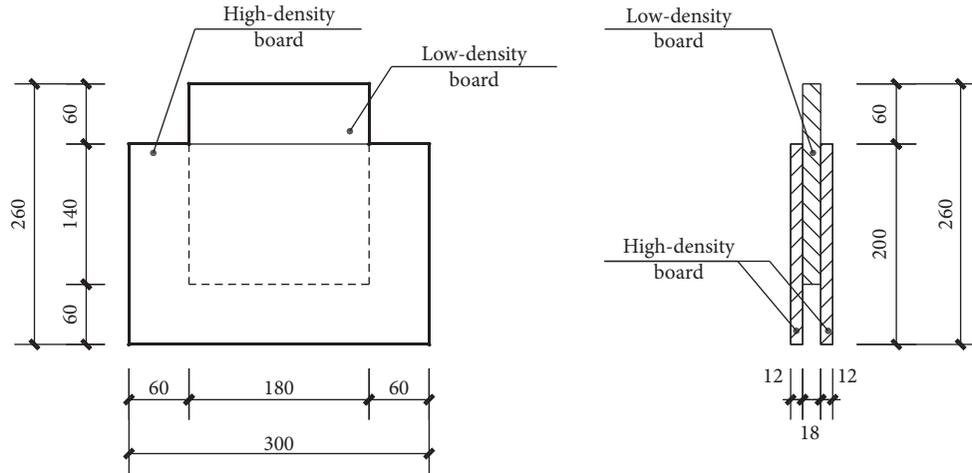
FIGURE 3: Geometrical sizes of a straw brick (unit: mm).

The proposed straw panel is a sandwich structure with tenon and groove, consisting of a low-density straw board ($\rho \leq 400 \text{ kg/m}^3$) and 2 high-density straw boards ($\rho \geq 700 \text{ kg/m}^3$). The low-density board with good thermal insulation

and sound insulation performance is used as the lining, of which 2 high-density boards are placed on both sides. The lower end of the low-density lining board is a groove. The high-density outer panel and the low-density lining board are staggered to form a tenon and groove. Considering the requirements of the building modulus and the conditions in the transportation and construction process, the size of the straw panel is decided as shown in Figure 3.

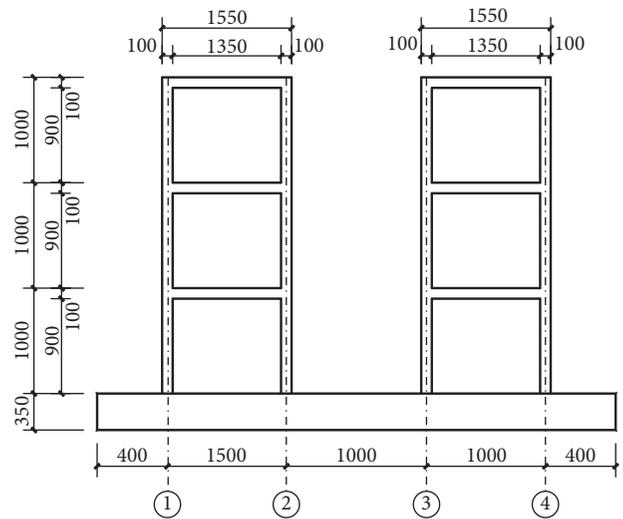
FIGURE 4: Front elevation view of test structures (unit: mm).

According to the Chinese Code for Design of Concrete Structures [26], the component layout and the reinforcement diagrams of components in the test structures are designed and shown in Figures 4–6. The straw brick is presented in Figures 3 and 7, and the photo of test structures is shown in Figure 8.

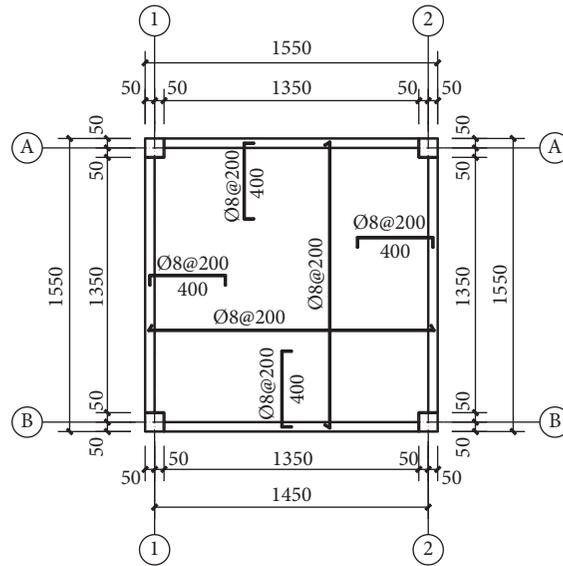
FIGURE 5: Reinforcement diagram of floor slab (unit: mm).

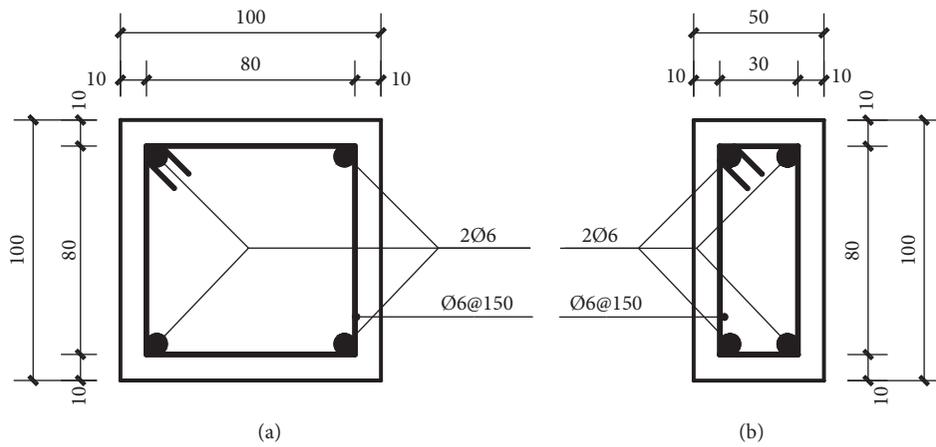
FIGURE 6: Reinforcement diagrams of columns and beams (unit: mm). (a) Column. (b) Beam.

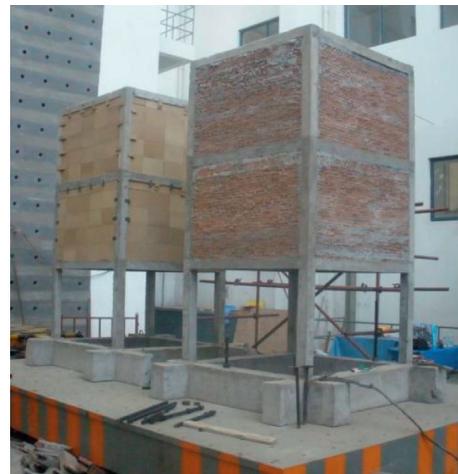
FIGURE 8: Test structures on shaking table.

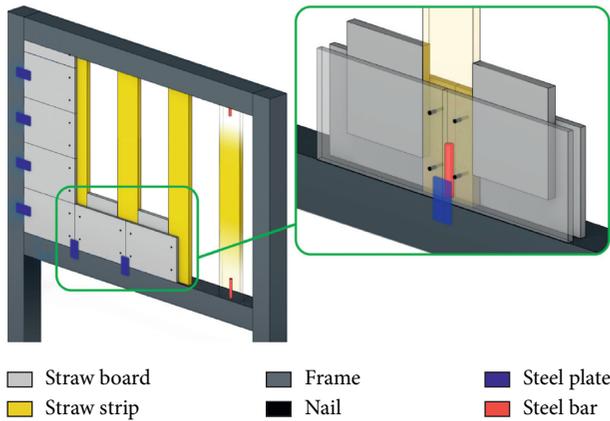
FIGURE 9: Connections between straw components and frame.

the straw wall. The straw strips, with the basic geometric size of 120 mm × 18 mm × 900 mm, could be perfectly stuck between two horizontally adjacent straw boards, as shown in Figure 9.

- (2) Straw strips and frame beams are fixed by embedded parts to avoid slipping and falling off during the vibration. The 10-centimeter-long steel bars in Figure 9 acted as the embedded parts whose diameter is 12 mm. Proper holes were reserved at the ends of the straw strips for the embedded parts.
- (3) To prevent the straw wall from falling off or tilting out of the frame, steel plates were used to fix the straw wall to the frame. The steel plates were coated with glue to ensure the connection between the straw wall and frame.

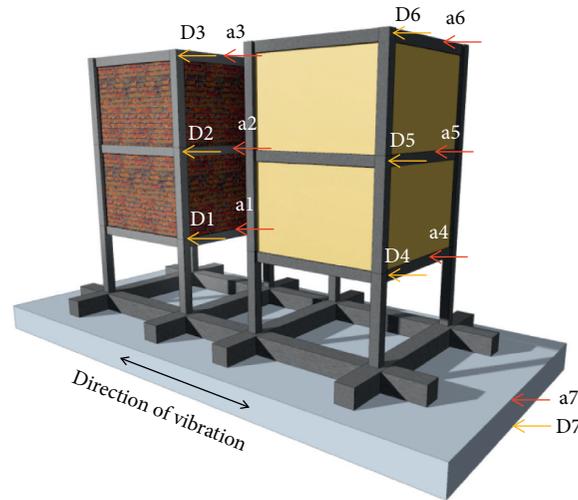
FIGURE 10: Layout of measuring point.

3.2.3. *Measuring Point Layout and Data Collection.* After the models had been installed, the measuring points were arranged. 7 magnetic accelerometers (numbered a1–a7) and

7 pull-wire displacement meters (numbered D1–D7) were employed during the tests. An acceleration sensor and a displacement meter were arranged on the ② axis and ④ axis of each floor elevation, roof, and vibration table base of the models, as shown in Figure 10.

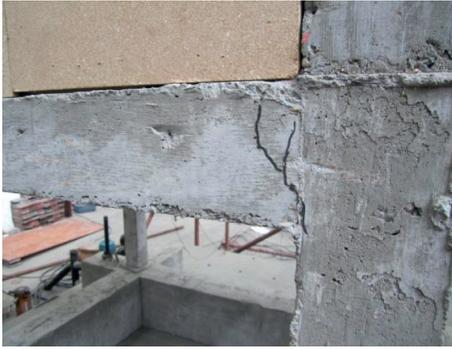
FIGURE 11: Diagonal cracks in a beam of straw frame.

- (4) Under the PGA of 220 cm/s^2 , micro cracks on the top of the bottom column in the brick frame began to expand, and cracks appeared in all four columns with a maximum length of 6 cm. Meanwhile, diagonal cracks took place in both ends of the 1st floor beams in the straw frame, as shown in Figure 11.

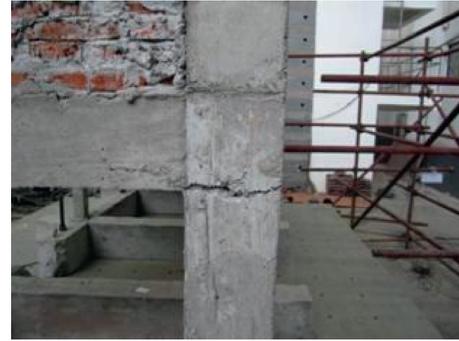
FIGURE 12: Crack in the bottom column of brick frame.

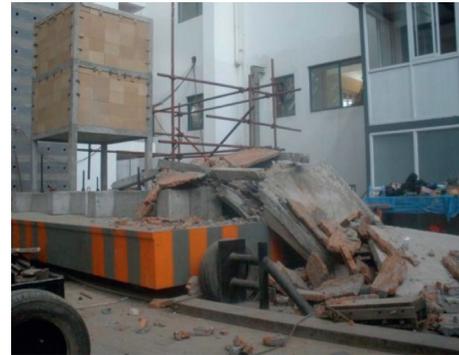
FIGURE 13: Crumble of the brick frame.

(8) Under 1100 cm/s^2 , the bottom columns in the brick frame were twisted, the top of which showed obvious plastic hinge characteristics. The bottom columns in the straw frame twisted in a low amplitude. The local cracks of the brick wall were slightly developed, and the overall performance was good. The straw wall of the top layer of the A axis showed an outward inclining trend. At 1400 cm/s^2 , the maximum width of cracks in the bottom column in the brick frame is around 5 mm, as shown in Figure 12. The cracks in the brick walls still developed locally and the walls still presented good integrity. The cracks at the beam ends on the 1st floor of the straw frame are about 3 mm, which all extended to the full sections. The straw wall at the top of axis A was about to crumble. At 1800 cm/s^2 , displacement of the top layer in brick frame became too big. As the bottom column broke, the brick frame overturned as a whole, as shown in Figure 13. Straw frame remained intact.

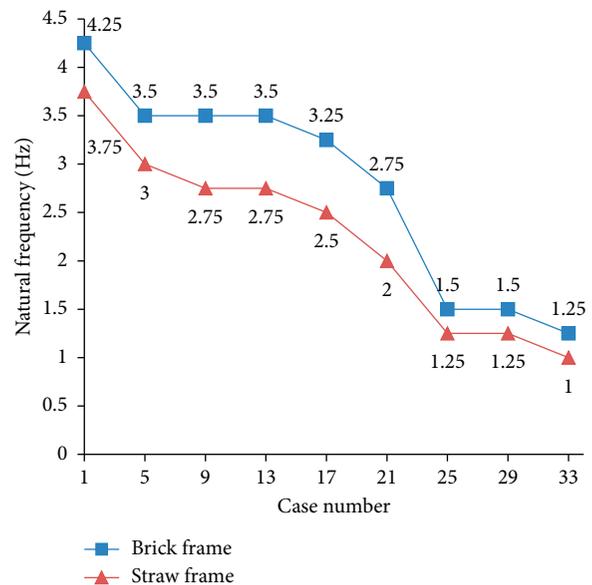
FIGURE 14: The frequencies of models in different cases.

3.3.2. Dynamic Characteristics of Structure. White noise was input on the table before and after the earthquakes at different cases. By performing frequency spectrum analysis on the horizontal acceleration data collected by the acceleration sensor under the action of white noise, the amplitude-frequency curve of the transfer function was acquired. So, the frequencies and damping ratios of the structures were obtained, which are shown in Figures 14 and 15 .

Results show that the attenuation law of the first-order frequency of the two models is basically the same, but the main reasons for the stiffness loss of the testing structures are different. It is also deduced from the damping ratios curve that the straw frame consumes more energy than the brick frame. Apparently, the straw frame with flexible connection has strong energy consumption capacity and is safer than brick frame structure under the action of big earthquakes.

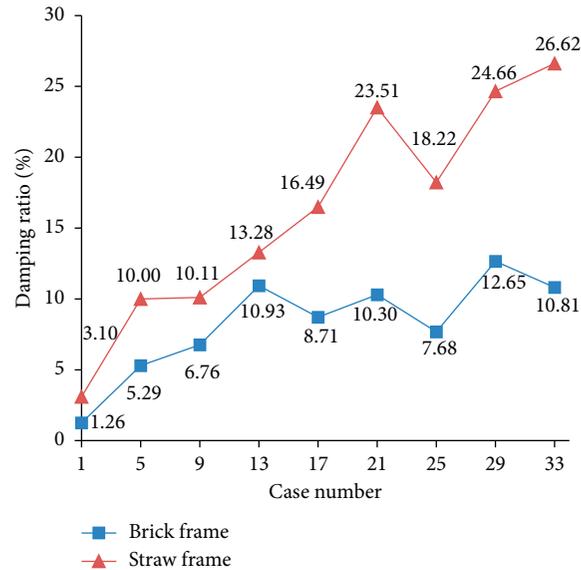
FIGURE 15: Damping ratios of models in different cases.

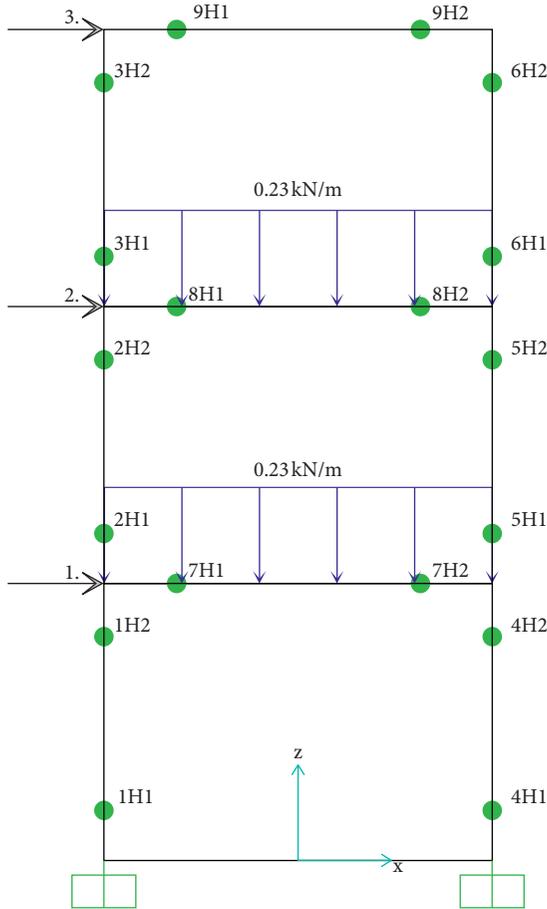
FIGURE 16: FEM model of straw framework.

4.1. FEM Models. By using SAP2000 (version 22.1.0), numerical analysis models of frameworks were built based on experimental structures. The only difference of FEM models was the way that those infill walls were considered. Compression struts, with no mass, were adopted to represent the stiffness contribution of masonry walls, as code ASCE/SEI 41-06 [17] proposed. The width of strut was the same with the thickness of masonry infill walls, namely, 40 mm. And the depth of strut was calculated based on (equation (7)) [17], which was 148 mm. With low elastic modulus and

flexible connection, however, straw wall was treated as nonstructure component, whose stiffness was ignored. Both the self-weight of masonry bricks and straw panels were considered as vertical linear loads on beams.

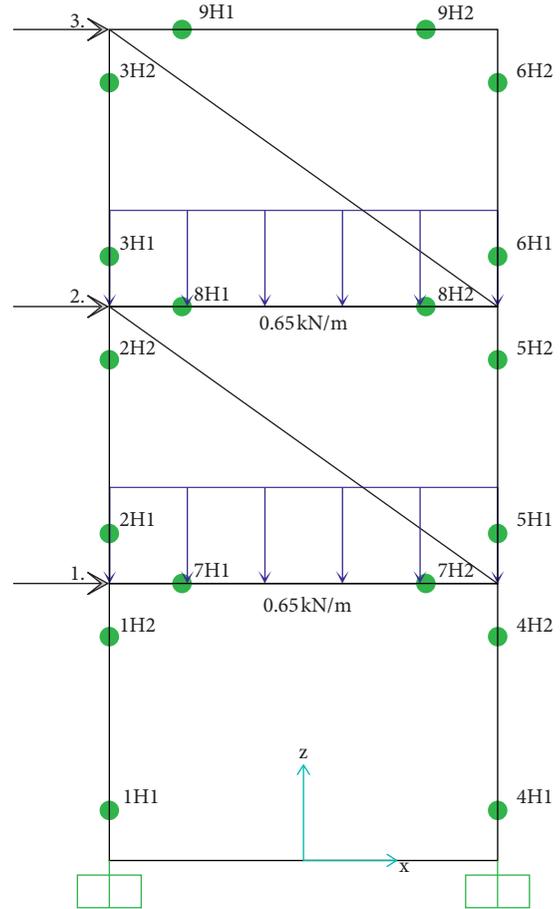
FIGURE 17: FEM model of brick framework.

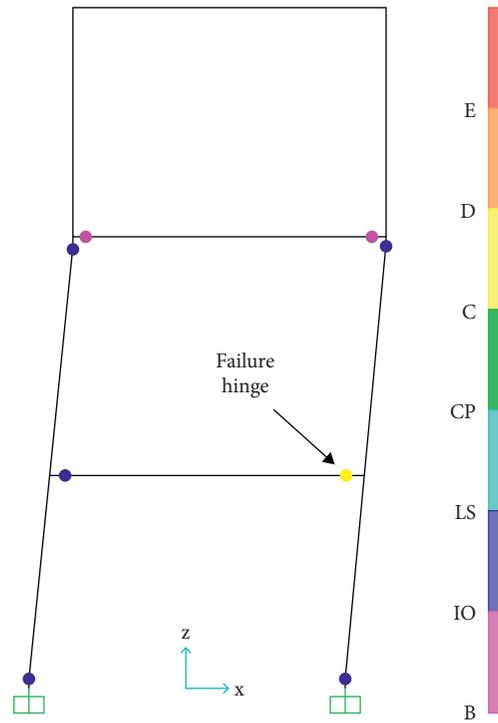
FIGURE 18: Hinges distribution of straw framework.

4.2. Numerical Results and Discussion. As pushover analysis proceeded, plastic hinges took place. Figures 18 and 19 show records of the pushover steps, where first hinges that reached C stage [16] appeared. In the straw framework, the first failure hinge emerged at the beam end of the 1st floor, while 7 other hinges appeared in other beams and columns. In the brick framework, first failure hinges took place only

With the difference of these structures produced by unequal stiffness, the failure modes differ. Numerical analyses show that the first failure hinge took place at the end of the 1st floor beam in the straw frame, while the first failure hinges appeared at the ends of the bottom columns in the brick frame, which accords with the experimental observations above. Failure of beams undoubtedly brings about local damage, while it sometimes in turn protects the structures by absorbing and dissipating part of the seismic energy. However, as vertical load bearing members, the failure of columns would lead to the collapse of the whole structure. This is the reason why the Chinese code [7] recommends the notion of strong column and weak beam, making sure columns fail after beams to protect the living at its best in seldomly occurred earthquakes. In a word, straw frame presents better seismic performance than brick frame.

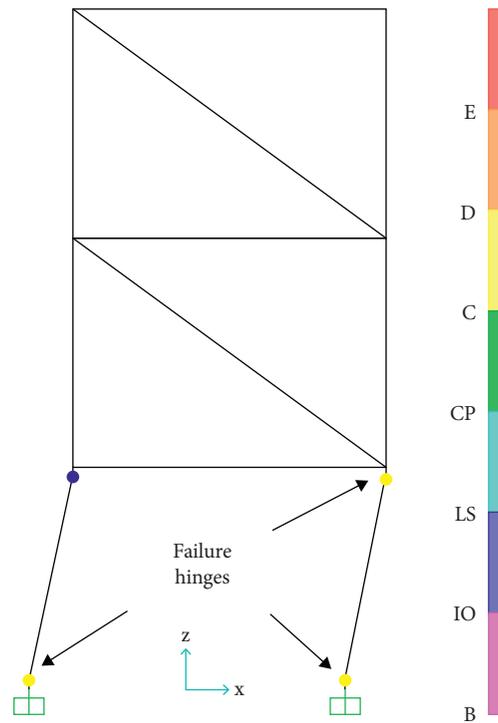
FIGURE 19: Hinges distribution of brick framework.

at the column ends of the 1st floor. Table 8 lists the displacements, story displacements, and story drifts at the time.
