An Analysis of Loess Tunnel Failure and Its Mechanism

Shuai Shao, Shengjun Shao

Department of Civil and Architecture Engineering, Xi'an University of Technology, No. 5 South Jinhua Rd., Xi'an 710048, China

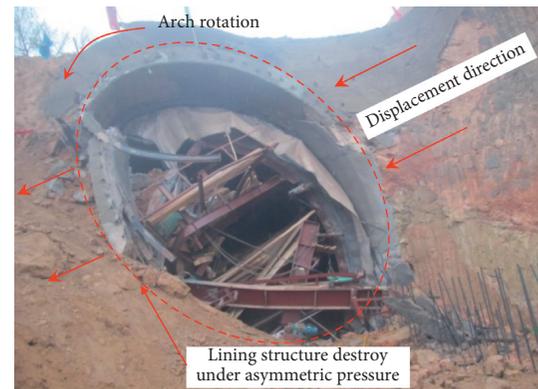
2.1. Tunnel Collapse due to Asymmetric Pressure. Due to the development of the gully cut, large terrain changes often give rise to asymmetric pressure on the entrance and exit of loess tunnels. Also, gully development will bring about shear deformation of the slope soil, weakening the soil structure and the resistance of the slope against landslides. Meanwhile, when the slope is steep, due to the poor rock surrounding the slope and its orthogonal cross section, on the one hand, the slope would face a rather large load of asymmetric pressure. On the other hand, the soil strength will decline as the shear further develops with the tunnel excavation. The slide and deformation of the slope together with the subsidence of the arch foot will dysfunction the supporting structure as a whole, at length, leading to the collapse of the upper stratum soil. As shown in Figure 1, a typical feature of this type of collapse is that it is dependent on the mountain and that the tunnel is subjected to high lateral pressure while the tunnel is only shallowly buried. This belongs to the collapse problem of the collapsible loess shallow tunnel under the effect of asymmetric pressure on the cross section slope. Damage often occurs on one side of the tunnel, which bears less stress than the other. In constructing this type of tunnel, the

FIGURE 1: Tunnel collapsed under asymmetric.

principle of “short excavation, strong support, early closure should be followed, and its distribution of surrounding rock pressure should be readjusted, in a bid to prevent the tunnel ground shear slip and arch-end subsidence deformation caused by the development of rock surrounding deformation.”

Loess tunnels built under asymmetric pressure require ground treatment when the surrounding rock above the vault drops or even when the entire loess stratum sinks, as there is no internal support, while landslides occur. A rather effective way is to reload and limit the development of the slope shear deformation and enhance the inside support of early lining. First, to reduce asymmetric pressure, the slope on the lining structure is excavated and filled to reload on two sides and avoid the stratum collapse and destroy the lining structure. Then, to support the collapsed body and limit the displacement of two sides of soil mass, the ground masonry rubble and the shotcrete protection are conducted. Last, the toe of the slope, which conducts the asymmetric pressure, is enhanced by the retaining wall to support the surrounding rock, so as to help the tunnel travel through the slope as shown in Figure 2. In the initial stage of excavation, an additional cross-wall against lateral unbalanced soil pressure on both sides should be set up in the early lining hole.

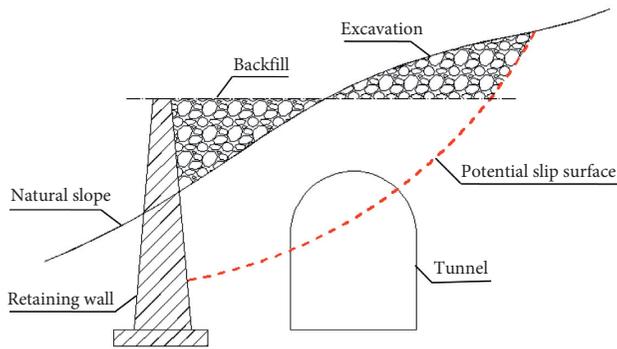
FIGURE 2: Schematic diagram of reloading method.

homogeneous soil but also with nonhomogeneous soil, development of underground cave, natural slope, and weak intercalation. It can not only adapt to the surrounding rock of loose loess but also denser old loess as well as different loess geological units. When the support structure is weak, the parameters of the tunnel section with largely different mechanical properties of surrounding rocks do not conform to the actual condition as reflected in actual construction, represented by insufficient bearing capacity of loess foundation under the arch foot of the lining structure, and the large settlement in skewback of collapsible loess, also leading to large development of settlement of the vault. Landslide is caused by destruction of the support structure and deformation development of the weak surrounding rock.

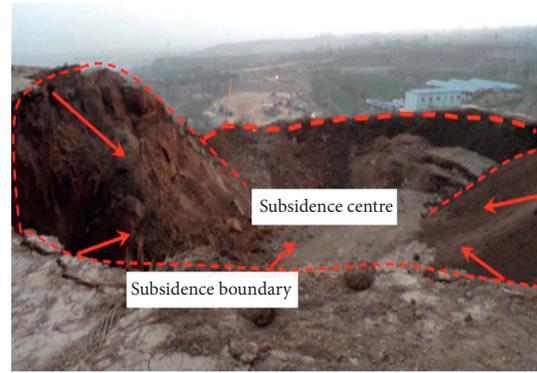
The entrance to the loess tunnel is located on a shallow buried loess slope and the excavation disturbance has caused large loess slides in the tunnel section. The loess was deposited on a gully developed by natural cutting of ancient landforms and mountains. The new loess (Q3 and Q4) deposited by different migration methods is thicker and is often buried at a shallow depth in the tunnel construction when the trench is first to cut in front of the tunnel inlet and then into the tunnel section. The foundation and the surrounding rock of the shallow-burying tunnel include new loess with loose soil quality, which settles under later construction. When the support structure is weaker, the lining structure is closed later, the foundation of structure skewback is gradually damaged, and compression settlement is increased, the settlement of the vault is large, and stability of the surrounding rock decreases with structural attenuation of excavation. Damage to the soil beneath the structure reduces the bearing capacity of the surrounding rock, and the collapse of the strata at the top of the vault causes the sidewalls and retaining walls to slide towards the tunnel excavation space. The damaging of soil mass on two sides of the tunnel shallowly imbedded in new loess lead to collapse of the overlying layer above the arch, as shown in Figure 3. The stronger the characteristics of damage of soil mass on two sides of the tunnel, the greater is the sliding scale and the collapsing deformation of strata above the arch.

FIGURE 3: A wide range of surface subsidence.

By putting up the horizontal support inside the lining structure and restricting the lateral shift of the lining structure, the stability of the surrounding rock and its lining structure is improved to control the settlement development

of strata above the vault. By shortening the support time of the surrounding rock, reinforcing the skewback foundation, and timely closing of the lining structure, the stability of the surrounding rock and its lining structure is also enhanced. And, when the loose overlying layer is thicker, support of the surrounding rock and the lining structure is enlarged to maintain stability.

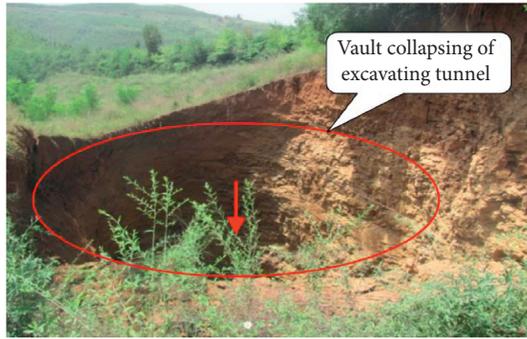
The vertical fissure in the loess is developed, and it leads to the collapse of the overlying soil mass on the tunnel arch. Besides, influent seepage of excess surface water forms a butterfly shaped concave, damaging the original structure of the soil, and thereby forming a vertical transfixing fissure plane on the outer side of the concave. The soil column in the concave applies pressure to support the structure of the vault. When the support structure on the vault cannot bear the vertical load of the overlying soil column formed by fissure development, or when the concave develops to form the load of the soils column, the support structure is damaged to cause the vault collapsing, as shown in Figure 4.

FIGURE 4: Vault collapsing of excavating tunnel.

Erection of grouted anchor pipes or advance support with pipe tops to restrain vault settlement, as a means of locking the anchor pipes of the lining structure and increasing anchorage, can effectively control vault settlement. By increasing the vertical support structure, decreasing the excavated section, timely closing of the lining structure, and enlarging the lining structure, the stability of the surrounding rock and the lining structure is improved significantly.

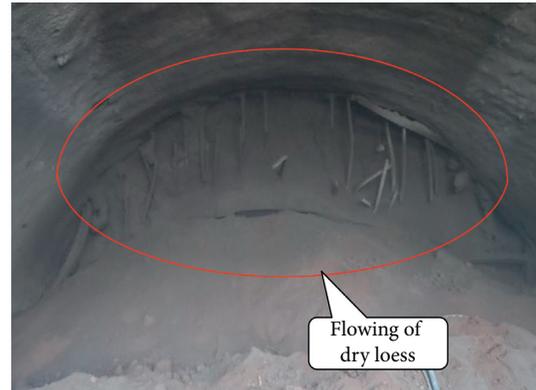
damaged, excavation face destabilizes, the support effect for soil mass of excavation face is lost, and then the overlaying soil mass on the vault may collapse. The collapsed soil mass accelerates flowing of soil onto excavation face. The flow failure caused by excavation is as shown in Figure 5.

FIGURE 5: The dry loess flowing on excavation face.

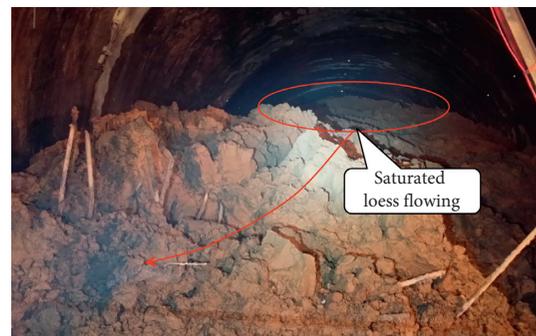
After the loess with a large porosity ratio is immersed and saturated, the original structure of the loess Q_3 and upper Q_2 is destroyed largely by subjecting to collapsing deformation disturbance. When the deformation is caused by excavating, the loess structure will change further. If a soft plastic consistency or a fluid plastic consistency is reached, a debris flow will occur at the excavation face as shown in Figure 6. The disturbance in the processing of excavation and construction can be decreased by setting anchor pipes on excavation face to soil mass.

FIGURE 6: The saturated loess flowing on excavation face.

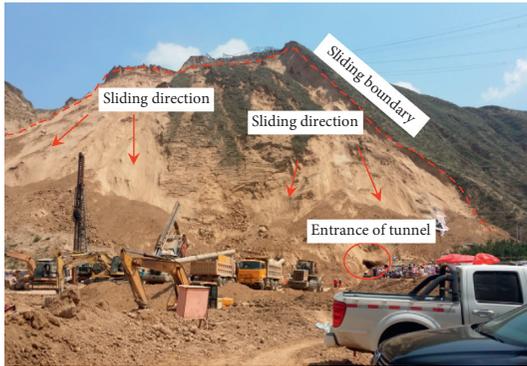
redistributed. The settlement of overlaying soil mass on the vault and shearing deformation of excavation face can enhance the loess mass breakage. When the compression stress is unloaded by excavating the space of the tunnel portal, the support action of soil mass at the slope foot is not enough to maintain the stability of the slope, or when the vault collapses and the lining structure is destroyed, the whole stability of slope may be lost, resulting in general sliding, as shown in Figure 7.

As a whole, engineering geologic condition of the natural loess slope is poor. In constructing the loess tunnel with a large-span section, the sliding damage is caused by the deformation developing under the cutting slope and unloading at the entrance, and the whole stability reduces in the evolutionary process of structural property distribution of soil mass. The destabilization of the overlaying slope also damages the supporting and lining structure at the entrance. The construction of the entering tunnel in the loess slope must follow the principles of grout pipe (grout pipe or long grout pipe shed), short excavation (controlling the excavation length, decreasing the disturbance of the surrounding rock), strong support (anchoring, reinforcing net, steel arch supporting, jetting concrete), quick closing (after excavating the short length and supporting the vault and the lateral wall, timely closing of the invert arch), prohibit damage caused by blasting (in constructing the tunnel, not utilizing the blasting excavation to lower disturbance of the surrounding rock), high-quality grout (in spacing of grouting pipe distribution, guaranteeing the grouting effect), frequently measure

FIGURE 7: Front slope sliding.

(timely monitoring of the vault settlement, horizontal convergent deformation, surrounding rock pressure, law of support and lining structure, to facilitate timely adjustment of parameters of excavation outline, control over excavation and under excavation), form early closed ring (preliminary support closing as early as possible and forming a whole stable structure).

To avoid destabilization of the cutting slope in constructing the tunnel entrance, the excavation length of upper, middle, and lower steps are limited reasonably by considering the geologic conditions of the surrounding rock. The water proofing system on the loess plateau and mountain, and drainage system of the slope at the entrance should be constructed well before excavating the tunnel hole. According to the settlement of the vault, the supporting method, and stability of the surrounding rock, the long grout pipe shed is constructed, and the distance from the invert arch to heading face is limited reasonably. Because the displacement of excavation boundary in the loess tunnel occurs before an invert arch is not closed, the invert should be closed as early as possible, and the second lining structure should be timely constructed properly at the tunnel entrance. The selection of a reasonable excavation method can effectively control deformation of the surrounding rock, prevent cracking induced by different settlements, or even the landslide of the slope. In the process of excavation, the over excavation prohibited strictly softens the primary support effectively controlling the strata settlement on the vault.

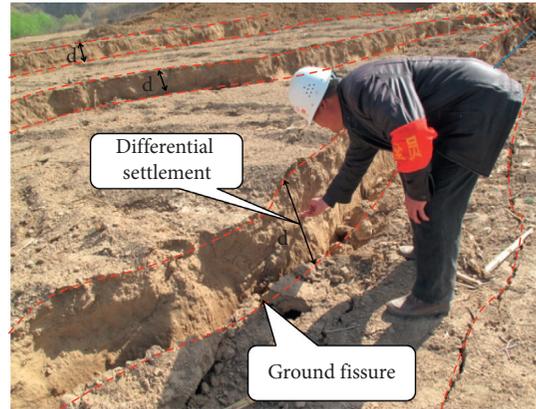
The bearing capacity of loess foundation is low, and the stability of the arch foot is bad. In the construction course, because the primary lining is not enough to support the loading of the surrounding rock, the settlement of soil mass on the tunnel vault is large. Along with the settlement of primary lining and soil mass on the vault, the cavity slump influences the safe work practices. The change and adjustment of stress yield in construction of the shallowly buried loess tunnel causes the displacement of loess mass. It is easy to lead to ground fissures, and has a great influence on geoenvironment and buildings, as shown in Figures 8 and 9. This kind of deformation, developed from the vault to the surface, can form an uneven settlement groove with a certain range on the ground and in short duration. Thereby, the

FIGURE 8: Ground fissure and differential settlement.

Ground settlement and surface crack on the loess tunnel are easy to form in the low-lying land where the ground runoff yield comes together and the seepage flow in the strata channel appears. The surface water in the low-lying land seeps and continuously moves downward, and centralizes on vault of the lining structure, and continues to seep into tunnel foundation along the outer channel of the lateral wall of the lining structure. The humidification of overlaying soil mass on the vault causes its deformation, leading to further development of ground settlement and crack. The increased moisture in the foundations causes the lining structure to settle, which leads to cracks in the lining structure. The seepage channel is closed by cutting groove and backfilling surface to bare ground fissure. The rainfall seeping in low-lying lands is drained out by drainage passage to avoid loess collapse deformation by immersing.

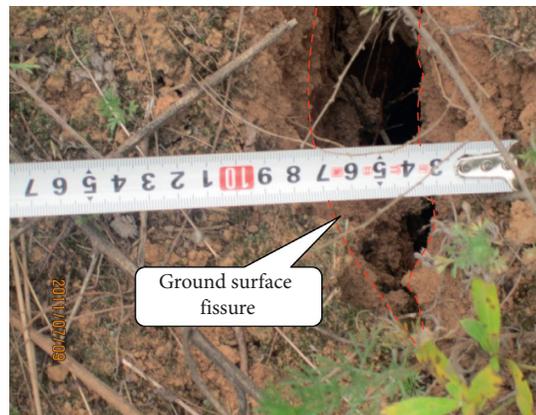
FIGURE 9: Ground surface fissure.

wedge body with a tendency toward sliding on upside loess of the excavated tunnel is developed to create the horizontal shift of two sides of the tunnel center, which points to the direction of the tunnel center line. There is a point with the largest horizontal shift on two sides of the tunnel center line, which is also located at the position of inflection point of surface vertical displacement.

Soil mass on vault settling toward excavated free face causes the sliding wedges of the upper loess on the tunnel extending toward the two sides. When tension stress or shear stress of sliding plane is greater than soil strength, the actual damage face is formed. When the sliding wedge moves downward and cracks the ground, the settlement on the vault becomes too large, and the lining structure destabilizes, resulting in landslides. After the formation of the upper sliding surface of the loess slope, the loess bodies on both sides of the tunnel squeeze each other. And the actual shear surface on the lower part is closed instead of opening shallow stratum. When the slide surface extends through to the surface, it is damaged due to tension stress equaling to soil tensile or shear strength, and a visible crack is formed due to good verticality of loess column.

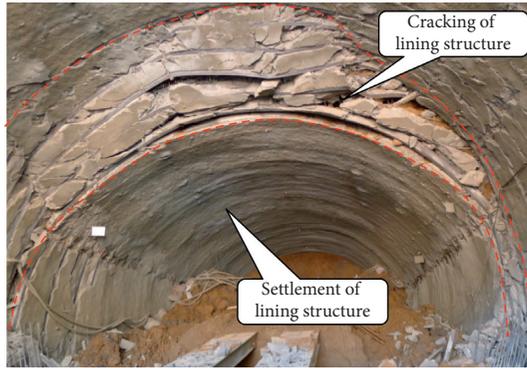
FIGURE 10: Cracking and settlement of the preliminary lining structure.

capacity rapidly. Especially after the immersed loess at skewback takes on the flow mold state, the bearing capacity is obviously inadequate, leading to settlement of the arch feet, and the preliminary shotcrete lining suddenly cracks, and steel grids severely flex and deform. If this is left untreated for long, ground fissures will appear and trend to further development. If the arch structure on the vault cannot meet to support the pressure of the surrounding rock, the overlaying strata will become loose rapidly. And when the loess foundation is sheared under self-weight or additional load and self-weight, soil structure will be damaged rapidly, and bearing capacity rapidly declines, making the surrounding rock disturbed by excavation rapidly lose self-stabilization capacity. While collapse and deformation develop, the lining structure can crack or even be damaged. If support measure fails to meet requirements on controlling surrounding rock deformation and applied load on the arch structure, sliding and vault collapsing up to surface is easy to occur.

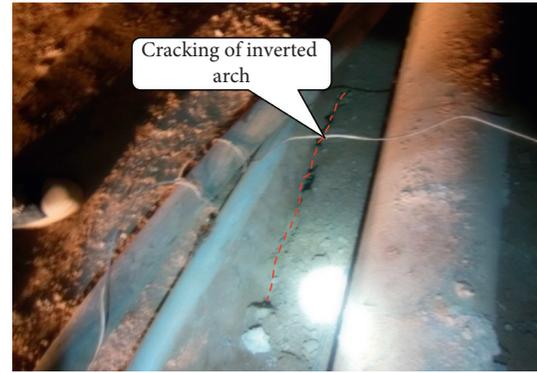
FIGURE 12: Cracking of the inverted arch.

Even after permanent lining structure is constructed, additional settlement produced by loess immersion and an increase in surrounding rock pressure will also cause too large additional stress of lining structure to avoid the structure crack. The longitudinal crack on inverted arch is as shown in Figure 12. The inhomogeneous settlement between tunnel foundation center of inverted arch and arch

feet makes inverted arch produce tension stress, which is greater than tensile strength of concrete and induces inverted arch cracking. The sidewall cracking of secondary lining structure along longitudinal direction on arch foot, on which outside earth pressure acted and reduce the support force of inverted arch, is as shown in Figure 13. The obvious settlement difference between sidewall on arch foot and inverted arch leads to shear damage of the foundation. After the loess outside sidewall is immersed, the lateral earth pressure increases, the concrete on the inner side of tunnel is tensioned, causing crack along the longitudinal direction, as shown in Figure 14. The transverse crack caused by different settlements in the longitudinal direction is as shown in Figure 15. Because of unloading fissure developed and asymmetric earth pressure of tunnel entrance in the slope, the difference of foundation settlement is large. When the difference of foundation settlement is significant along longitudinal direction of the tunnel, a transverse crack is created. Even transfixing crack is formed on inverted arch, the sidewall, and the vault arch. The ground water can infiltrate into foundation along a transversal crack to aggravate nonuniform settlement in the entrance tunnel.

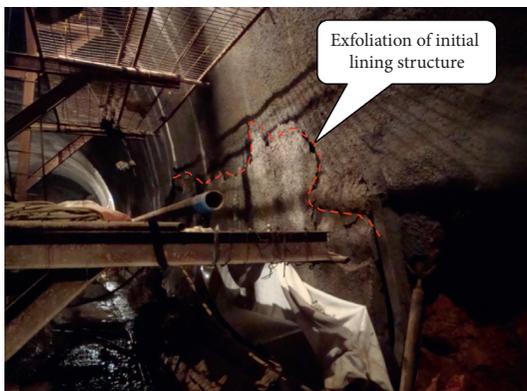
FIGURE 11: Exfoliation of the preliminary lining structure.

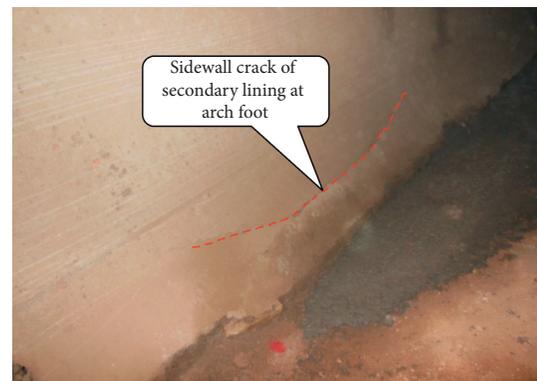
FIGURE 13: Crack of secondary lining at arch springing.

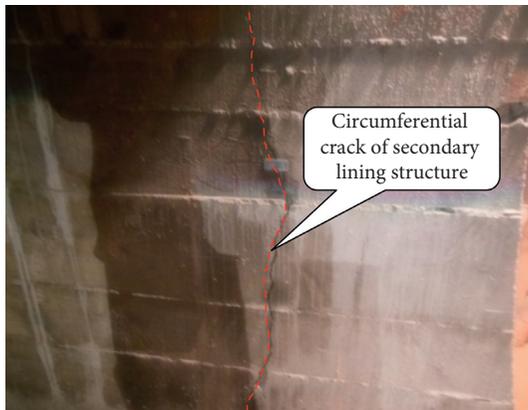
FIGURE 15: Circumferential crack of secondary lining structure.

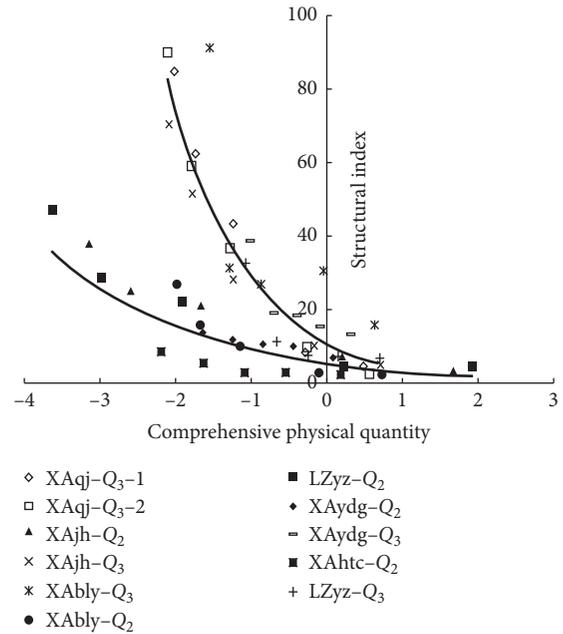
FIGURE 16: Relationship between the structural index of loess and the comprehensive physical quantity [11].

structural index, the greater the strength change of soil subjected to immersion and disturbance is, and the potential danger to the project is much greater. As for collapsible loess, the strength decreases greatly after encountering water, and it has great influence on the soil structure. It shows that flooding is the dominant factor causing the soil structure to be destroyed. Similar to disturbance sensitivity of undisturbed soil, the product of disturbance sensitivity of unsaturated loess and that of immersion sensitivity can be defined as generalized sensitivity [11]. The relationship between the generalized sensitivity and the comprehensive physical quality of loess in different sedimentary ages is as shown in literature [1], where generalized sensitivity expression of loess has been established in different sedimentary ages.

$$Q_3 \text{ loess: } s = 10.7e^{-0.98 \cdot (I_L \rho_d / (\rho_w e_0))} + 1, \quad (1)$$

$$Q_2 \text{ loess: } s = 6.75e^{-0.52 \cdot (I_L \rho_d / (\rho_w e_0))} + 1. \quad (2)$$

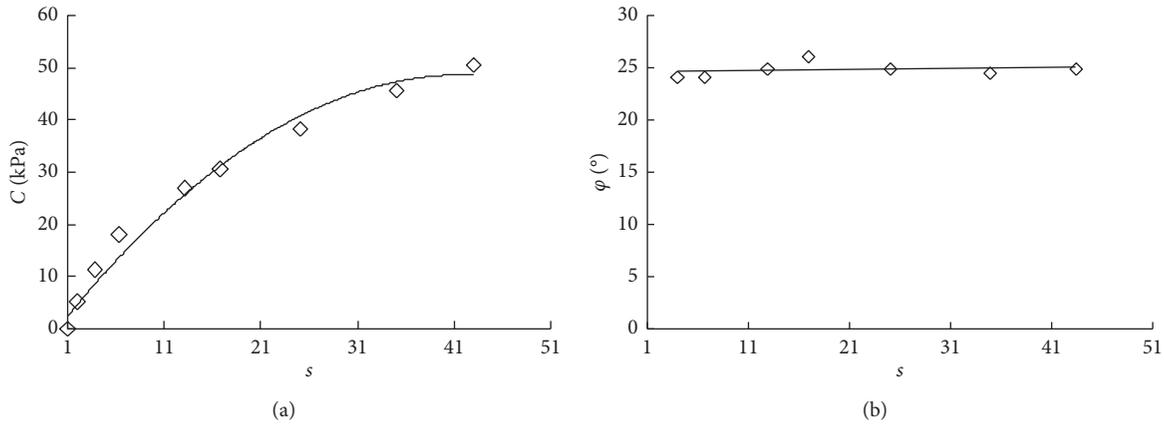
FIGURE 17: Relationship between structure parameter and cohesion. (a) Variation of cohesion with generalized sensitivity; (b) Variation of internal friction angle with generalized sensitivity.

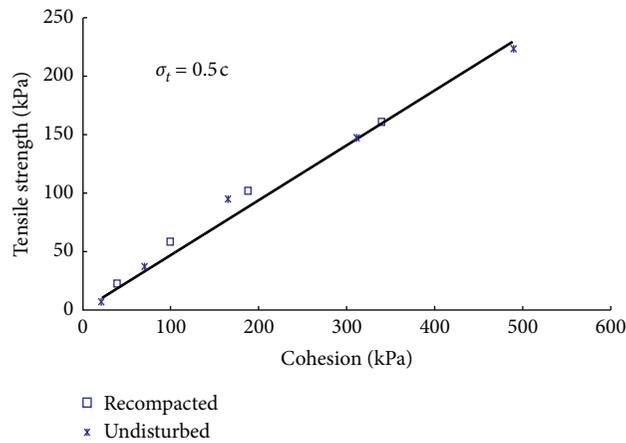
FIGURE 18: Relationship between cohesion and tensile strength.

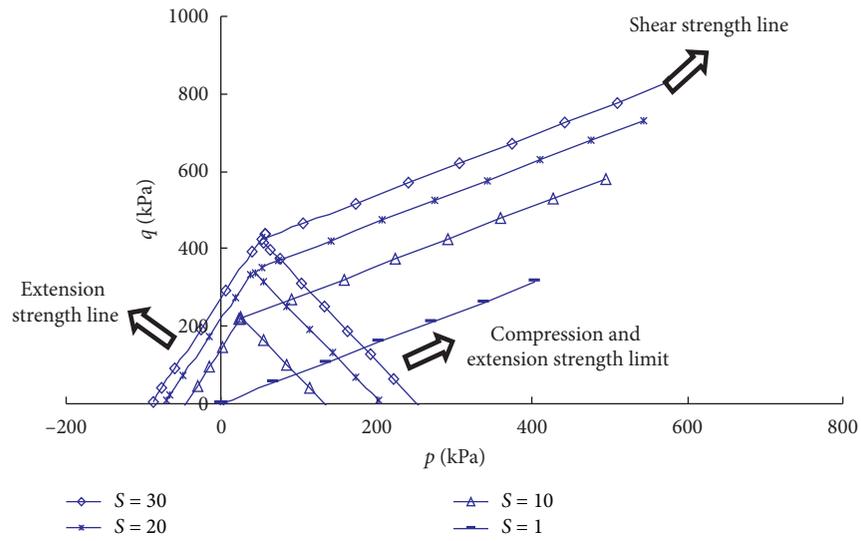
Considering that cohesion and tensile strength are affected by the decrease of generalized sensitivity, the corrected Mohr–Coulomb strength failure surface is shown in Figure 19.

FIGURE 19: Modified Mohr-Coulomb failure plane.

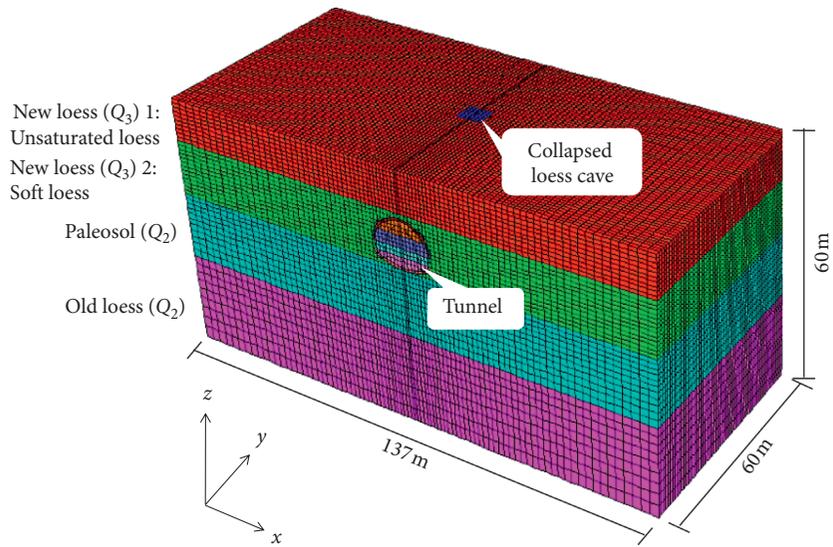
In order to reflect a variety of engineering failures, loess damage and fractures caused by excavation, vault collapsing, and mud flowing on excavated face in the process of excavation and slope sliding as well as other issues were simulated and analyzed, respectively. Two kinds of models were set up, as shown in Figures 20 and 21. A model mainly simulates the collapsed loess cave buried in different formations, which is caused by loess collapsing in the low-lying land; another model simulates the entrance tunnel at the overlying slope.

In these models, the solid element is adopted in the stratum. The preliminary lining structure of the tunnel adopts shell element, and the secondary lining structure of the tunnel and the filled concrete in inverted arch are linear elastic solid elements. Initial stress is calculated by Mohr–Coulomb elastic-plastic constitutive model, and tunnel excavation is conducted by simulating the three-bench method, as shown in Figure 22. The Mohr–Coulomb elastic-plastic model, in which strength parameters of surrounding rock soils decrease with structural attenuation, is applied in the process of excavation simulation. When the soil thickness on the vault is small and the generalized sensitivity is attenuated to 1, it is destroyed, and the residual

FIGURE 20: Computation model A.

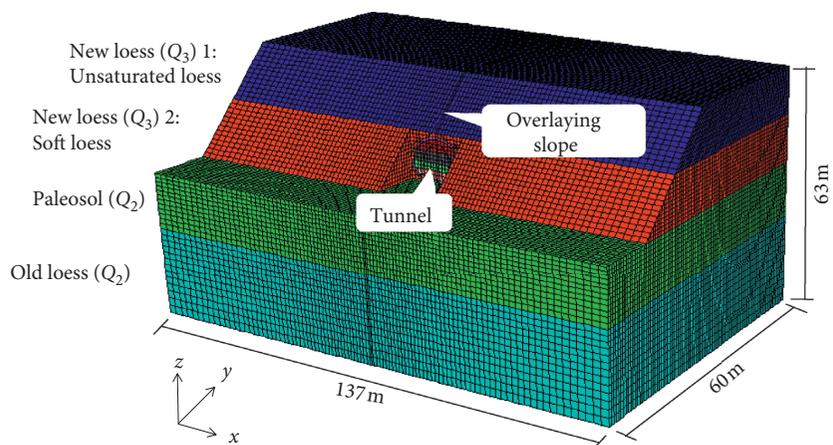
FIGURE 21: Computation model B.

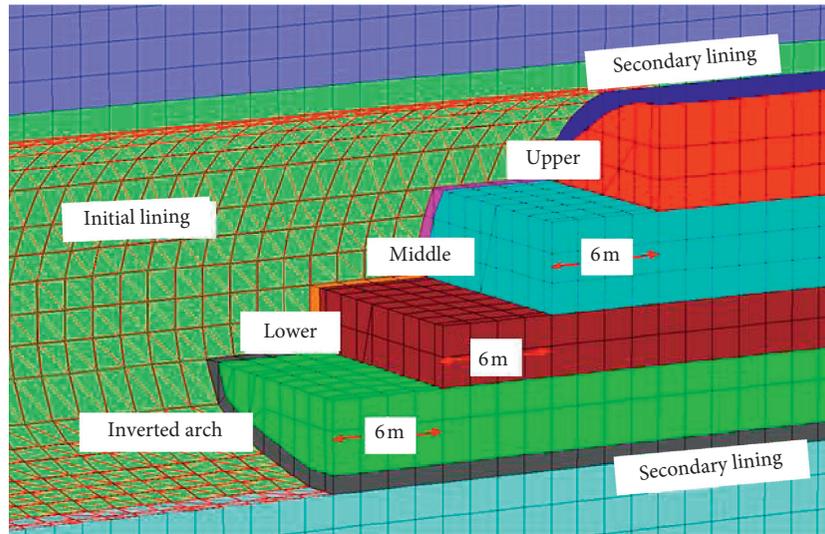
FIGURE 22: Simulation of three-bench method excavation.

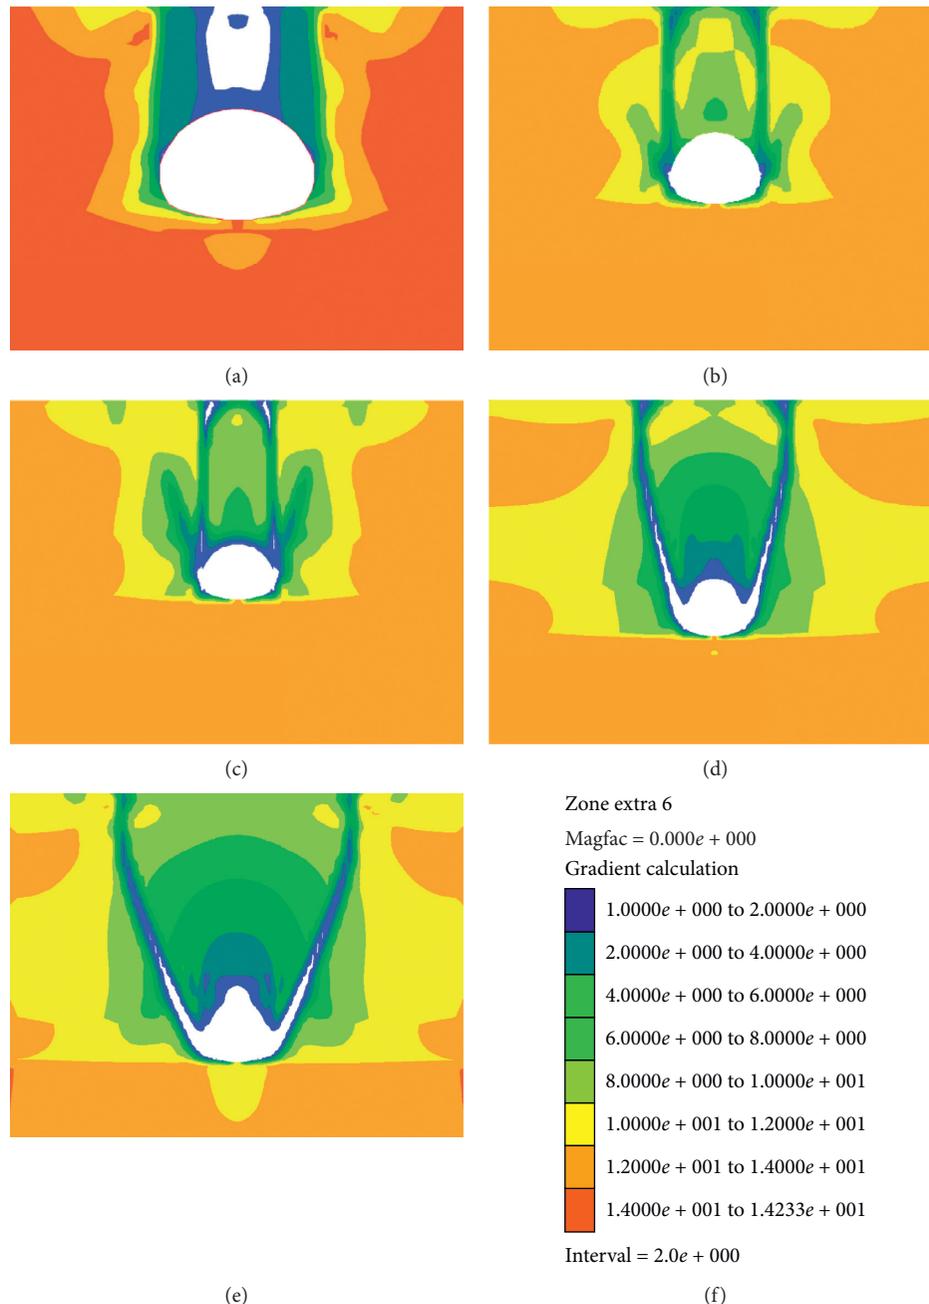
As can be seen from Figures 23 and 24, during the excavation of the tunnel, the structure failure zone (generalized sensitivity attenuated to 1) of the surrounding rock of Q_3 loess varies from center zone and two sides on the vault to two sides on arch shoulders, and increasing with the buried depth, the soil structure damaging curve surface forms gradually. After the

damage of the soil structure, there is basically no residual strength. When the buried depth is less than 30 m, the structure damage surface of the surrounding rock develops almost vertically toward the ground (the generalized sensitivity equaling to 1 in the white and blue area nephogram, which shows that the original structure of soil has been destroyed). The surrounding rock pressure is the soil-column pressure on the vault, and there is shear fracture on the surface above the tunnel. Due to the formation loess, a tensile plastic zone (red zone in plastic nephogram) is formed in a certain area of both sides of the ground, and cracks appear in the soil layer. From the shear crack to the tension crack at different locations, a table similar to that shown in Figure 8 has been formed. Under the condition of large buried depth (≥ 30 m), shear plastic zone develops outward the arch shoulder, and outward inclining angle is about 30 degrees. The soil column between soil structure damaging curve surfaces still mainly acts on the vault, on which vertically shearing is developed at arch shoulder. Shear plastic zone expanding to the outer side of shoulders still reaches to the surface, and plastic domain on vault develops obviously. At the same time, the pressure on the surrounding

FIGURE 23: Distribution of structural damage after tunnel excavation. (a) Depth: 10 m, (b) depth: 20 m, (c) depth: 30 m, (d) depth: 40 m, (e) depth: 50 m, and (f) generalized sensitivity.

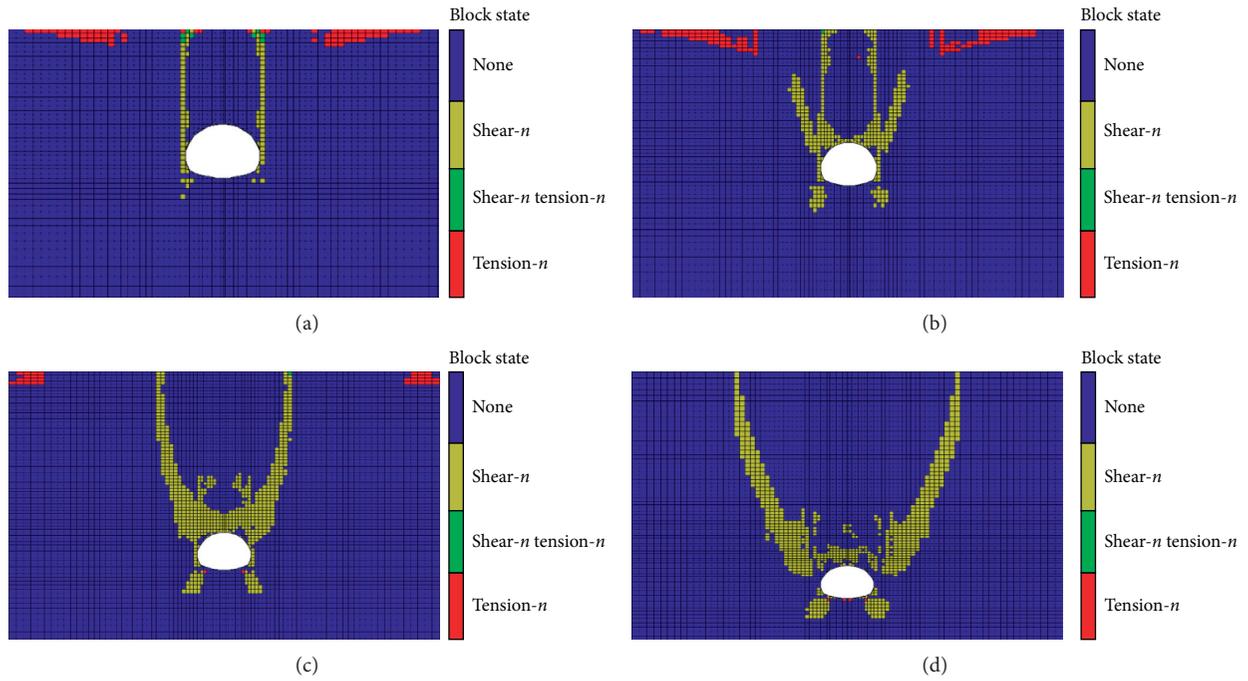
rock increases due to the expansion of the shear plastic zone on the arch where the tilt occurs. The shear plastic zone is neither the pressure of the soil column with two vertical shear plastic zones at the shoulder of the arch nor the pressure of the collapsed soil acting within the shear plastic zone tilted outwards. Developed shear zone leaning outward inhibits the tensile stress distribution of the shallow soil. Crack development in surface tensile plastic zone reduces significantly, and the location distribution is far from the tunnel centerline. Under the condition of buried depth of 40–50 m, outer inclining angle of shear band at shoulders gradually increases from 30 degrees to 45 degrees, and plastic domain of shear band leaning outward develops through the surface. Plastic region on the vault is obvious, and there appears obvious failure zone of sliding collapse soil mass. The surrounding rock pressure is mainly the effect of weight of sliding collapse soil mass within shear zone, and balanced by supporting of lining structure. There is no surface tension plastic zone responding to obvious cracks.

FIGURE 24: Distribution of plastic zone after tunnel excavation. (a) depth: 20 m, (b) depth: 30 m, (c) depth: 40 m, and (d) depth: 50 m.

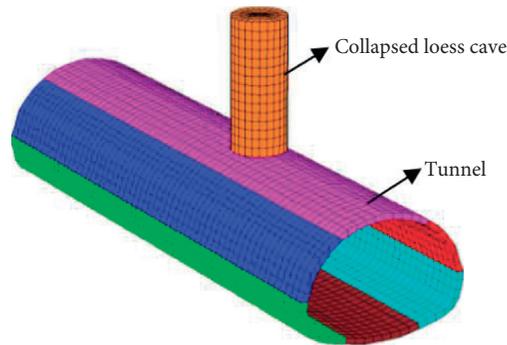
3.3. Evolution Analysis of Vault Collapsing. At the center of the tunnel axis of model A, a cylindrical body with 3 m diameter is set to simulate the effect of collapsed loess cave on the stability of the surrounding rock during the tunnel excavation. The depth of the tunnel is 10m, and the cylindrical body representing the collapsed loess cave is vertically connected to the vault. The relative position of the cylindrical body and tunnel is shown in Figure 25. In the course of collapsed loess cave development, the undisturbed structure of natural sedimentary loess is destroyed by immersing, thus the remolded loess in the cylindrical body is formed under the condition of moisture reducing after soaking. Compared with the undisturbed loess, the shear strength of the remolded loess decreases, and it has a significant influence on the safety of large-span tunnel excavation.

FIGURE 25: Diagrammatic sketch of collapsed loess cave and tunnel.

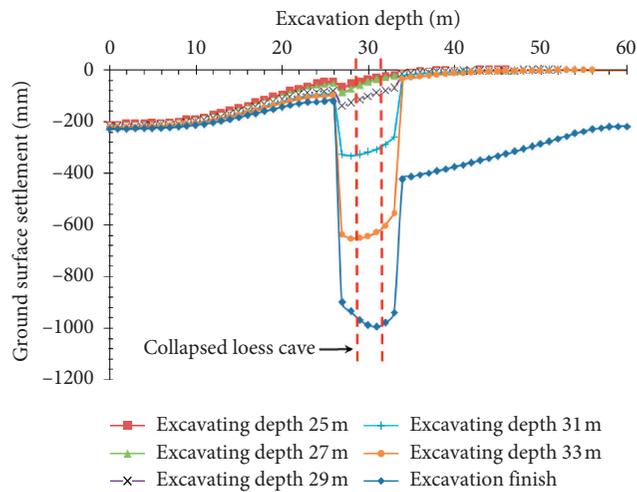
Settlement change of ground surface during tunnel excavation is as shown in Figure 26. When the tunnel excavation surface passes through the wet sinking loess cavern, the ground begins to settle significantly from the vault to the surface and the amount of settlement increases rapidly. When the working face goes across the collapsed loess cave until the end of model

tunnel excavation, the preliminary lining is not closed and the secondary lining support is unfinished, and deformation of collapsed loess cave and surrounding rock has not reached the convergence condition. Compared with the deformation of undisturbed loess, once the collapsed loess cave is disturbed by excavation, it will cause rapid settlement and deformation and lead to deformation destruction of the surrounding rock, resulting in vault collapse and other engineering accidents.

FIGURE 26: Ground settlement during passing through the collapsed loess cave.

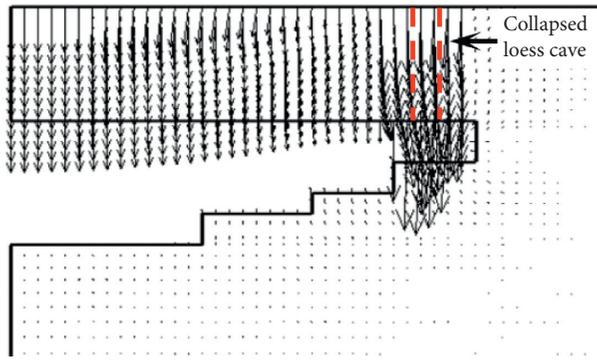
Figure 27 shows the stratum subsidence vector diagram that the tunnel goes across the collapsed loess cave. It can be seen that the form of collapsed loess cave failure is characterized by the overall settlement deformation failure in the process of

large-span tunnel excavation, and the influence depth is large and the range is wide. For large-span loess tunnel, loess structural unit is damaged, pore collapses, and fabric suddenly changes with the development of deformation, with brittle failure characteristics; at the same time, the tunnel excavation will cause more intense disturbance to the soil column of the collapsed loess cave; thus, the soil structure of the collapsed loess cave is destroyed again, inducing the development of large deformation, so as to cause the destruction of undisturbed loess nearby and serious damage of the surrounding rock. The soil mass, which structure has been destroyed, acts on the preliminary lining structure, which requires increasing the bearing

FIGURE 27: Vector diagram of settlement during passing through the collapsed loess cave.

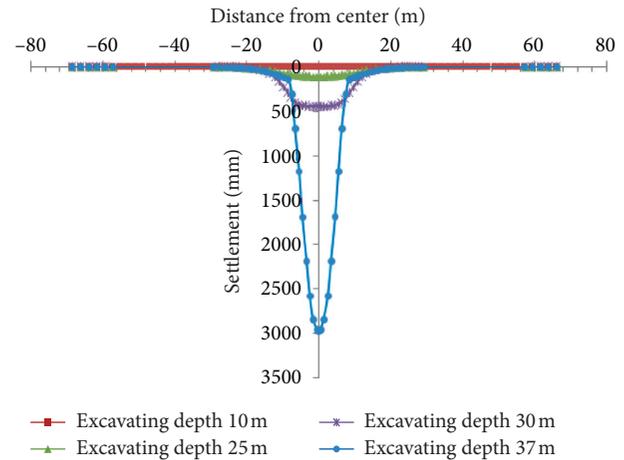
FIGURE 28: Tunnel vault settlement during excavation.

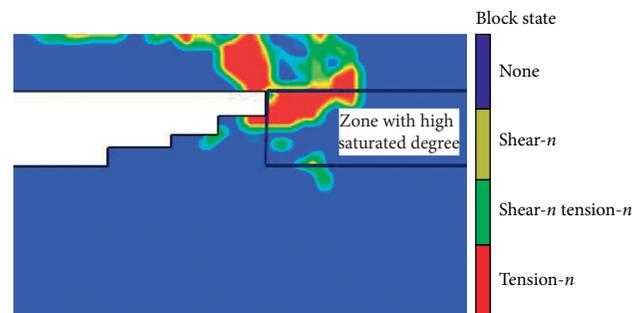
When the excavated face reaches the high saturated degree zone, the plastic zone of the surrounding rock is shown in Figure 29. Under the action of construction disturbance, the soil structure in the high saturated degree area is destroyed. With the development of the soil plastic deformation, the excess hydrostatic pressure is produced, thus the effective stress and shear strength of soil decreases. Soils in areas of high saturation develop large shear plastic zones and deform towards the excavation face, causing failure of the face. At the same time, with the large deformation of excavation face soil mass, vault soil and excavation face lose support, and then

FIGURE 29: Distribution of plastic zone when excavation face arrives at the high saturated degree area.

collapse. Therefore, the soil damage flowing of excavation face is essentially the combined mechanical effect of the surrounding rock on the vault, and excavation face deformation failure in longitudinal and vertical directions.

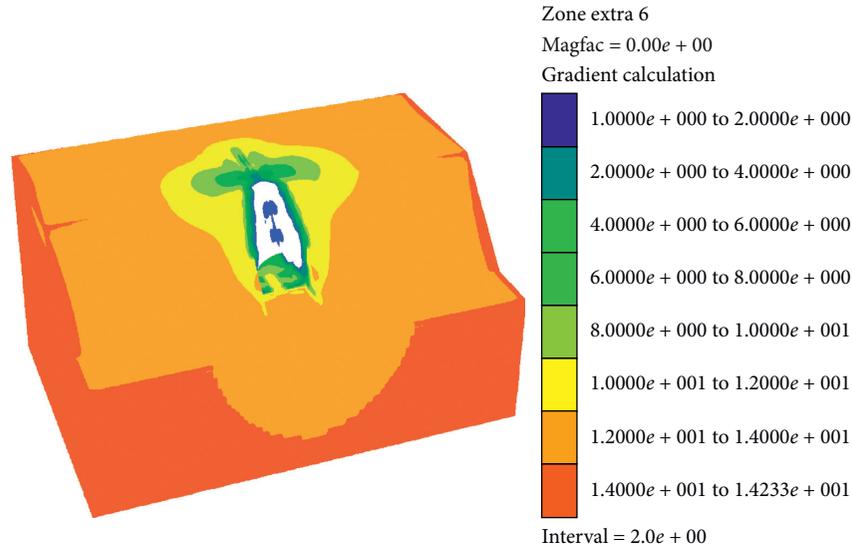
3.5. Instability Evolution Analysis of Overlaying Slope. The model B with tunnel entrance, passing into a slope with slope ratio 1, is set up. According to simulation analysis of excavating and supporting, the generalized sensitivity and plastic area distribution diagram of soil slope can be obtained, as shown in Figures 30 and 31. When the tunnel face is excavated up to 20 m, the structure damage area and plastic zone of soil slope with tunnel entrance are revealed, respectively. It can be seen that the slope destruction of undisturbed loess develops from the arch shoulder to the top of the slope forming two shear zones. A large area around shear zones forms a tension plastic zone caused by traction tension, which is through the top of the slope. The area, generalized sensitivity attenuating to 1.0, also develops from the vault to the top, and the scale of generalized sensitivity of soil attenuating at top expands to both sides of the tunnel. It is shown that the slope is subjected to shear, shear-tensile, and tensile action, resulting in the overall sliding shear failure of the slope and the collapse of the vault surface at the tunnel entrance. Therefore, due to the loess structure attenuation of the slope under shear and tension, the shear and

FIGURE 30: Distribution zone of generalization sensitivity of the overlying slope.

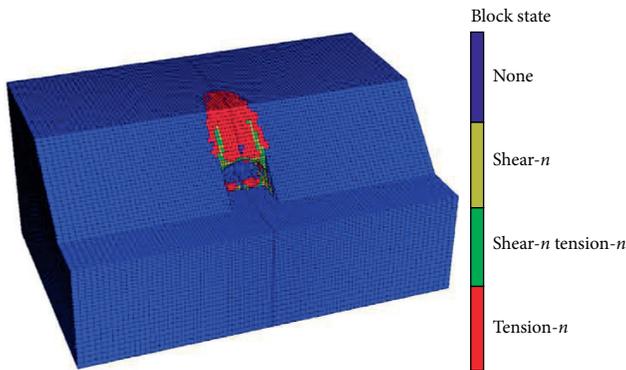
FIGURE 31: Plastic zone of the overlying slope.

tensile strength of the soil decreases and eventually results in the tensile and shear instability of the slope.
