Research Article

Corrosion Behavior and Failure Mechanism of Prestressed Rock Bolts (Cables) in the Underground Coal Mine

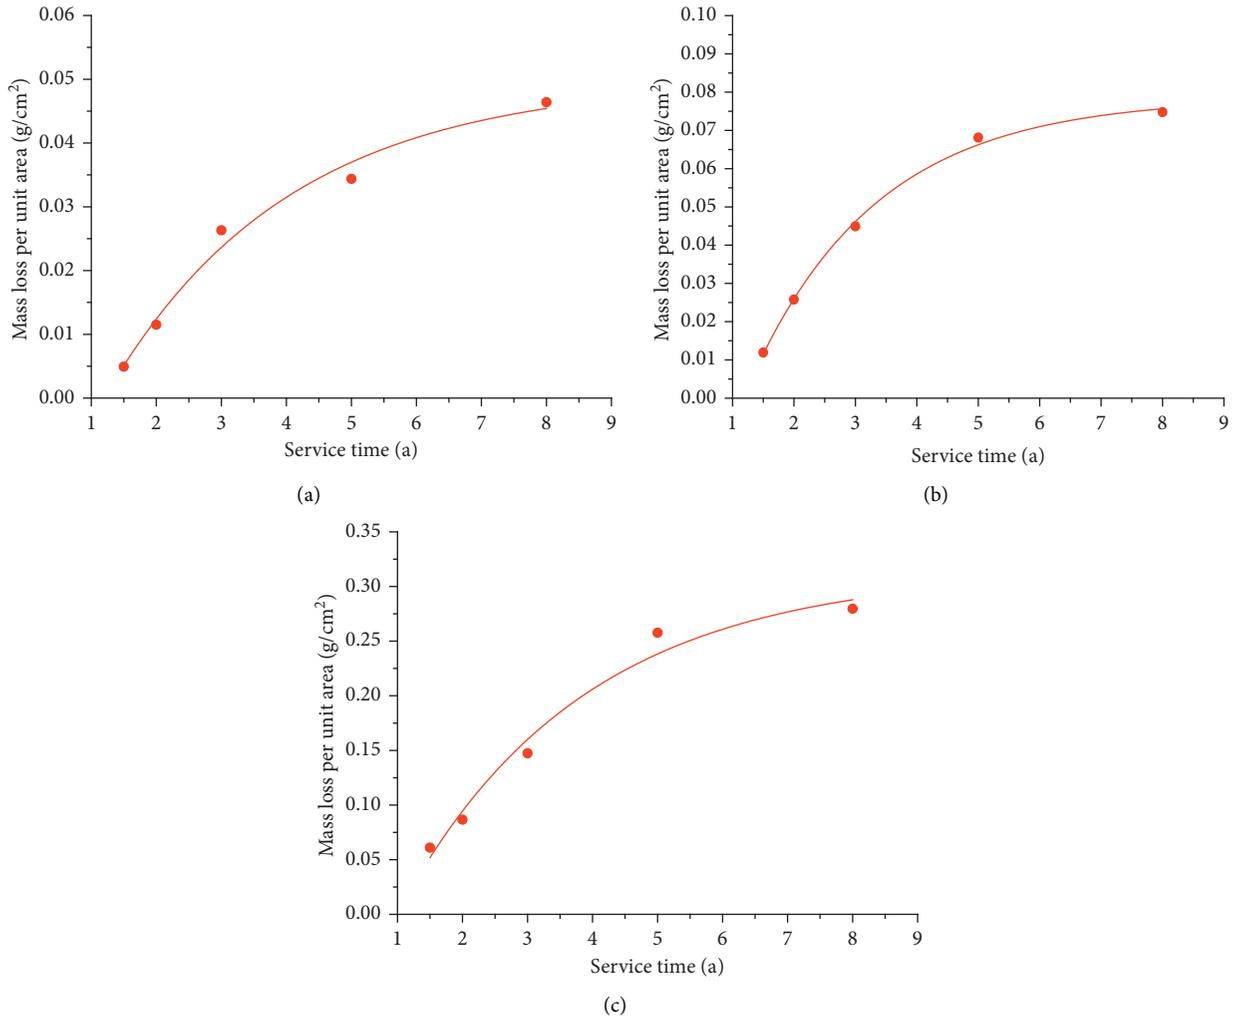
FIGURE 4: Time-mass loss relationship of different parts of the bolt. (a) Free section. (b) Anchor end. (c) Anchor head.

Figure 4 shows the time-mass loss relation diagram of different parts of the bolt. As shown in Figure 4, with an increase in service time, the corrosion degree of different bolt parts increases year by year. The rule of the anchor head characterizes the corrosion amount of different parts > anchor end > free section. This is because the anchor head has been exposed to the air for a long time, and O_2 in the air accelerates the corrosion of the anchor head, while other parts are wrapped by concrete mortar for a long time with less contact with corrosive media, so the corrosion is relatively light in degree.

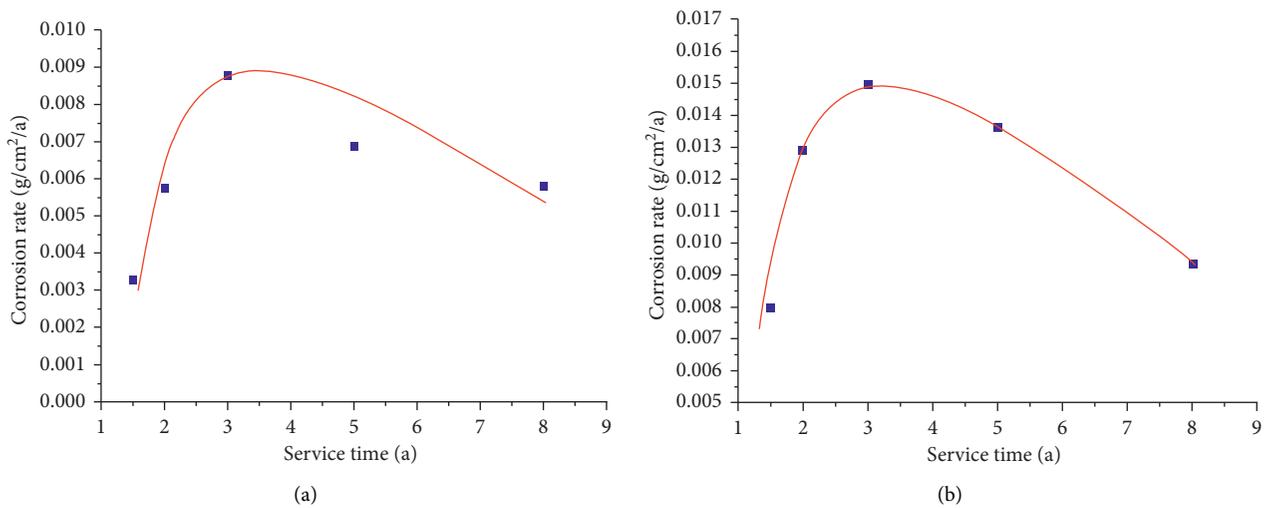
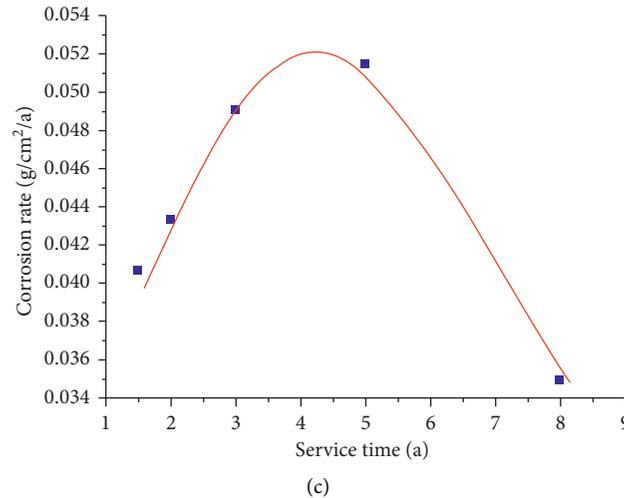
FIGURE 5: Variation of corrosion rate in different parts of the bolt. (a) Free section. (b) Anchor end. (c) Anchor head.

Figure 5 shows the variation curve of the corrosion rate of different parts of the bolt. It can be seen that each part of the bolt's corrosion rate increases rapidly in the early stage and slows down in the later stage. The reason is that, with the increase of service time, the corrosion on the surface of the bolt is accumulated, which avoids the large area of contact between the bolt body and external corrosion factors, thus reducing the growth rate of bolt corrosion.

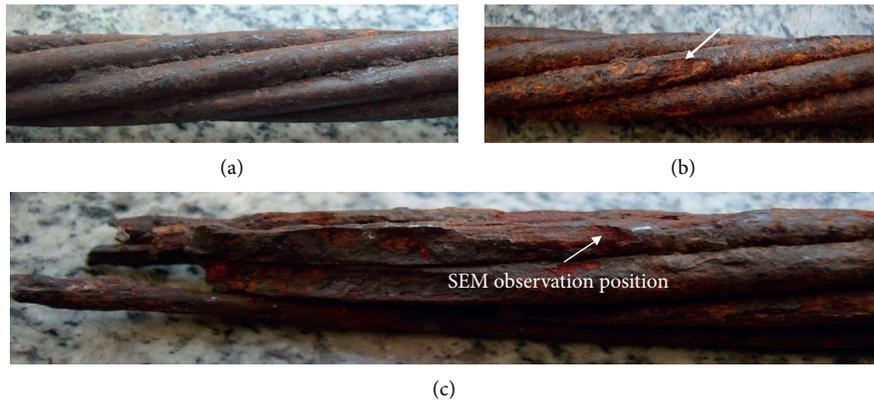
FIGURE 7: Macrofracture corrosion morphology of the anchor cable: (a) the steel strand near the anchorage; (b) the steel strand near the anchorage, about 900 mm away from the anchorage; (c) fracture position.

spalling (Figure 7(c)). As shown in Figure 7(c), the steel strand's length at the breaking point of the anchor cable is different. It is an inclined fracture formed under tensile stress with a certain angle to the axial direction, and the longitudinal length of the fracture is about 25 mm. There is no obvious necking before fracture of these steel wires, and it can be observed that the steel strands crack from the outer surface with more serious oxidation and corrosion.

4.1. Macroscopic Analysis of the Sample Fracture. The failure analysis of anchor cable sample S-6 in use for six years in Qishan Coal Mine was conducted. Figure 6 shows the overall morphology of S-6. The anchor cable has a brown surface and consists of seven steel strands. The corrosion morphology of each area of the broken anchor cable sample is shown in Figure 7. The macroanalysis results show that the whole anchor cable is characterized by uniform oxidation corrosion (Figure 7(a)). Pit corrosion is found in some steel strand areas in the region from about 900 mm away from the anchorage to the fracture, as shown by the arrow in Figure 7(b). However, near the fracture (about 1200 mm away from the anchorage), the number and degree of pit corrosion are relatively serious, and some places even have

5.1. Analysis of Corrosion Products on the Fracture Surface and Its Vicinity. The macroscopic and microscopic fracture morphology analyses were carried out after the position marked with white words was cleaned in Figure 7. The microscopic corrosion product morphology and EDS energy spectrum composition analysis on the fracture surface are shown in Figure 8. The fracture surface's microscopic analysis results show that the fracture surface is mainly covered by iron oxide, and sulfur corrosion products are detected in the local area.

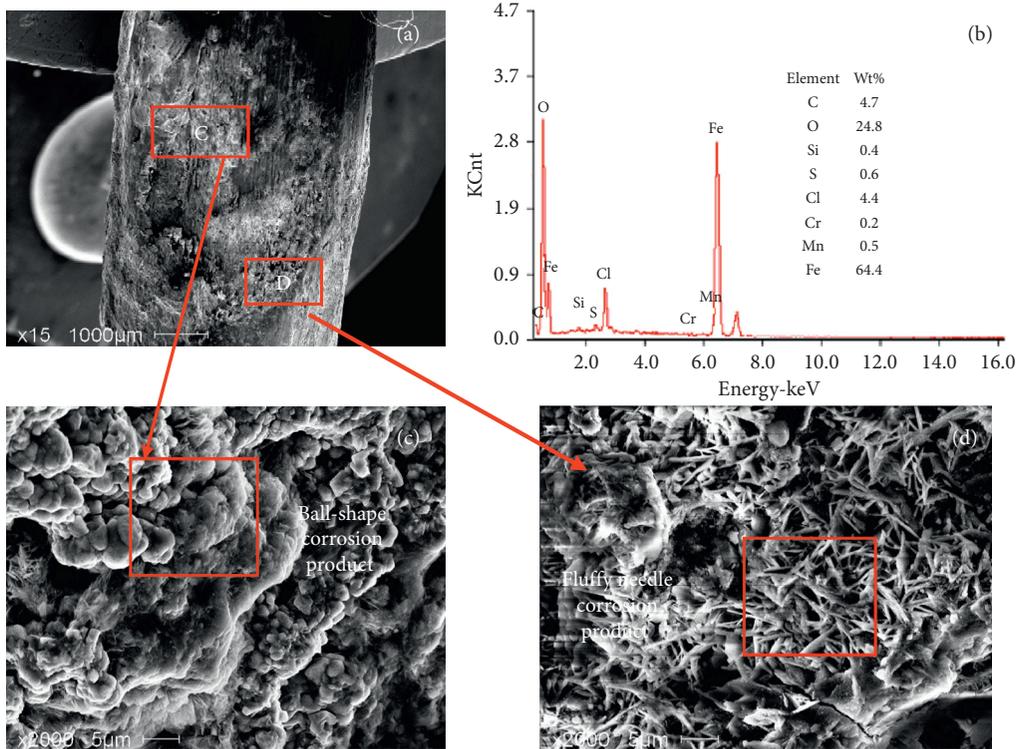
FIGURE 9: Morphology and EDS analysis of surface corrosion products near the fracture: (a) with 15 times magnification; (b) EDS analysis; (c) point C with 2000 times magnification; (d) point D with 2000 times magnification.

The morphology of microscopic corrosion products on the fracture edge surface and EDS energy spectrum composition analysis are shown in Figure 9. The results show that the corrosion products are mainly in fluffy needle and ball shape. The corrosion products' main components as detected are Fe, O, Cl, S, Si, Mn, Cr, etc. The content of element Cl in the corrosion products is as high as 4.4%, and the mass content of element S is 0.6%.

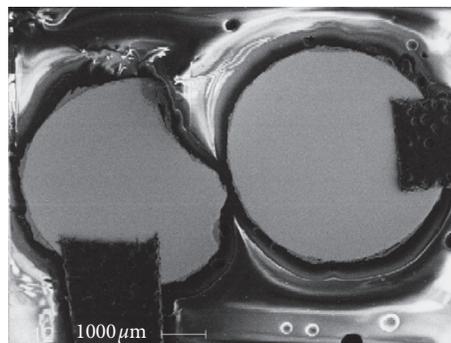
FIGURE 10: Low-power images of metallographic samples of the transverse section of the steel strand with and without pit corrosion.

5.2. Analysis of Corrosion Products on the Fracture and Steel Strand Profile. The transverse section's metallographic samples were taken from the pit corrosion area about 900 mm away from the anchorage near the nonfracture area. After sample grinding and polishing, the morphology was observed by using the scanning electron microscope, and the EDS energy spectrum composition was analysed. Figure 10 shows the low-speed fracture of the steel wire, while Figures 11(a)–11(c) show the microscopic morphology and composition analysis of corrosion products of the area near the matrix, near the surface, and inside the matrix of the reinforcement in the area with pit corrosion. Figure 12 shows the microscopic morphology and composition analysis of corrosion products near the matrix, near the surface, and inside the reinforcement matrix in the area without pit corrosion. The analysis results show that the depth of some pits reaches 0.9 mm. In the pit corrosion area, the corrosion products containing O, Cl, and S or O and S are found near the steel strand matrix and the surface; in the area without pit corrosion, the corrosion products containing O are mainly found near the steel strand matrix and the surface.

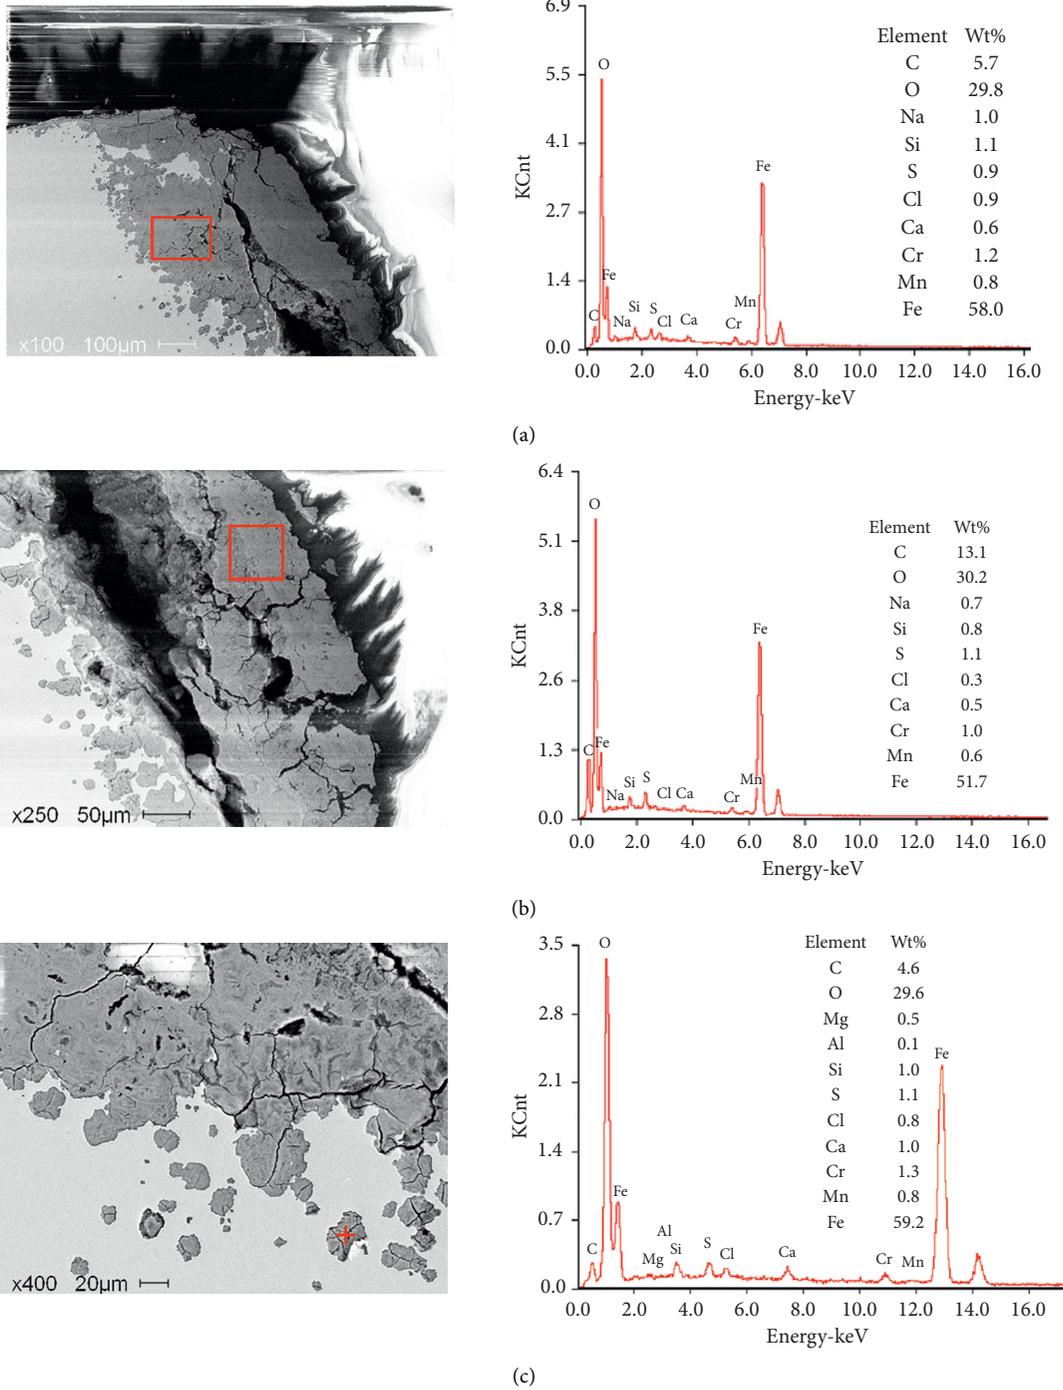
FIGURE 11: EDS energy spectrum analysis of corrosion products in pits of metallographic samples of transverse section. (a) Composition of corrosion products near the matrix in the pit corrosion area. (b) Composition of near-surface corrosion products in the pit corrosion area. (c) Composition of point corrosion products in the matrix.

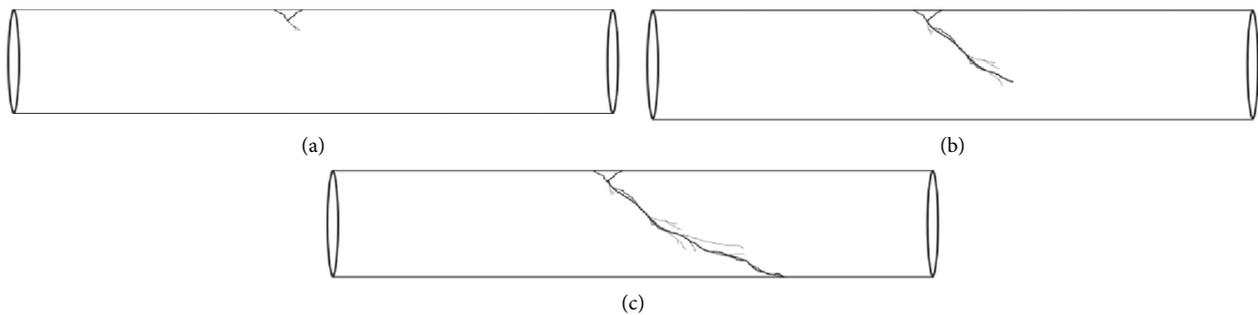
FIGURE 13: The fracture path profile of S-6. (a) Stage I. (b) Stage II. (c) Stage III.

As known from the macroscopic and microscopic analysis of the samples, the failure samples are not characterized by obvious plastic deformation or necking, indicating that the sample's failure mode is a brittle failure. The sample's fracture path profile can be divided into three stages, as shown in Figure 13. There is a shallow crack perpendicular to the applied load in the fracture initiation area (Figure 13(a)). Then, the crack deflects and propagates along the longitudinal direction in the second stage (Figure 13(b)). Lastly, the sample was suddenly fractured with a higher deviation angle in the third stage (Figure 13(c)). This type of failure has also been observed in other research results [20–22], which is considered to be a typical feature of SCC. To sum up, the failed samples have been in the O, Cl, and S surrounding rock environment for a long time, which results in pit corrosion, causes the corrosion and spalling of the surface material of the steel strand, reduces the outer diameter of the anchor cable and its bearing capacity, and leads to one-time SCC fracture of the anchor cable.

- (3) The failure mechanism of sample S-6 is that it has been in the surrounding rock environment of O, Cl, and S for a long time, resulting in serious pitting corrosion and spalling of the surface material of the steel strand, which reduces the outer diameter of the rock cable and its bearing capacity and finally leads to the instantaneous SCC fracture of the S-6 sample.
