Research Article

Large-Scale Model Test of a Micropile Group for Landslide Control

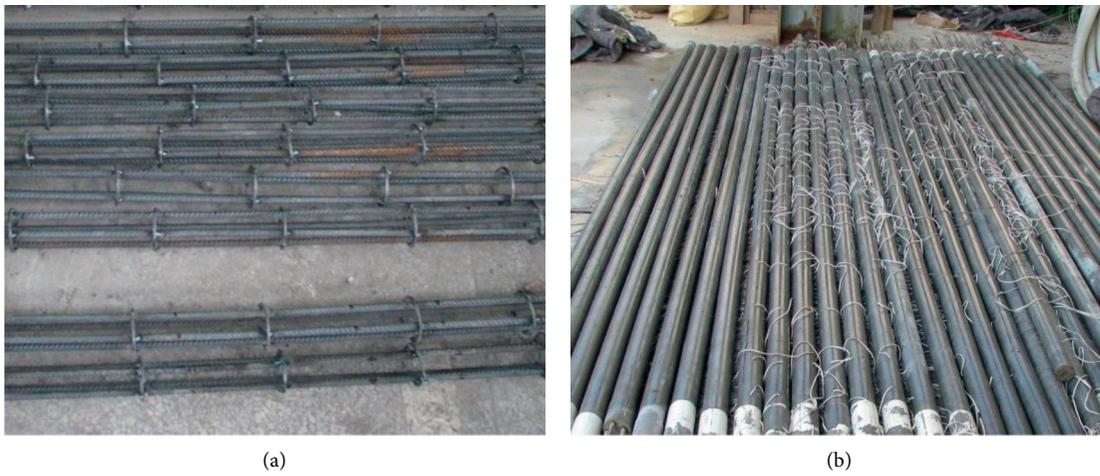
FIGURE 4: The precast reinforcement concrete micropiles: (a) Reinforcement; (b) micropiles.

2.3.3. Model Pile and Connecting Beam. Figures 4 and 5 show the precast reinforcement concrete and connecting beam of micropiles, respectively. To facilitate the burial of test instruments, the model piles used in this test were reinforced concrete prefabricated piles, and the micropiles were poured with fine aggregate concrete. The concrete strength grade was C25, and the cement strength grade was 42.5 R. The length of the pile was 4 m, the diameter of the pile was 60 mm, and the reinforcement method was $4 \phi 6.5$. The top of the piles was linked with the angle steel to simulate the connecting beam.

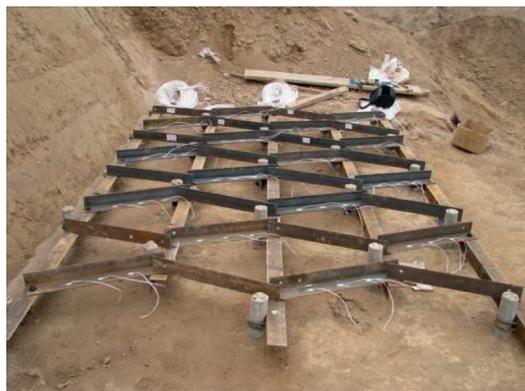
FIGURE 5: The connecting beam on the top of micropiles.

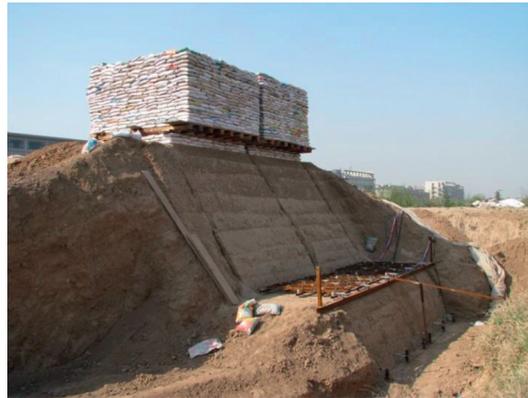
FIGURE 8: Multi-stage loading on the top of the landslide model.

2.6. *Loading Condition.* After model test was assembled and monitoring sensor was implemented, layers of sandbags used as the multi-stage loading were placed on the top of the landslide model. The photo of multi-stage loading is shown in Figure 8.

Each loading increment was 8 kPa. At each loading step, the recording of sensors was monitored [18, 19]. After reaching the stable value, the next step of load would be applied. A total of 48 kPa loads were applied in this test, as shown in Figure 8.
