Research Article

Influence of Corrosion and Fatigue on the Bending Performances of Damaged Concrete Beams

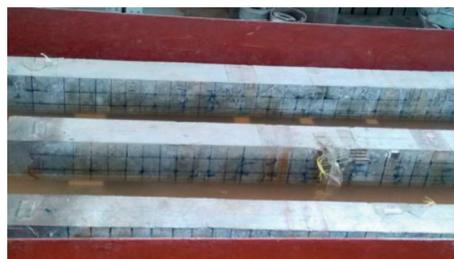
FIGURE 5: Schematic of the corrosion test setup.

corrosion test was achieved by alternating cycles of wetting-drying in a corrosion tank: a cycle was defined as wetting for 2 days and drying for 1 day. Schematic of the corrosion test setup is shown in Figure 5. The corrosion medium was a NaCl solution of 5% mass fraction. The fatigue load was controlled by a hydraulic servo system in a four-point bending load configuration. Schematic of the fatigue loading test setup is shown in Figure 6. The upper limit of the fatigue load was 21 kN (70% of P_u) and the lower limit was 2.1 kN (7% of P_u); the stress ratio is 0.1, with a loading frequency of 2 Hz. The deflection and crack width were recorded during the test. The failure of the beams was marked by the fracture of the steel bars.

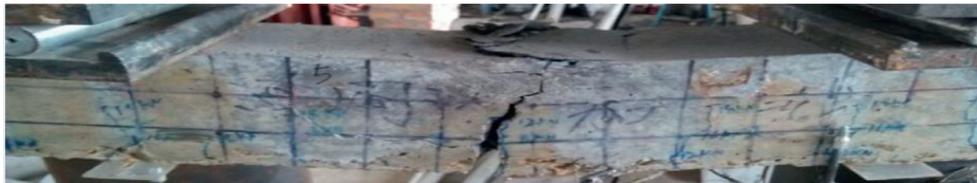
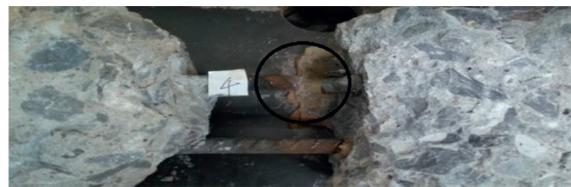
FIGURE 8: Fatigue failure form of the tested beams. (a) Beam 1. (b) Beam 2. (c) Beam 3. (d) Beam 4. (e) Beam 5. (f) Beam 6.

3.2. Influence of Corrosion and Fatigue on the Fatigue Life. A static load was applied to Beam 1 until failure, resulting in three phases of concrete cracking, steel bar yielding, and concrete crushing. The failure of Beam 1 includes the typical modes of flexural failure. A fatigue load was applied to Beams 2–6. During the loading process, cracks opened and closed as the fatigue load changed. The residual deflection also increased with the number of fatigue load cycles. When a beam was close to failure, the reinforcing steel bar broke suddenly at one of the loading points, crushing the concrete in the compression zone. The fatigue damage development processes and the forms of fatigue life of all beams were basically consistent. Figure 8 shows the fatigue failure form of the tested beams. The fatigue life and number of steel bars broken for each beam are shown in Table 2.
