A Case Study of Thaumasite Sulfate Attack in Tunnel Engineering

Research Institute of Highway Ministry of Transport, Bridge & Tunnel Research Center, Beijing 100088, China

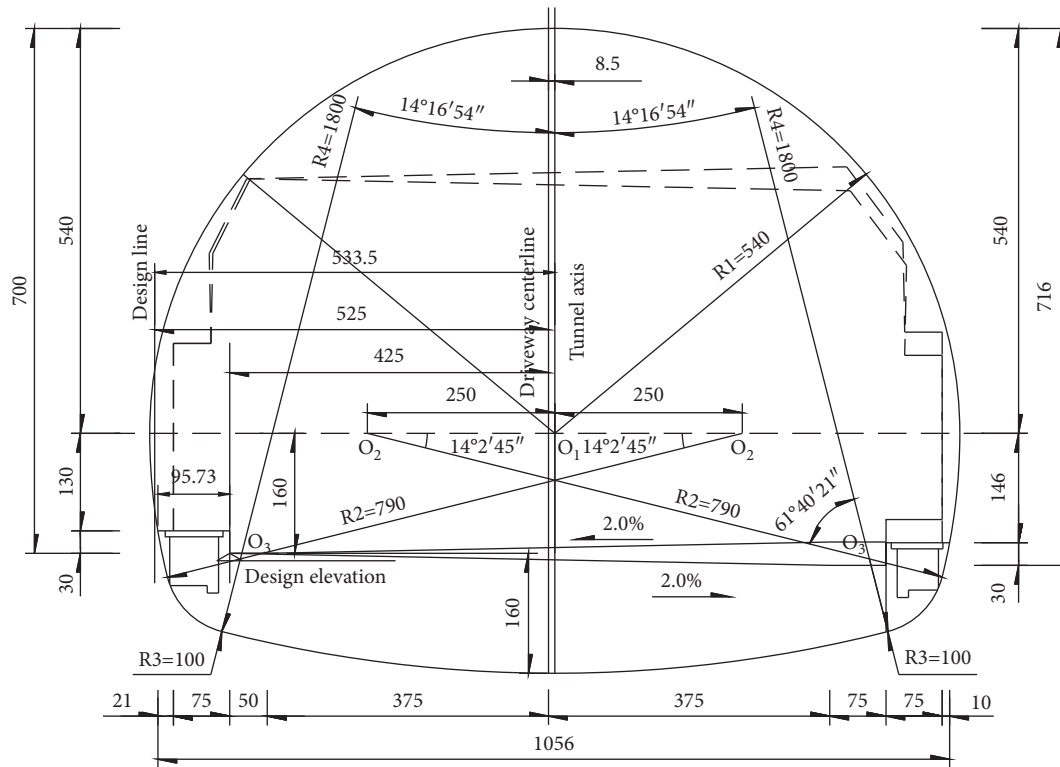
FIGURE 1: Interior outline design of the Dugongling tunnel (unit: cm).

tunnel axis is 264° , and the maximum depth of tunnel is 231 m. The construction clearance of the tunnel has a net width of 10.25 m and a height limit of 5 m (see Figure 1).

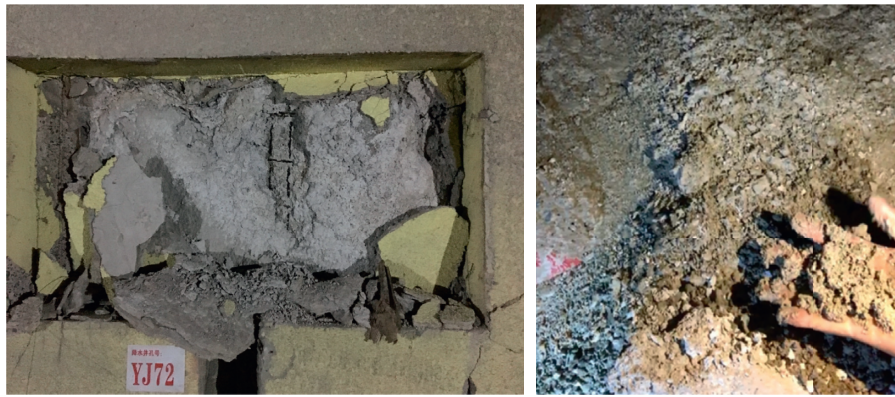
FIGURE 2: Photographs of the corroded tunnel lining concrete.

The Dugongling tunnel was completed in November 2012. Tunnel disease was first detected in the later stage of its construction. As of 2016, the total length of the tunnel structure that needed to be demolished and replaced due to diseases is 1,515 m. The main range of tunnel diseases occurred in sections from K34 + 500 to K34 + 800. Diseases in the Dugongling tunnel were mostly lining concrete cracking, and deformation at early stage of the diseases, no corrosion, and argillization phenomena of concrete were found. The concrete argillization phenomenon had not been discovered until the firebox was removed, as shown in Figure 2. Concrete argillization showed a feature of integrity in the dry environment, while seemed sludge-like under grasping in the wet.

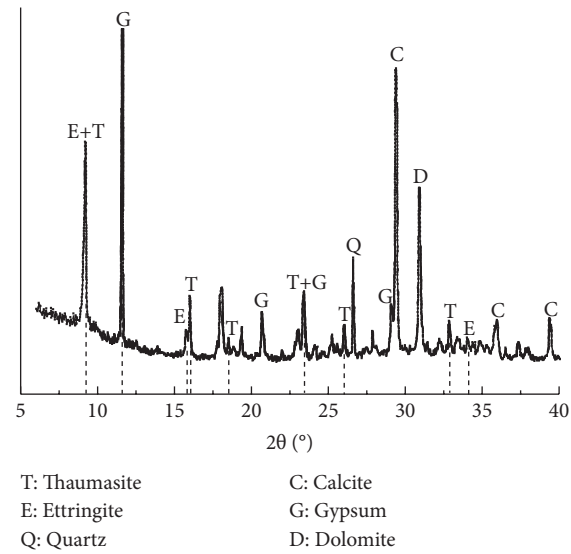
FIGURE 3: XRD pattern of tunnel lining concrete sample [22].

In the supplementary survey of tunnel diseases in 2016, 223 samples from 119 cross-sectional primary support concrete were picked. The mineral compositions of the concrete were mainly calcite, dolomite, quartz, potash feldspar, plagioclase, ettringite, gypsum, and thaumasite. 60 sections of the 119 sections were detected with TSA, accounting for 50.4% of total samples; 84 of 223 samples of primary supporting concrete were detected with thaumasite (Figure 3), accounting for 37.7% of total samples. It can be seen that the disease in the Dugongling tunnel was a typical case of TSA [22].

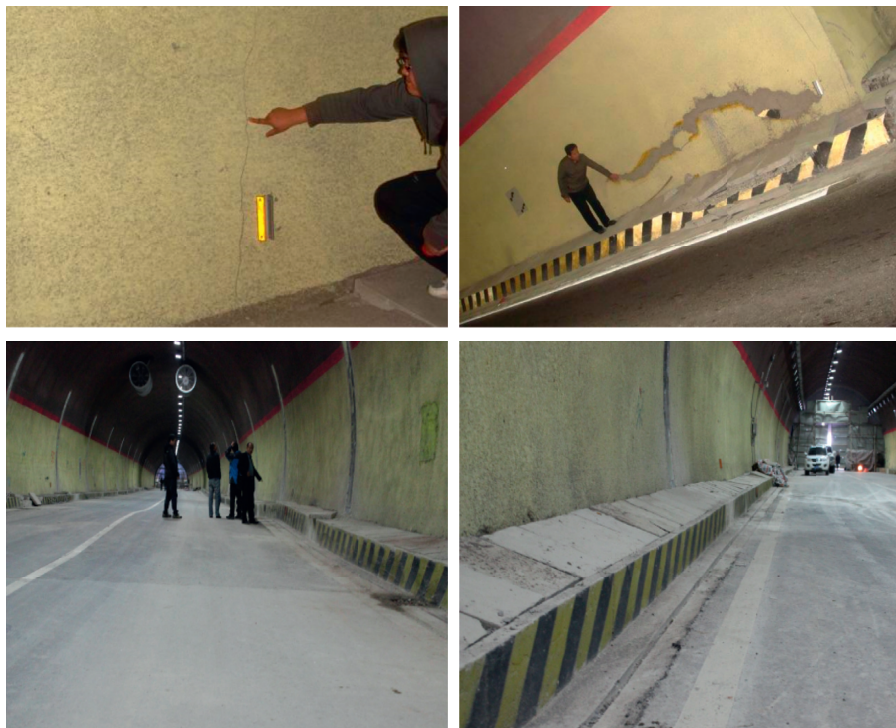
FIGURE 4: Photograph of early-stage tunnel disease.

3.1.1. Main Types of Tunnel Diseases. The types of diseases in the Dugongling tunnel, listed in Table 1, show an increasing trend in previous years. In 2012, the main kinds of tunnel diseases were lining cracking, pavement uplifting, and cracking. In 2013, the overturning of the cable trench was detected; in 2014, the staff found partial cracks at arch footing and intrusion of the clearance in some sections, as shown in Figure 4; and in 2016 and 2017, the diseases of the Dugongling tunnel deteriorated, leading to the collapse and fall of the secondary lining concrete (Figure 5) and the extrusion and damage of the inner wall of the cable trench (Figure 6).

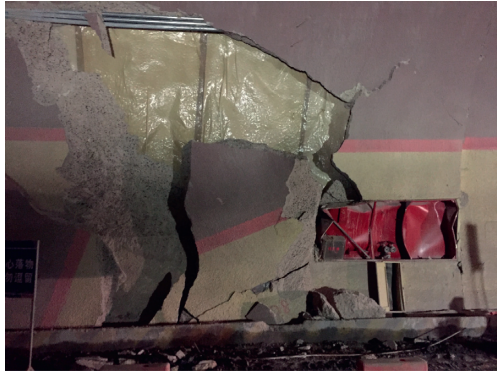
FIGURE 5: Sudden collapse of the secondary tunnel lining.

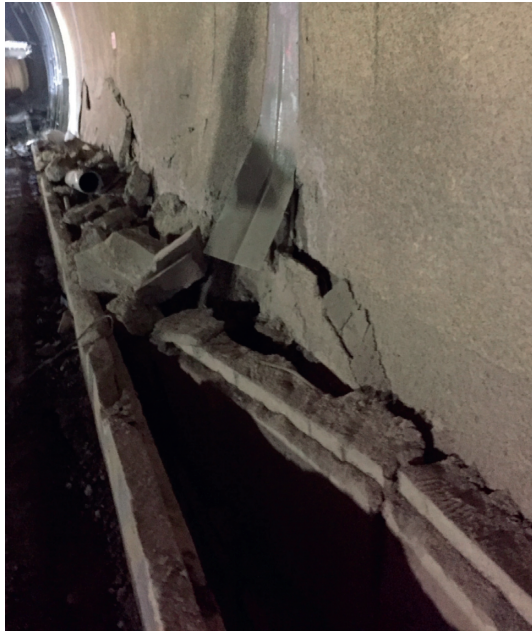
FIGURE 6: Inner wall extrusion of the cable trench.

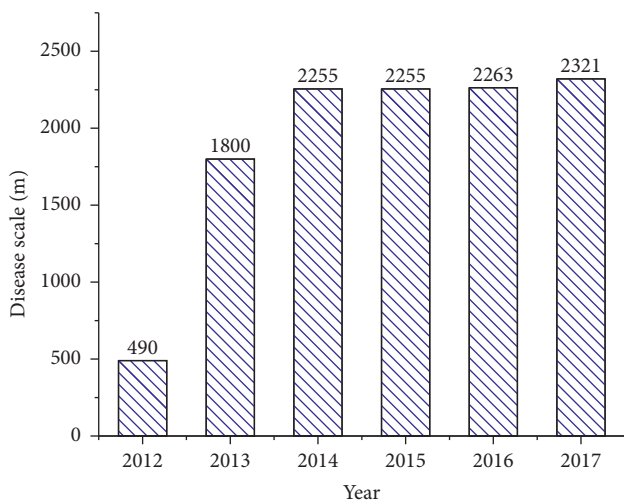
3.1.2. Scales in Previous Years. The disease scales over the years are shown in Figure 7. The disease scale of the tunnel reached 2321 m at the beginning of 2017, which accounted for 47% of the length of the tunnel. It can be seen from Figure 7 that the fastest development period of tunnel diseases took place in 2013 and 2014, 1765 m, which accounted for 76% of total length of diseases; there was a gradual increase in new diseases from 2015 to 2017. The length of new diseases was only 8 m and 58 m in 2016 and 2017, respectively. Thus, the scale of tunnel disease developed rapidly in the early stage of development of

FIGURE 7: Disease statistics in previous years of the Dugongling tunnel [23].

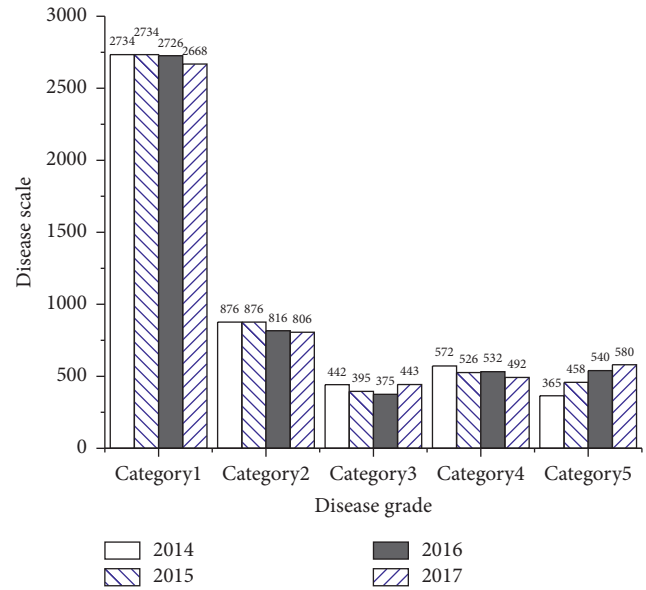
3.1.3. Degree of Disease Development. According to the classification of disease levels from *technical specification of maintenance for highway tunnel* (JTG H12-2015), the variations of disease scales over the years at all levels are shown in Figure 8.

- (i) The number of Level 1 (i.e., the tunnel structure is in serviceability and safety) and Level 2 (i.e., no negative effect on the traffic safety of tunnel vehicles, and further observation is needed) diseases in the tunnel decreased from 2014 to 2017, and the reductions in Level 1 and Level 2 were 66 m and 70 m, respectively.

- (ii) The number of Level 3 and Level 4 diseases fluctuated from 2014 to 2017, indicating that tunnel diseases were developing dynamically during this period.

- (iii) The number of tunnel sections with Level 5 diseases has gradually increased in the 3 years, with an increasing rate of 86% and a length of 215 m, of which the fastest development occurred in 2014 to 2015 and 2015 to 2016. There was an increase in more than 80 m per year in 2014 to 2015 and 2015 to 2016, respectively.

- (iv) By the year when diseases began to be resolved, 2017, the total scale of Level 3, Level 4, and Level 5 diseases in need of treatment reached 1515 m.

FIGURE 8: Annual variations of disease scale of different levels [23].

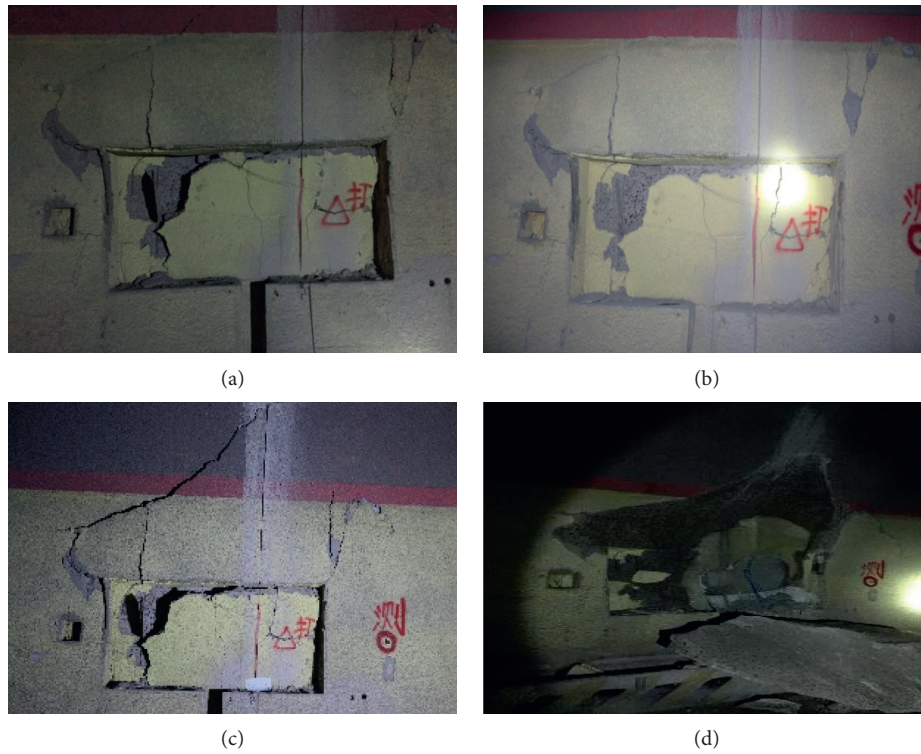
- (1) The process of collapse. During the construction safety inspection in March 2017, cracks around the fire chamber were discovered; the monitoring data in April showed that the length and width of the diagonal cracks on the upper left side of the fire chamber increased, extending upward from the spandrel; cracks continued to develop in May and June, and a small area of concrete surface peeling occurred; in July, the concrete collapsed suddenly (Figure 9).
- (2) Description of the surrounding rock. The concrete in the internal side of the fire chamber showed that the internal (secondary lining and primary supporting) concrete expanded and deformed outwards about 5 cm–10 cm, showing a “belly bulging” shape (Figure 10); the expansion of the waterproof board, after the collapse of concrete, was particularly obvious,

FIGURE 9: Disease development process of the fire chamber in YK34 + 500. (a) 2017.03. (b) 2017.04. (c) 2017.05. (d) 2017.07.

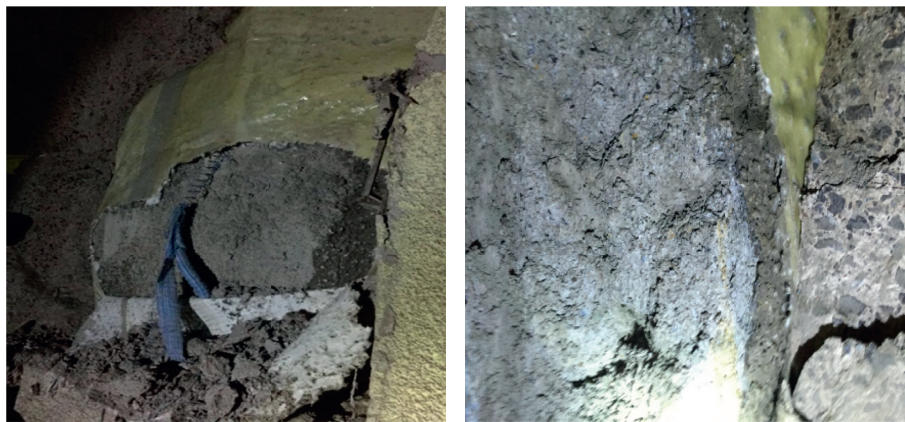
and the primary supporting concrete behind it showed damp and sandy features.

FIGURE 10: Photographs of concrete in the field of YK34 + 500.

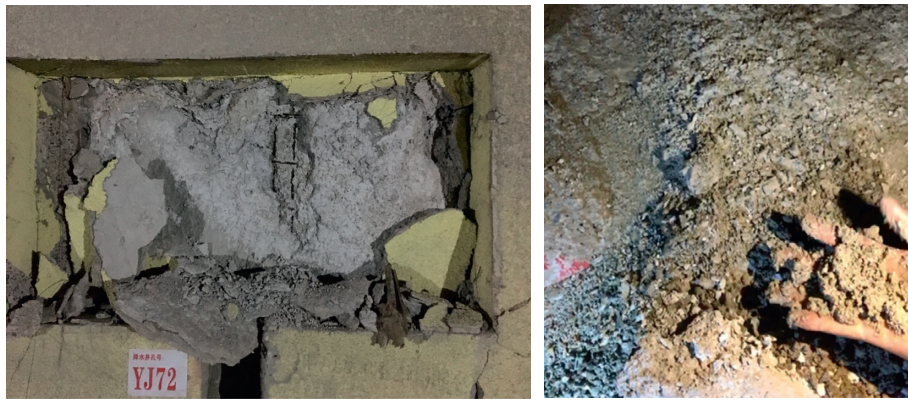
FIGURE 12: Photographs of the corroded tunnel lining concrete.

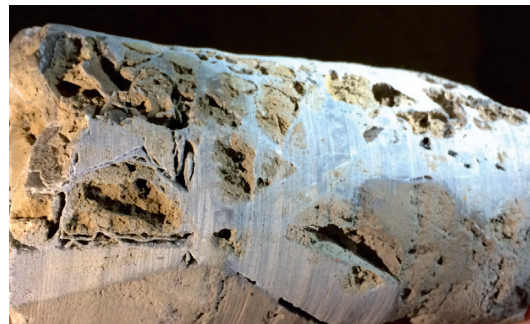
After the surface water infiltrates, it circulates along the internal cracks and pores in the rock mass. The dissolution and development conditions of the tunnel rock mass provide a path for this circulation. According to engineering survey data and tunnel construction information, there are many joints, cracks, and dissolution in the surrounding rock of the tunnel, and the dissolution of the tunnel site shows a typical characteristic of combined carbonate and sulfate erosions [24, 25]. Most of the dissolution is dissolution pores, channels (Figure 13), and small karst caves (Table 3). Moreover, due to the

FIGURE 13: Dissolution of rock core sample in the field.

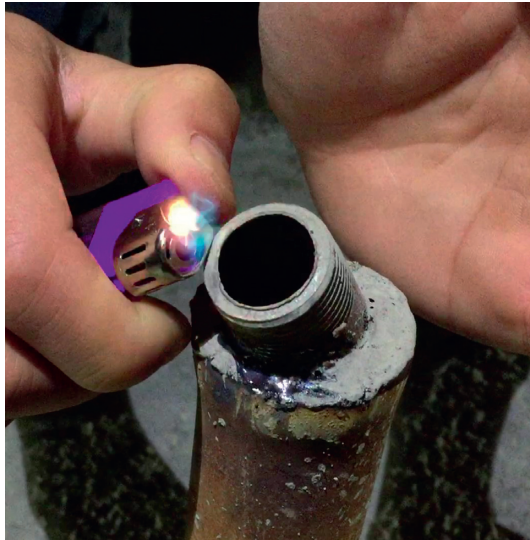
interconnection between the dissolution pores the air blow in the tunnel drilling is observed (Figure 14).

FIGURE 14: Air blow in the drilling.

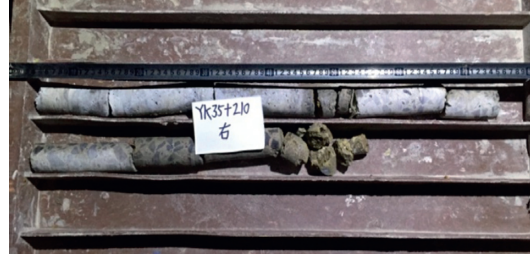
FIGURE 15: Core samples from the surrounding rock and concrete.

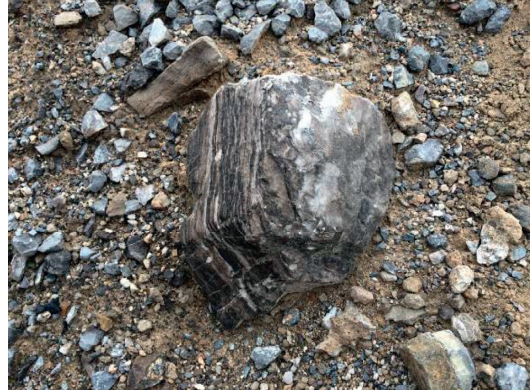
FIGURE 16: Gypsum rocks in the abandoned dredge site of the tunnel.

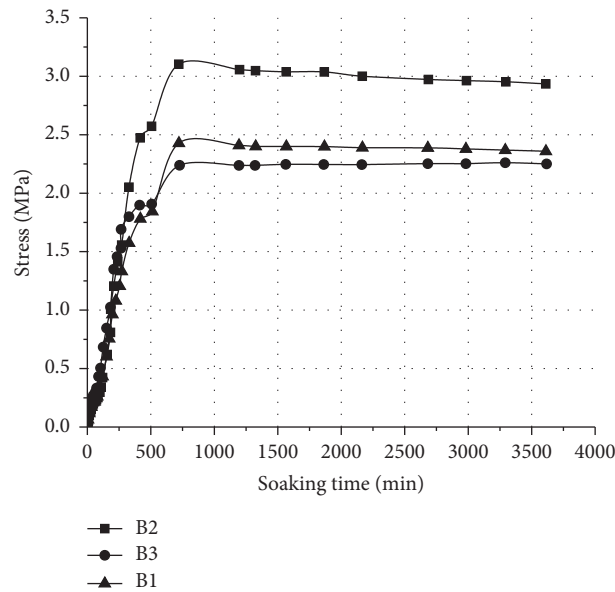
The irregular distribution of gypsum in the limestone formation aggravated the softening and swelling features of gypsum. According to the indoor expansion tests of lateral confinement on anhydrite in the Dugongling tunnel [21], the expansion forces of the specimens with anhydrite content are greater than 90% reaching 1.94–3.1 MPa, as shown in Figure 17. The existence of anhydrite made the swelling characteristics of the surrounding rock more significant.

FIGURE 17: Expansive force test results of gypsum rock [21].

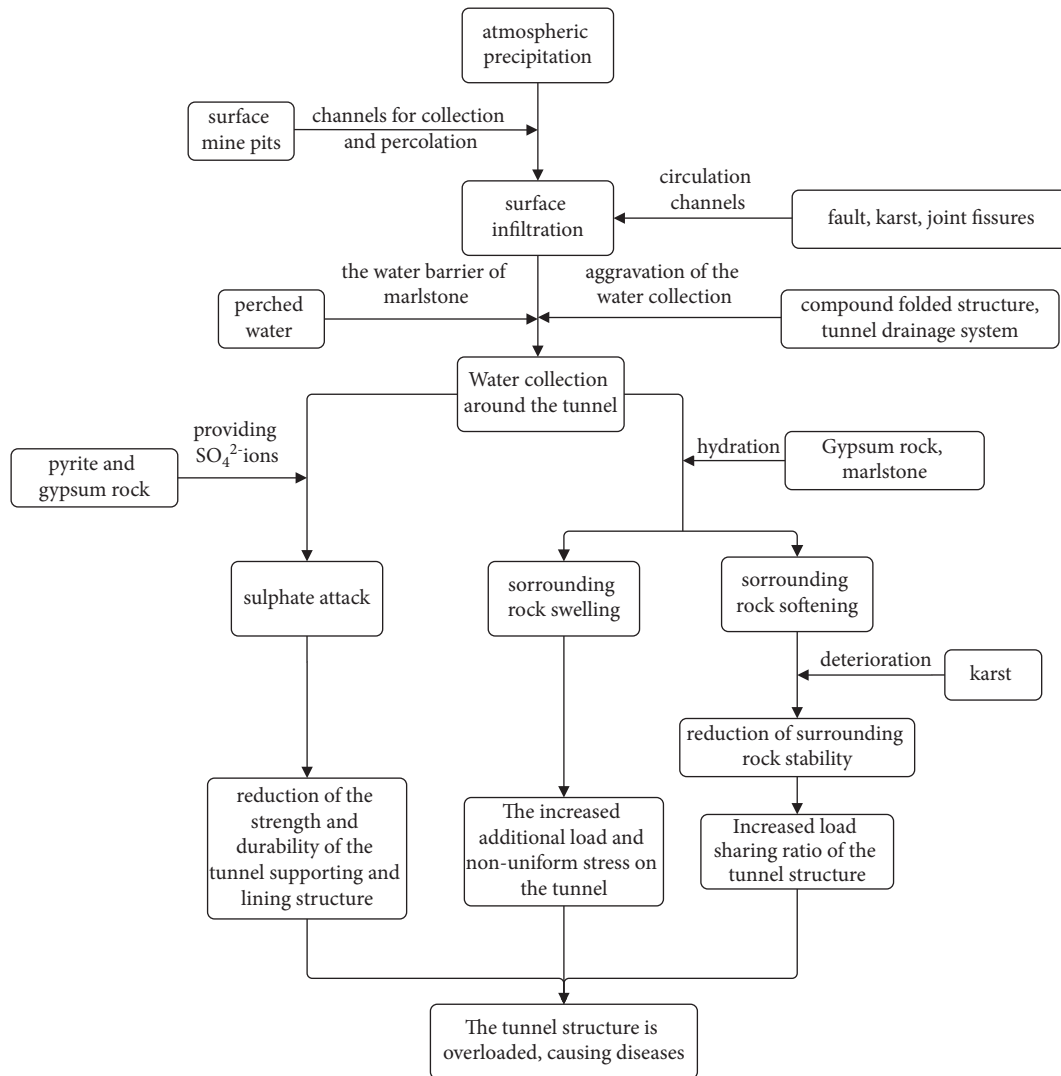
groundwater. The composite fold structure and the water barrier formed by marl made the groundwater converge behind the tunnel section lining and kept accumulation. It dissolved and carried a large amount of sulfate ions and carbonate ions when the water flowed through, which was prone to thaumasite sulfate attack in the low temperature. In summary of various factors, the formation of tunnel diseases can be described in Figure 18 as follows.

FIGURE 18: Mechanism of engineering harmfulness in the Dugongling tunnel.

According to the causes of tunnel diseases, the treatment of tunnel diseases can be done in the following aspects: groundwater treatment, surrounding rock reinforcement, and lining structure optimization.
