Research Article

Bending Capacity of Concrete-Encased Underground Electrical Duct Banks under Monotonic Loading: An Experimental Study

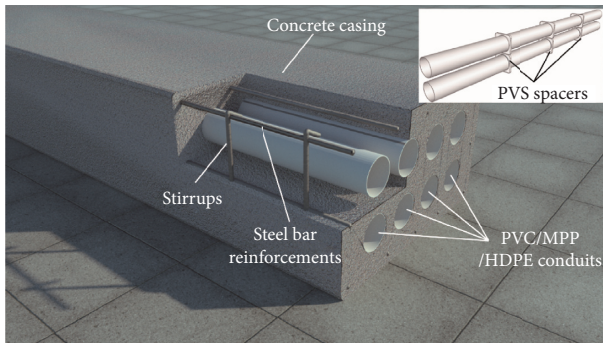
FIGURE 1: Sketch of concrete-encased underground electrical duct bank.

(MPP)/high-density polyethylene (HDPE) conduits that are bundled together. These groupings of conduits are often protected by concrete casings. PVC spacers are also used to separate the internal conduits from concrete walls, as shown in Figure 1. In general, all concrete-encased electric conduit duct banks contain steel reinforcement throughout their entire length. The reinforcing steel is installed longitudinally at each corner of a duct bank (in cross section) and along the top and bottom. Stirrups are also needed to hold the longitudinal steel in place during the placement of the concrete.

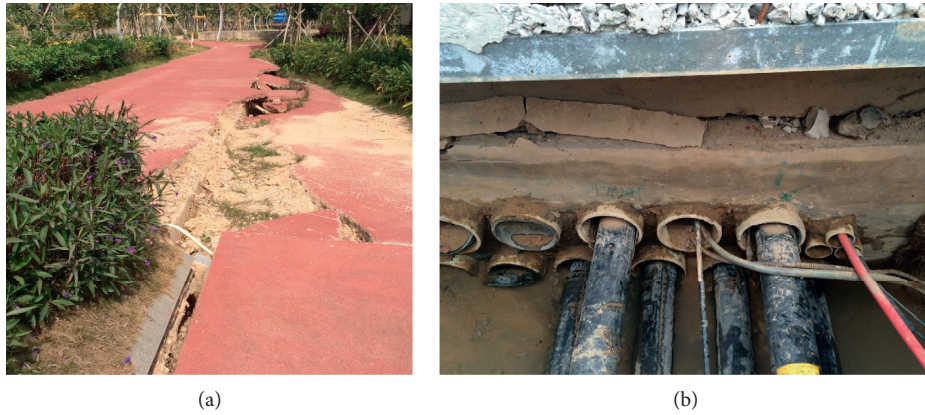
FIGURE 2: Ground subsidence (a) and damage (b) caused by deficiencies in concrete-encased underground electrical duct banks.

construction, and nearby infrastructure, deficiencies such as the differential settlement, tilting, and cracking of concrete and HDPE conduits can appear in electrical duct banks and working wells, as shown in Figure 2. Hence, protecting electrical cable duct banks and controlling their deformation and damage has become an important issue.

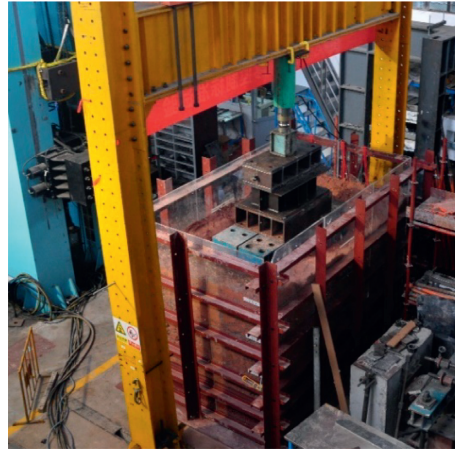
FIGURE 3: Test setup details (millimeters).

2.1. Test Setup and Loading Protocol. The experimental program was based on a monotonic loading static test of four electrical duct banks. The test setup consisted of reaction frames made from hollow steel sections and a soil box providing lateral and vertical soil pressure. The electrical duct banks were tested vertically. Two hinge supports were set at the bottom of the soil box to prevent the excessive settlement of the specimens. The hinge supports were rectangular columns made of Q335 steel with dimensions of 800 mm × 300 mm × 300 mm. The specimens were placed 200 mm above the supports. The physical and mechanical properties of the soil used in the experiment are given in Table 1. The soil box was made of Q235 steel and tempered glass with a size of 4.2 m × 2.7 m × 2.7 m. An actuator was used to apply the load, and the load magnitude was measured by a force sensor. A load distributing beam was used to transfer the concentrated load into a distributed surface load. The test adopted monotonic static step loading, and the load of each stage was approximately 10 kN. When approaching the failure load, the loading mode was converted from force-control loading to displacement-control loading until a significant decrease in load appeared in the readings of the force sensor. The details of test setup are shown in Figure 3.

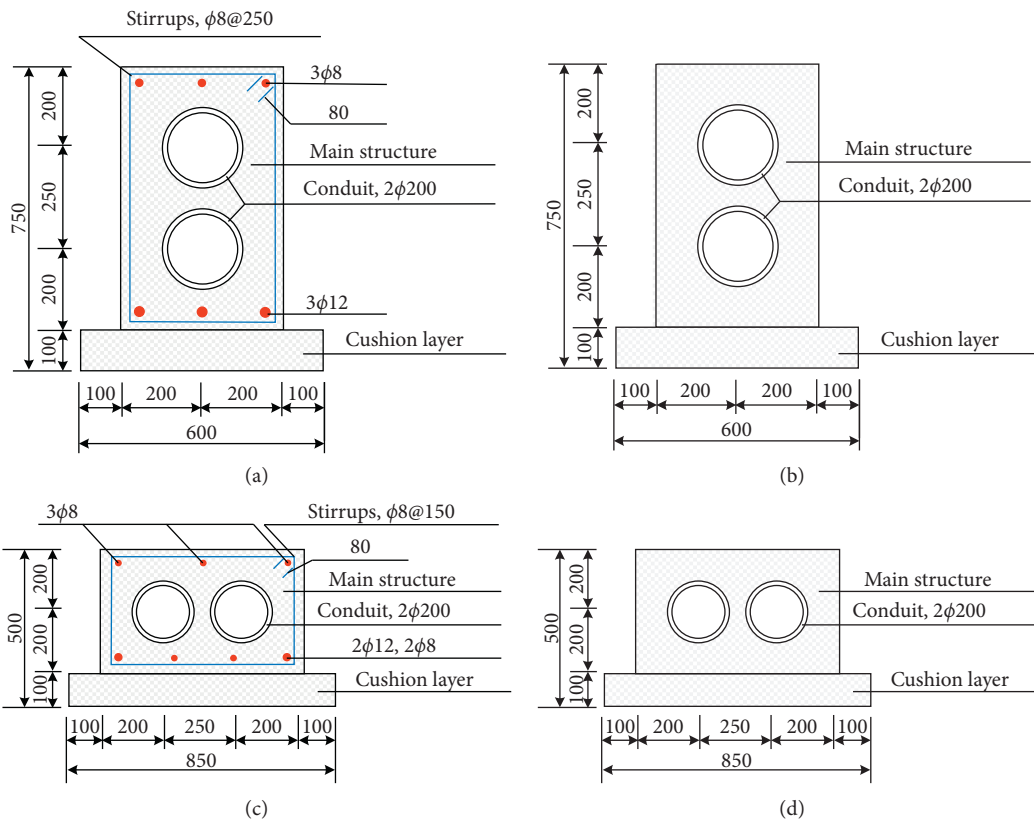
FIGURE 4: Test specimen arrangement (millimeters): (a) A1, (b) A2, (c) B1, and (d) B2.

geometric dimensions and reinforcement specifications for the specimens are shown in Table 2. For A-type specimens, the section height of the main structure was 650 mm, and the conduits were laid vertically, while B-type specimens were 400 mm, and the conduits were laid horizontally. Specimens A1 and B1 were reinforced, but there were no rebars in A2 and B2. The reinforcing rebars in specimens A1 and B1 were HRB335 with diameters of 8 mm and 12 mm. The stirrups for A1 and B1 were closed with 135° hooks on both ends. The compressive

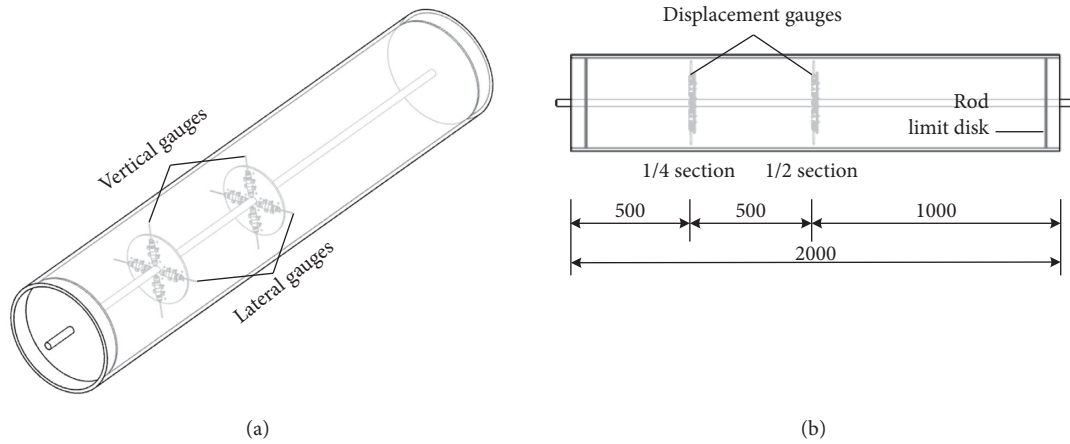
FIGURE 5: Conduit diameter-change measuring device. (a) Perspective drawing. (b) Elevation.

2.3. Monitoring System. Accurate monitoring technologies play an important role in physical experiments. In this study, the change in conduit diameter was a key factor. Thus, a conduit diameter-change measuring device was employed to measure the diameter change of the HDPE conduits, which could replicate the deformation behaviors inside the conduits. Figure 5 shows details of the conduit diameter-change measuring device.

The conduit diameter-change measuring device was provided with two round limit disks at both ends that matched the inner diameter of the measured conduits to ensure that there was no relative displacement between the measuring device and the measured conduits. Between the two limit disks, two fixed round disks with four displacement gauges installed orthogonally were used to measure the displacement change of the quarter-span and midspan of the measured conduits. To ensure the stability of the fixed round disks and the accuracy of the measuring points, the round disks and limit disks were connected in series on one steel rod. Thus, there was little relative slip or shedding between the device and the conduits.

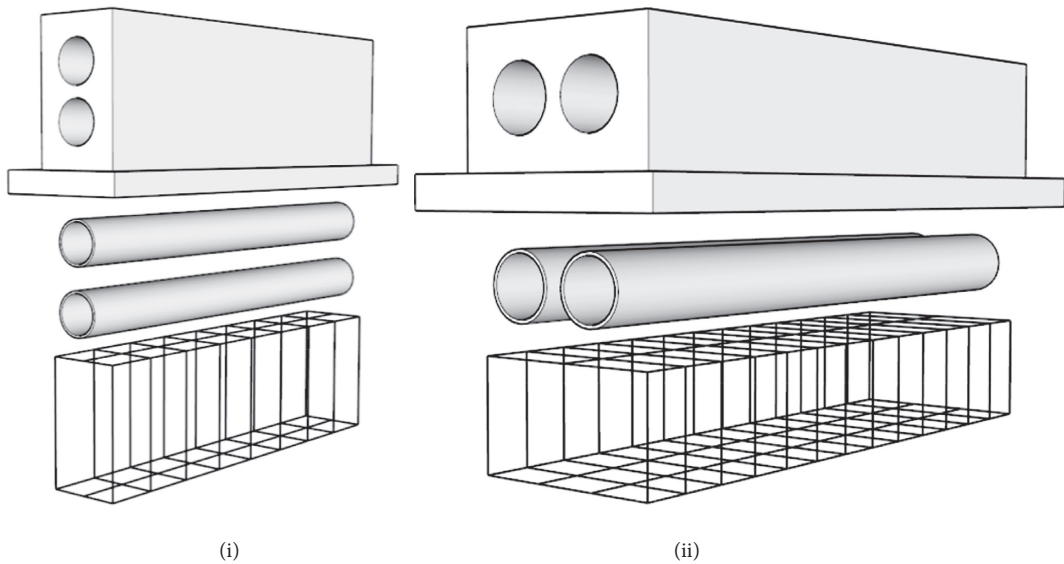
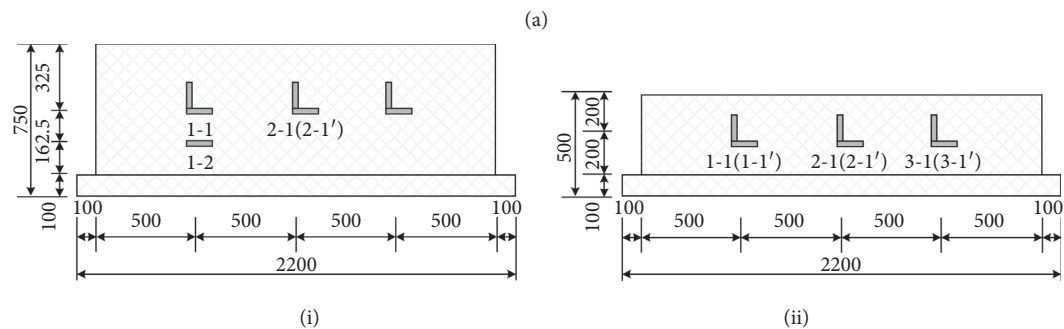
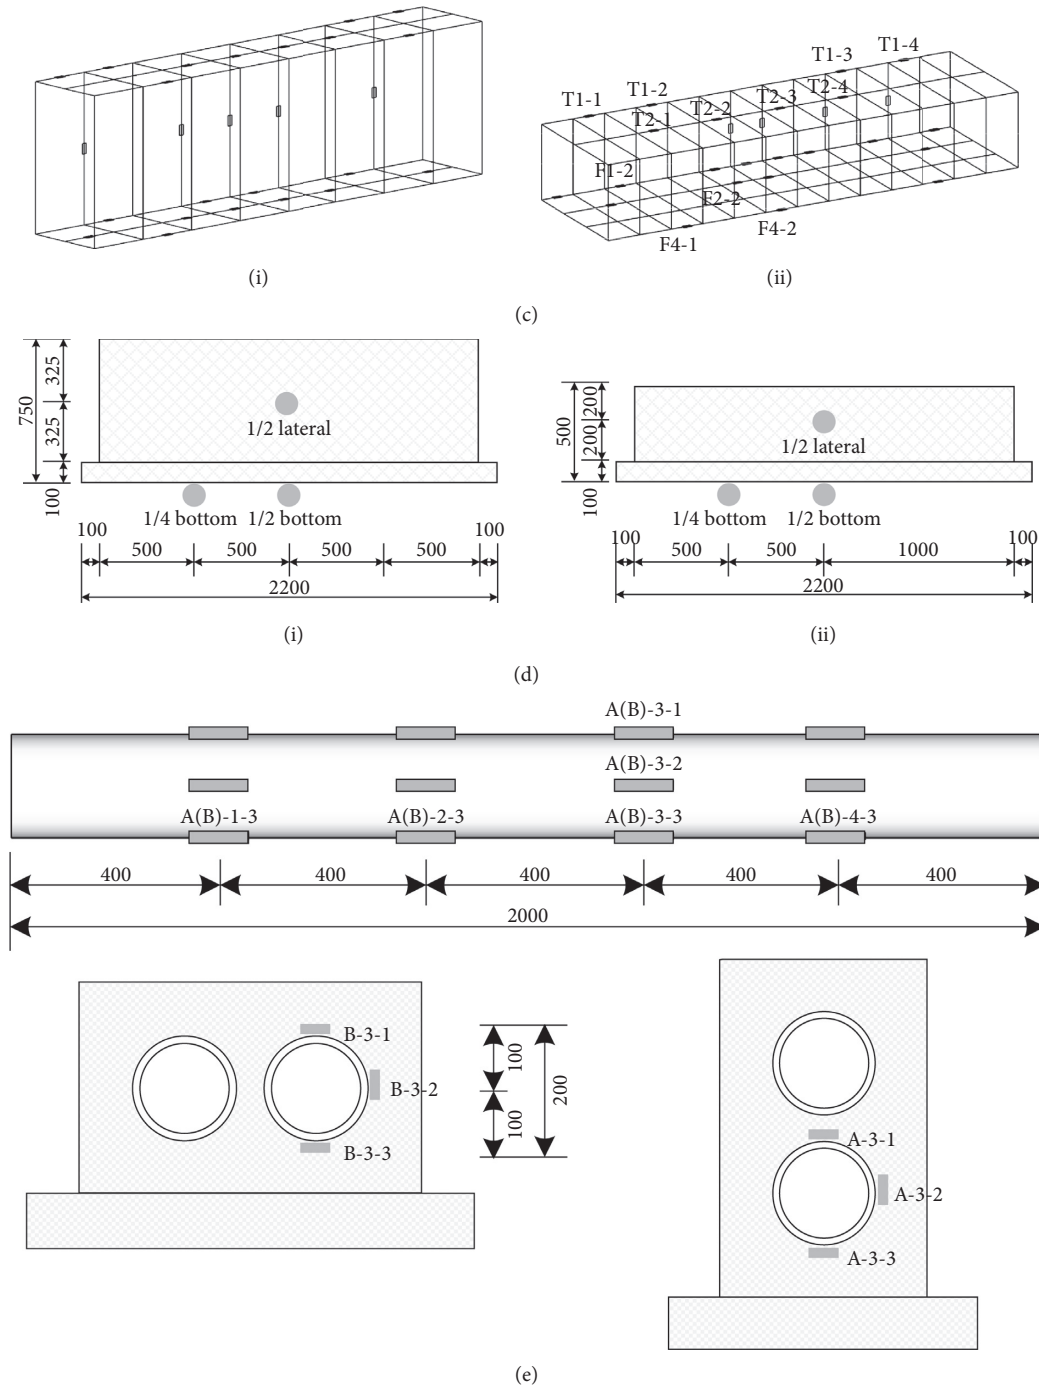
FIGURE 6: Specimen diagram and measurement points in the experiment (millimeters). (a) Specimen diagram: (i) A-type and (ii) B-type. (b) Cover concrete: (i) A-type and (ii) B-type. (c) Reinforcements: (i) A-type and (ii) B-type. (d) Soil pressure: (i) A-type and (ii) B-type. (e) HDPE conduits.

In addition, there are other monitoring devices shown in Table 3. Soil pressure cells were used to record the soil pressure variation during the loading process. Strain gauges were used to measure the strain of the cover concrete, reinforcements, and HDPE conduits. Displacement gauges were used to measure the overall displacement of the specimens. The positions of the measuring points are shown in Figure 6. Note that the data of numbered measuring points were analyzed and those without numbers were either lost or unreasonable.

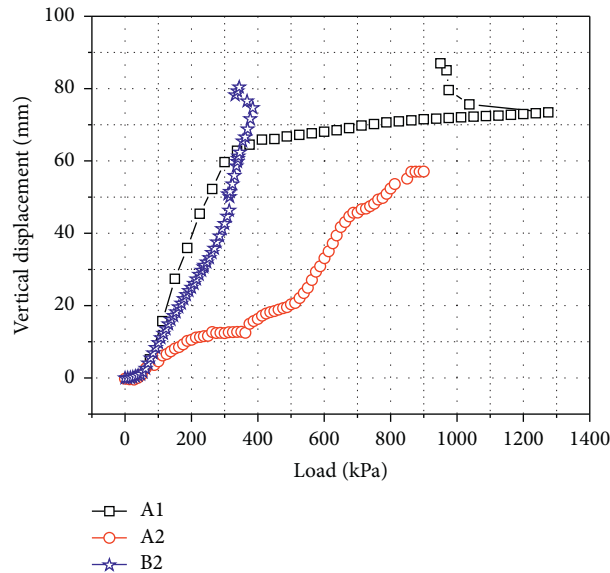
FIGURE 7: Load-displacement curve.

3.1. Damage Pattern. Figure 7 shows the load-displacement curve. Due to improper instrument operation, the load-displacement curve of specimen B1 was lost. As shown in Figure 7, the failure loads of specimens A1, A2, and B2 are 1275 kPa, 900 kPa, and 400 kPa, respectively. Specimen A1 contains the reinforcements, while A2 does not. Specimen A2 has a higher section height than specimen B2. Hence, it

can be concluded that the reinforcements and higher section height have an effect on improving the bending capacity and the section height may be a larger contributor than the reinforcements. After the failure load, a steep load drop appears in A1, but the load drops in A2 and B2 are gentle. In addition, the midspan deflections of A1, A2, and B2 are close within the range of 60 mm~80 mm. Although the bending capacity of the specimens differs greatly, their midspan deflections are close. Furthermore, a visible yield stage can be seen in A1, while no yield stage can be seen in A2. Thus, it can be speculated that the reinforcements cause the yield stage. The displacement of B2 shows an approximately linear increase without a yield stage, which means that B2 underwent brittle failure.

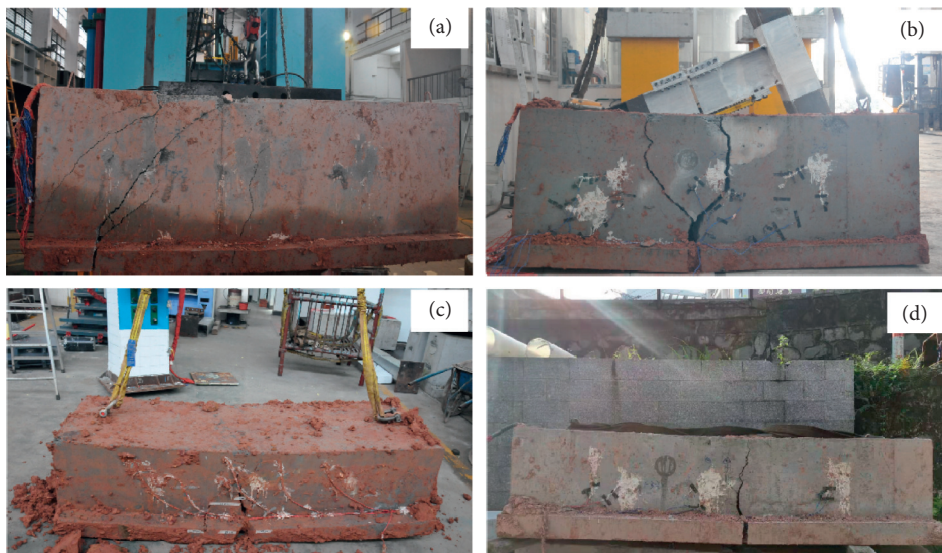
FIGURE 8: Damage patterns: (a) for A1, (b) for A2, (c) for B1, and (d) for B2.

Figure 8 shows the damage patterns of the four specimens. The main cracks of specimens A2, B1, and B2 appear at the midspan, while the main crack of A1 is a diagonal crack that appears near the left hinge support. The main crack widths in the main structure of A1, A2, B1, and B2 are approximately 10 mm, 40 mm, 25 mm, and 20 mm, respectively. In addition, there are other secondary cracks. For specimen A1, there is one 4 mm diagonal crack near the left support and one 3 mm vertical crack at the midspan. For specimen A2, the main crack is split into one 10 mm crack and one 20 mm crack extending to the top of the main structure. For specimen B1, one 8 mm crack appears 180 mm to the left of the main crack. For specimen B2, the main crack is split into one 2 mm crack and one 10 mm crack extending to the top of the main structure. Furthermore, the concrete on the compression side is crushed in the A-type specimens, while no crushing is found in the B-type specimens. In summary, it can be seen that the damage pattern of specimens A2, B1, and B2 is similar to that of simply supported beams.

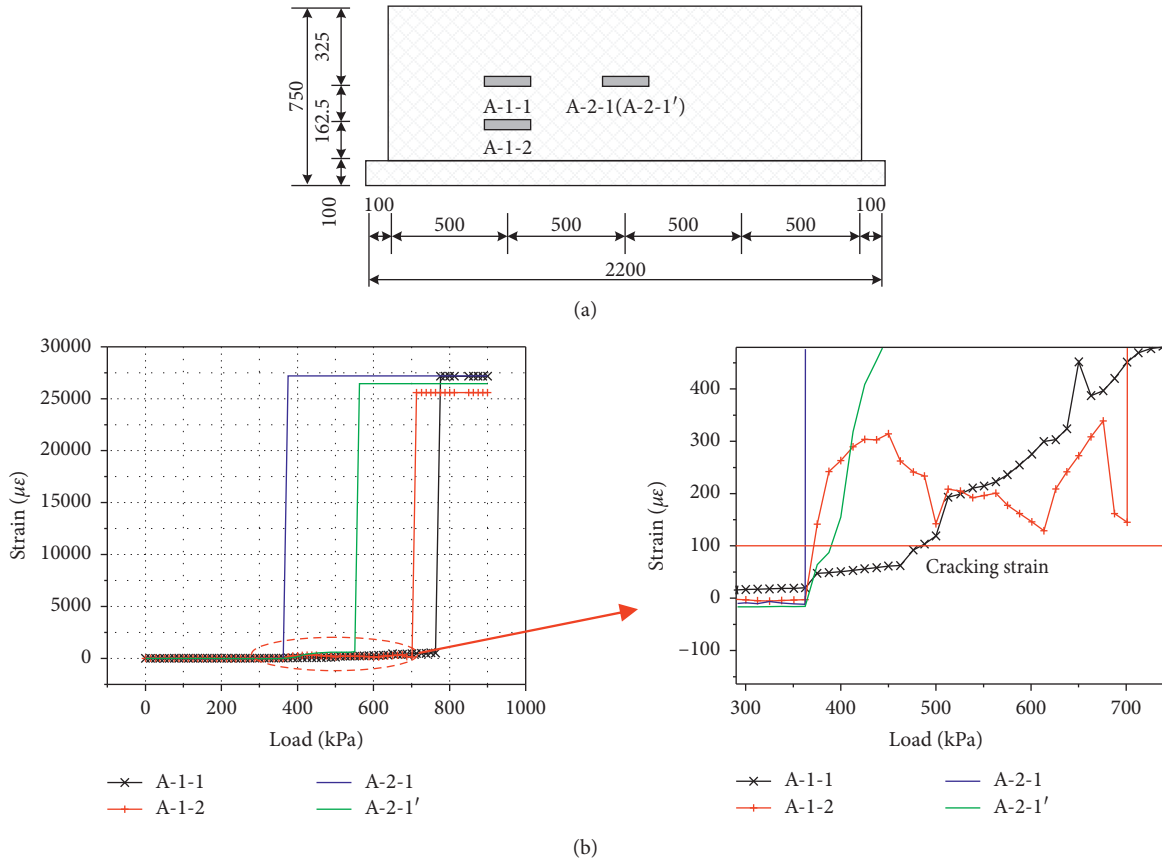
FIGURE 10: Strain evolution of A2. (a) Measuring points of cover concrete. (b) Load-strain curve.

3.3.1. Cover Concrete. As shown in Figure 10(a), measuring points A-1-1, A-2-1, and A-2-1' (' representing the back side) were arranged at a height of 1/2H, and A-1-2 was arranged at a height of 1/4H; A-1-1 and A-1-2 were arranged at a 1/4 span; A-2-1 and A-2-1' were arranged at a 1/2 span. Figure 10(b) shows the strain curve of the cover concrete. As shown in Figure 10(b), all the strains are tensile strains.

When the load is less than 375 kPa, the strain barely increases. When the load exceeds 375 kPa, the strains of A-1-2, A-2-1, and A-2-1' are larger than the tensile cracking strain ($100 \mu\epsilon$), which means that cracks appear at $1/2 H$ of the $1/2$ span and $1/4 H$ of the $1/4$ span. When the load reaches 500 kPa, the strain of A-1-1 exceeds $100 \mu\epsilon$; hence, cracks appear at $1/2H$ of the $1/4$ span. Thus, it can be inferred that cracks extend from $1/4H$ to $1/2H$ at the $1/4$ span when the load increases from 375 kPa to 500 kPa. In the meantime, the neutral axis moves upwards, and the crack width starts to grow after the strain exceeds $100 \mu\epsilon$. Furthermore, a visible inflection point appears in the four curves. The inflection points of A-2-1, A-2-1', A-1-2, and A-1-1 appear at loads of 375 kPa, 551 kPa, 701 kPa, and 763 kPa, which corresponds to the maximum crack width.

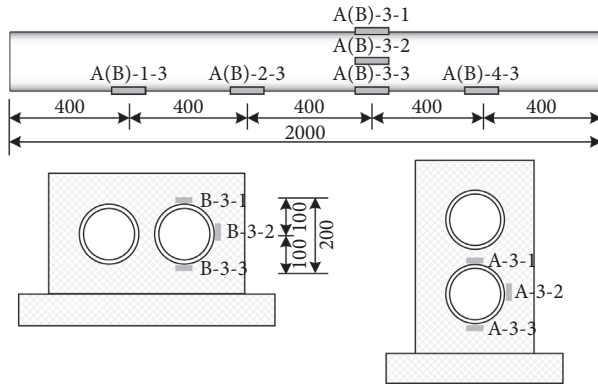
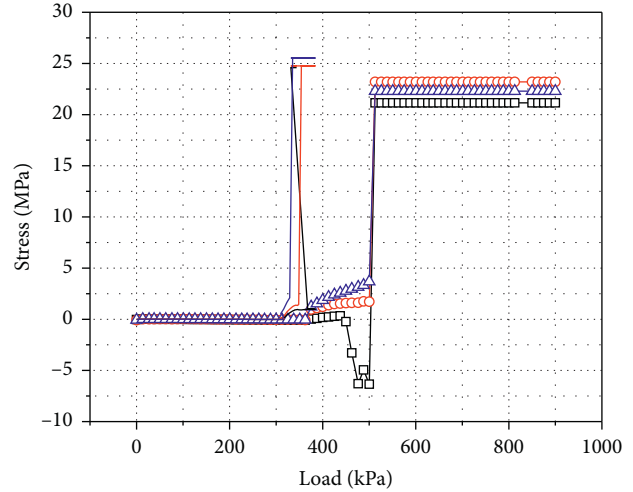
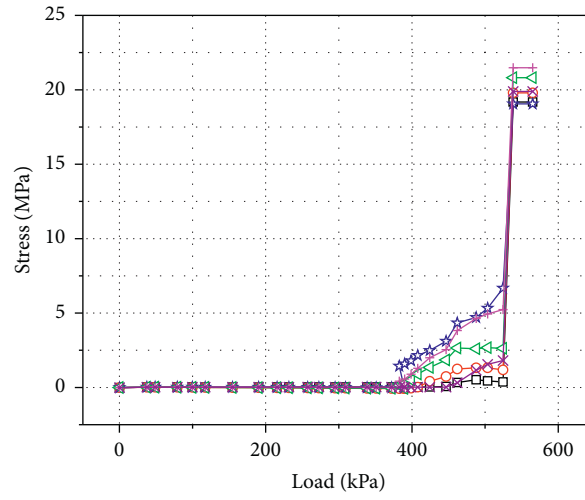
FIGURE 13: Stress evolution of HDPE conduits. (a) Measuring points of HDPE conduits. (b) Load-stress curve of A2 and B2. (c) Load-stress curve of B1.

3.3.3. HDPE Conduit. As shown in Figure 13(a), measuring points A (B)-3-1, A (B)-3-2, and A (B)-3-3 are arranged on the same transverse section; B-1-3, B-2-3, B-3-3, and B-4-3

are arranged on the same profile. As shown in Figure 13(b), when the load is less than 300 kPa, the stresses barely increase. When the load exceeds 300 kPa, the stresses start to increase linearly. Then, the stresses of A2 and B2 undergo a sharp increase at loads of 500 kPa and 350 kPa, respectively, exceeding the tensile strength of the conduit (18 MPa). As shown in Figure 13(c), when the load exceeds 400 kPa, the stresses start to increase linearly. Similarly, the stress of B1 exceeds the tensile strength at a load of 525 kPa. The three curves have the same evolution trend, which is similar to that of the bottom rebar F1 given in Figure 14.

As shown in Figures 13(c) and 14, rebar F1 yields at a load of 400 kPa, and, at the same time, the stress of the conduit starts to increase. As shown in Figures 13(c) and 12(a), the stress of the conduit exceeds the tensile strength at a load of 525 kPa, and rebar T2 exceeds the yield strength at a load of 539 kPa. During the upward movement of the neutral axis, the stresses of rebar F1, the HDPE conduit, and rebar T2 exceed their designed tensile strengths. Thus, it can be inferred that HDPE conduits serve as the rebars during the experiment. Moreover, the stresses of different measuring points on the same conduit are close.

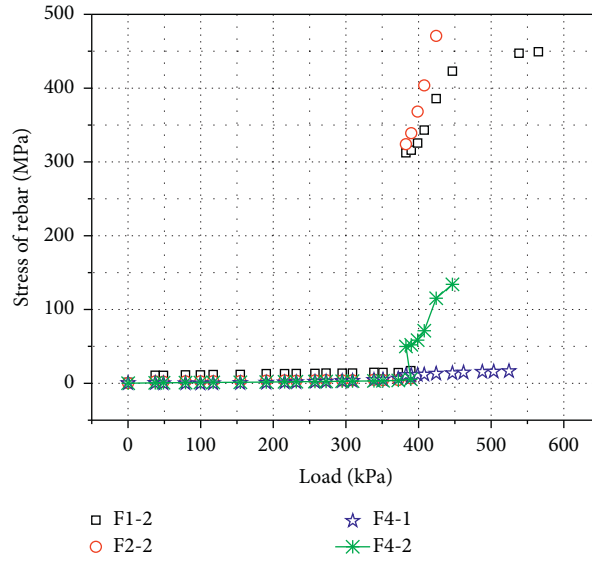
FIGURE 14: Load-stress curve of bottom rebars.

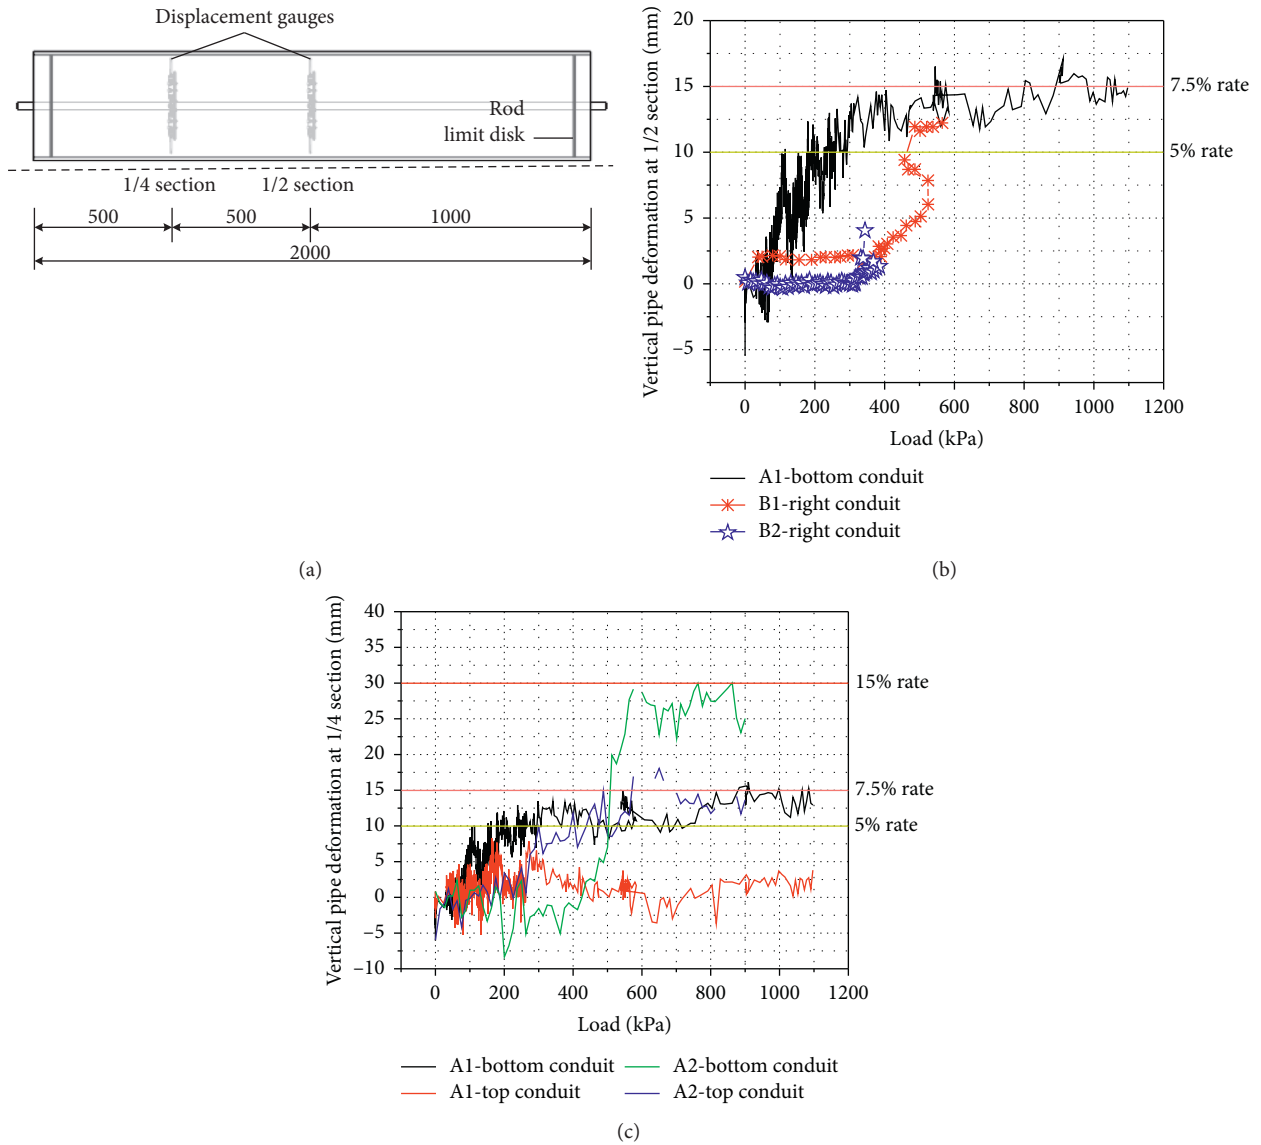
FIGURE 15: Vertical deformation of HDPE conduits. (a) Measuring points of HDPE conduits: (b) 1/2 section and (c) 1/4 section.

As shown in Figure 15(a), the measuring points are arranged on a 1/2 section and 1/4 section of the conduit. As

shown in Figure 15(b), the compressive deformation of A1 and B1 at the midpoint exceeds 10 mm (5% conduit diameter), while B2 is below 5%; the compressive deformation of A1 exceeds 15 mm (7.5% conduit diameter), while B1 is below 7.5%. Moreover, a visible yield stage appears in the A-type specimens. As shown in Figure 15(c), the deformation rates of A1 (bottom conduit) and A2 (both conduits) are larger than 7.5%; the compressive deformation of A2 (bottom conduit) reaches 30 mm (15% of conduit diameter). Thus, it can be concluded that the deformation rate of A2 is larger than that of A1. For A-type specimens, the

deformation rate of the bottom conduit is larger than that of the top conduit, which corresponds to the typical characteristics of bending specimens. The reason may be that the bottom conduit carries a larger bending moment and reaches the tensile strength earlier.

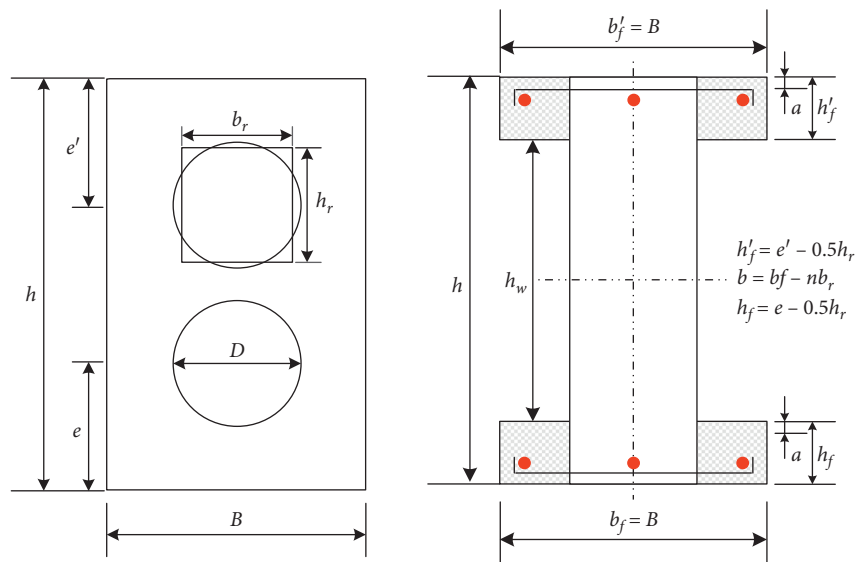
FIGURE 16: Equivalent I-shaped cross section of the concrete cable duct.

4.1.1. Conversion of Cross Section. The cross section of the concrete cable duct can be converted into an I-shaped cross section regardless of the cushion layer. As shown in Table 2, B , H , and D represent the width of the cross section, the height of the cross section, and the diameter of the HDPE conduits, respectively. As shown in Figure 16, by the rule of equal area and moment of inertia, the round hole can be converted into a rectangular hole. The dimensions of the I-shaped section can be calculated by the following formulas. Table 4 shows the result:
