Research Article

Geological Analysis and Model Test of Bedding Rock Cutting Landslide

2. Project Overview

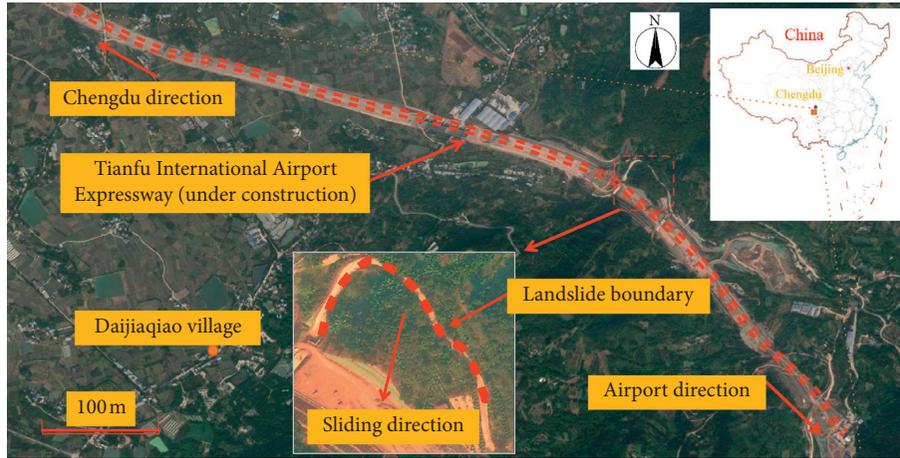
FIGURE 1: K17 + 700 ~ K 17 + 900 landslide view.

The landslide site selected for this test is located at K17 + 700 ~ K17 + 900 of Taiping, Tianfu International Airport Expressway, Shuangliu district, Chengdu. The front edge of the landslide has a highway cutting structure. Figure 1 is K17 + 700 ~ K 17 + 900 landslide view.

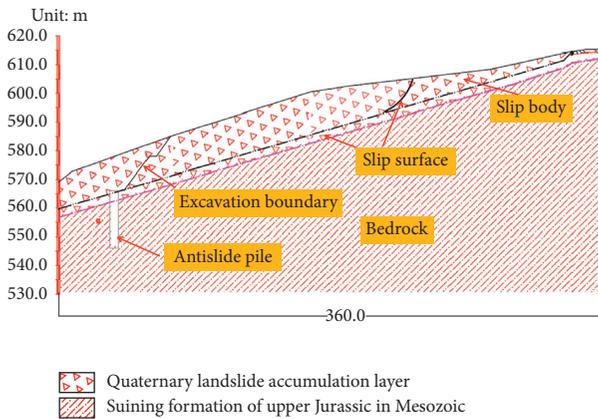
FIGURE 2: No. 2-2' landslide engineering geological section (unit: m).

According to engineering geological survey data [25], the landslide is a bedding rock cutting landslide, and the thickness of the slip body is between 4.1 m and 15.6 m. The slip body is mainly composed of block stones and mudstone, the slip surface is a soft interlayer of silty mudstone, and the main shape of the slip surface is linear. The underlying bedrock is J_{3s} silty mudstone. Among them, the geological section 2-2' of the main sliding direction of the landslide is shown in Figure 2.

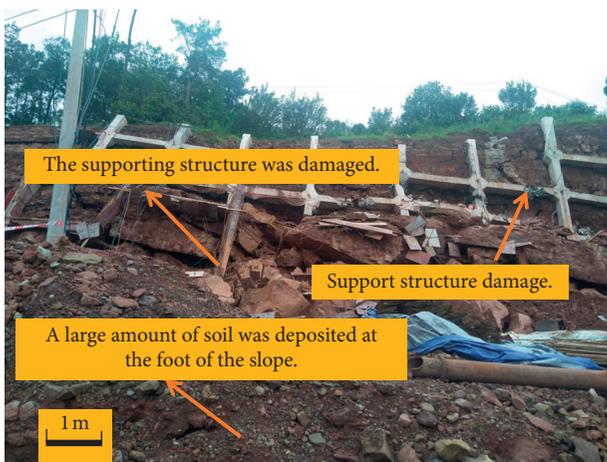
FIGURE 3: Failure diagram of frame anchor cable on landslide front edge.

As shown in Figure 3, the anchor rod and frame anchor cable set in the front edge of the landslide have large deformation and even failure. During this period, the water content of the slip body is saturated. Under the influence of rain erosion and soil gravity and other factors, the original cracks in the slip body gradually disappeared, and the sliding soil is silted at the empty position at the foot of the slope. Figure 4 shows the deformation process of the landslide.

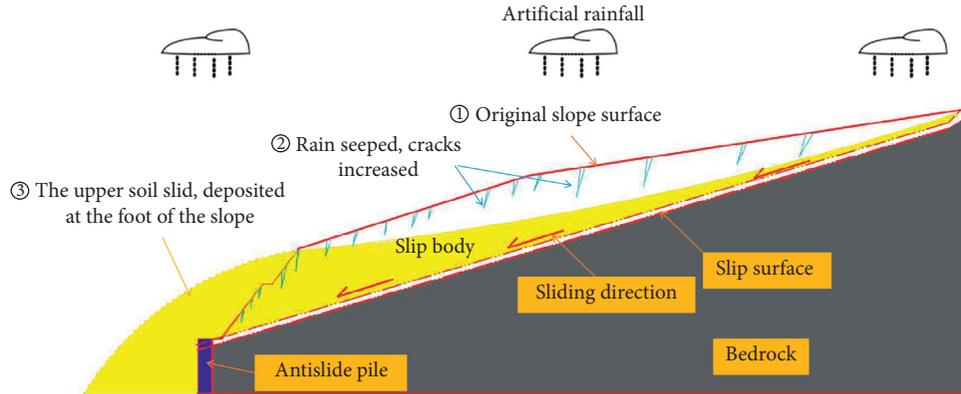
FIGURE 4: Schematic diagram of the landslide deformation process.

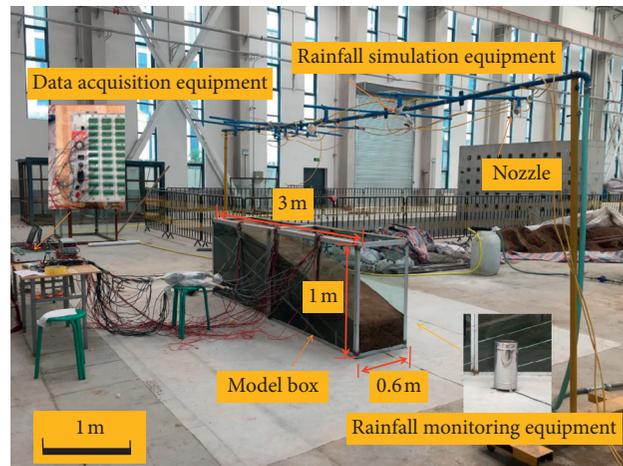
FIGURE 5: Rainfall equipment used in the test.

3.1. Model Box Size and Rainfall Equipment. The size of the model box selected for this experiment is length \times width \times height = 3.0 m \times 0.6 m \times 1.0 m. The model box is made of angle steel and 10 mm thick transparent tempered glass. As shown in Figure 5, the rainfall equipment is self-developed rainfall equipment, and the rainfall intensity is measured by a rain gauge.

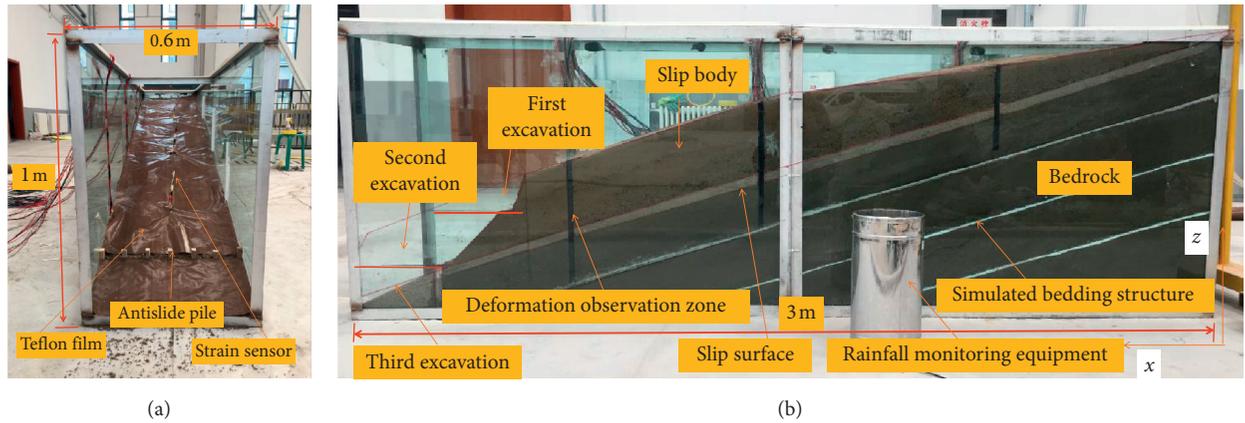
FIGURE 6: Test model filling. (a) Laying Teflon film. (b) Test model at the end of filling.

which proved the feasibility of the filling method. Yin et al. [29] used Teflon material to simulate the weak interlayer. Li et al. [30], Ju et al. [31], and Tang et al. [32] used gypsum material to fill the soft bedding structure between the rock and soil and studied the failure mechanism and process of rock slopes. In view of this, this test model adopts the layered filling method. After each layer is filled, a layer of 1 cm thick gypsum was spread to simulate the bedding structure of the bedrock, and it is leveled and lightly pressed. As shown in Figure 6(a), in order to fully simulate the actual engineering situation and provide convenience for the sliding process of the slip body, a layer of impermeable Teflon film is laid between the slip body and the slip surface. Figure 6(b) is the completed test model. To facilitate the observation of experimental phenomena, a 2 cm wide vertical deformation observation zone was set up at the foot, middle, and top of the landslide.

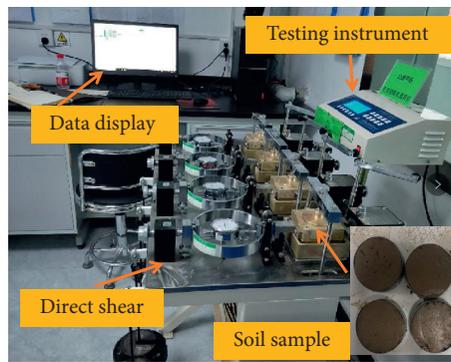
FIGURE 7: Conventional direct shear test.

As shown in Figure 7, by carrying out the conventional direct shear test, the material parameters of the slip body, slip surface, and bedrock used in the test are determined as shown in Table 2.

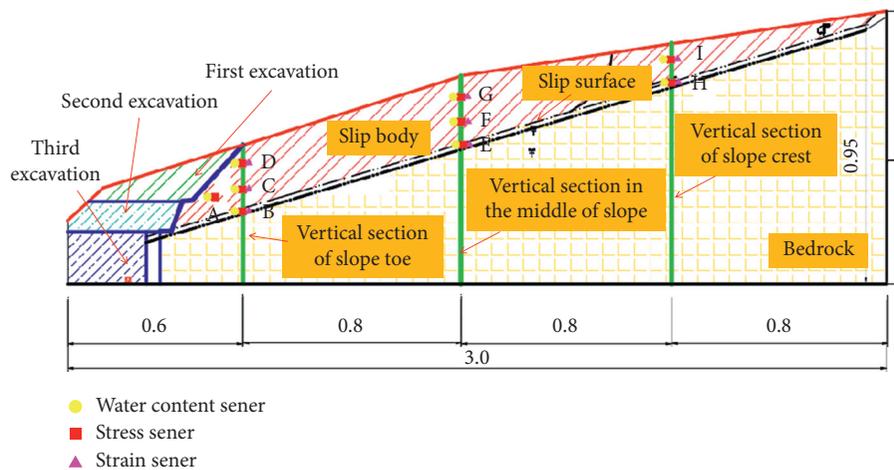
FIGURE 8: Schematic diagram of sensor layout (unit: m).

3.4. *Sensor Layout.* According to the similarity ratio, the original slope model is simplified, and the simplified slope size and sensor layout are shown in Figure 8. The types of

sensors deployed include moisture content, strain, and stress sensors. In the slip surface and slip body, each measuring point is equipped with a moisture content, strain, and stress sensor, and the A measuring point is only equipped with moisture content and stress sensors. Three sets of sensors were set on the vertical section of the slope foot and the middle of the slope from top to bottom, and two sets are set on the vertical section of the top of the slope, and the vertical distance between them is 10 mm.

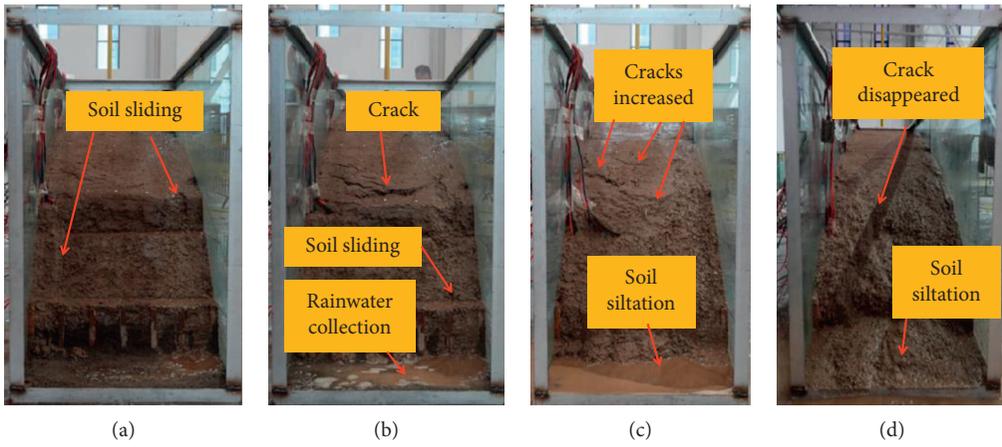
FIGURE 9: Summary of test phenomena. (a) 15:45. (b) 16:10. (c) 17:10. (d) 18:30.

Rainfall stage: the test started at 15:00 and ended at 18:30. The test phenomena affected by the rainfall are summarized as follows: at 15:45, the soil at the foot of the slope near the sides of the left and right box walls collapsed and the soil fell siltation at the foot of the slope. At 15:45, Figure 9(a) shows that the part of the toe of the slope had multiple transverse cracks, and the rainwater on the right slope formed a runoff channel. At 16:10, affected by continuous rainfall, the existing cracks in the soil at the foot of the slope continued to develop, and the gully formed by the erosion of the water on the right slope at the corner of the slope continued to deepen. There were transverse and longitudinal cracks in the middle and back edge of the sliding mass. Figure 10(b) shows the cracks at the corresponding position of the back edge of the slope. As can be seen from Figure 9(b), the toe of the slope was seriously deformed and the cracks in the vertical section of the toe continue to widen and deepen. At 17:10, the existing cracks on the surface of the slope gradually disappeared owing to the sliding of the rear soil and the splash erosion of rain. Figure 9(c) shows that the soil sliding at the foot of the slope is further intensified. Figure 10(a) shows the damage phenomenon at the foot of the slope at the project site, the destruction phenomenon between the two is consistent. At 18:30, after the end of the test, in addition to the further aggravation of the

slippage at the foot of the slope, by observing the change trend of the vertical observation zone on the side wall of the model box, it can be found that the deformation of the slope during the test is based on the soil deformation at the foot of the slope. Mainly, the soil deformation in the middle of the slope is the second. Figure 9(d) shows that the deformation of the soil at the top of the slope is the weakest.

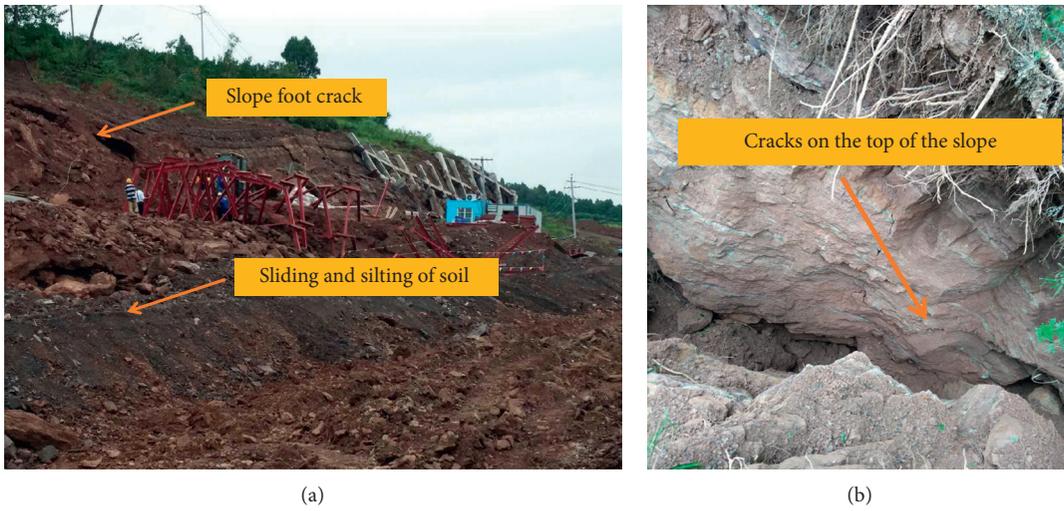
FIGURE 10: Engineering site pictures. (a) Slope foot. (b) Top of the slope.

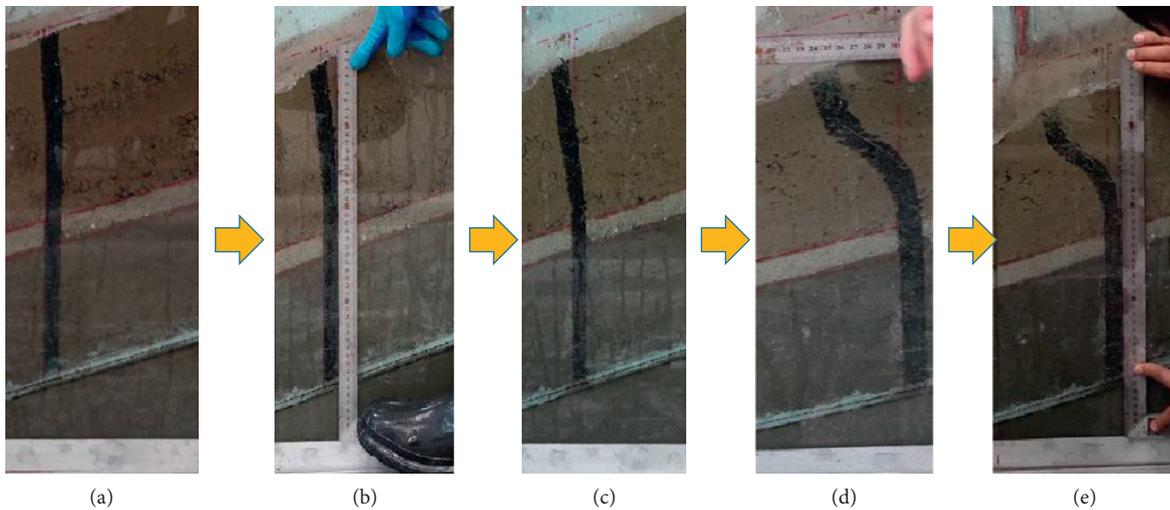
FIGURE 11: Horizontal displacement change of vertical section of slope toe. (a) 15:41. (b) 16:18. (c) 17:13. (d) 17:54. (e) 18:30.

The above part is the frontal test phenomenon of the model box, and the side test phenomenon of the model box is mainly reflected in the aspect of deformation. From 15:00–17:13, the deformation of the landslide body is not obvious (Figures 11(a)–11(c)). After 17:13, the deformation gradually becomes faster (Figures 11(d) and 11(e)). At the end of the test, at the upper part of the vertical section of the slope toe, the horizontal deformation reached 8 cm and the vertical settlement reached 6 cm. In addition, by observing the test phenomenon on the side of the model box, it is found that the soil is mainly deposited on the top of the slope toe.

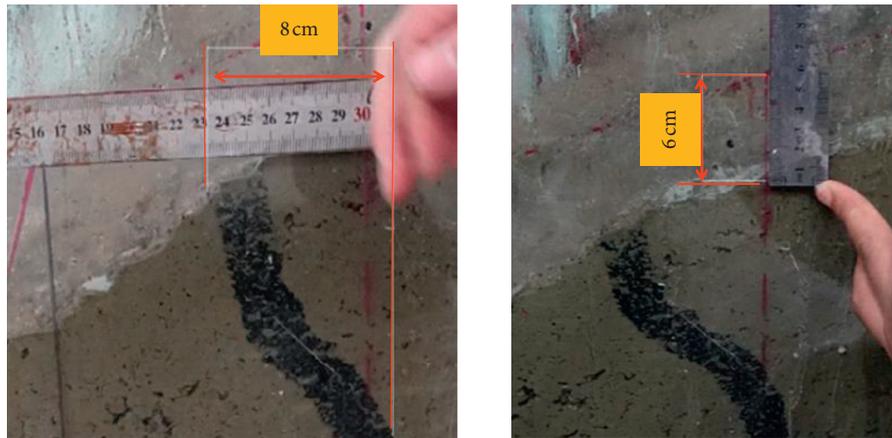
FIGURE 12: Displacement and settlement change of slope foot section.

Figure 12 shows the changes in the horizontal displacement of the vertical section of the toe during the entire test. It can be seen from Figure 12, the horizontal displacement at the bottom of the slope increases slowly at 15:00 to 17:13. From 17:13 to 18:30, the slope toe displacement increased significantly, and this period of time

corresponds to the accelerated deformation stage. Therefore, displacement can be used as an early warning indicator of landslide disasters under construction and rainfall conditions.

It can be seen from Figure 12, under the influence of construction excavation and rainfall, the deformation of the slope foot is the largest, and the deformation of the slope top is the smallest. The position of the slope foot is around 17:00, and there is obvious displacement. The horizontal displacement of the vertical section of the toe is greater than the vertical displacement, and the vertical section deformation of the slope toe is mainly concentrated in the accelerated deformation stage. Therefore, displacement change can be used as an indicator of landslide disaster warning.

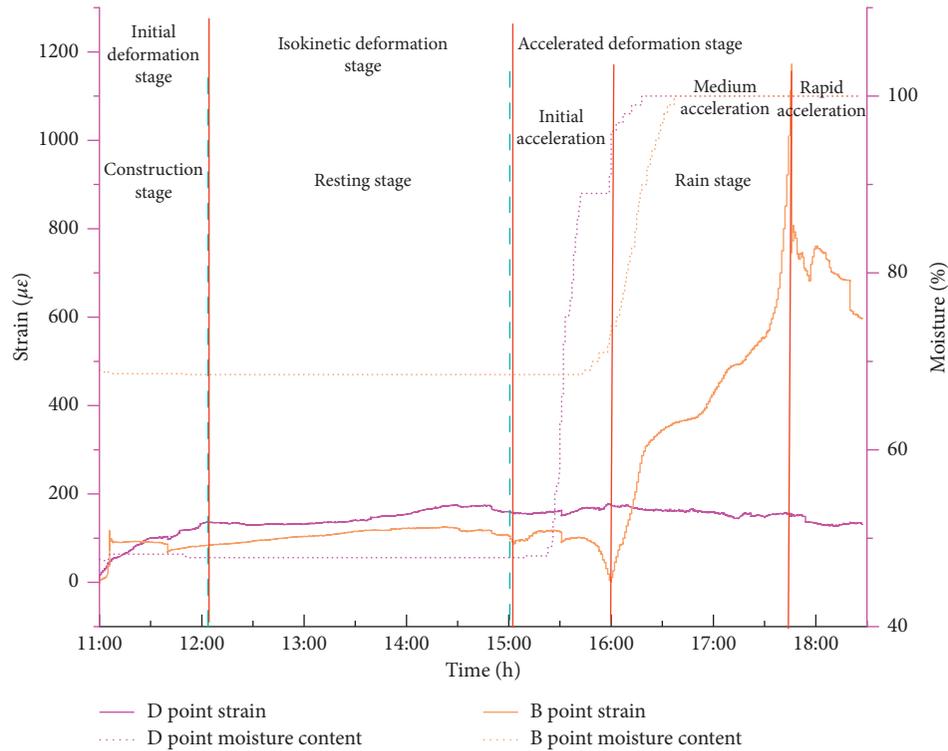
FIGURE 13: B, D measuring points strain-water content time history curve.

4.3.1. Vertical Section of Toe. To understand the coupling response of the slip body and the sliding belt strain-water content during the whole test period, draw the strain-water content time history curve of the vertical sections B and D of the slope foot (Figure 13).

Construction stage: during the entire construction period from 11:00 to 12:05, the strain at the B and D measuring points at the vertical section of the slope toe showed a slow increase trend. Under the influence of construction disturbance factors, the sliding force inside the slip body and slip surface is slightly greater than the antisliding force, and the landslide body is in the initial deformation stage.

Static stage: from 12:06 to 15:00, the sliding force and antisliding force at measuring points D and B are basically maintained in a dynamic equilibrium state. At this time, the strain growth rate remained basically unchanged, but the sliding force was slightly greater than the antisliding force. At this stage, the strain values of the two measuring points B and D increased slightly. Since the measuring point B is located directly below the measuring point D, it is strongly restrained by the surrounding soil mass and the strain value

is relatively small. The strain at measuring point D is always greater than that of B, and the landslide body is in the stage of constant velocity deformation.

Rainfall stage: after 15:01, the rainfall system is turned on, the water content of measuring point D has a sharp increase before point B. With the continuous infiltration of rainwater, the measuring point D is gradually in a relaxed state, the stress around the measuring point gradually dissipates, the stress in the upper area of the slope toe section gradually approaches 0. Affected by this, although the strain value of measuring point D has a slight increase, it is basically maintained at a small value. The measurement point B is located inside the slip surface. With the continuous infiltration of rainwater, the soil moisture content reaches a saturated state at about 16:30. The bulk density of the soil around point B increases, and the stress continues to increase, coupled with the impact of the surrounding soil. Then, the stress cannot be dissipated, causing the strain value of the B measuring point to increase sharply. Slope toe section changes from the initial acceleration deformation stage to the middle acceleration deformation stage. Affected by continuous rainfall, rainwater that cannot infiltrate in time forms a runoff phenomenon on the surface and takes away small particles in the soil, which increases the deformation around the measuring point. At the same time, the continuous infiltration of rainwater reduces the stress of the vertical section at the angle of the slope, and the strain values of measuring points B and D gradually decrease. At this time, the toe of the slope is in the acceleration deformation stage, and the vertical section of the toe collapses and loses stability.

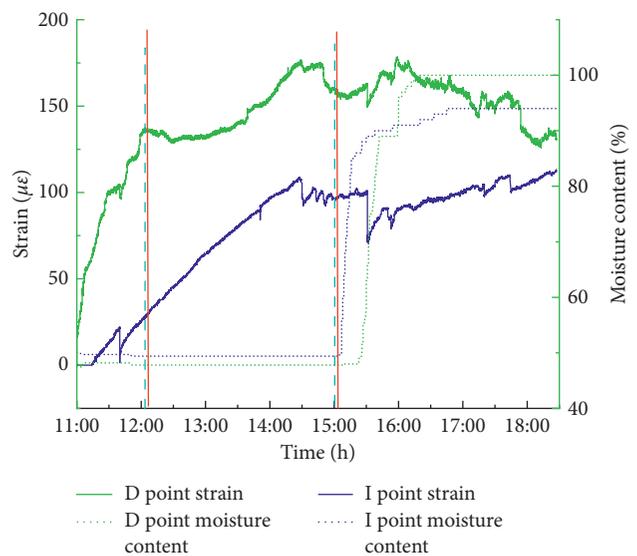
FIGURE 14: D, I measuring points strain-water content time history curve.

4.3.2. Sliding Body D, I Plane. Measurement point D is located at the upper part of the vertical section of the slope toe, and measurement point I is located at the upper position of the vertical section of the top of the slope. From the strain-water content time history curve of measurement points D and I in Figure 14, the strain of the entire slip body increases to a certain extent in the initial and constant deformation stages. The sliding force is greater than the antisliding force,

and the deformation process continues. Throughout the construction and operation phase, the strain value of the D measuring point is always greater than the I measuring point.

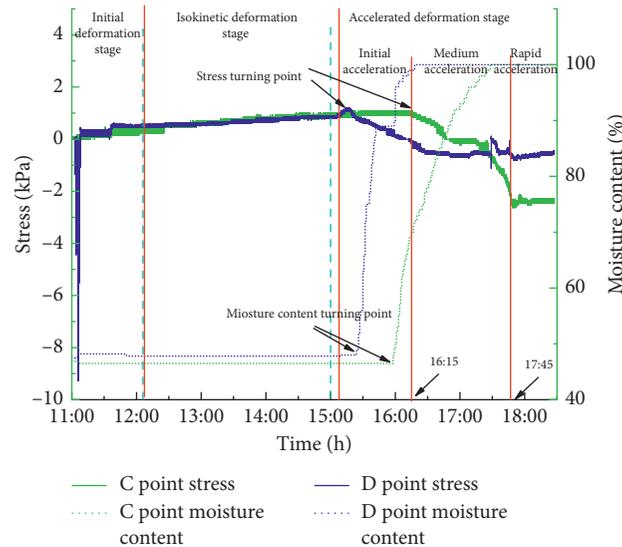
FIGURE 15: Stress-moisture content time history curve at C and D measuring points of the vertical section of slope foot.

Construction stage: Figure 15 shows the stress-water content time history curve of the vertical sections C and D of the slope toe. It can be seen from Figure 16 that, as the progressive excavation work (11:11–11:05, 11:30–11:35, 12:00–12:05) is carried out in an orderly manner, the stress at each measuring point of the vertical section of the slope foot has a small stepped increase, and the stress remains positive. The slip body changes from the original free state to

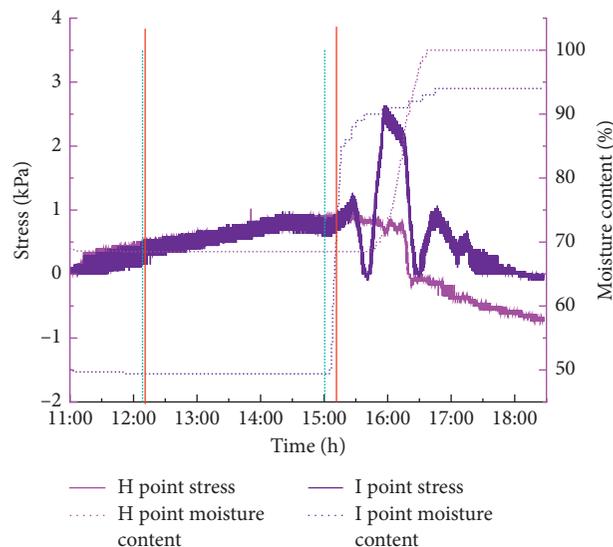
FIGURE 16: Time history curve of stress-moisture content at H and I measuring points of the vertical section of slope top.

Figure 16 shows the stress-water content time history curve of the vertical sections H and I of the top of the slope. The changes in earth pressure during the construction and static phases are basically the same as the vertical section of the toe and the middle of the slope. After starting the rainfall system at 15:00, the stress value in the soil under the influence of water content increases rapidly, and the pushing effect in the soil is greater than the traction effect.

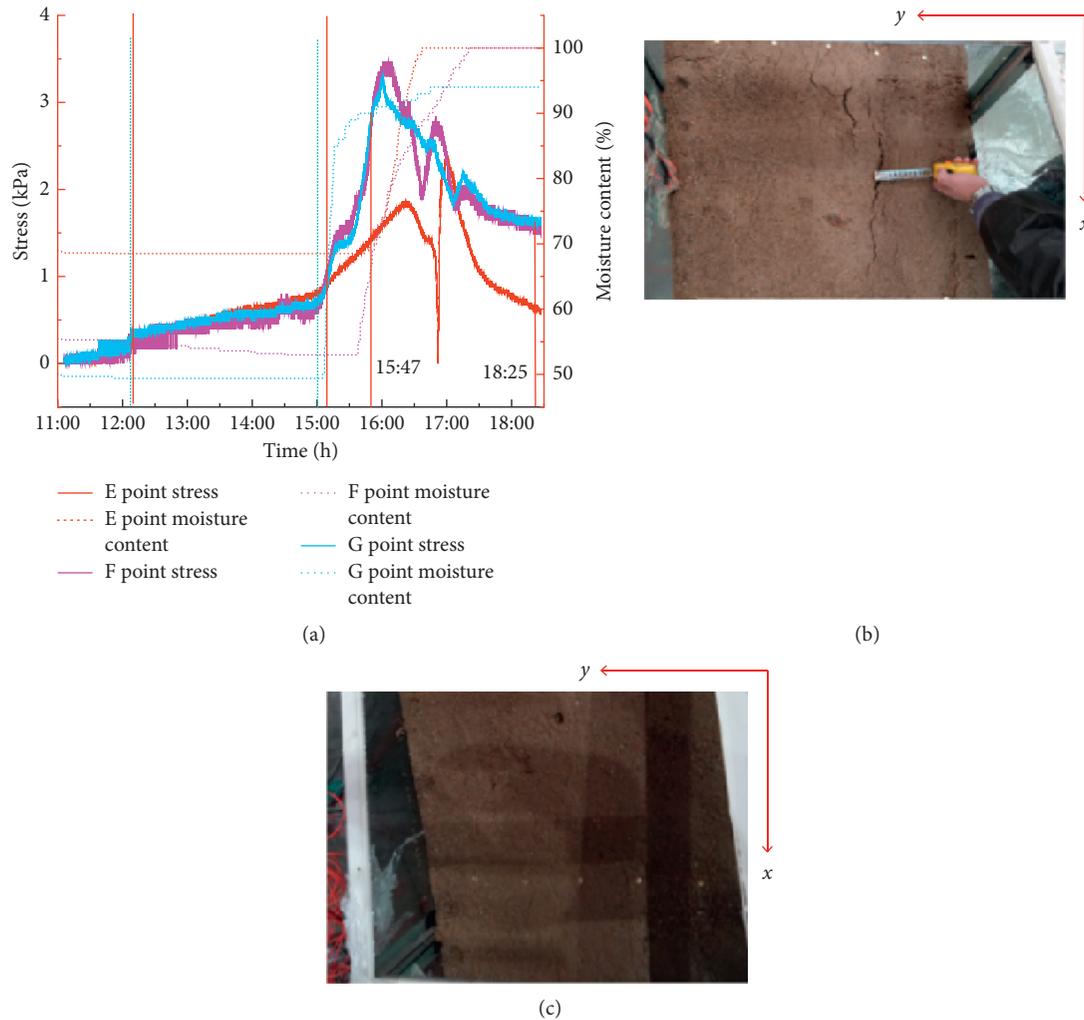
FIGURE 17: Stress-moisture content time history curve of vertical sections E, F, G in slope.

The stress-water content time history curves of the vertical sections E, F, G in the slope are shown in Figure 17. The stress change trend of vertical sections E, F, G in the slope is basically the same as that of C and D, so I will not repeat it.

Rainfall stage, after the rainfall system, is started at 15:00, the G and F measuring points located on the upper part of the vertical section of the slope are affected by rainwater seepage before the E measuring point. The water content and stress turning points of G and F measuring points appeared earlier than point E, and they increased rapidly. The stress at point F increased from 0.84 kPa before rainfall to 3.49 kPa, the stress at point G increased from 0.79 kPa before rainfall to 3.24 kPa, the stress at measuring point E increased from 0.68 kPa before rain to 2.37 kPa, indicating that the sliding force of the vertical section in the slope is far greater than the antisliding force. At this point, Figure 17(b) shows that horizontal cracks appear in the vertical part of the slope. The soil on the slope interruption surface is not only blocked by the front soil but also affected by the displacement of the rear soil, and the landslide has entered the accelerated

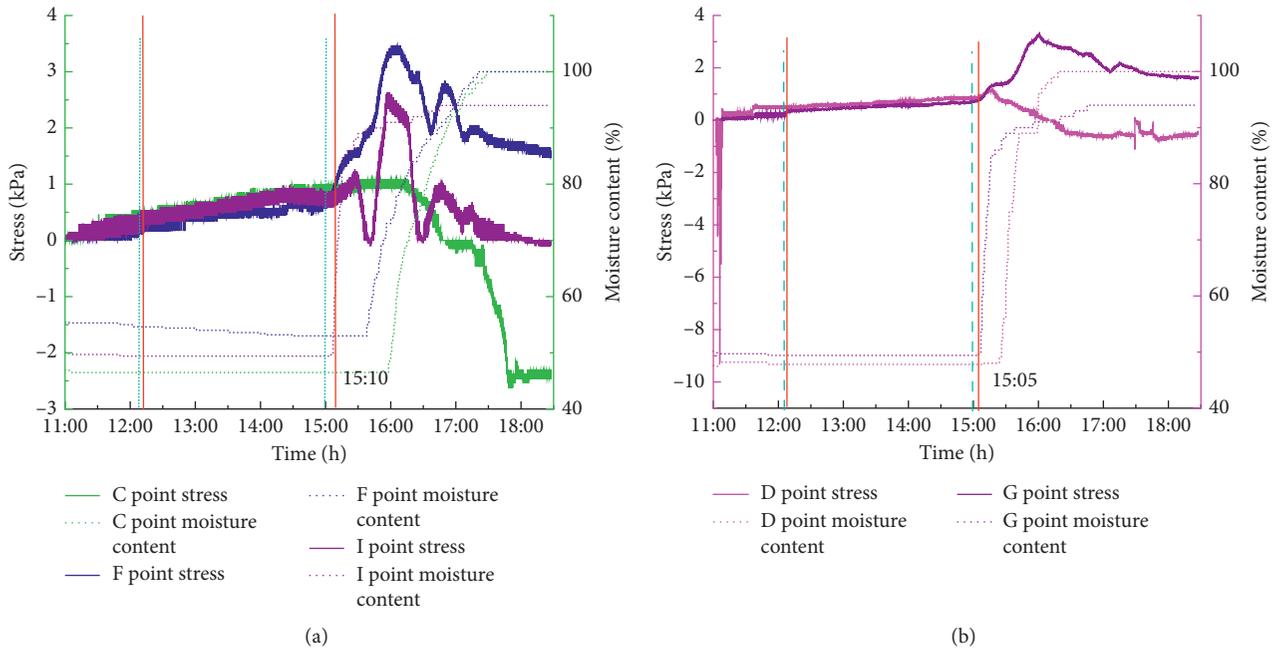
FIGURE 18: Time history curve of stress-water content in the upper and lower planes of the sliding body. (a) C, F, I measuring point. (b) D, G measuring point.

Figure 18(a) is the stress-water content time history curve at C, F, I measurement points, and Figure 18(b) is the stress-water content time history curve at D and G measurement points. It can be seen from Figure 18 that the stress-water content time history curves in the initial and constant deformation stages are basically the same, and the stress values have a slight increase. After the rainfall system was started at 15:00, the earth pressure increased around 15:05 at the D and G measuring points. However, the C, F, and I measurement points are affected by the embedding

depth, and the stress increases at around 15:10. With the continuous progress of rainfall, after 17:00, although the stress values of C and D measuring points oscillated slightly, they remained below 0. It shows that the toe section of the slope is greatly affected by the traction of the front soil, the stress at the measuring points G and F of the slope interruption surface, and the measuring point I of the slope crest section is maintained above 0. The front soil body has local collapse and slipping deformation, showing a traction sliding mode [37].
