Research Article

Field Experimental Study on Mechanical Properties of Frame Support Structure Composed of Subway Foundation Pit Retaining Pile and Steel Strut Rigid Joint

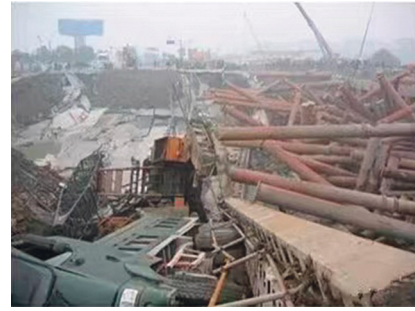
FIGURE 1: Foundation pit collapse.

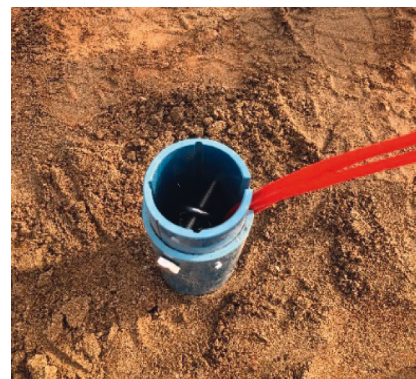
2.4.2. Embedding of Inclinometer. The fixed inclinometer developed by golden civil engineering company is used to monitor the lateral displacement of piles. Two inclinometer monitoring holes are set in the test, and one measuring point is arranged every 1 m in each monitoring hole, with a total of three measuring points. First, install three inclinometers in parallel on the ground, point the high guide wheel to the

foundation pit, slowly lower it into the buried inclinometer pipe, and record the corresponding data line number of each measuring point, as shown in Figure 4.

FIGURE 4: Burying the inclinometer.

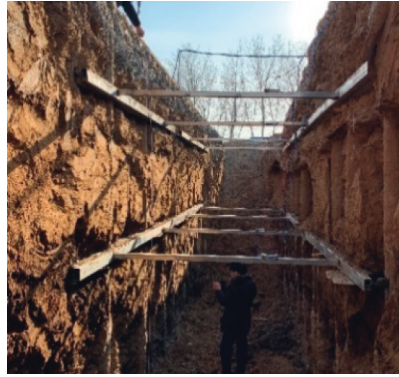
2.4.5. *Steel Strut Design.* The cross section size is (height × width × thickness) 4.5 cm × 4.5 cm × 2 mm square steel pipe simulated steel strut. Its horizontal spacing is 1.8 m, four supports are installed in the horizontal direction,

and two layers of steel struts are set at -1 m and -2.5 m, respectively, in the vertical direction. The strut that can only bear the axial compressive stress is installed on the south half of the foundation pit, the steel strut is overlapped between the two brackets, and the gap between the steel strut and the waist beam is filled with a wooden wedge. The strut that can bear axial compressive stress and tensile stress is installed on the north half of the foundation pit, and the steel strut is welded with the waist beam to realize rigid joint. The supporting structure is shown in Figure 5.

FIGURE 5: Supporting structure.

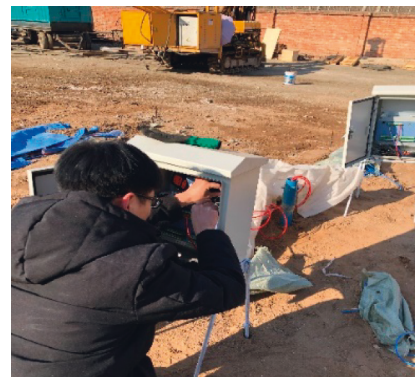
2.4.7. Monitoring Record and Data Processing. The process of foundation pit collapse takes a short time, and the manual collection of various monitoring data is slow and has poor accuracy. Therefore, all monitoring data are stored, recorded, and processed in the automatic collection box developed by Golden Civil Engineering Company, as shown in Figure 7.

FIGURE 7: Data acquisition instrument.

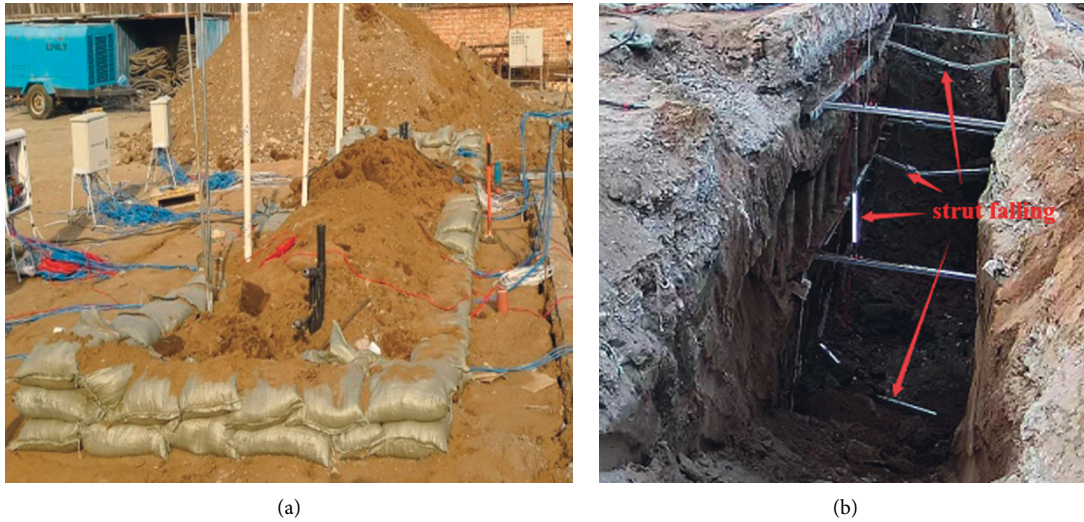
- (1) Pit side stacking: at 1 m to the west of the foundation pit, the spoil shall be taken and bagged, and an earth pile of 8 m long, 2 m wide, and 1.5 m high shall be stacked.
- (2) Underground water pipe leakage: water injection pipeline and gas pipeline shall be embedded in the soil replacement area of foundation pit, and the embedding work shall be completed together with formation replacement. The water injection pipe is made of two round steel pipes with a length of 6 m, a diameter of 10 cm, and a wall thickness of 2.5 mm. Multiple water outlet holes are arranged on the pipe wall, and the end is connected with the surface water pump through plastic hose.
- (3) Support falling: use the mechanical arm of the drilling rig to remove the traditional compression steel strut and rigid joint steel strut in the middle of the foundation pit from top to bottom, and observe

the whole process of foundation pit damage. The whole working condition simulation process is shown in Figure 8. The whole test process is shown in Table 1.

FIGURE 8: Simulation of test conditions. (a) Pit side loading. (b) Strut falling.

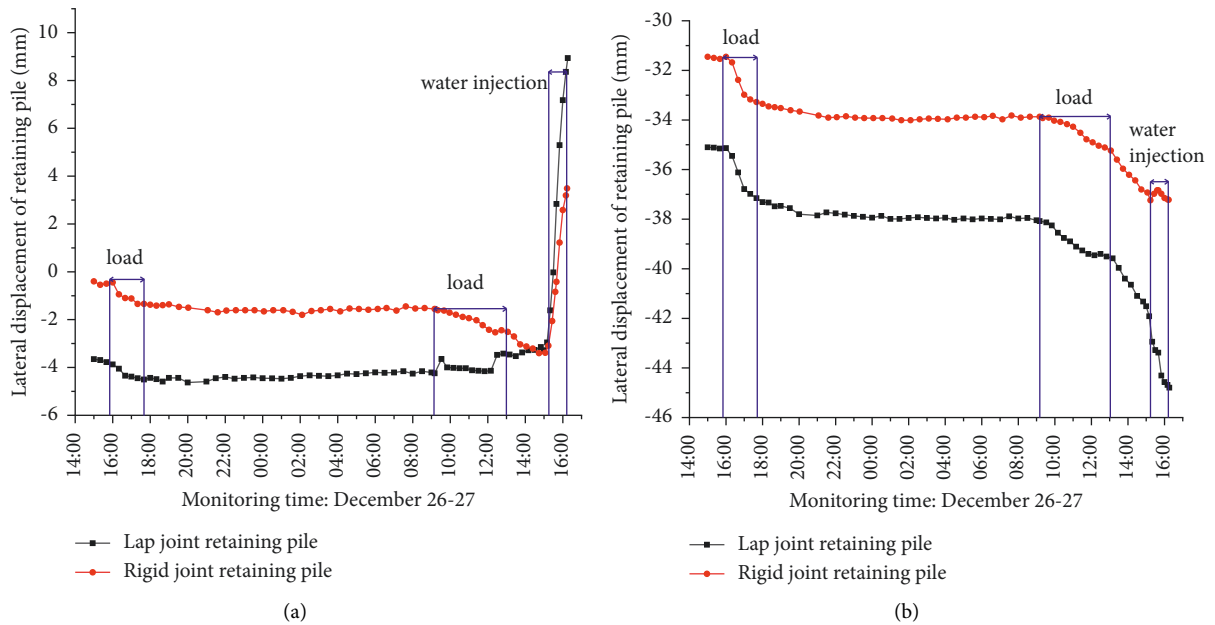
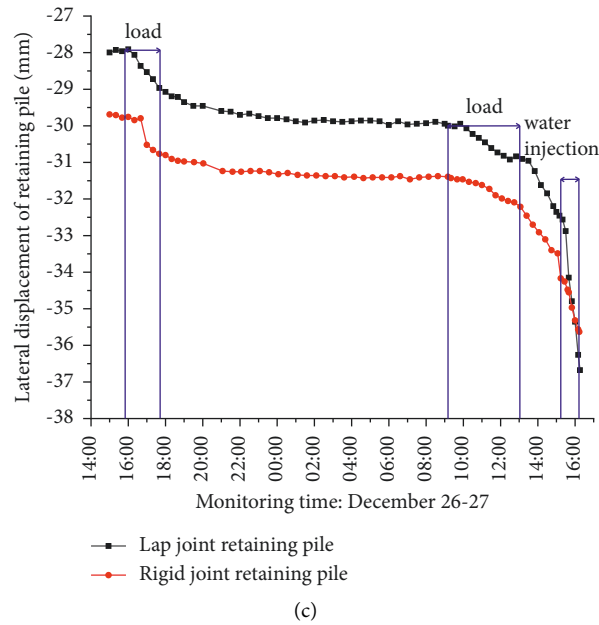
Figure 11 shows the time evolution law of lateral displacement of retaining piles at the same depth under two kinds of support structures. It can be seen from Figure 11 and Table 2 that the horizontal displacement of all measuring points shows an approximate linear growth trend after the first and second pit side loading, but during the second loading, the position of -1 m depth of lap connected retaining pile begins to produce a displacement trend outside the foundation pit.

The lateral displacement of retaining pile increases rapidly after the leakage of underground water pipe, which is due to the intrusion of groundwater, which changes the physical properties of soil and reduces the cohesion c and friction angle ϕ . It makes the self-stability of soft soil near the pit worse. The lateral displacement of the retaining pile with lap joint at -1 m depth is $+7.18$ mm and that of the retaining pile with rigid joint is $+2.58$ mm, indicating that the frame support structure has a better effect on controlling the lateral displacement of the top of the retaining pile outside the foundation pit. At the depth of -2 m and -3 m, the lateral displacement of the lap joint retaining pile is -44.57 mm and

-36.84 mm. The lateral displacement of rigid joint retaining pile is -39.15 mm and -37.49 mm. It shows that the frame support structure can reduce the overall lateral displacement of the foundation pit and is more conducive to maintaining the stability of the foundation pit.

FIGURE 11: Comparison diagram of horizontal displacement of retaining pile at each measuring point. (a) Measuring point at -1 m depth, (b) measuring point at -2 m depth, and (c) measuring point at -3 m depth. (Note: the value “-” in the figure indicates the horizontal displacement of the retaining pile to the foundation pit; “+” indicates the horizontal displacement of the retaining pile towards the soil layer outside the foundation pit).

In Table 2, from the beginning of loading to the end of leakage of underground water pipe, the horizontal displacement increment of lap joint connection retaining pile at -1 m depth is 10.95 mm, and the horizontal displacement increment of rigid joint retaining pile is 3.07 mm, which is reduced by 71.96%. The horizontal displacement increment of the retaining pile with lap joint at -2 m depth is 9.42 mm, and the horizontal displacement increment of the retaining pile with rigid joint is 7.61 mm, which is reduced by 19.21%. The horizontal displacement increment of the retaining pile with lap joint at -3 m depth is 8.88 mm, and the horizontal displacement increment of the retaining pile with rigid joint is 7.71 mm, which is reduced by 13.18%.

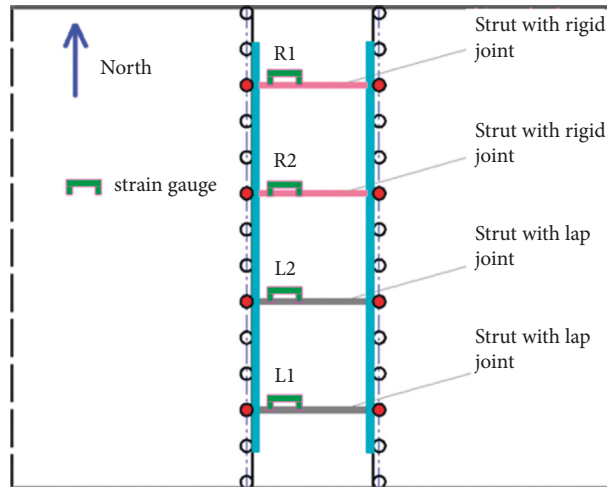
3.2. Strain Analysis of Steel Strut. The steel plate gauge measures the surface strain of the steel strut and is arranged on the first and second layers of steel strut. There are 8

measuring points in total. The measuring points of the two layers of steel plates are in the same position. Taking the first layer as an example, the number of measuring points is shown in Figure 12.

FIGURE 12: Strain gauge measuring point number of the first layer of steel strut.

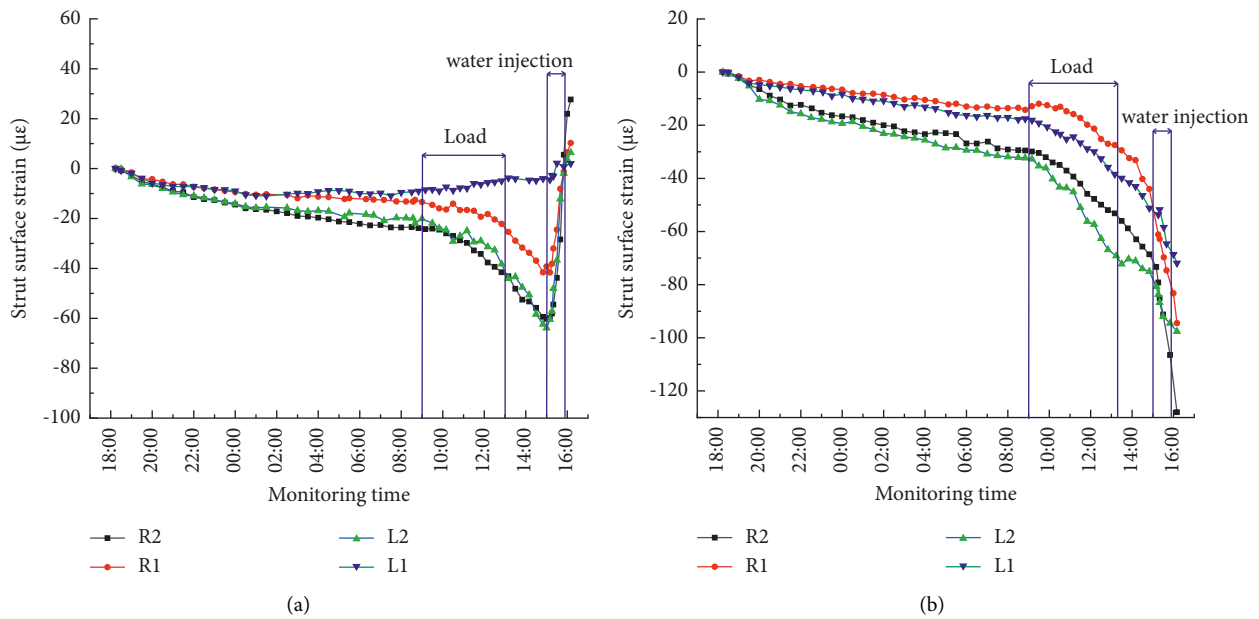
When analyzing the strain gauge data, focus on the stress and deformation law of the support under the influence of working conditions. Take the data after 18:14 pm on December 26 and draw the monitoring data of steel strut strain of each layer in Figure 13.

As can be seen from Figures 13(a) and 13(b), in the excavation and loading stage, the surface strain of the strut in the middle of the foundation pit is significantly greater than that on both sides of the foundation pit; that is, the axial force of the support is greater. This is because the spatial effect of the foundation pit inhibits the development of earth pressure and displacement in the adjacent area of the pit angle so that the earth pressure and displacement in the center of the pit wall are greater than those in a certain range of the pit angle.

In Figure 13(a), in the process of underground water pipe leakage, the surface strain of the first layer of steel strut decreases rapidly, and the surface strain of the overlapped steel strut (L_1 and L_2) decreases to about 0 and tends to be stable, but the surface compressive strain of the rigidly connected steel strut (R_1 and R_2) decreases rapidly and changes to a larger tensile strain, which is consistent with the lateral displacement law of the retaining pile in Figure 12.

In Figure 13(b), the surface compressive strain of the steel strut with rigid joint is less than that of the steel strut with lap joint ($R_1 < L_1$ and $R_2 < L_2$). This is because the steel strut with rigid joint on the first floor bears the tensile stress and shares part of the surrounding rock pressure, which shows that the frame support structure can not only bear the tensile stress caused by the displacement of the retaining pile to the outside of the foundation pit, but also distribute the support axial force more evenly and reduce the occurrence of stress concentration.

FIGURE 13: Strain curve of steel strut with time. (a) Surface strain of first layer strut. (b) Surface strain of second layer strut.
