Experimental Study on the Influence of Type of Stirrup of Prestressed Concrete Beams with Corroded Rebars

Fang-Yuan Li

Department of Bridge Engineering, Tongji University, Shanghai 200092, China

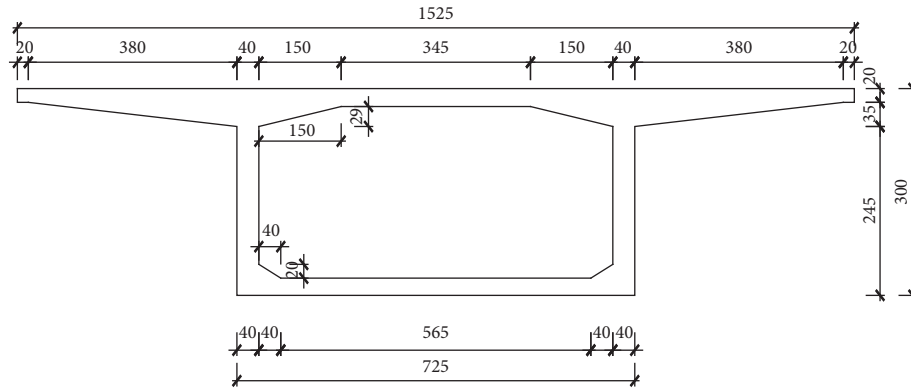
FIGURE 1: Midspan cross section of 5 × 50 m simple-continuous box girder of Donghai Bridge (mm).

2.1. Specimen Design. The specimens used the 5×50 m simple-continuous box girder of the Donghai Bridge as the prototype (Figure 1), in order to be more realistic and make the results more credible. For the sake of facilitating the production and loading of specimens, the prototype beam was simplified to an equivalent T-shaped beam (Figure 2), and the scale ratio was 1/8.

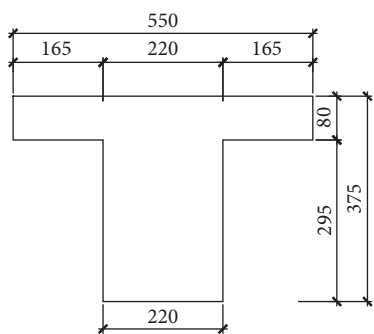
FIGURE 2: Midspan cross section of model beam (mm).

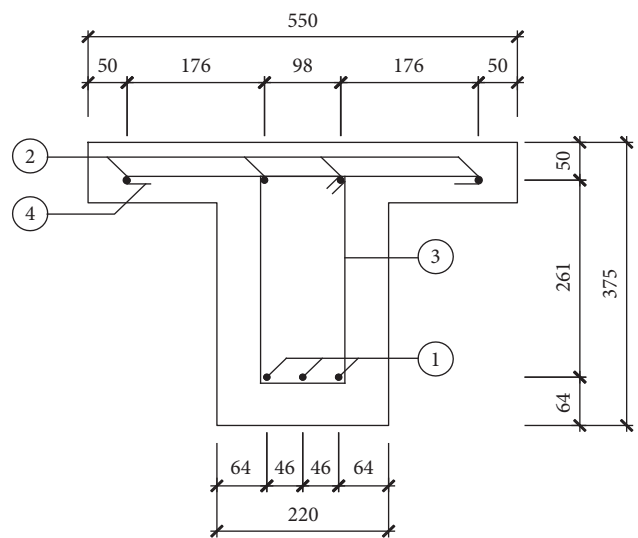
FIGURE 3: Reinforcement of model beam (mm).

If the principle of scale was strictly followed, the model beam will be as long as 6.25 m, which was expensive to manufacture. Considering that the main purpose of the test was to study the bending performance of the model beam, the beam only needs to meet the loading requirements to avoid shear failure caused by too small shear span ratio and had enough pure bending sections to observe conveniently. Taking 4 prestressed reinforced concrete simply supported beams with a length of 3300 mm and a height of 375 mm as the research objects (Figures 3 and 4), the lower part of the test beam was equipped with three longitudinal steel bars with a diameter of 16 mm without hooks. The reinforcement used in the stirrup was the same as the longitudinal reinforcement, and the spacing was 200 mm, which was 0.64 times the effective height of the beam. The thickness of the protective layer was 40 mm according to the requirements of the reinforced concrete beam structure. The concrete strength grade was C50, and the mix proportion was shown in Table 1. In order to enhance the conductivity of concrete, the specimens were immersed in an electrolytic cell containing 5% sodium chloride solution for 7 days before the energization test, which can greatly reduce the resistance of concrete. The prestressed tendons were steel strands with a nominal diameter of 15.2 mm and a tensile strength of 1860 MPa, and the tensile control stress was 1395 MPa.

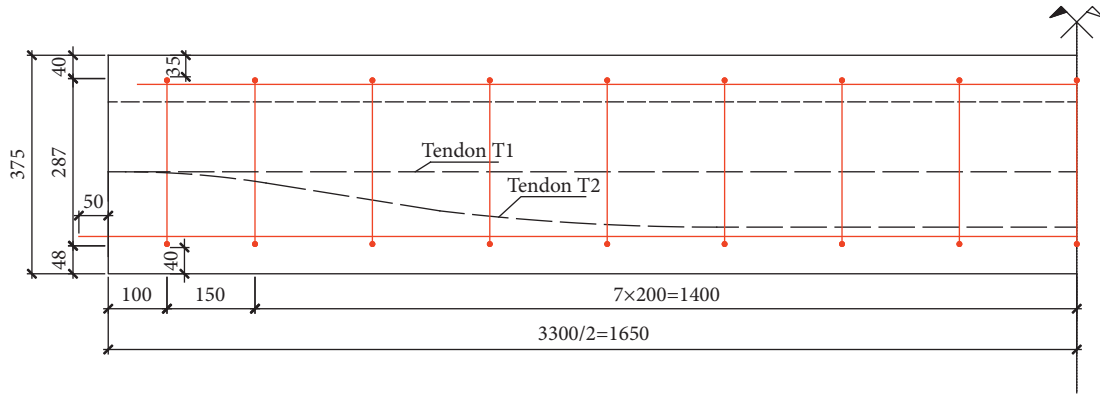
FIGURE 4: Arrangement of prestressed tendons of model beam (mm).

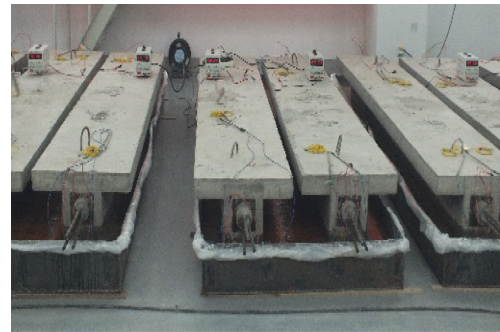
FIGURE 7: Electric corrosion.

The positive pole of the DC power supply was connected to the rusty longitudinal bars, and the cathode was connected to the carbon rod immersed in the solution to form a loop. In order to accurately control the degree of corrosion,

each beam was equipped with an independent constant DC power supply with a current density of $800 \mu\text{A}/\text{cm}^2$ as shown in Figures 7 and 8. For the full immersion energization test, when the sodium chloride concentration reached 5%, the electrolysis efficiency was about 80%. In this test, the concrete strength was higher, the protective layer was thicker, and the lower edge concrete was in a higher compressive stress state.

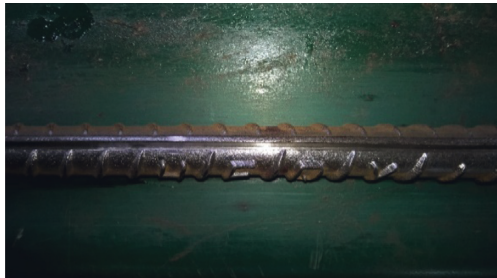
FIGURE 5: A groove of longitudinal reinforcement.

2.2. Specimen Fabrication and Electric Corrosion. The corrugated pipes were tied to the short steel bars welded to the stirrups, in order to avoid the corrosion of the steel strands caused by the later electrification. Epoxy was applied to the outside of the metal corrugated pipes for insulation. In order to measure the bond-slip between the corroded longitudinal bars and the concrete and the stress history of the corroded reinforcement during the loading process, before pouring the specimens, shallow grooves of steel bars were made to bury the fiber grating sensor (Figures 5 and 6).

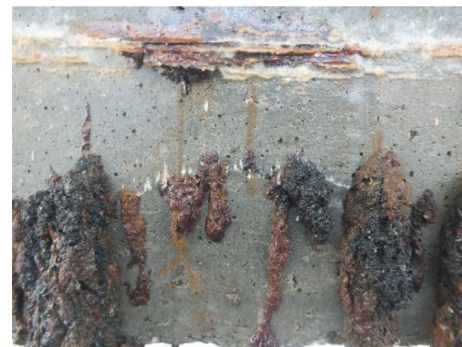
FIGURE 8: Rust products ooze out.

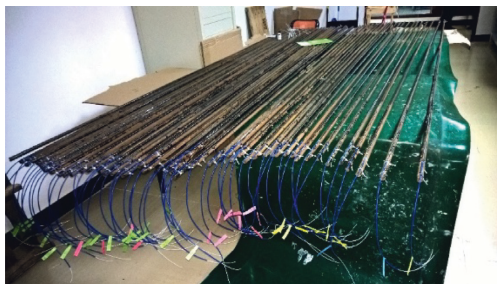
FIGURE 6: Arrangement of FBG.

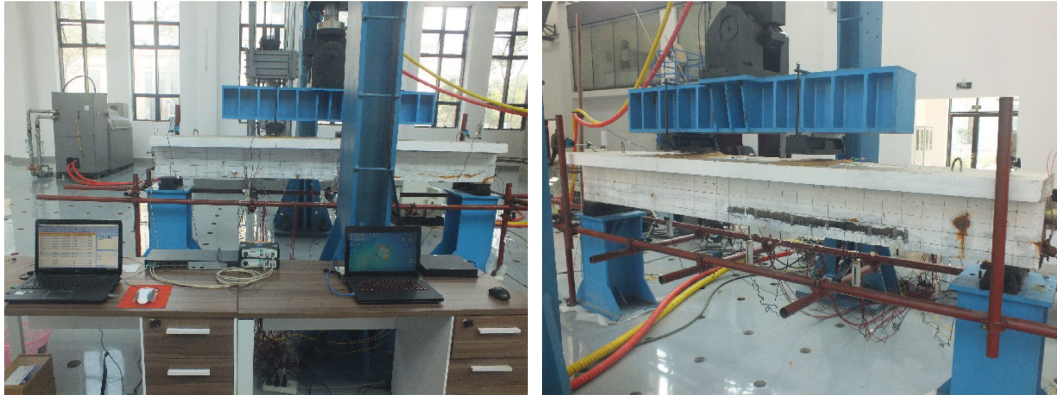
FIGURE 9: Loading test.

2.3. Loading Test. As shown in Figure 9, the test used three-point loading. In order to avoid the unevenness of the upper edge of the concrete causing the load asymmetry, a layer of fine sand should be laid under the loading pad. In order to eliminate the gap between the loading equipment and the test beam to ensure the normal operation of the test instrument, preloading was carried out before the formal loading, and the level was 40 kN. After the preloading was confirmed to be correct, the formal loading began. Force control was applied in the early stage of loading.

Before reaching 80% of the calculated cracking load (120 kN), the load was carried out according to one step of 40 kN; then, it is loaded according to the step of 10 kN, and the crack development is observed by holding the load for several minutes. When the number of cracks does not increase, the load was applied at 20 kN per step. When the load is close to 80% of the calculated ultimate load (400 kN), the displacement control loading is adopted according to one step of 3 mm. When the load is close to the ultimate load (450 kN), the load is carried out 2 mm per step until the specimen is destroyed. During the test, load, strain gauge, and midspan displacement were automatically collected by dynamic acquisition equipment, and optical fiber data were collected by FBG optical fiber modulation and demodulation instrument. In order to facilitate later data processing, the sampling frequency was set to 1 Hz.

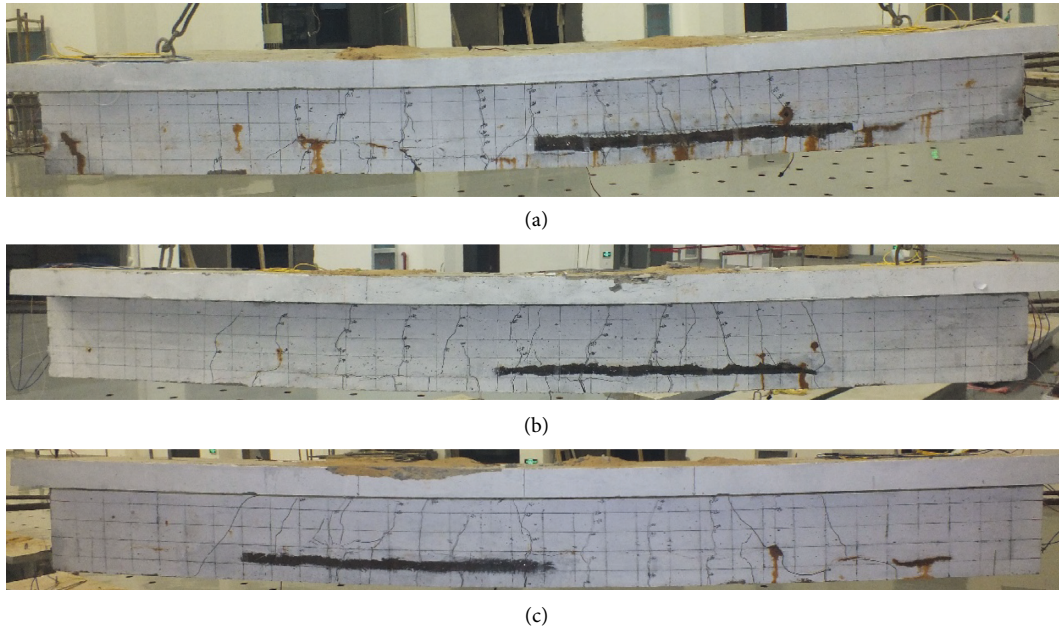
FIGURE 11: Cracking distribution of specimens with 10% corrosion rate. (a) 10P10, (b) 10H10, and (c) 10B10.

For the specimen with a rust rate of 10%, the corrosion of reinforcement produced long longitudinal cracks and the distribution of cracks in the tension zone was quite irregular. Due to the influence of stirrup corrosion, the crack distribution of ordinary stirrup specimens was more complicated than that of epoxy-coated stirrup specimens and stainless steel stirrup specimens. As shown in Figure 11, in the ultimate limit state, the vertical bending moment cracks and the transverse rust-expansion cracks in the tension zone were intricately intersected, and the width of the cracks increased significantly compared with the comparison beam.

In summary, all specimens were damaged due to the crushing of concrete in the compression zone. It can be seen from the test results that the corrosion of steel bars had a great influence on the distribution of cracks during the final loading state. After the steel bars were corroded, obvious longitudinal rust expansion cracks would be produced, which made the vertical bending moment cracks and transverse rust expansion cracks intersect each other in the tension zone, and there were vertical rust expansion cracks after the stirrups were corroded.

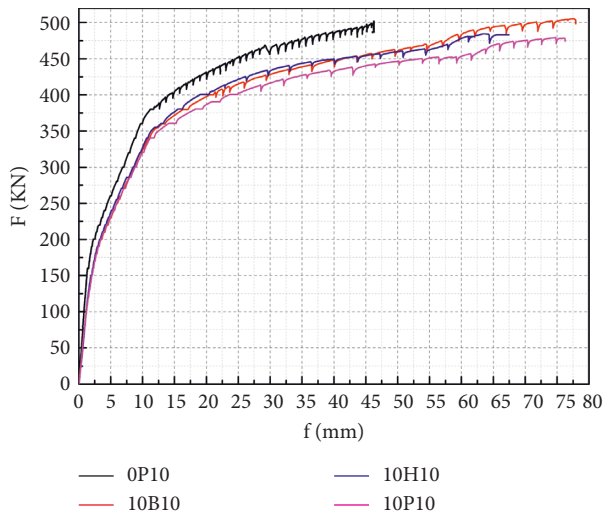
FIGURE 12: Load-deflection curves of the specimens.

3.2. *Load-Deflection Curve and Initial Stiffness.* For the contrast beam 0P10 with a thick protective layer, the position of the tension steel bar and the neutral axis was higher, so the compression zone height was lower. When the upper edge of the concrete was crushed, the deformation of the beam was very large. The load-deflection curves of the specimens are shown in Figure 12.

It can be seen from Figure 12 that the stiffness of the specimens with a corrosion rate of 10% was significantly lower than that of the contrast beam, and the deflection was significantly increased. The ultimate bearing capacity and deflection of each specimen are shown in Table 3.

It can be seen from Table 3 and Figure 12 that the corrosion of steel bars would cause a decrease in the ultimate bearing capacity, but the degree of reduction was very

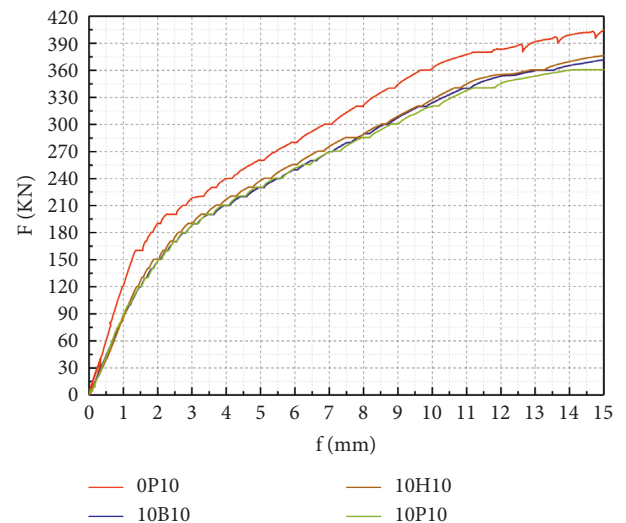
FIGURE 13: Stiffness at an earlier stage of specimens.

It can be seen from Figure 13 that the corrosion of steel bars had a significant effect on the early stiffness and cracking load of the specimens. With the increase of corrosion rate, the early stiffness of the specimens decreased gradually. Most notably, for the specimens with a corrosion rate of 10% in this test, although the corrosion of steel bars reduced the initial rigidity, the rust expansion cracks were longitudinally long and part of the internal corrosion products had leaked out along the cracks, which did not cause further damage. This was beneficial to the initial stiffness. The test showed that the type of stirrup had very little effect on the initial stiffness, and the initial stiffness of the specimens of the three kinds of stirrups was basically the same after corrosion. Among them, the early stiffness of epoxy-coated stirrup specimens was slightly greater than

that of stainless stirrups and ordinary stirrups, the load-deflection curves of stainless stirrups, and ordinary stirrups after corrosion almost overlapped, and the early stiffnesses were basically the same.
