Research Article

Deformation Characteristics and Safety Evaluation of the Throw Filling Soft Clay Cofferdam under Super-Historical Flood Conditions

2. Background of Project

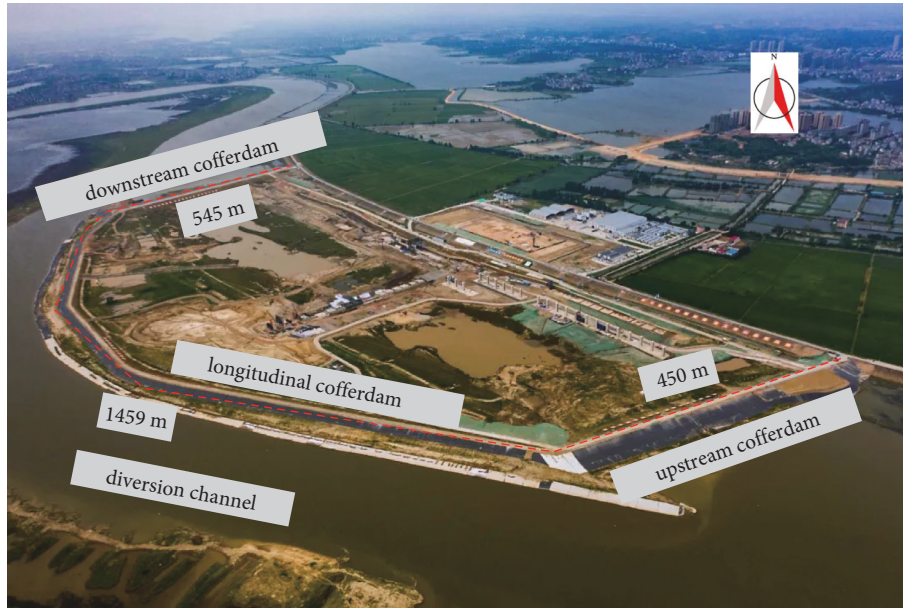
FIGURE 1: Layout of cofferdam and divert.

the cofferdam is 2454 m, including 450 m length of upstream cofferdam, 1459 m length of longitudinal cofferdam, and 545 m length of downstream cofferdam, with the service life of the cofferdam which belongs to the perennial cofferdams ranging from 2 to 2.5 years. According to the Design Code for Cofferdams of Water Resources and Hydropower Engineering (SL645-2013), the lock level is Class II and the design level of the cofferdam is Class IV. The layout of diversion channel and cofferdam is shown in Figure 1.

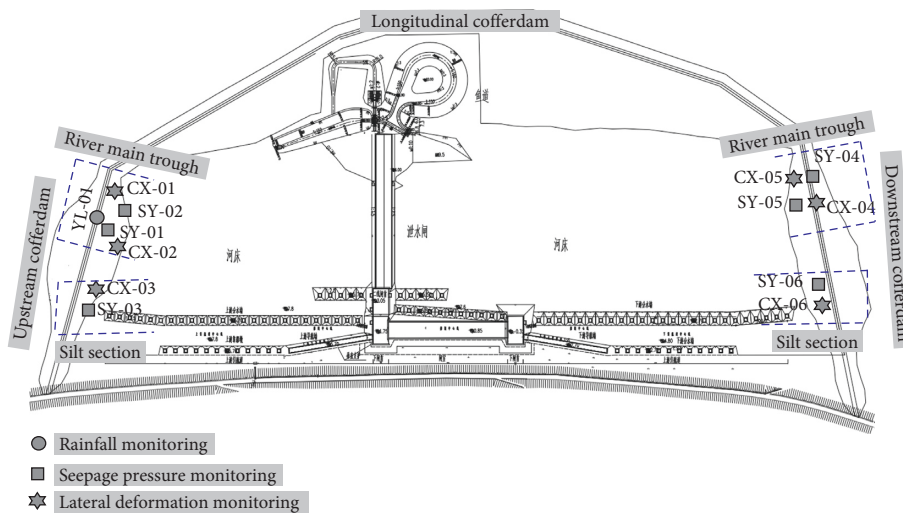
FIGURE 2: Schematic layout of cofferdam slope monitoring points.

2.2. Automatic Monitoring of Cofferdam. Considering the lack of experience references for this type of cofferdam and because of the low strength, discreteness of mechanical properties, and uncertainties of spatial distribution of filling materials, the automatic monitoring of displacement and seepage force is applied to monitor the real-time deformation and stability of the cofferdam for ensuring the safety operation of it. The arrangement plan of automatic monitoring is shown in Figure 2. According to the results of numerical simulation and field experience, the early warning value and alarm value of horizontal displacement rate of the cofferdam is set as 1.5 mm/d and 2.0 mm/d [31, 32].

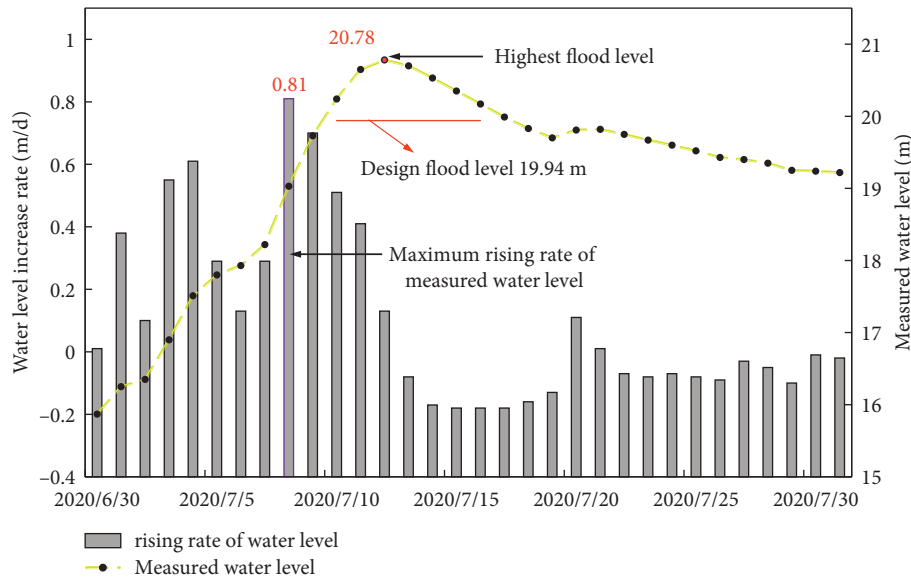
FIGURE 3: Curve of water level change outside the cofferdam during flooding.

Affected by the super-historical flood, the water level outside the cofferdam is reached to 20.8 m that it is 0.86 m higher than the design flood water level of the cofferdam. From June 30 to July 12, the increment of water level outside the cofferdam was 4.91 m, and the maximum water level increasing rate was 0.81 m/d, which was higher than the maximum daily water level increasing rate in 1998. The change curve of water level outside the cofferdam during flood period is shown in Figure 3.

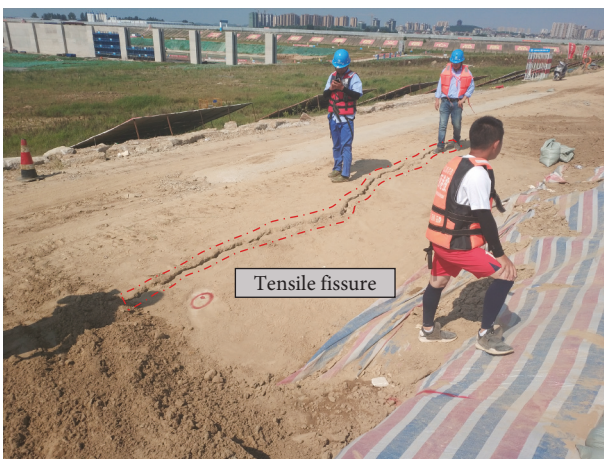
occurred at the top of cofferdam. The length and width of the tensile fissure are 99 m and 2.0~3.0 cm separately as shown in Figure 4 and the strike almost parallels with the extended direction of road. The height of meteorism deformation is 6.0~8.0 cm generally.

FIGURE 4: Tensile fissure at the top of upstream cofferdam.

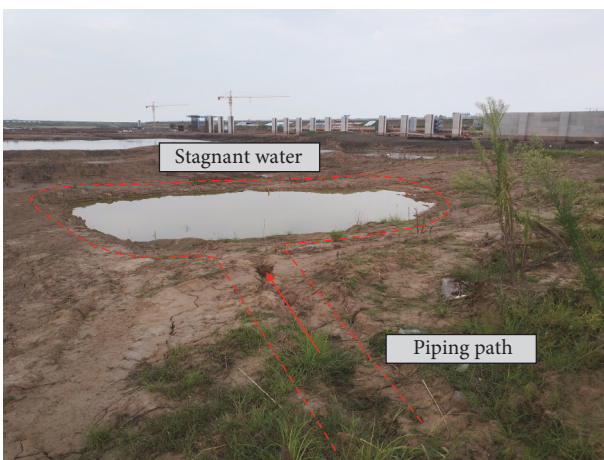
Meanwhile, there is a small sized piping damage occurred at the position of elevation of 11 m which is located in the horse path of downstream face caused by the huge seepage force which is formed by the water head difference between upstream face and downstream face. Fortunately, the filling material of cofferdam almost consists of clay particles whose permeability is small so that the seepage water from the piping is clean and there is a small threat to the stability of cofferdam (as shown in Figure 5).

FIGURE 5: Piping effect at downstream face slope of cofferdam.

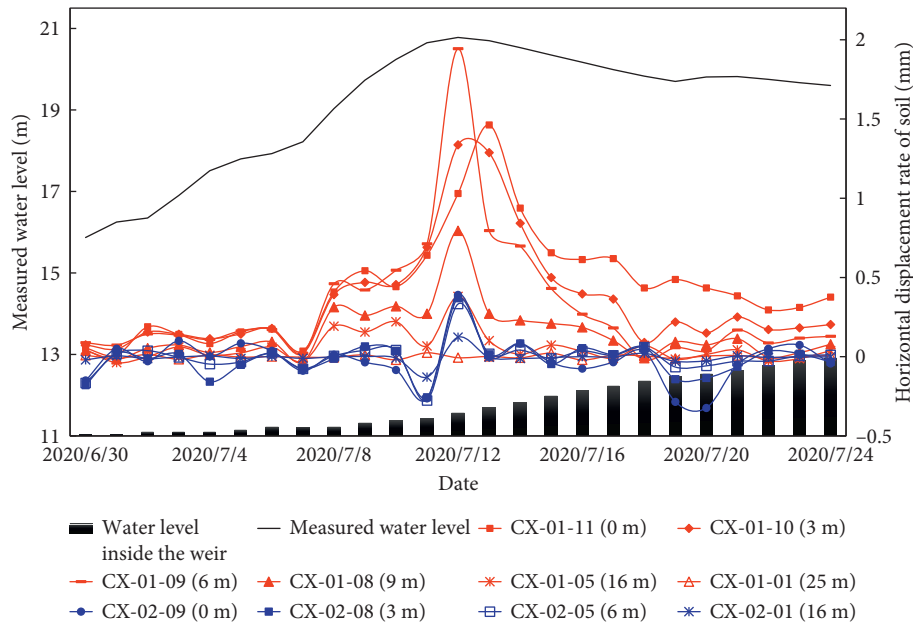
show that (Figure 6), during the flood rising period, the soil deformation rate below the path way is small and the state is stable. However, the soil above the path way of the downstream face has an accelerated deformation rate, and the maximum value reaches to 1.95 mm/d that is closing to the alarm value, and there is a potential risk of sliding. The generation and development of tensile cracks are closely related to the displacement of the soil below the cofferdam crest of the downstream face slope.

The real-time monitoring results show (Figure 6) that the deformation rate of potential sliding area is less than 1.5 mm/d and the situation of deformation rates is

FIGURE 6: The displacement changing rates of CX-01 and CX-02 during the super-historical flooding period.

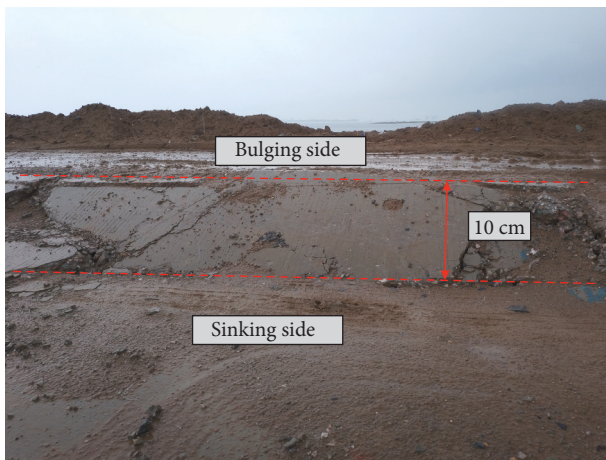
3.2. Deformation Characteristics of Cofferdam in Flood Decline Period. The tensile fissure and meteorism deformation which has been reinforced at the top of cofferdam continue to develop that the width of tensile fissure is increased to 4 cm and the height of meteorism deformation is increased to 10 cm (Figure 7). The scope of piping is not expanding, and its flow rate is reduced benefitting from the reinforcement measure.

FIGURE 7: Meteorism deformation in the top of upstream cofferdam during flood decline period.

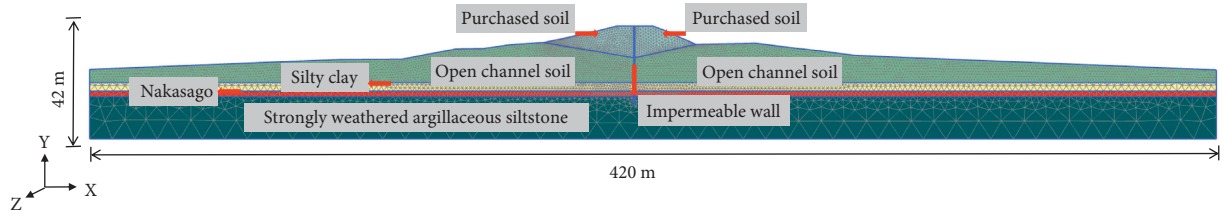
4.1. *Computational Model.* According to the field investigation and drilling boring information, a 2-dimensional calculation model is established by the Plaxis software, which represents the most dangerous profile of the cofferdam as shown in Figure 8.

FIGURE 8: Cofferdam structure and filling distribution.

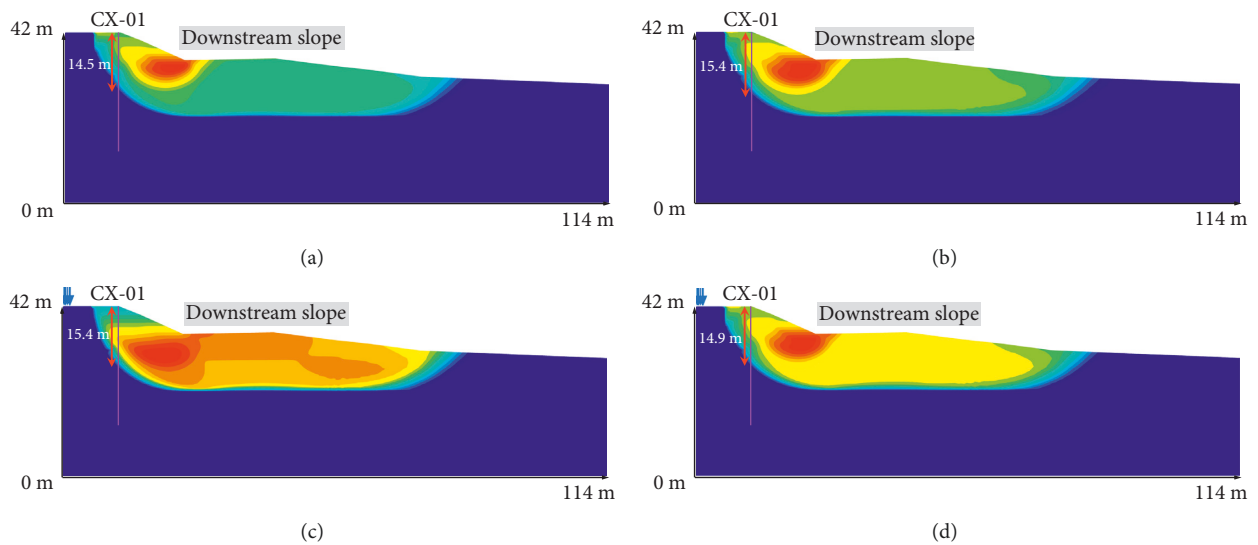
FIGURE 9: Horizontal displacement clouds of the backwater slope hazardous slip surface: (a) working condition A1; (b) working condition B2; (c) working condition C3; (d) working condition D4.

numerical method are consistent with the automatic monitoring data that the potential sliding region is transfixion from the toe to the top of downstream face slope.

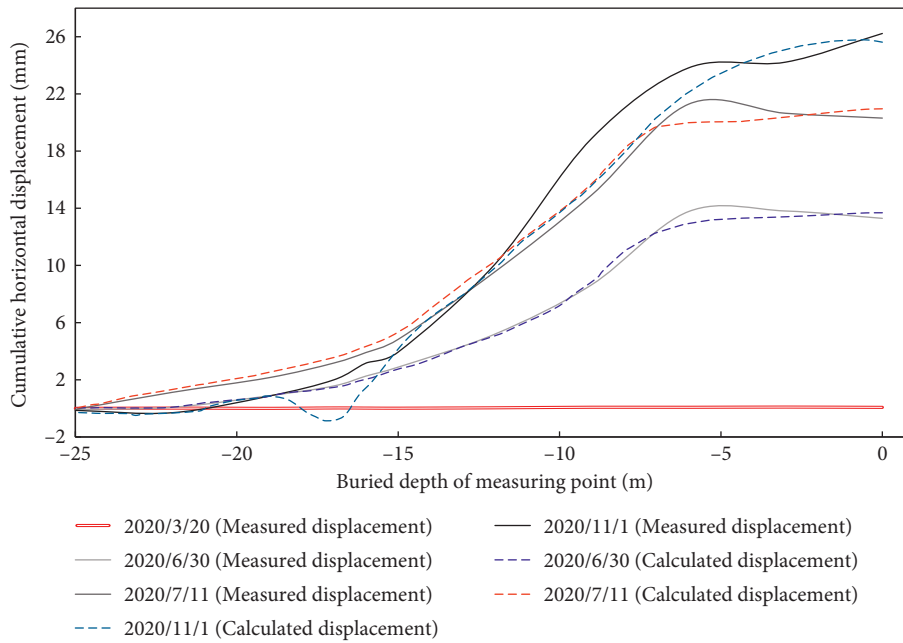
- (5) Figure 10 shows the horizontal displacement of calculated and measured at the position of CX-01, and we can see that the value and regulation of them are consistent ultimately. The result indicates that the actual situation of the cofferdam engineering can be reflected excellently by the numerical simulation of Plaxis.

FIGURE 10: Cofferdam slope soil horizontal displacement fitting curve.

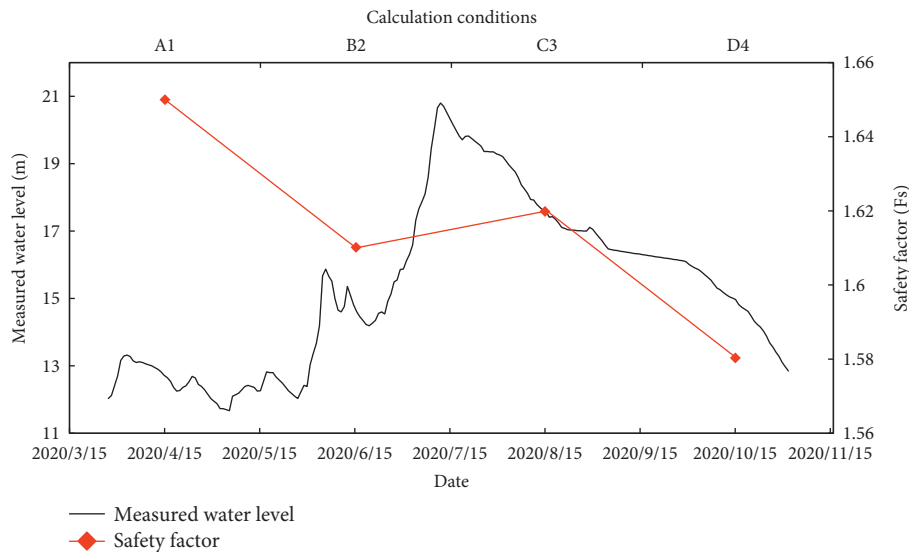
As shown in Figure 11 that the safety factors of cofferdam in each condition are reduced, the reduction rates are really small. It is because that the actual slope ratio of cofferdam is much more gentle than the design slope ratio and the permeability coefficient of filling materials is really

FIGURE 11: Variation of safety factors under different operating conditions.

small so that the change of seepage pressure in the downstream face slope is tiny during the transient seepage state of high flood water level.
