Research Article

Stability Analysis of the Lining Reinforcement Structure of a Double-Track Heavy-Haul Railway Tunnel

Daheishan Tunnel, completed in 1984 under the management of the Chawu Railway Engineering Section of a heavy haul railway in northern China, is located between Yanqing North Station and Xiazhuang Station northeast of the Changping District of the Daqin Railway. It is a double-track tunnel.

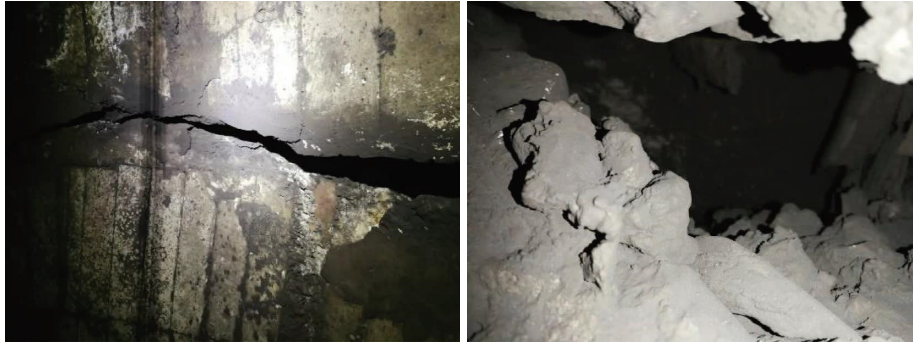
FIGURE 1: Real map of lining diseases of Daheishan Tunnel on Datong to Qinhuangdao Railway.

severely. In March 2021, according to data provided by the tunnel management and maintenance unit and through geological radar detection and three-dimensional laser scanning, it was found that the lining of the tunnel 1605–1625 m away from the tunnel entrance had cavities, falling blocks, wrong platforms, and other diseases seriously affecting driving safety, as shown in Figure 1. The size of the cavity opening is $0.1 \times 0.8 \times 0.3$ m; the thickness of lining concrete is about 30 cm; the deterioration is serious; and no reinforcement was found. The depth of the cavity was about 1 m and extended for 10 m in the direction of tunnel entrance. According to the *Evaluation Standard for Deterioration of Railway Bridge and Tunnel Buildings Part 2: Tunnel* (Q/CR 405.2-2019) of China, the disease grade was evaluated as AA, which meant treatment had to be taken immediately because of the risk to traffic safety (see Figures 2 and 3).

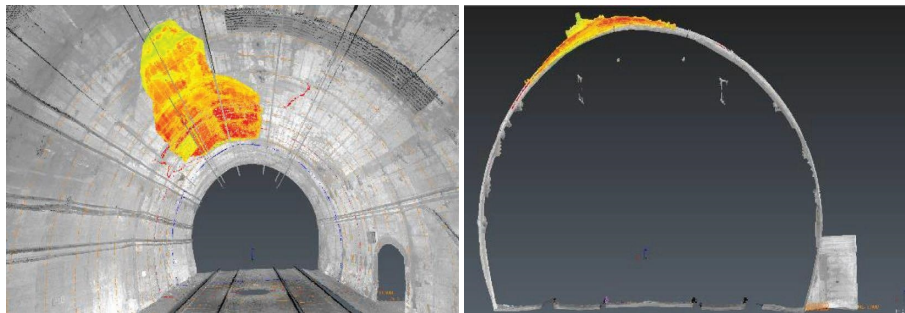
FIGURE 2: Three-dimensional laser scan of lining diseases in Daheishan Tunnel on Datong to Qinhuangdao Railway.

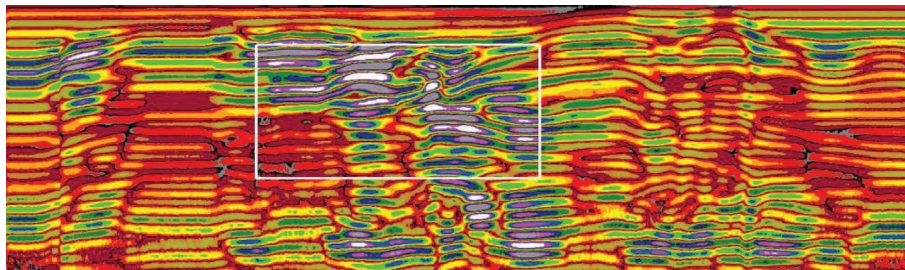
FIGURE 3: Geological radar detection of lining disease of Daheishan Tunnel on Datong to Qinhuangdao Railway.

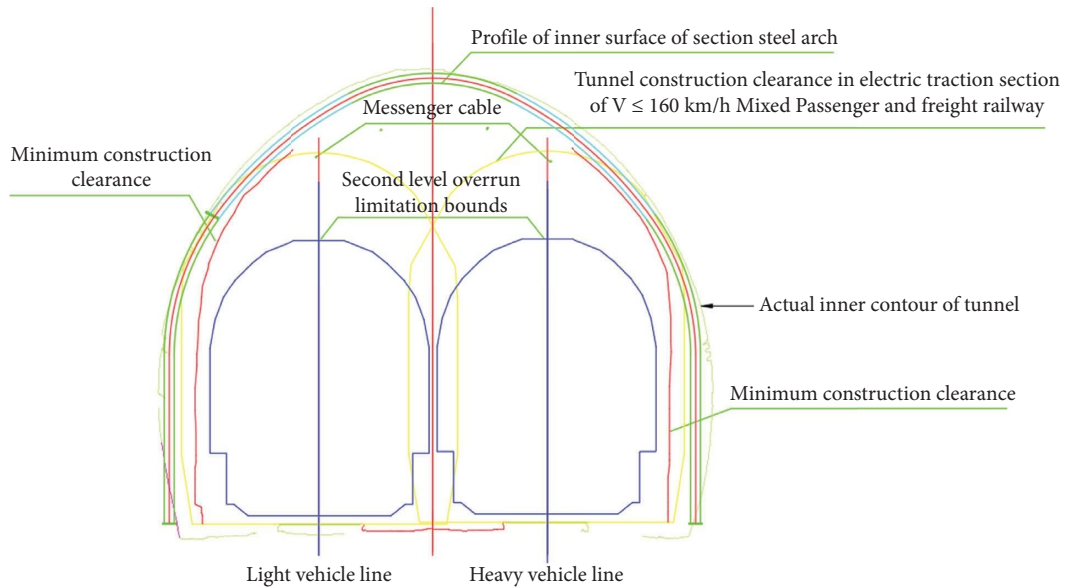
FIGURE 4: Gauge comparison.

The specific measures were as follows. An H175 steel arch frame was erected on the inner side of the lining according to the clearance requirements, and spacing of the steel arch frame was 1.0 m. The two steel arches were longitudinally connected with 20 mm in diameter deformed steel bars. The circumferential spacing was 1 m. Deformed steel bars were connected longitudinally with a circumferential spacing of 1 m; short anchor bolts were constructed between the steel arches; circumferential reinforcing mesh was erected; cavity grouting behind the lining was carried out; 6 mm thick steel plates were welded, and C35 concrete was poured inside, as shown in Figures 4 and 5.

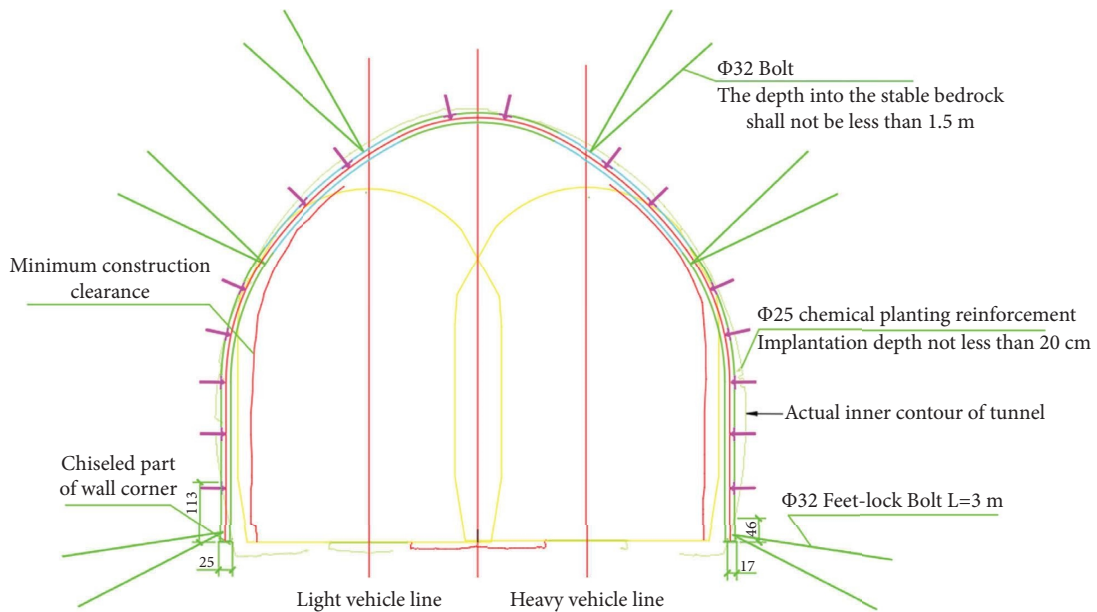
FIGURE 5: Overall cross section layout.

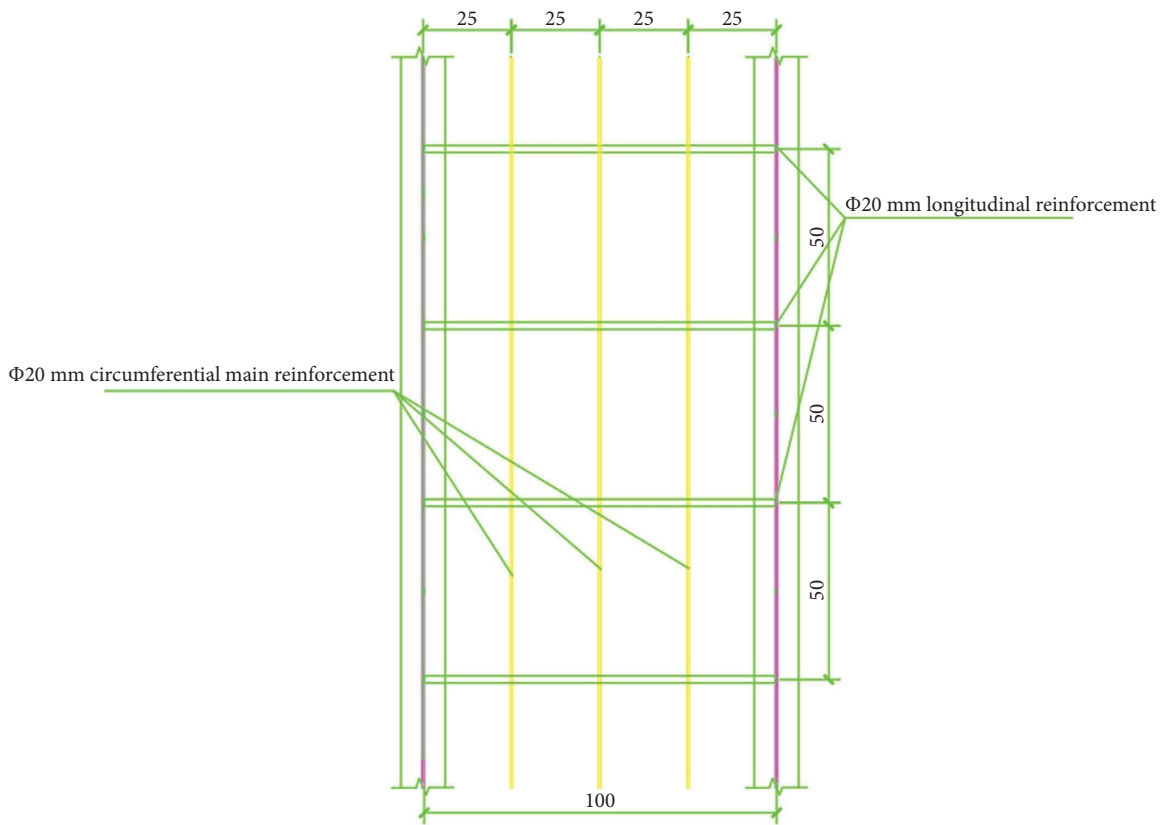
FIGURE 7: Reinforcement layout drawing.

Taking the stress condition of the circular arch as an example, the internal force was calculated and solved (see Figures 6 and 7). As shown in Figure 8, the arch was divided into n segments, where C_i represents the i th segment from bottom to top; the stiffness is E_i ; the node length is expressed as L_i ; and the arch crown had no nodes. The semistructural analysis is shown in Figure 9.

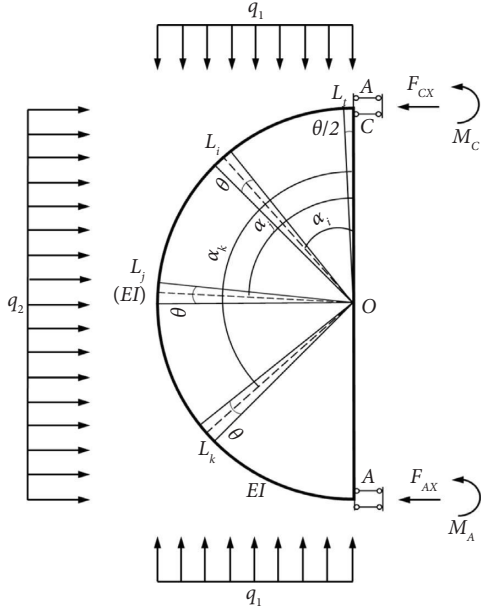
FIGURE 8: Stress analysis diagram.

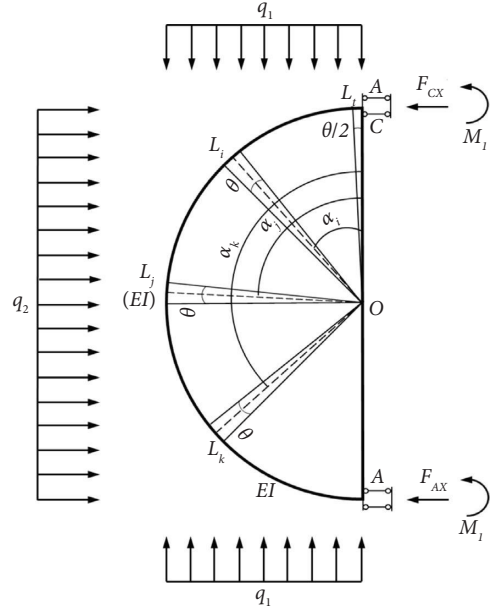
FIGURE 9: Basic system of force method.

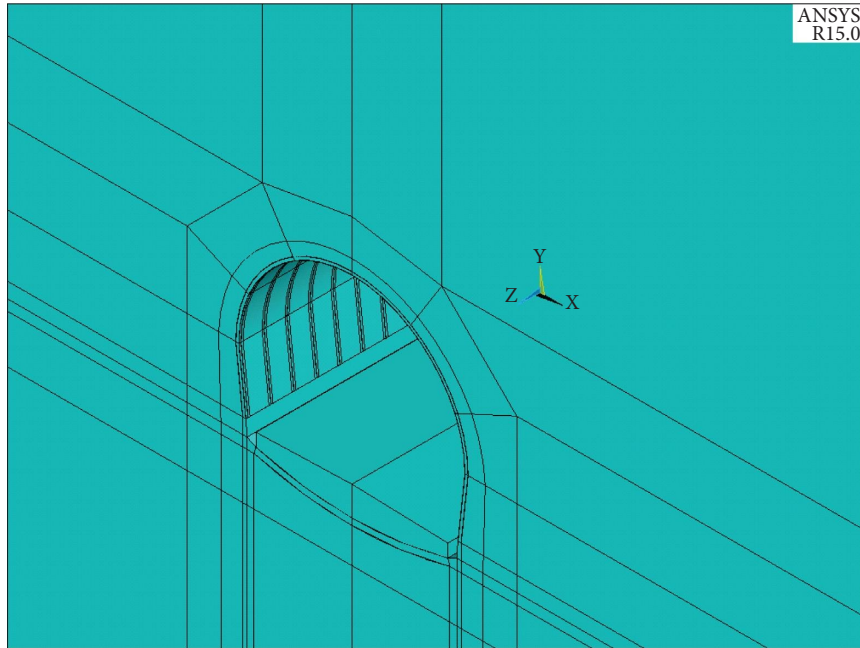
FIGURE 10: Numerical model.

4.6. Model Dimensions. The dimensions were 16 m along the longitudinal direction of the tunnel, 4 times the tunnel diameter on both sides, 2 times the tunnel diameter at the bottom, and the value at the top taken according to the actual buried depth. The model is shown in Figures 8–11.

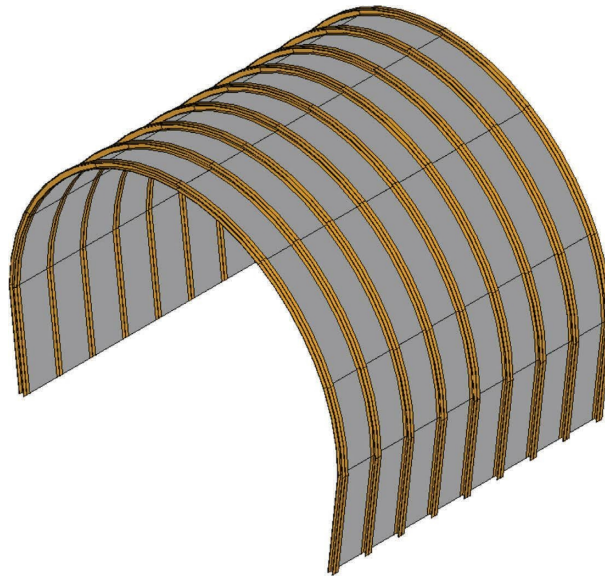
FIGURE 11: Steel frame and steel plate assembly.

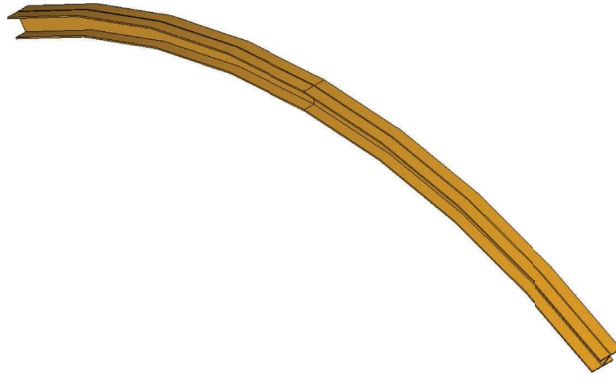
FIGURE 12: Steel frame model.

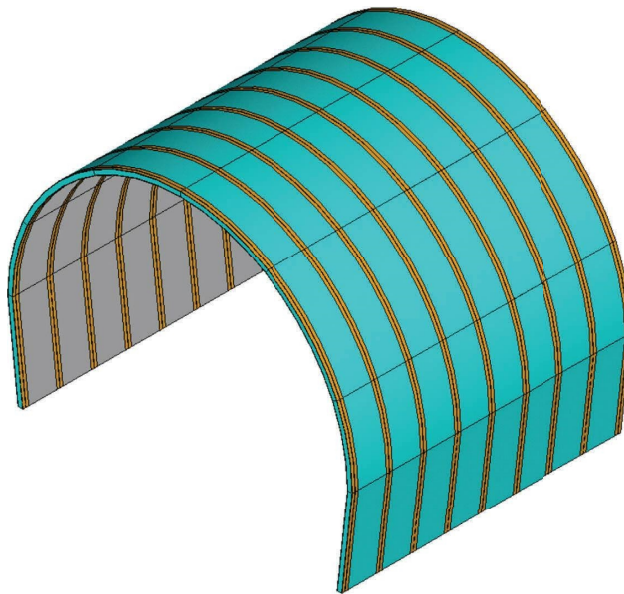
FIGURE 13: Steel frame steel plate concrete composite model.

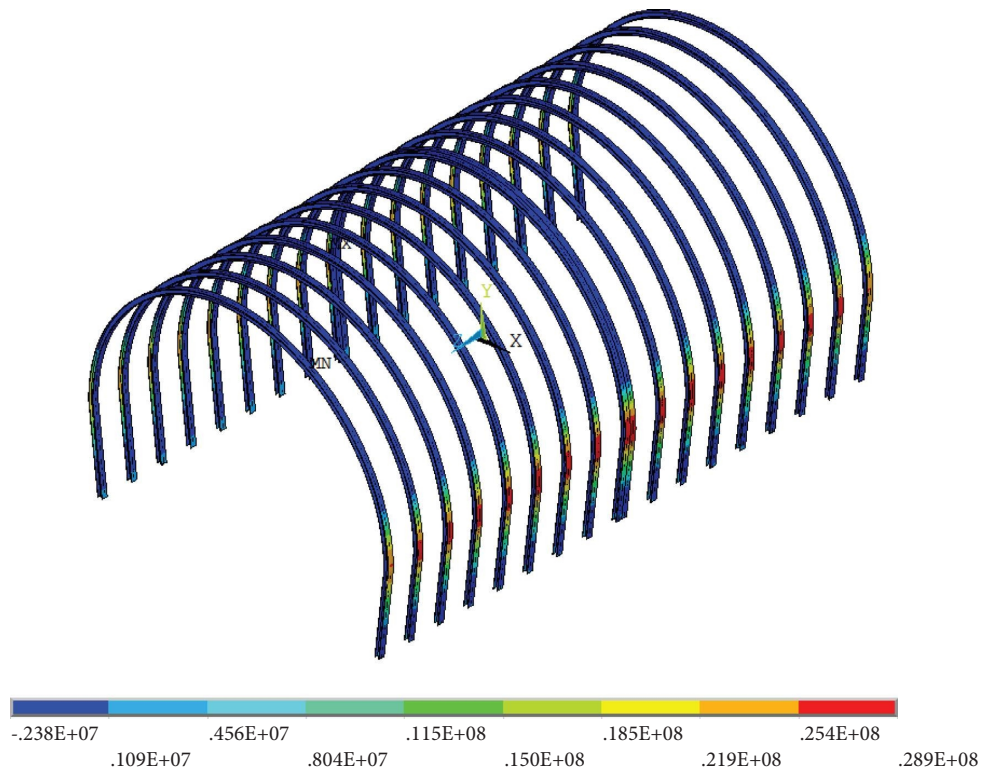
FIGURE 14: Stress diagram of steel frame with H175 steel.

The maximum tensile stress of the steel frame was 30.9 MPa, which occurred at the top of the side wall, meeting the specification requirements (Figure 14).

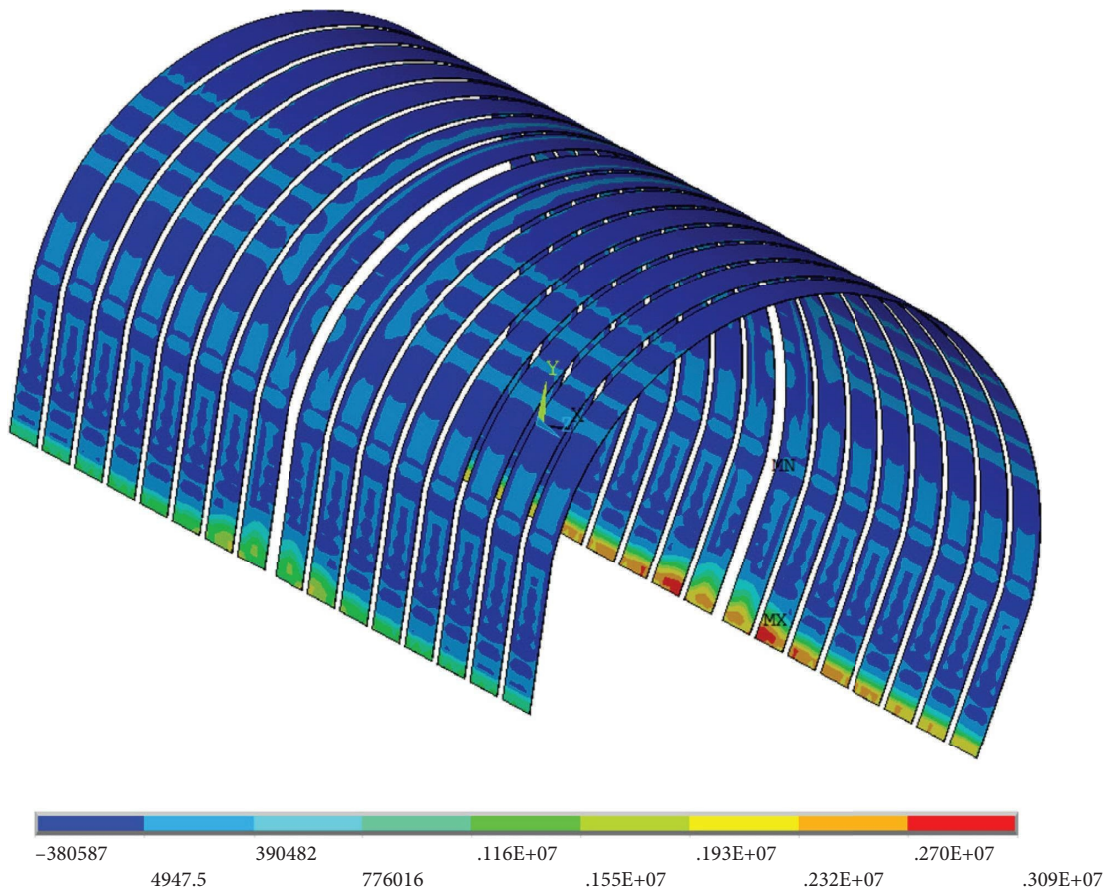
FIGURE 15: Stress diagram of steel plate with H175 steel frame.

The maximum tensile stress of the steel plate was 3.42 MPa, which appeared at the bottom of the side wall, meeting the specification requirements (Figure 15).

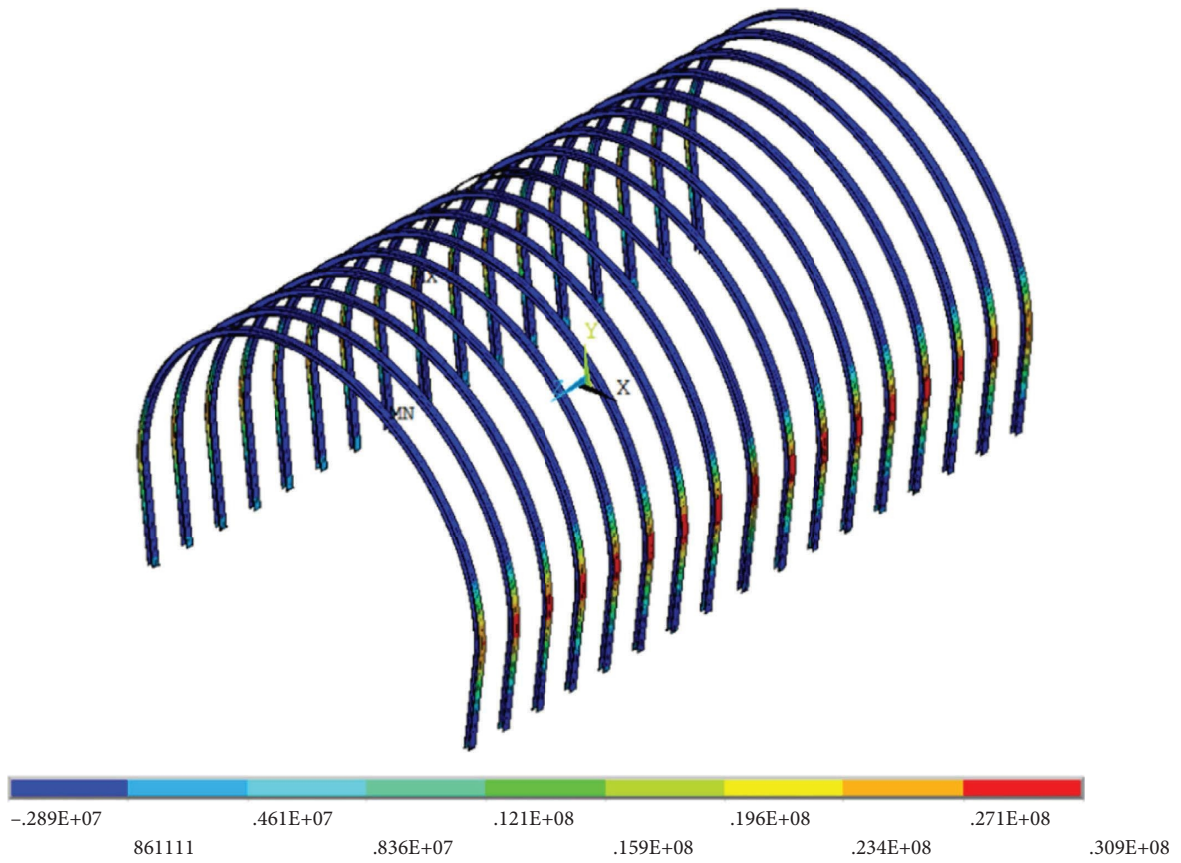
FIGURE 16: Stress diagram of steel frame with H125 steel frame.

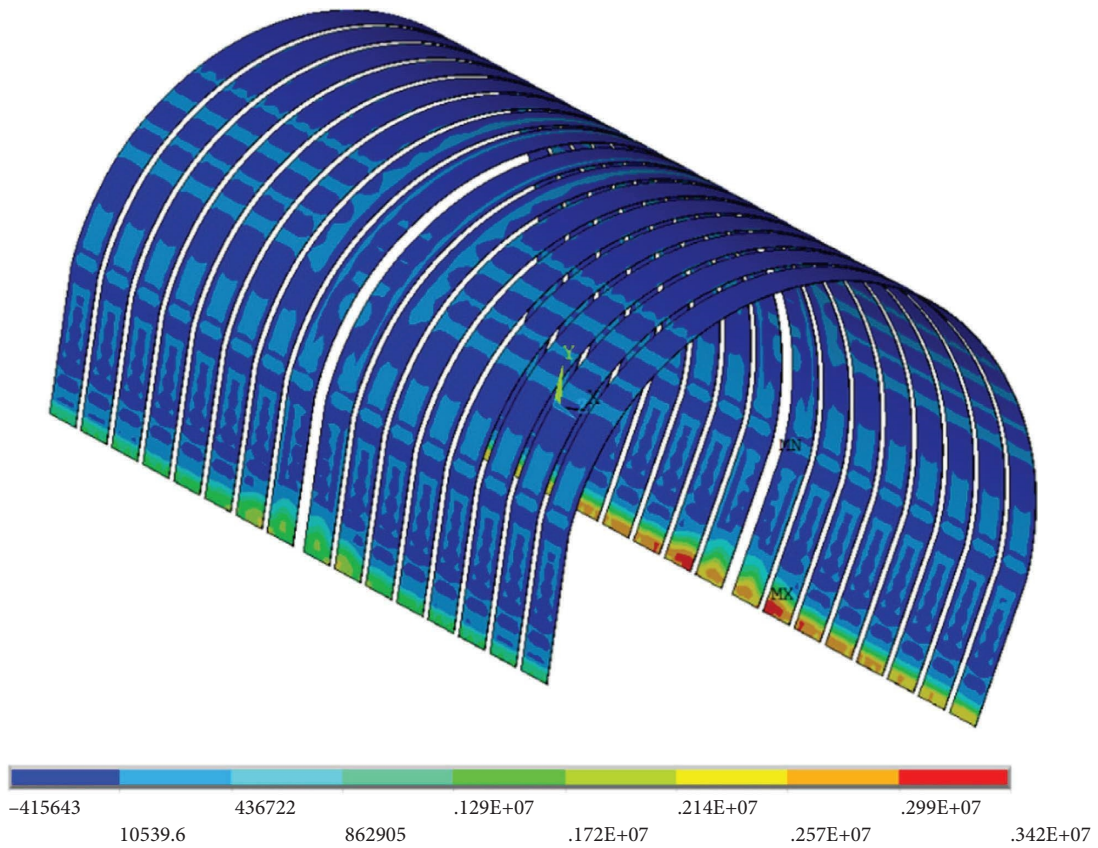
FIGURE 17: Stress diagram of steel plate with H125 steel frame.

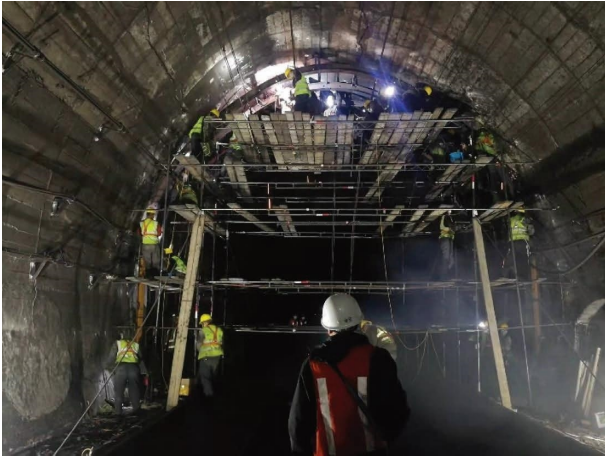
FIGURE 18: Installation site of steel arch.

4.7. Application Effect. In 2021, after the Daheishan Tunnel was reinforced with the lining steel arch frame structure (Figures 16 and 17), the crack and cavity of the tunnel lining were effectively repaired; the service capacity of the lining structure was effectively improved; the speed limit of the train in the diseased section was lifted; and the train returned to normal operation (see Figures 18 and 19).

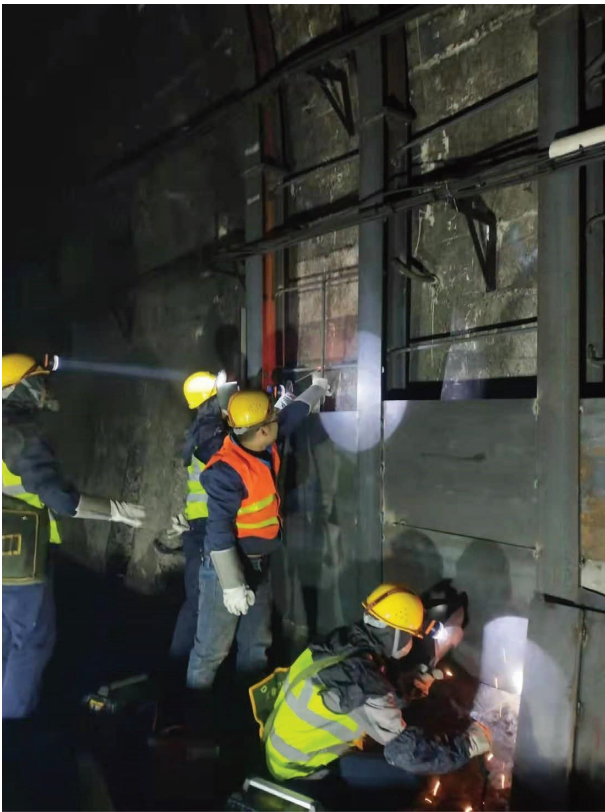
FIGURE 19: Installation site of connecting reinforcement and steel plate.
