Research Article

First-Time Application of Underwater Live Concrete for Economic Retrofitting of Damaged Bridge Piers in Bangladesh

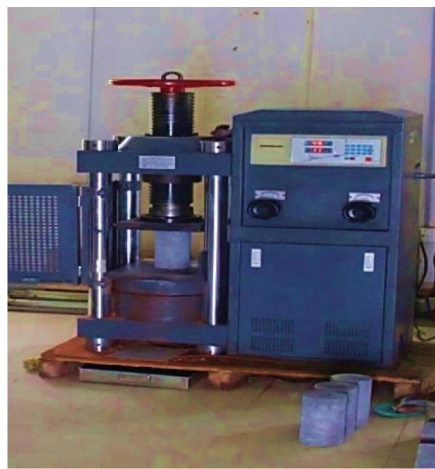
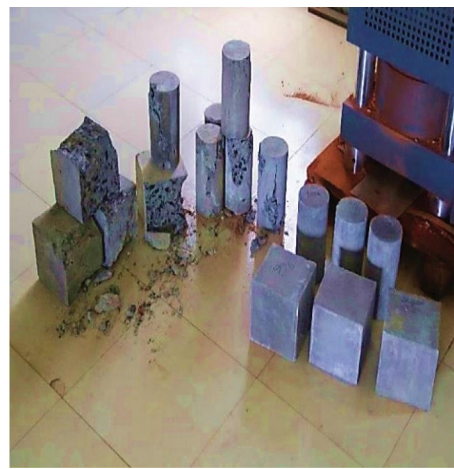
All the extracted cores were preserved in plastic bags following ASTM C42 standard [23]. Drilled cores were then carefully arranged in a cardboard box with cork sheet and transported to CRTS, KUET, for testing. Thirteen specimens were prepared for compressive strength tests following ASTM C 39 and ASTM C 42 Standards [23, 24]. The setup of the compressive strength test is given in Figure 5.

FIGURE 5: (a) and (b) Compressive strength test machine and extracted core samples.

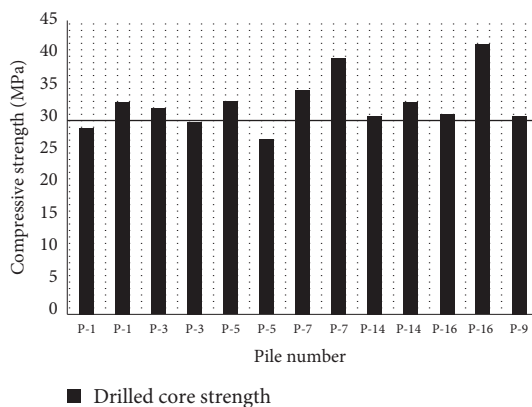
(4) Test Results of Extracted Cores. The design strength of the core extracted from the piles is 30 MPa. From the test results, it appears that the subsurface concrete (Figure 6) is of good quality and has sufficient strength. No individual test result falls below 75% of the design strength (f'_c) of 30 MPa according to ACI 301-16 [25]. Also, the average test strength is about 32.7 MPa, which is well above the design strength of

(6) *Conclusion from the Core Extraction.* From Table 2, the average compressive strength found for the damaged piles is 32.7 MPa. The piles were designed with C30-grade concrete. Therefore, it is justified that there was no faulty or defective work done from the contractor's end.

FIGURE 6: Bar chart of compressive strength with respect to pile number.

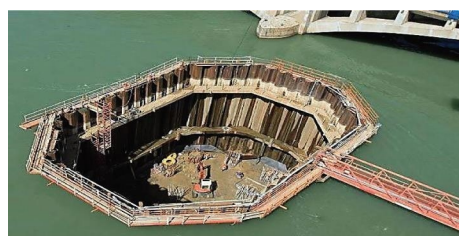
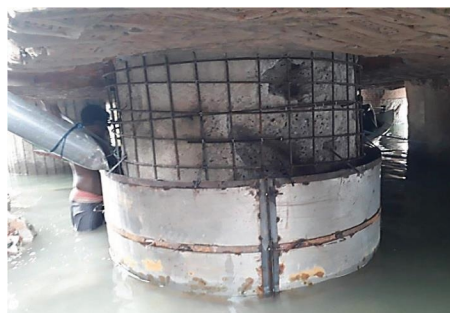
FIGURE 7: (a) Braced cofferdam and (b) underwater concreting using the tremie method of concrete placement underwater.

2.3.2. Underwater Live Concreting. UWC using the tremie method is convenient for pouring large amounts of high-flowable concrete. Tremie pipe, the upper end connected to a hopper and lower end continuously submerged in fresh concrete, is used to place concrete at the exact location from a hopper at the surface. There are several methods to carry out underwater concreting, such as the tremie method, pumping methods, preplaced aggregate concrete, etc. The underwater concreting techniques are designed mostly to prevent cement washout. The underwater concreting method is less costly and consumes less time. It also requires less manpower. Underwater concreting allows construction and excavation in an adverse environment. The biggest challenge to execute underwater concreting is pouring concrete in moving water. If the water is moving, it can wash away the cement paste which is holding the sand and gravel together. If this issue can be

handled properly, underwater concreting is more convenient to execute than the cofferdam method. Pictures of the braced cofferdam and tremie methods of underwater concreting are given in Figure 7.

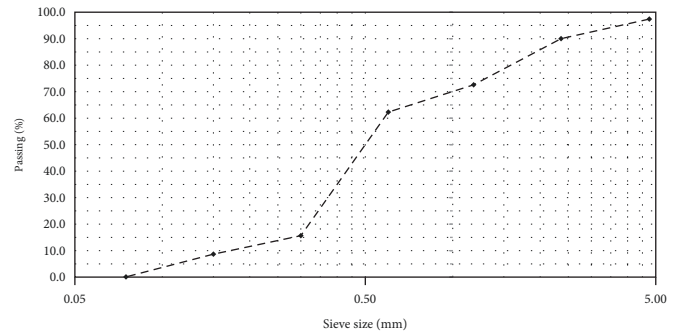
3.1.2. Fine Aggregate. Sieve analysis and grain size distribution of sand were done following ASTM C136 standard [26]. Sylhet sand having a fineness modulus of 2.53 was used for the mix design, which is better in quality than local sand. The gradation curve of the fine aggregate is given in Figure 9. Besides fineness modulus, other physical properties, such as various categories of specific gravity and absorption percentage of fine aggregate, were also determined and summarized in Table 5.

FIGURE 9: Gradation curve of fine aggregate.

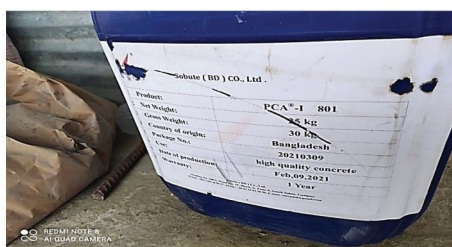
3.1.3. Admixture. PCA[®]-I concrete superplasticizer is a polycarboxylate polymer-based composite admixture. It is a liquid substance that has the characteristics of high-range water reduction, excellent slump, retention, and strengthening. It is especially suitable for producing high-durability, self-compacting, high-compressive-strength, and high-workability concrete. Besides, it has low alkali content with no chloride ions and is non-corrosive to steel bars. PCA[®]-I Concrete superplasticizer is formulated to comply with the following specification for concrete admixture: ASTM C494/C494M [29]. Figure 10 picturizes the admixture used in this study.

FIGURE 10: Admixture used in the concrete.

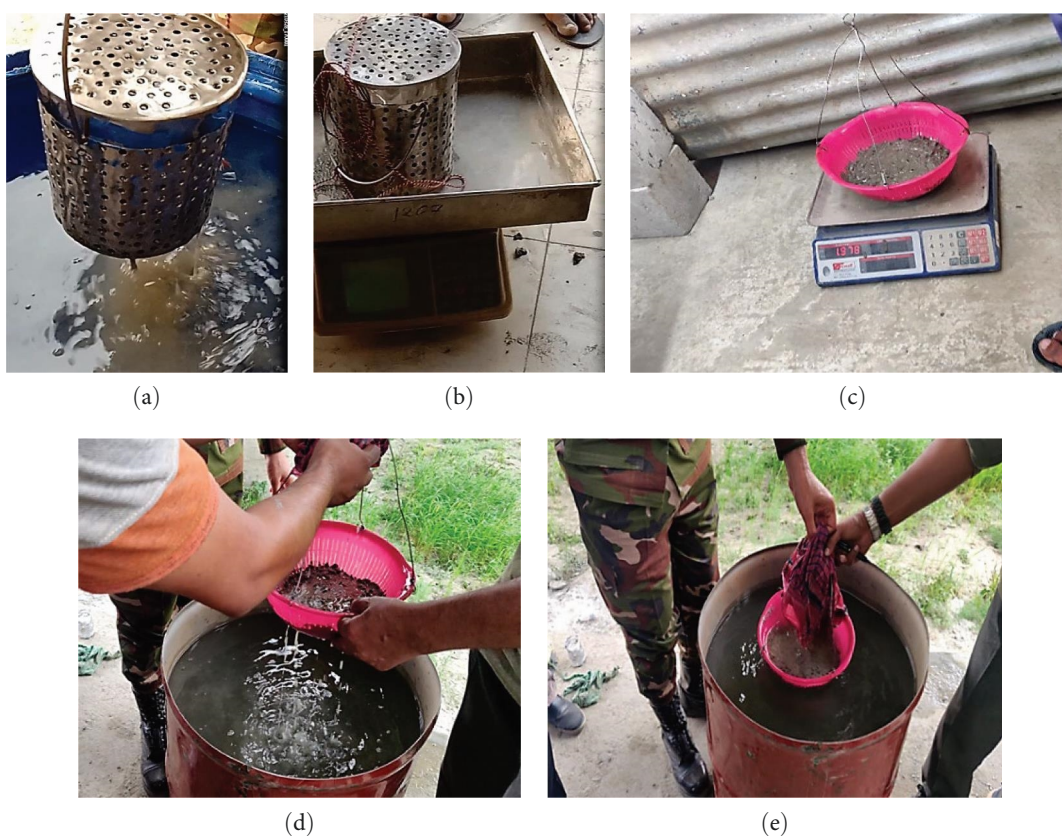
(1) *Antidispersal Test.* This test was done to determine the performance of the concrete underwater. In water medium, any liquid or semiliquid material tends to disperse. After applying the admixture to the concrete, the standard test for antidispersal was carried out both in field and laboratory conditions. Antidispersing agent for underwater non-dispersing concrete is a new type of admixture made of a variety of special organic polymer materials and active carriers based on the characteristics of UWC. It improves the viscosity of the solution between the polymer chain and cement. The admixture can give the UWC excellent construction performance and good mechanical properties. The process of antidispersal test at the laboratory and at the site are shown in Figure 11.

FIGURE 11: (a) and (b) Antidispersal test at laboratory, (c), (d), and (e) at field.

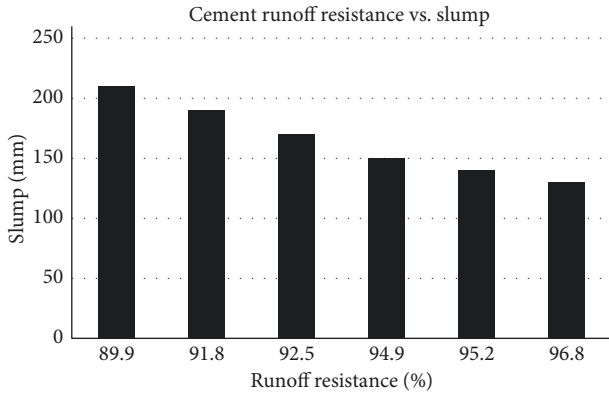
Figure 12 illustrates the correlation between concrete slump values and cement runoff resistance. The figure demonstrates that there exists a connection between these two factors. As the

FIGURE 12: Analysis of cement runoff resistance vs. slump curve.

runoff resistance of cement increases, the slump value of concrete increases as well. This implies that the more resistant the cement is to runoff or washout, the stiffer the concrete becomes, leading to a higher slump value. Since cement serves as the binding agent for the various components of concrete, a greater runoff of cement leads to a reduction in the cohesion among these components. Consequently, the concrete’s consistency becomes softer, exhibiting a decreased slump value.

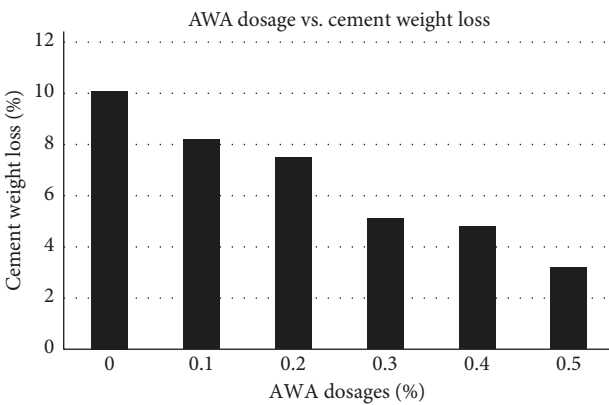
FIGURE 13: Relation between cement weight loss with respect to varying AWA dosages.

In Figure 13, it is evident that as the dosage of AWA increases, there is a gradual reduction in cement weight loss. This reduction is most significant at the highest AWA dosage, highlighting a direct correlation between increased AWA usage and decreased cement weight loss. This positive effect can be attributed to the chemical constituents of AWA, which play a crucial role in enhancing the cohesion of the cement–concrete paste and thereby minimizing weight loss.

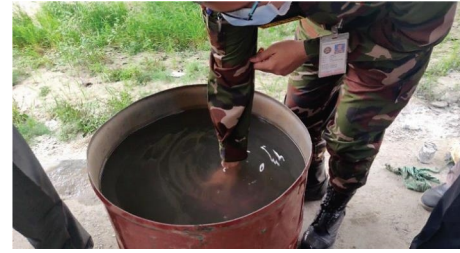
(3) *pH Value Check.* Before and after the admixture was mixed, the pH of the water was measured to observe if there had been any changes, both in the field and the lab. It was found that there was negligible change in pH value even after adding admixture in the concrete (Table 6). Before the addition of the admixture, pH of water was found 7.000, which then increased to 7.001 after mixing admixture. Therefore, it can be concluded that the admixture has an insignificant

FIGURE 14: Check for pH value after the addition of admixture.

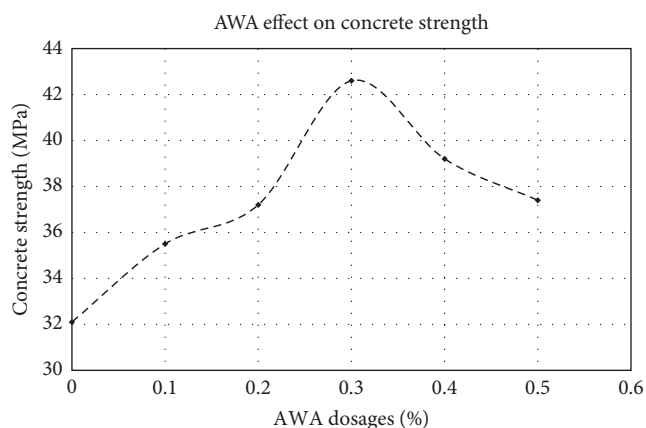
From the graph of Figure 15, it can be observed that the compressive strength of the concrete increases steadily with mild upward fluctuations and reaches a peak of 42.6 MPa strength, corresponding to 0.3% of AWA dosage. However, after reaching the peak at 0.3% of AWA dosage, it has been depicted that the strength of the concrete plummets with a further increase in the percentage of AWA. Thus, it is evident from the graph that though the addition of AWA increases the strength of concrete, after reaching an optimum amount the situation alters.

FIGURE 15: Relation of concrete compressive strength with varying AWA dosages.

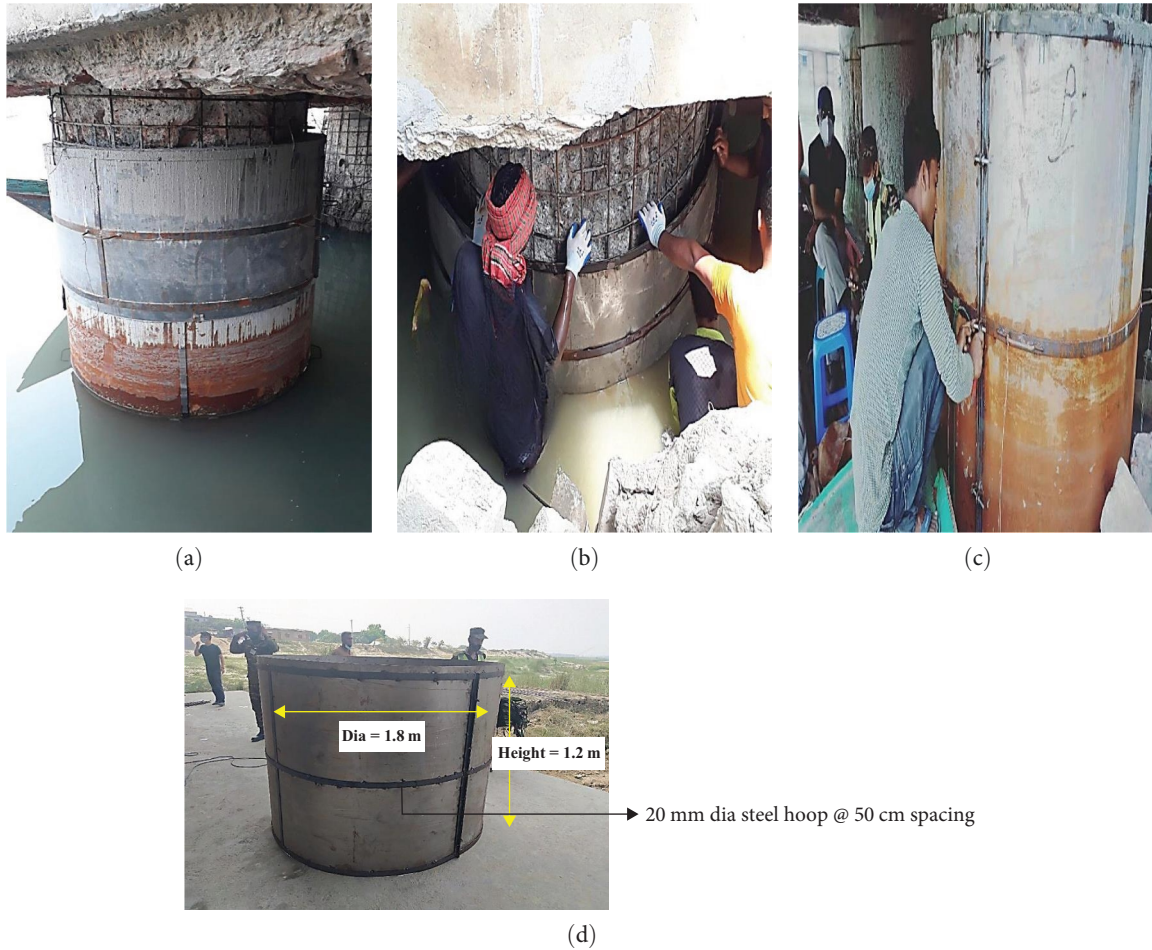
5.3. Production and Processing of Permanent Casing. The formwork consists of semicircular, 3 mm thick iron sheet formwork with a diameter of 1.8 m and a height of 1.2 m.

The exterior is strengthened with 20 mm steel hoops spaced 50 cm apart. The two templates are overlapped by 10 cm and secured with two 20 mm steel hoops on the exterior. Using the inverted assembly process, the formwork is inverted-pulled onto the top of the pile. The assembly is completed on the surface of the water, each section is completed and lowered individually, and the first part of the formwork is placed in the river bed. After

construction is finished, the iron template will not be destroyed. It will be incorporated into the concrete as part of the protection and stability of the pile. Specifications of the permanent casing and the placement process are picturized in Figure 18.

FIGURE 18: (a)–(c) Placement of permanent casing process and (d) iron permanent casing dimension.

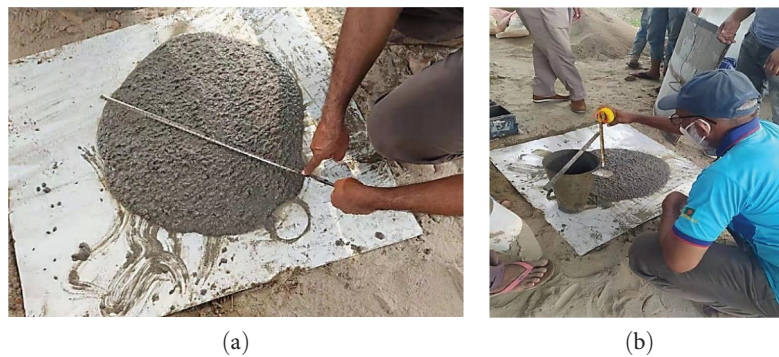
FIGURE 19: (a) and (b) Field slump test of concrete mix.

5.5. *Slump Test.* For each trial and final concreting work, slump was obtained. Slump was found to be around 150 mm while executing the final concreting work. Figures 19(a) and 19(b) show slump test carried out in field.

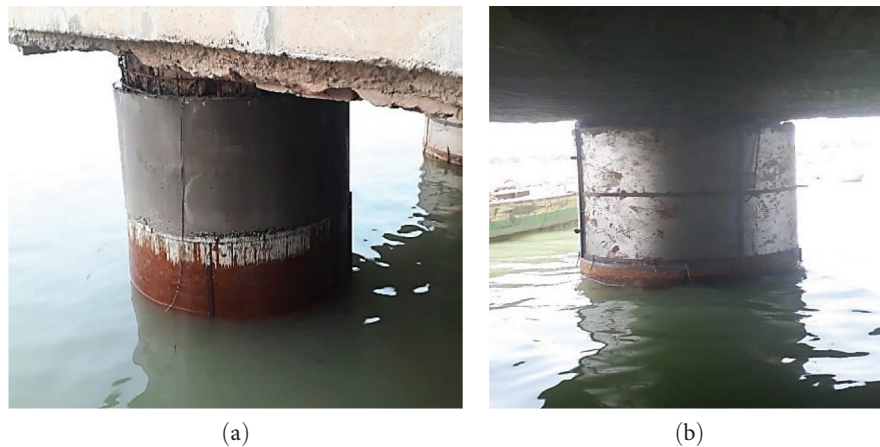
FIGURE 20: Piles after completion of retrofitting.

After underwater concreting in between retrofitting and the steel casing formwork, the casings were not removed and placed as permanent formwork. This is to provide extra protection to the pile concrete surface against erosion and surface damage due to water contact and tidal waves. Figure 20 shows the final look of the piles after completion of all the necessary repair works and retrofitting.
