## Research Article

# Assessing the Quality of Concrete Tunnel Lining Exposed to Tunnel Fire through Residual Compressive Strength

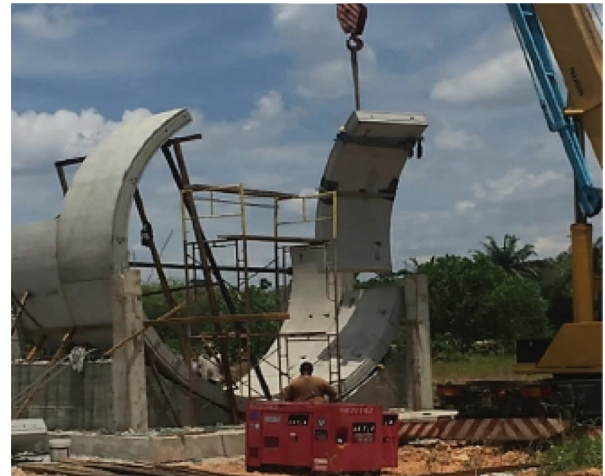
FIGURE 1: (a) Elevation of the ring and (b) assembling the segments into rings (18).

*2.2. Testing Setup for Attaining Tunnel Fire Temperature.* To attain tunnel fire temperature to study its effect on the concrete tunnel linings, an innovative testing setup is designed and described by Alhawati et al. [18]. Two rings of tunnel lining were constructed, one using MYC and the other using SPC. Figure 1(a) shows the typical arrangement of tunnel lining segments to form the tunnel ring and Figure 1(b) shows the assembling process during the construction of tunnel ring. Brick walls with opening are constructed covering the both tunnel rings to provide confinement effect. This helped to achieve the desired tunnel fire time-temperature curve of RABT-ZTV [18].

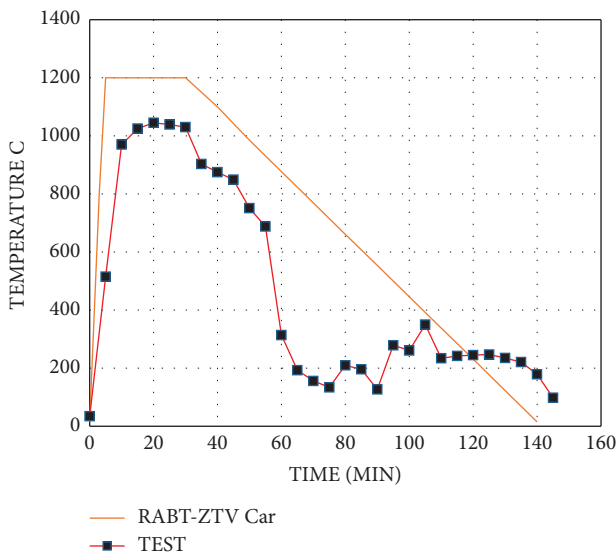
FIGURE 3: Time-temperature curves produced by test setup and the RABT-ZTV.

All the details for the test and the temperature measurement during the test were described in the previous study [18]. Figures 2(a) and 2(b) show the peak fire and maximum temperatures during the test measured by a thermal image camera. The time temperature curves for this test compared with the RABT-ZTV car is shown in Figure 3.

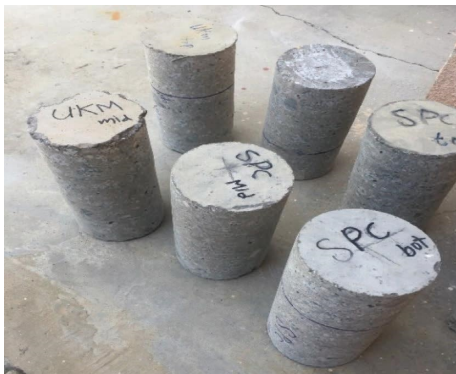
FIGURE 6: Extracted core samples from the tunnel segments.

the surface on which the core would be extracted. Figure 5 shows the core drilling process in the full-scale tunnel segment, and Figure 6 shows the core samples after being extracted from the tunnel segments.

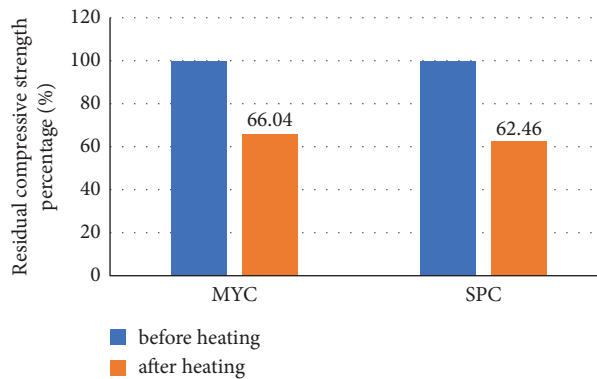
FIGURE 7: Comparison of residual compressive strengths between MYC and SPC concrete.

decreased and remained at 66.04% after exposure to an elevated temperature of 1000°C and above, whereas the SPC concrete strength was decreased to 62.46% after exposure to tunnel fire.

Therefore, the residual compressive strength of MYC concrete was reduced and dropped to 48 MPa, which meant it was reduced by 33.96% after exposure to a 1000°C tunnel fire. Figure 7 shows the comparison of the residual compressive strengths between MYC and SPC concrete.

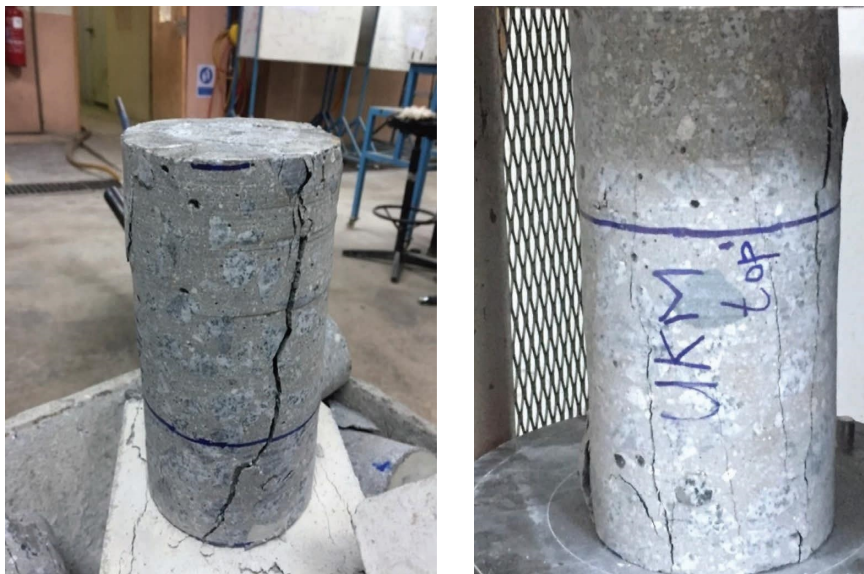
FIGURE 8: Failure of coring SPC and MYC sample after compression.

Figure 8 shows the failure of the SPC and MYC core samples after compression test. From the fire test, it can be seen that explosive spalling occurred mostly in the SPC tunnel lining as shown in Figure 9. Moreover, some of the concrete covers had been scalded off, exposing the steel reinforcements, which greatly influence the load-bearing performance of the tunnel linings. However, in both concrete mixes, the PP fibre had melted due to the very high temperatures, reducing the amount of pore pressure build-up [35]. Spalling contours show how much damage has been occurred in a particular point, as well as how much of the surface area has been damaged. Spalling patterns for SPC and MYC segments are depicted in Figures 9 and 10. Some patterned cracks were appeared in one of the MYC
