## Research Article

# Effect of Elevated Temperature on Microstructural and Durability Properties of High-Strength Concrete-Containing Eggshell

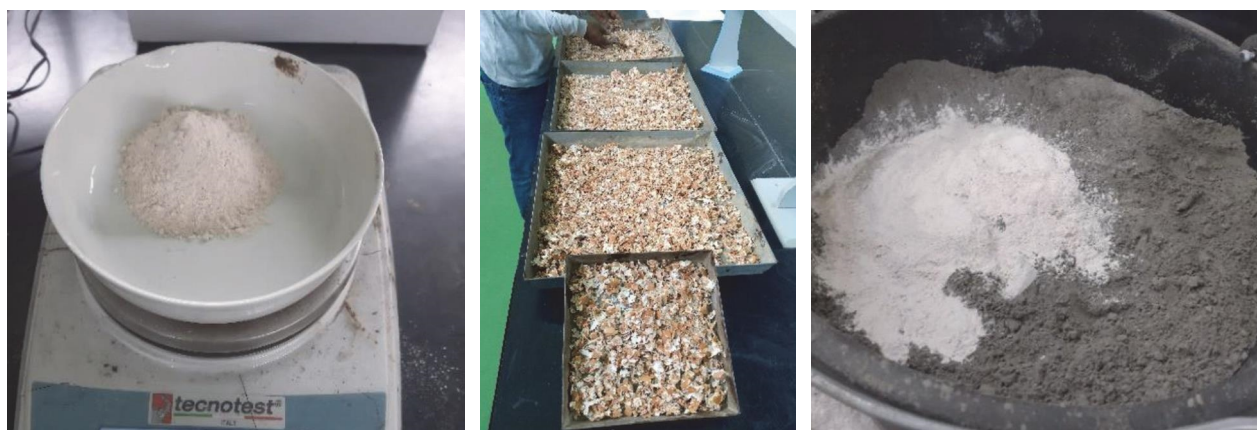
FIGURE 1: Eggshell powder. Source: Own work, 2022.

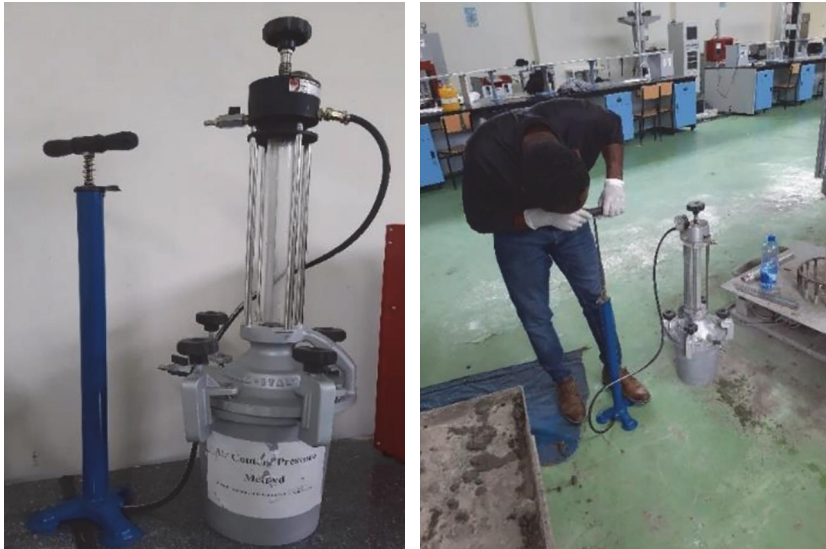
FIGURE 5: Air content (pressure method) testing equipment. Source: Own work, 2022.

strength, this test is useful in estimating the longevity of concrete. The pressure method (Type B concrete air meter), one of the known types of air content test methods, was therefore used in this study. Figure 5 shows the apparatus used to measure the air content in each fresh mix.

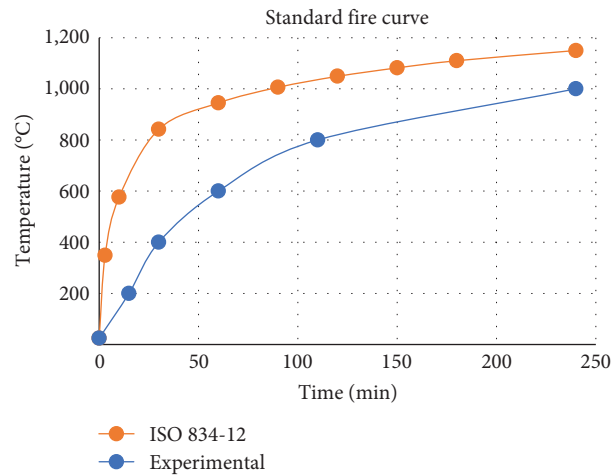
FIGURE 6: Time-temperature curve of the electrically controlled furnace. Source: Own work, 2022.

**2.2.6. Unstressed Residual Compressive Strength Test.** Compressive strength, which is the main durability property of concrete, is affected when the hydration process of Portland cement is attacked due to high temperatures. According to BS 1881-116, a residual compressive strength test was performed [30]. Using an electric furnace, the concrete cube specimens were heated at average rates of  $10^\circ\text{C}/\text{min}$  to temperatures of 200, 400, 600, and  $800^\circ\text{C}$ . Figure 6 illustrates how the temperature was raised in accordance with the ISO-834 fire curve.

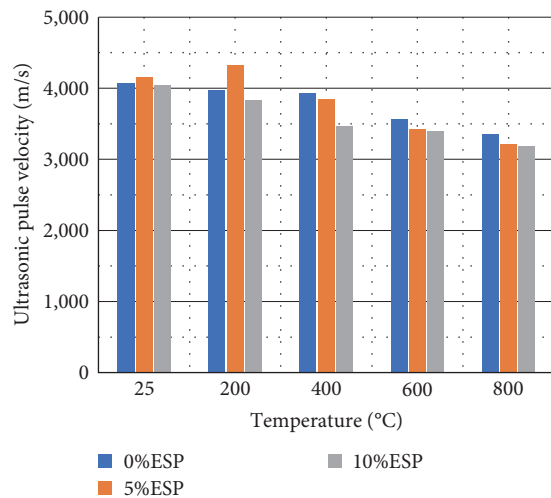
FIGURE 11: Variation in UPV values of concrete mixtures due to elevated temperature. Source: Own work, 2022.

**3.5. Residual Ultrasonic Pulse Velocity (UPV).** UPV, which is a nondestructive test, was used to assess the quality, homogeneity, and presence of pores and cracks. As can be seen, the ESP's presence has no appreciable impact on the UPV values of the concrete. The UPV values of the concrete mixtures were somewhat high at ambient temperature; however, lower values were seen in all test specimens at higher temperatures. In terms of concrete quality [33], the higher UPV values for the control mix and the 5%ESP mix at room temperature were 4,230 and 4,380 m/s, respectively. It is possible that the melted ESP form serves as a filler for crystal pores because a concrete sample containing 5%ESP has a greater UPV at  $200^\circ\text{C}$  with an average of 4,320 m/s. The fluctuations in the UPV of the ESP-concrete mixtures exposed to the specified temperatures are shown in Figure 11.

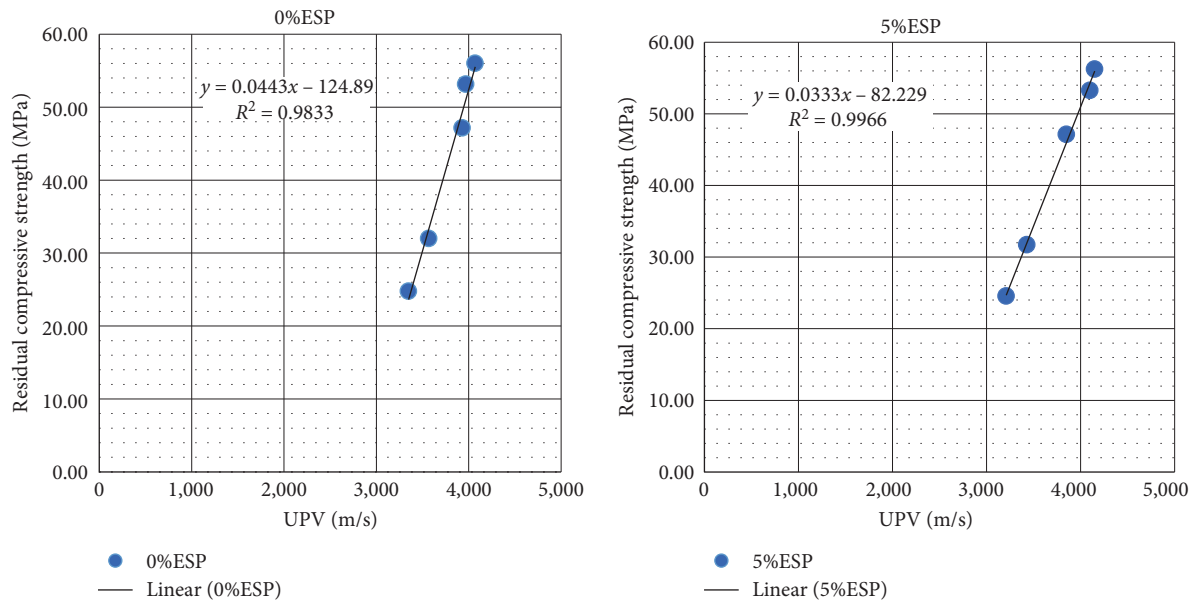
FIGURE 13: Correlation among residual compressive strength and UPV for 0% and 5%ESP mixtures. Source: Own work, 2022.

**3.7. Relationship among the Residual Compressive Strength and UPV.** It was observed that the UPV values could be correlated with the corresponding residual cube compressive strength. The obtained result of residual cube compressive strength was used as a response factor with the residual UPV values as their predictor parameter. To correlate the experimental data, the linear regression method was employed, resulting in Equations (1) and (2), with  $R^2$  values of 0.9833 and 0.9966 for samples with 0%ESP and 5%ESP, respectively, which signified excellent positive confidence for the relationships between UPV and residual compressive strength.

$$f_{\text{rcu}} = 0.0443V - 124.89 \quad (R^2 = 0.9833), \quad (1)$$

$$f_{\text{rcu}} = 0.0333V - 82.229 \quad (R^2 = 0.9966), \quad (2)$$

Figure 13 illustrates a good relationship between the residual compressive strength and UPV values of the control (0%ESP) and 5%ESP concrete mixtures at high temperatures.

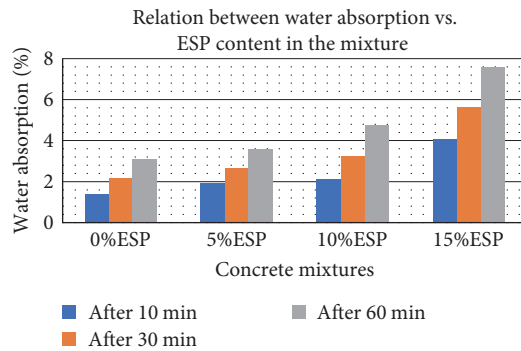
FIGURE 14: Effect of ESP on concrete water absorption characteristics. Source: Own work, 2022.

**3.8. Water Absorption.** One important test to measure the durability of concrete is water absorption. Mohd Arif et al. [31] claim that higher ESP substitution levels cause an increase in the amount of water absorption. In comparison to the control mix, water absorption of sample specimens increased by 0.56%, 0.7%, and 2.7% after 10 min, 0.45%, 1.05%, and 3.45% after 30 min, and 0.5%, 1.65%, and 4.5% after 60 min of immersion. The replacement levels of ESP were 5%, 10%, and 15% of the total cement weight. As a result, the 5%ESP mix outperforms the other mixes and has durability strength that is comparable to the control

mix. Figure 14 shows the effect of excess in ESP on the concrete water absorbability.

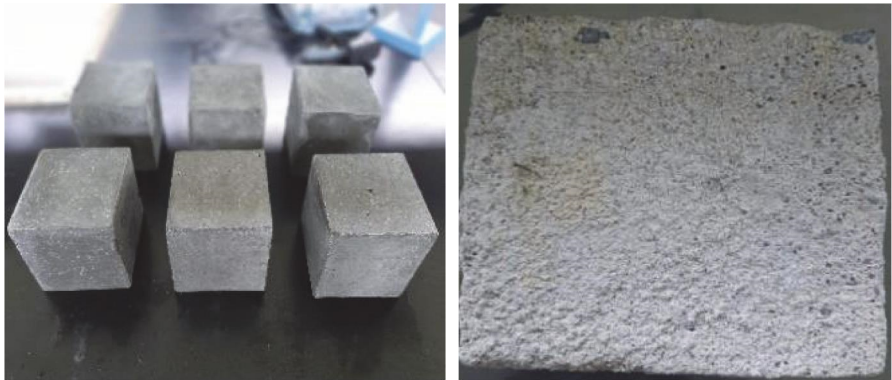
FIGURE 15: Sample concrete specimens color change due to sulfuric acid solution. Source: Own work, 2022.

**3.9. Acid Attack.** Concrete specimens with and without ESP were made in order to examine the impact of sulfuric acid attack. Following 28 days of curing, those samples were heated to 25, 200, and 400°C then cooled for three hours. After cooling, the sample specimens were submerged for 56 days in a 3% solution of  $H_2SO_4$  (sulfuric acid). In all samples of concrete mixture, the presence of an acid solution significantly changes the color. This scenario also supported a decline in surface smoothness and a decrease in concrete

strength. Figure 15 illustrates the effect of sulfuric acid concentration on the surface of sample cubes.

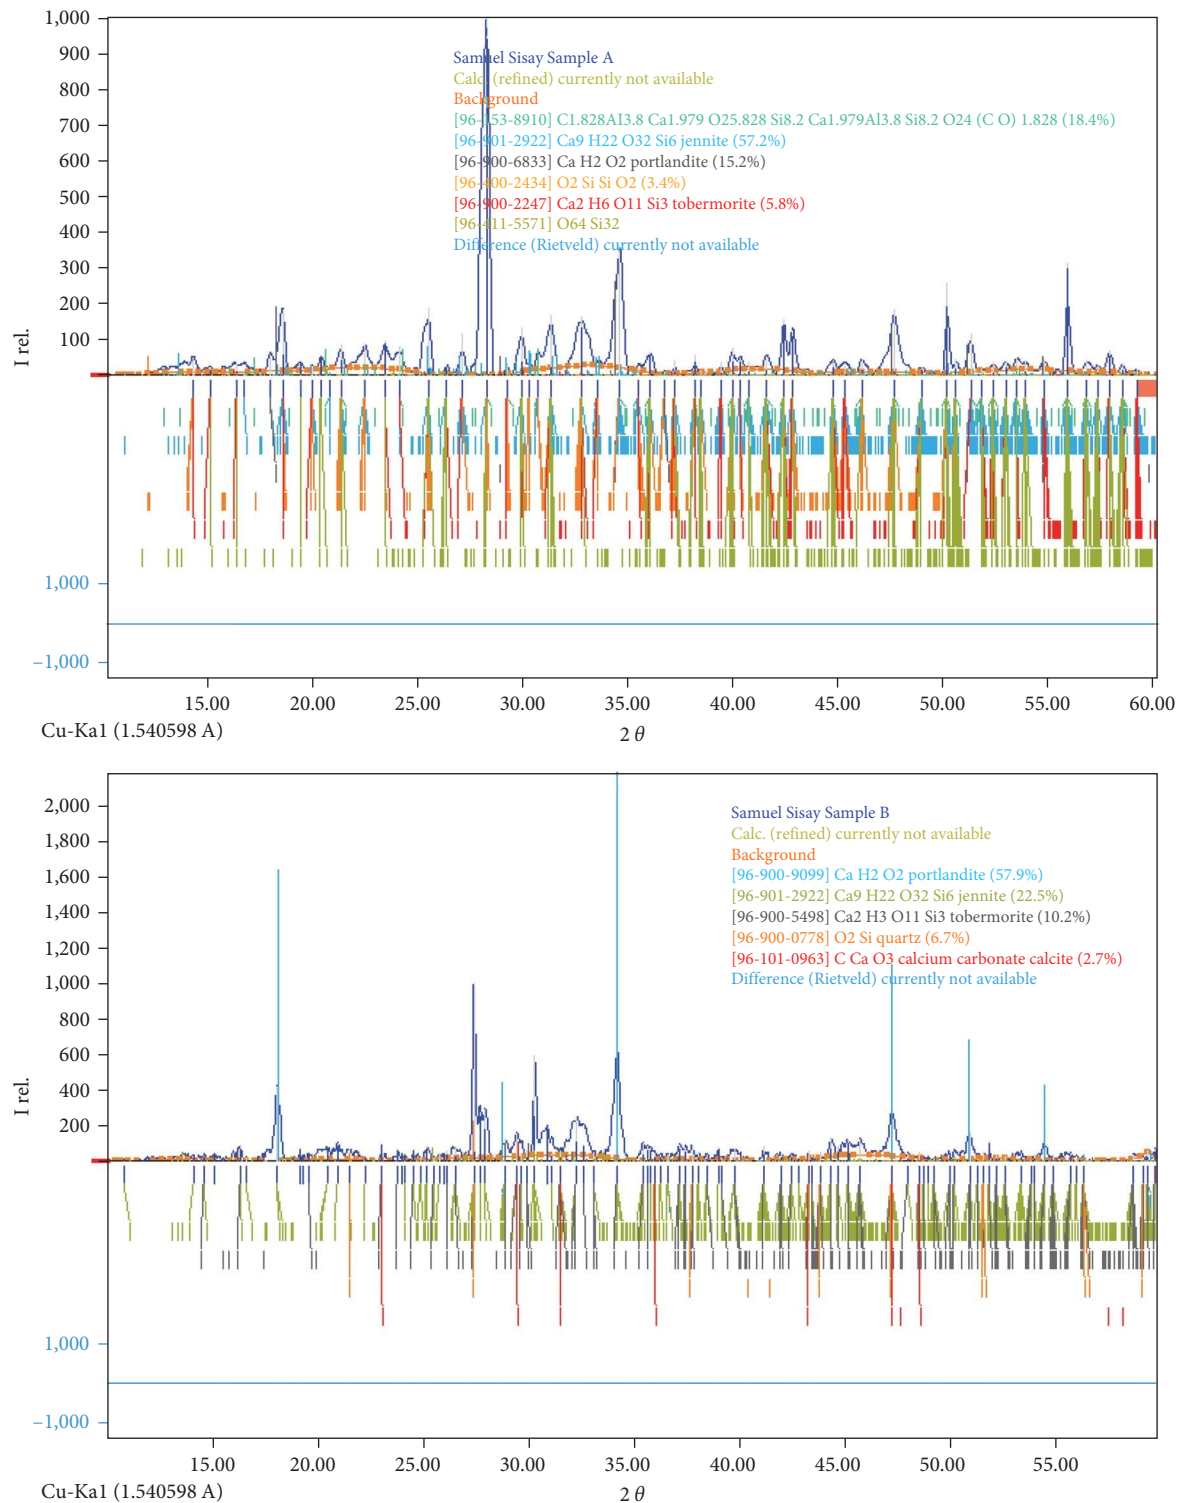
FIGURE 19: XRD result for 0%ESP @25 and 200°C. Source: Own work, 2022.

**3.13. XRD Analysis.** The outcome shows that the hydration of  $C_3S$  and  $C_2S$  caused a significant amount of jennite (C—S—H gel) to develop under ambient conditions. As the primary hydration product,  $Ca(OH)_2$  was also produced.

However, samples heated to 200°C showed a higher rate of portlandite (calcium hydroxide) synthesis, which may be related to the degradation of limestone, which is present in cement by endothermic heating and transforms to calcium oxide. A quiet quartz peak can be seen, which may be brought on by dissolved silicon dioxide. However, the value is larger in the heated sample concrete, which could be the result of temperature or pressure changes creating a quartz crystal. Generally, at 5%ESP, the finding in both SEM and XRD shows a higher degree of presence in C—S—H and CH, which are the major components affecting the microstructural integrity of concrete. Moreover, those experimental tests can clearly show the morphological and mineralogical composition of the sample concretes. The result of XRD analysis of concrete samples at 25°C and 200°C after 28 days of hydration for 0% and 5%ESP are shown in Figure 19.
