Research Article

Gully Morphology and Rehabilitation Measures in Different Agroecological Environments of Northwestern Ethiopia

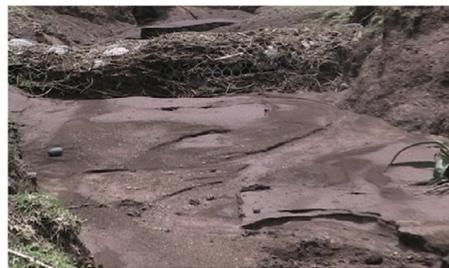
FIGURE 5: Properly constructed gabion check dam which is strong enough to resist the force of the runoff.

probably prefer them because such check dams have a faster implementation timeline, are cost effective, will not displace communities, and will not affect natural resources. Moreover, these check dams are simple to construct and do not rely on advanced technologies as it was documented by [40]. As an illustration, the most successful check dams for controlling gully erosion in the study area are displayed in Figures 3–6. Each of these check dams was integrated with different

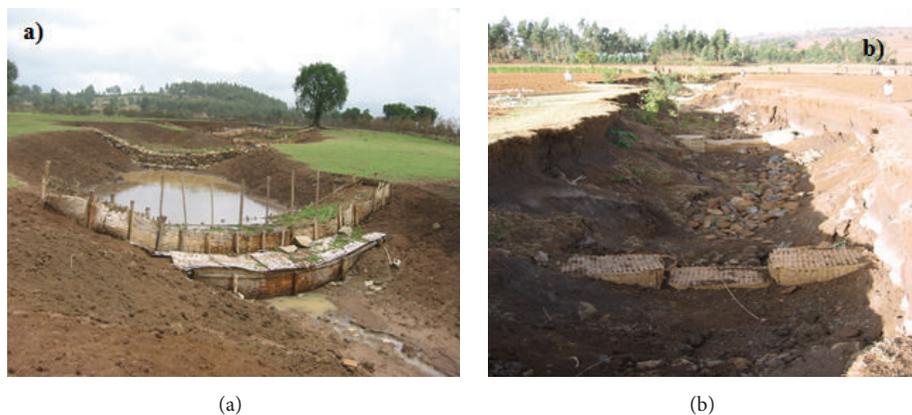
FIGURE 6: Combination of different technologies: (a) bamboo box and loose stone check dams and (b) bamboo box.
