## Research Article

# Material Weakening of Slip Zone Soils Induced by Water Level Fluctuation in the Ancient Landslides of Three Gorges Reservoir

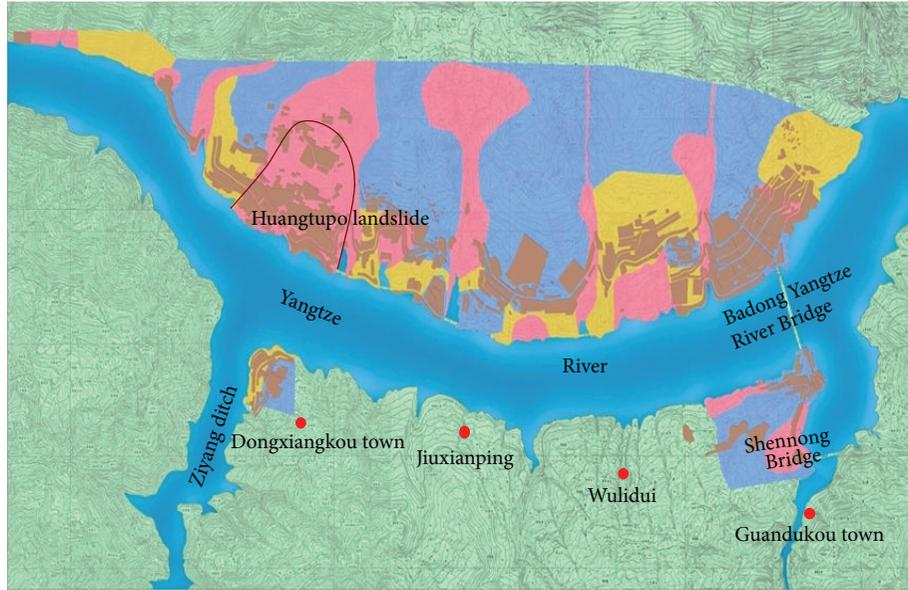
(a) Landslide location

FIGURE 1: Huangtupo landslide.

The Huangtupo landslide, located in the Badong County, Hubei Province, south bank of Yangtze River, is one of the largest and most complicated landslides in the Three Gorges Reservoir. The Huangtupo landslide has upper, middle, and bottom surface slopes of  $40^\circ$ ,  $15^\circ$ – $20^\circ$ , and  $30^\circ$ – $35^\circ$ , respectively. Moreover, its front edge, drowned by water, has an

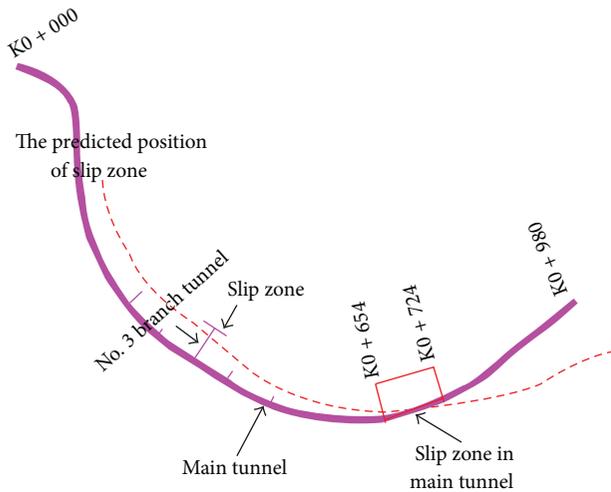
FIGURE 2: Schematic diagram of the exploratory tunnel in the Huangtupo landslide (plan view).

The Huangtupo landslide is composed of four independent sliding masses, including the Biandianzhan landslide, the Yuanyichang landslide, the No. 1 slumped mass, and the No. 2 slumped mass. These masses are divided by the town of Sandaogou, whose west front lies on the No. 1 slumped mass. The Yuanyichang landslide lies on the upper part of the No. 1 slumped mass, whereas its east front lies on the No. 2 slumped mass. The Biandianzhan landslide lies on the upper part of the No. 2 slumped mass (Figure 1). Both the Biandianzhan and Yuanyichang landslides are bedding rock ones. The No. 1 and No. 2 slumped masses are located in the front part of the Huangtupo landslide which has a steep slope surface. This portion of the Huangtupo landslide suffers from frequent human activities and poor stability. The China University of Geosciences investigated the basic geological background of the disaster-prone area in the Three Gorges Reservoir; as a disaster prevention measure, a tunnel was excavated inside the No. 1 slumped mass. The tunnel was 908 m long and divided into five branches. Among the branches, the No. 3 branch was the longest with a length of 140 m (Figure 2).

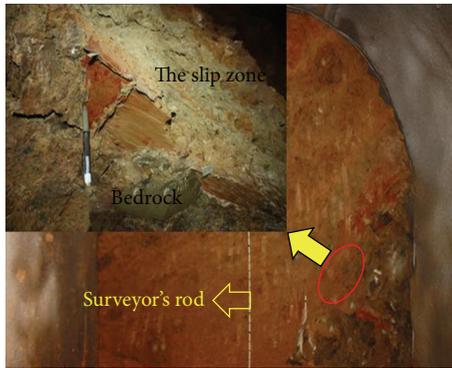
FIGURE 3: Slip zone of the Huangtupo landslide in No. 3 branch tunnel.

*3.1. Experimental Material.* The experimental material was the original slip zone soil taken from the 138 m depth of the No. 3 branch in the excavated tunnel (Figure 3). The elevation

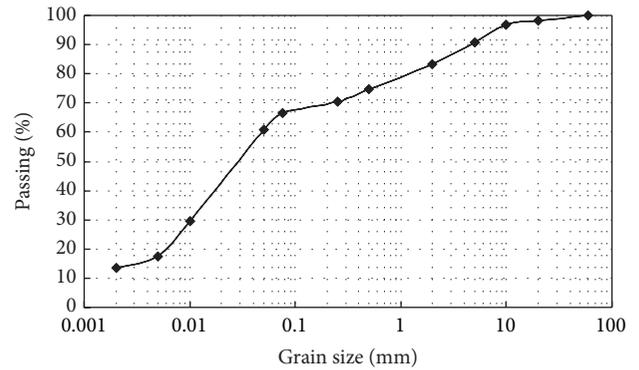
FIGURE 4: Grain size distribution curve for the slip zone soil.

Figure 4 shows the grain size distribution curve obtained by using screening and densimeter methods. As can be seen, 14.5% of the slip zone soil is composed of clay. Moreover, the liquid and plastic limit and the grading curve indicate that the slip zone soil belongs to low liquid limit clay containing gravel [15].

repeated wetting-drying condition. A wetting-drying cycle refers to the process of the complete saturation to natural dry state. The sample preparation was to reproduce the saturated and dry states of several wetting-drying cycles. According to the particle distribution of the soil sample plotted in Figure 4, the particle size less than 2 mm accounts for about 85%. In order to reduce the influence of size effect, the gravels larger than 2 mm were removed in the process of the sample preparation. The original slip zone soil is weighed and made into a cutting ring sample with height of 20 mm and diameter of 61.8 mm, respectively. In a wetting-drying process, the sample is firstly vacuumized in a vacuum pump, secondly, water is injected into the vacuum pump to submerge the sample for 2-3 hours, and thirdly, the sample was soaked in water in a container for 48 hours to saturate it completely. After corresponding tests, the sample was dried for the next round of tests. It was exposed in the air for natural drying until its weight returns to the original state (at the room temperature of 25°C). To ensure drying state, the sample was weighed several times until its weight did not change any longer. After returning to its original state, the sample was wrapped in plastic and put into a moist air cabinet for 48-72 hours to keep the water content constant (Figure 5). This experimental methodology has the advantages of easy operation and sample reuse.

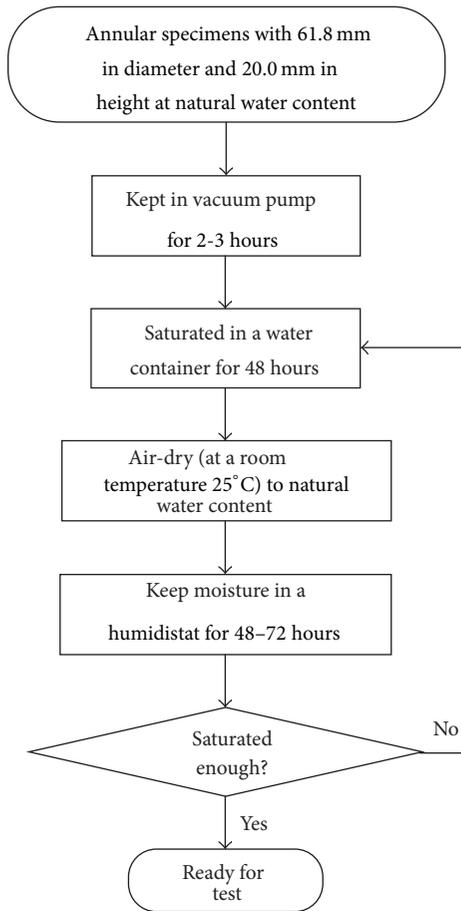
FIGURE 5: Flowchart of the wet-dry cycle.

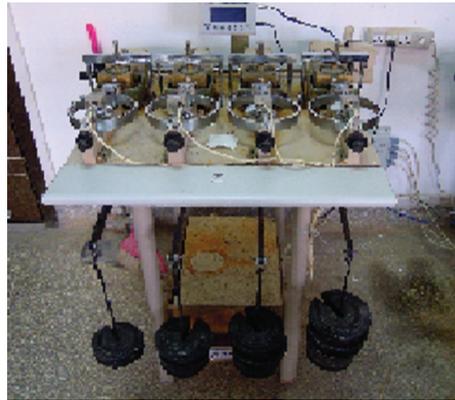
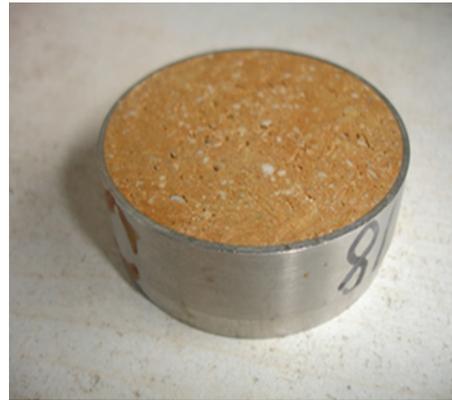
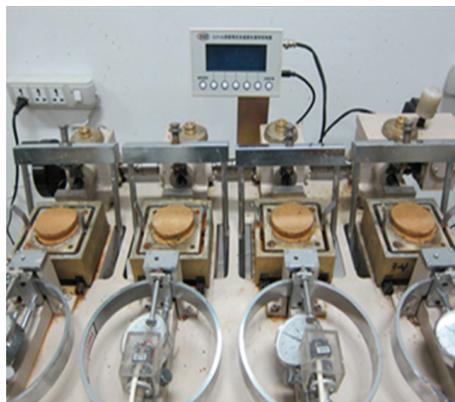
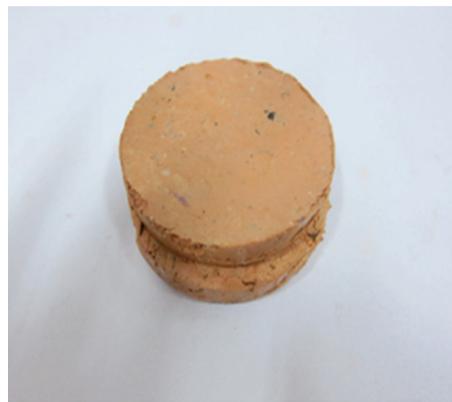
(a) Testing apparatus

(b) Annular specimen with diameter of 61.8 mm and height of 20.0 mm

(c) End of the test

(d) The destructed sample

FIGURE 6: Direct shear test.

To investigate the relationship between the shear strength and the wetting-drying cycle, a shear test for consolidated samples was conducted by using DJY-4 quadruple uniform strain direct shear apparatus (Figure 6), the loading rate was 0.8 mm/min, and the so-called consolidation was achieved through putting the sample under a heavy punch for 24 hours [15]. This test was conducted for 0 to 6 cycles, and each cycle included two groups of parallel tests by two same testing machines. Each group had four samples, and 14 groups in total were tested. After the shear tests, two of the eight samples in each cycle were taken for XRD tests, and the rest were used for liquid and plastic limit tests.

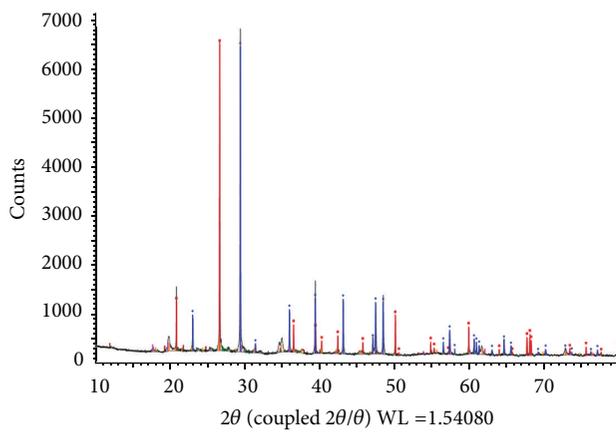
- Quartz, syn.  $\text{SiO}_2$
- ◆ Calcite, syn.  $\text{CaCO}_3$
- Montmorillonite-chlorite  $\text{Na-Ca-Al-Si}_4\text{O}_{10}\text{-O}$
- Montmorillonite-15A  $\text{Ca}_{0.2}(\text{Al, Mg})_2\text{Si}_4\text{O}_{10}(\text{OH})_{2.4}\text{H}_2\text{O}$
- Kaolinite  $(\text{Al, Si})_2\text{Si}_2(\text{O, OH})_9$
- Illite 2M1  $\text{K-Na-Mg-Fe-Al-Si-O-H}_2\text{O}$
- Feldspar (K-component)  $\text{K}(\text{AlSi}_3\text{O}_8)$

(a) Diffraction pattern of the sample after six cycles

FIGURE 7: XRD test.

wavelength of the X-ray and  $\theta$  is the diffraction angle. Finally, we compared the diffraction patterns obtained by XRD tests with the standard diffraction patterns of known minerals; different mineral contents can be accordingly quantified (Figure 7).

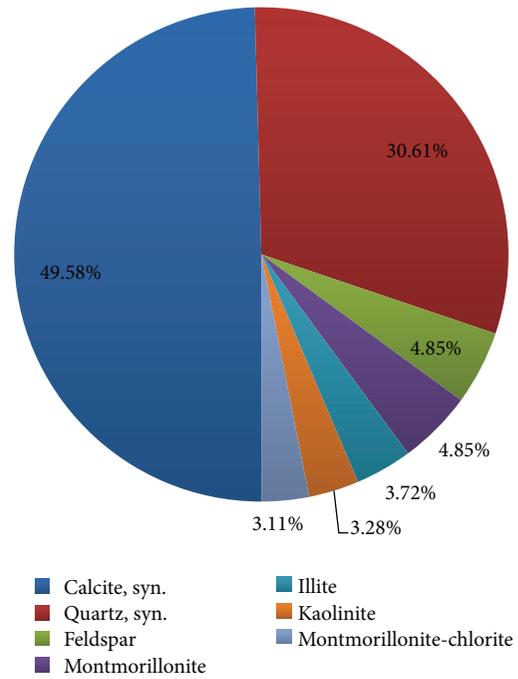
- Calcite, syn.
- Quartz, syn.
- Feldspar
- Montmorillonite
- Illite
- Kaolinite
- Montmorillonite-chlorite

(b) Schematic diagram of processing results

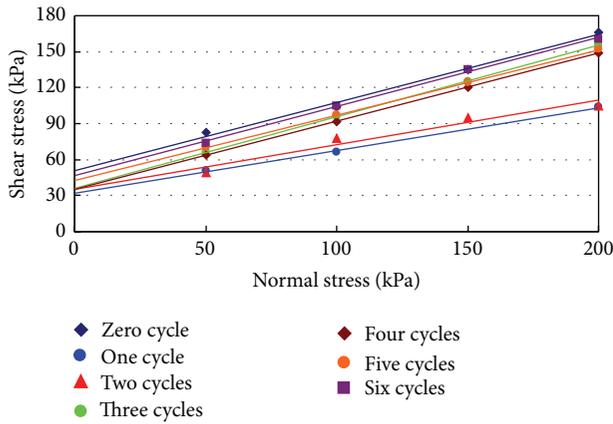
FIGURE 8: The strength envelope of the slip zone soil under different numbers of cycle.

**4.1. Direct Shear Strength.** Based on the strength envelope line under different cyclic conditions (Figure 8), the slip zone soils became weak after the first cycle and the strength values reached relatively stable states after four cycles. However, the relatively stable values of the slip zone soils are smaller than their initial values. Figure 9 shows the impact of the wetting-drying cycle on the strength parameters of the slip zone soil. As can be seen, two strength parameters of the slip zone soils, namely, cohesion  $c$  and friction angle  $\varphi$ , initially decreased and then increased with increasing number of cycles. The strength parameter  $c$  showed maximum reduction after the first cycle and gradually reached a relatively stable value after four cycles, decreasing by approximately 14.7% compared to its initial value. Similarly, for the strength parameter  $\varphi$ , maximum reduction after the first cycle was observed and gradually a relatively stable state was reached after four cycles. The reason for the soil behaviors observed above might be due to the water-soluble and hydrophilic mineral contents. Upon the first appearance of the water, physical and chemical changes occur, and the strength values decrease accordingly. With some soluble components going into the water, the soil strength parameters reach relatively stable values. The deep mechanism of these phenomena needs to be further uncovered. According to statistics [18], approximately 50% of reservoir landslides occurred during the first impounding, whereas most of the rest landslides occurred within three to five years after impounding [4]. These results are consistent with the test results of the current study. Maximum decrease in strength of the slip zone soils after the first wetting-drying cycle was observed, indicating that the reservoir bank slope loses stability in the early stage of impoundment. The strength values generally stabilized after four cycles, but generally the stabilized values were smaller than the initial values. The results show that the safety factor of the bank slope decreases and the slope loses stability gradually upon the first impoundment and after several cycles of water level fluctuation.

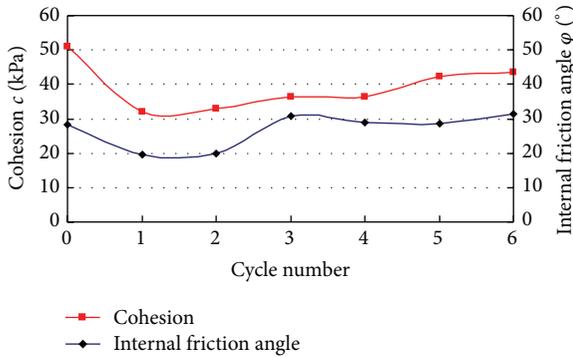
FIGURE 9: Relationship between the shearing strength parameters and cyclic number.

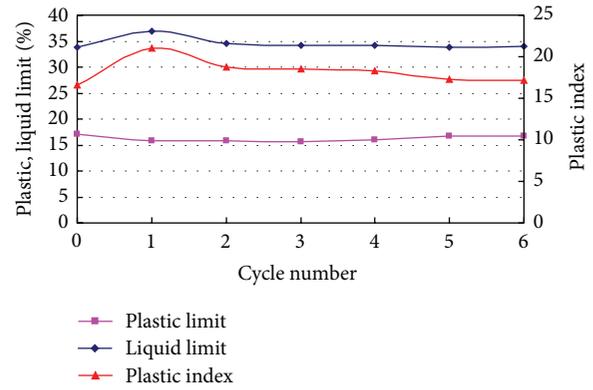
FIGURE 10: Variations in the plastic, liquid limit, and plastic index with cycle number.

**4.2. Liquid and Plastic Limit Tests.** The results of the liquid and plastic limit tests for the slip zone soils under different wetting-drying cycles are shown in Table 2 and Figure 10. As can be seen, there was a significant increase of the liquid limits of the slip zone soils after the first cycle and then the gradual decrease was observed with the increasing number of the cycles. Correspondingly, the plasticity index of the slip zone soils had a maximum increase after the first cycle and then stabilized gradually. The reason for the observed variation of the soil indices is similar to soil strength parameters. Due to the water-soluble and hydrophilic mineral contents, physical and chemical changes may occur under the participation of

water, and changes in liquid and plastic indices may take place corresponding to the mineral contents in the soils. The liquid limits and plastic limits are important physical characteristic indices that reflect the impact of water on the soil properties. Therefore, the plasticity index can be used for engineering soil classification. The liquid limit, the plastic limit, and the plasticity index of soils vary depending on the wetting-drying cycle. The plasticity index of the slip zone soils increased by 27.1% from its initial value of 16.6–21.1% after the first cycle, indicating that the wetting-drying cycles can significantly change the properties of the slip zone soils.

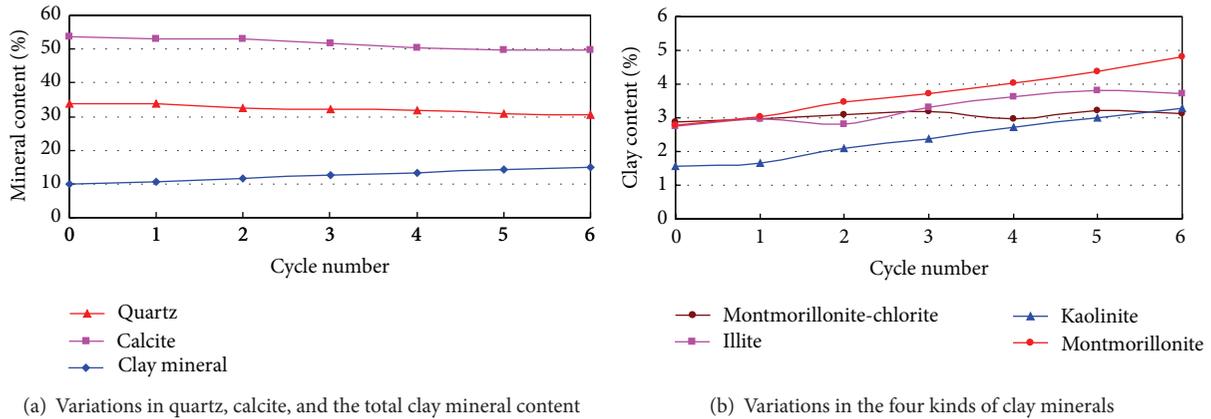
FIGURE 11: Variation in mineral content under the wet-dry cycle.

4.3. XRD Test Results. As summarized in Table 3 and Figure 11, the results of the XRD tests show that the main minerals in the slip zone soils include quartz and calcite which occupy 30% and 50% of the soil, respectively. The clay minerals include illite, montmorillonite, kaolin, and montmorillonite-chlorite-mixture; they occupy 9.98% of the soil in total. The content of clay minerals in the slip zone soil gradually increased with the increase of cycle number; 15% of increment was found after six cycles. Among the clay minerals, the contents of montmorillonite and kaolin relatively increased, particularly after the first cycle, whereas the content of the illite remained constant. On the other hand, the contents of calcite and quartz in the slip zone soils slightly decreased. The above mentioned phenomenon may be due to the fact that an amount of hydrophilic and water-soluble minerals exist in the soils, and upon the appearance of water, physical and chemical changes take place, and some of the minerals went away with the water during the soaking of the samples; resultantly, alteration in mineral contents occurs.
