Weathering Influence on Properties of Siltstones from Istria, Croatia

Martina Vivoda Prodan and Željko Arbanas

University of Rijeka, Faculty of Civil Engineering, Radmile Matejčić 3, 51000 Rijeka, Croatia

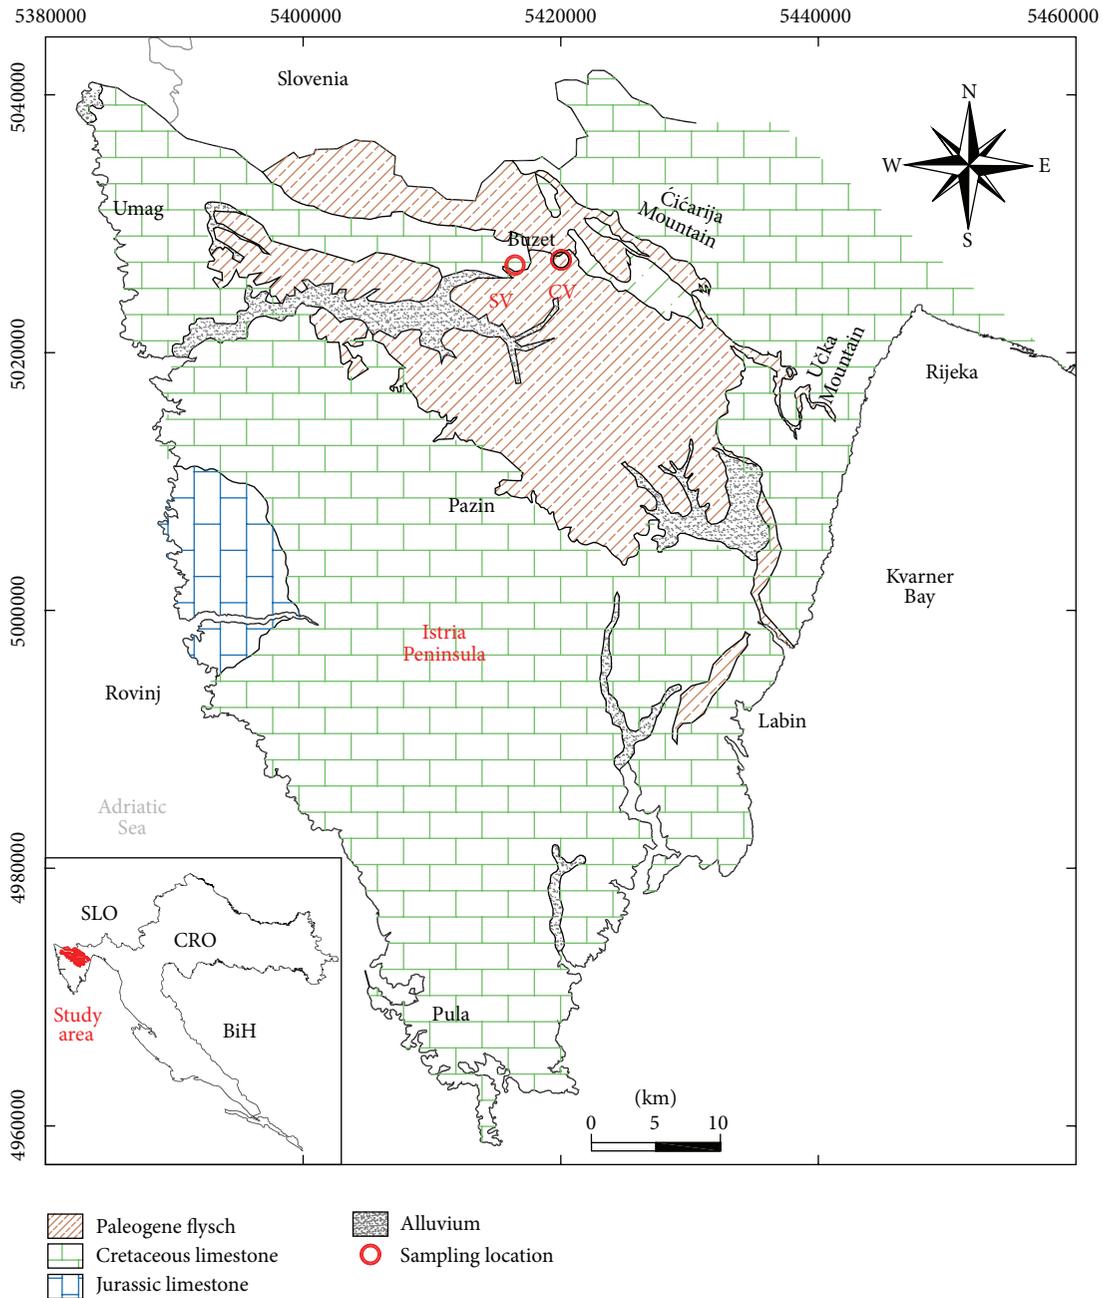
FIGURE 1: Geological map of the Istria Peninsula (based on [19]). CV = Cunj Village, SV = Sovinjak Village.

The Istrian Peninsula is located in the northwestern part of the Adriatic Sea and is composed of Paleogene flysch, Cretaceous and Jurassic limestone, and alluvial deposits (Figure 1; [19]). It can be divided into three major regions: (i) Red Istria—Jurassic, Cretaceous, and Eocene plains (southern and western part of the Istria Peninsula); the term originates from the thick Quaternary deposits of so-called “terra rossa,” which overlie the Mesozoic and Tertiary carbonate bedrock; (ii) White Istria—the Cretaceous Eocene carbonate platform and clastic zone (mainly the Čičarija and Učka massifs), which have a characteristically imbricated structure; the term originates from the white color of the weathered Cretaceous and Eocene limestone; (iii) Gray Istria—the Eocene flysch basin (northeastern part of the Istria Peninsula). The term originates from the gray color of the marls, which are interbedded with sandstones and together form the flysch rock mass complex.

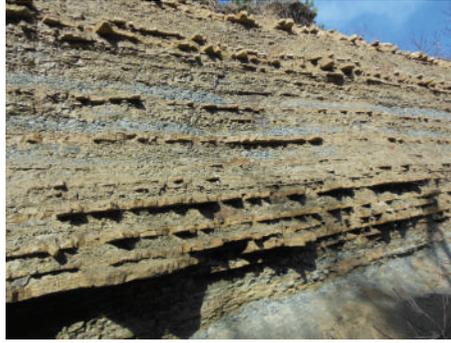
FIGURE 2: Vertically alternating sandstones and siltstones in the flysch rock mass at the lateral scarp of the Brus Landslide in the Istria Peninsula.

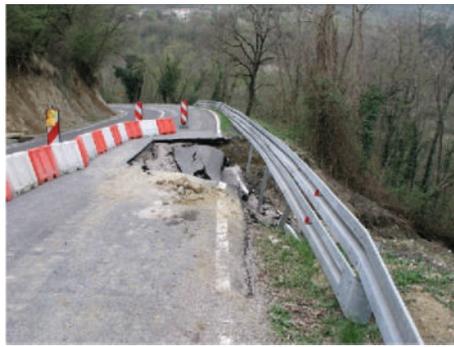
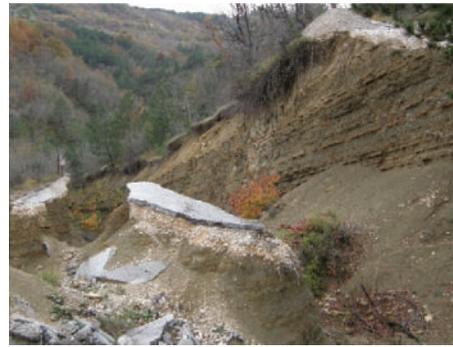
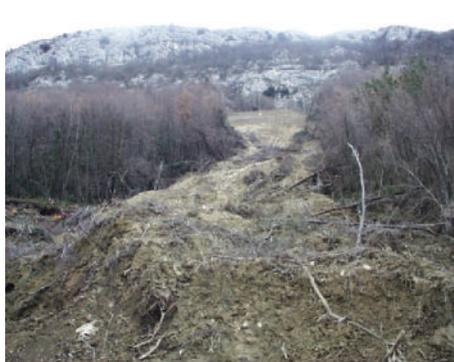
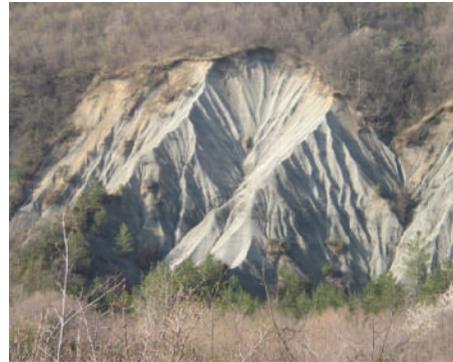
FIGURE 3: Geomorphological processes at the study area: (a) the rotational Marinci Landslide, (b) the translational Brus Landslide, (c) a debris flow at Krbavčiči, and (d) erosion at Lesiščina.

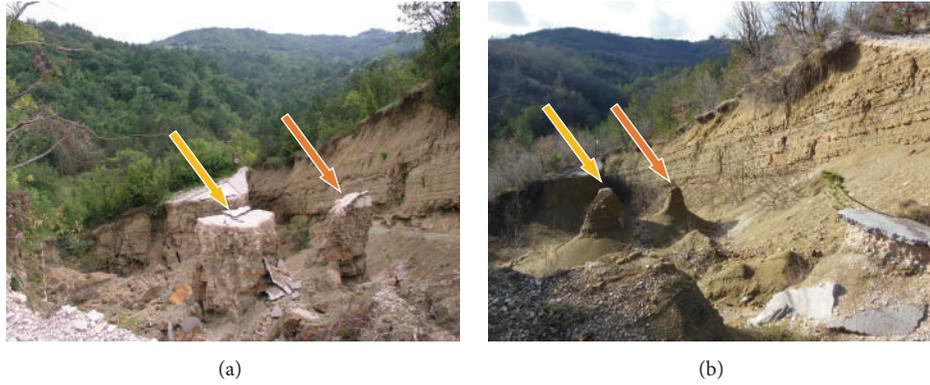
FIGURE 4: View of a landslide body and lateral scarp from the crown of the Brus Landslide in (a) August 2005 and (b) January 2013.

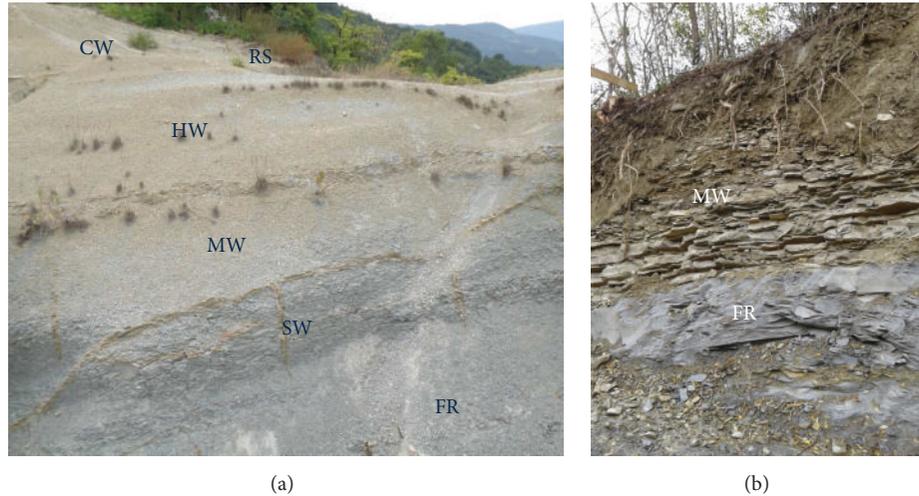
FIGURE 5: Locations of samples that were collected for laboratory testing from flysch outcrops near (a) Cunj Village and (b) Sovinjak Village.

In this study, six standard grades of weathered siltstone [15] were investigated in a flysch weathering profile (Figure 5(a)). The weathering profile was defined using the following categories: fresh (FR), slightly weathered (SW), moderately weathered (MW), highly weathered (HW), and completely weathered (CW) rock masses and residual soil (RS). The evaluation of the weathering profile in the study area was based on a qualitative description of the colors and discoloration, discontinuities states, the existence or absence of the original rock texture, and the uniaxial compressive strength of the intact rock based on the Schmidt hammer rebound value. Progressive and gradual weakening and

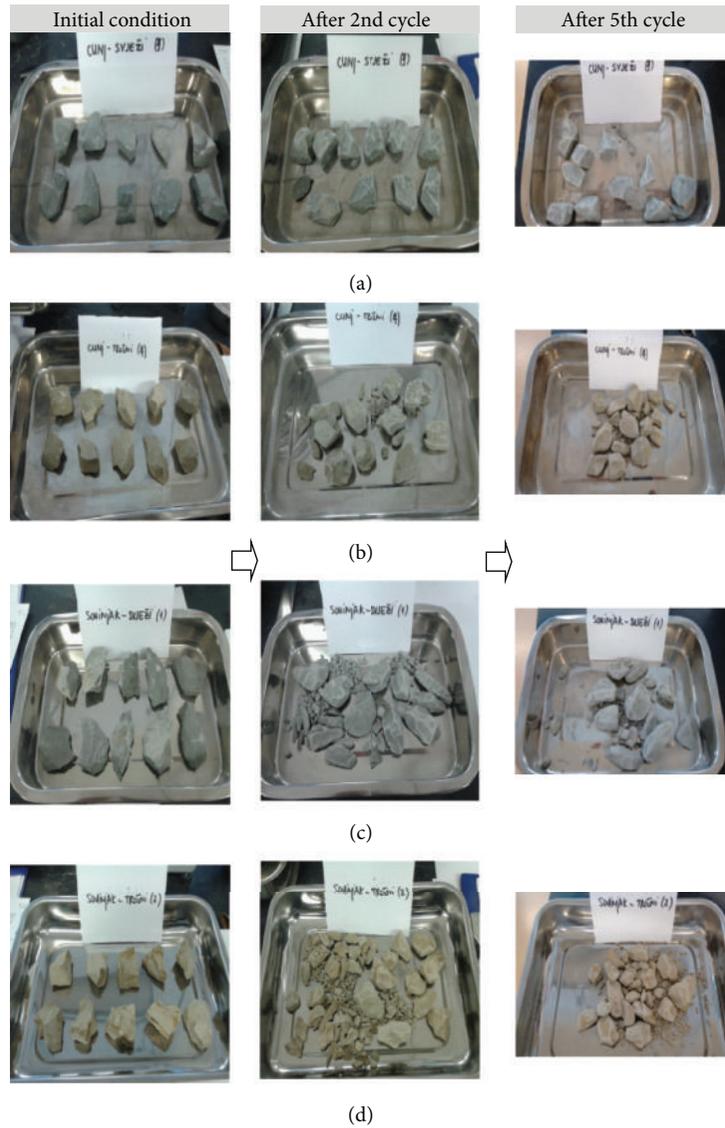
FIGURE 6: Samples taken from flysch outcrops near ((a), (b)) Cunj Village and ((c), (d)) Sovinjak Village, including initial conditions (left), after the 2nd cycle (middle), and after the 5th cycle (right) of the slake durability test.

Gamble [8] suggested that slake durability index values that are taken after three or more cycles of slaking and drying may be useful for evaluating rock durability. The slaking behavior of siltstones cannot be described adequately using only two cycles and only a single aperture, such as the 2 mm mesh drum that is used in the standardized slake durability test. Therefore, in this study, 5 cycles were applied to each sample, and the fragment size distribution approach was used to better define the slaking characteristics of the tested siltstones. Figure 6 shows the fractions of the tested samples that were retained in the test drum for the initial conditions and after the second and fifth cycles.

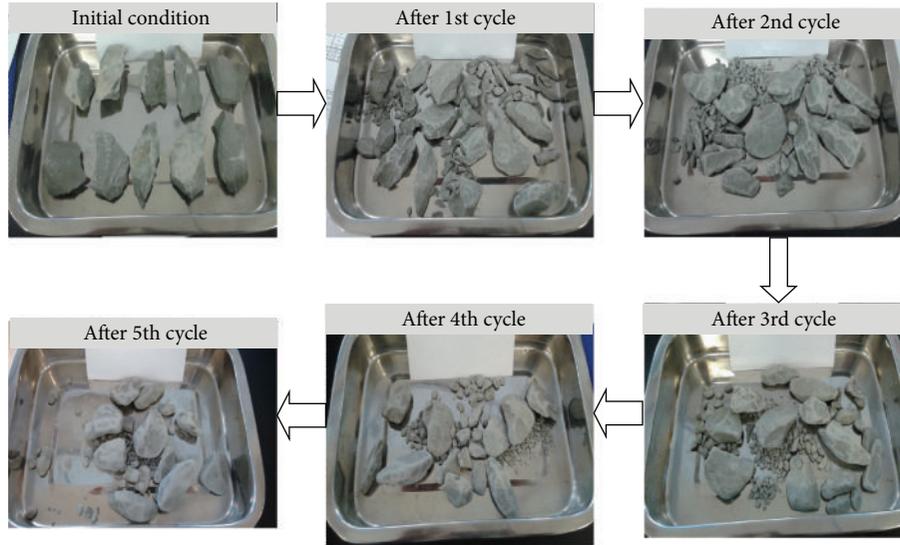
FIGURE 7: Example of a heavily degraded siltstone sample of weathering grade I (FR) (1) taken from a flysch outcrop near Sovinjak Village after five cycles of the slake durability test with $I_{d2} = 88\%$ and $I_{d5} = 73\%$.

The samples that were retained in the drum were extremely fragmented and appeared highly degraded (Figure 7). However, the fragments were larger than 2 mm, which led to the high I_{d2} values. However, high I_{d2} values do not correlate with this highly degraded state. Therefore, the fragment size distribution of the fragmented siltstone that was retained in the drum after each cycle of the slake durability test was quantified.

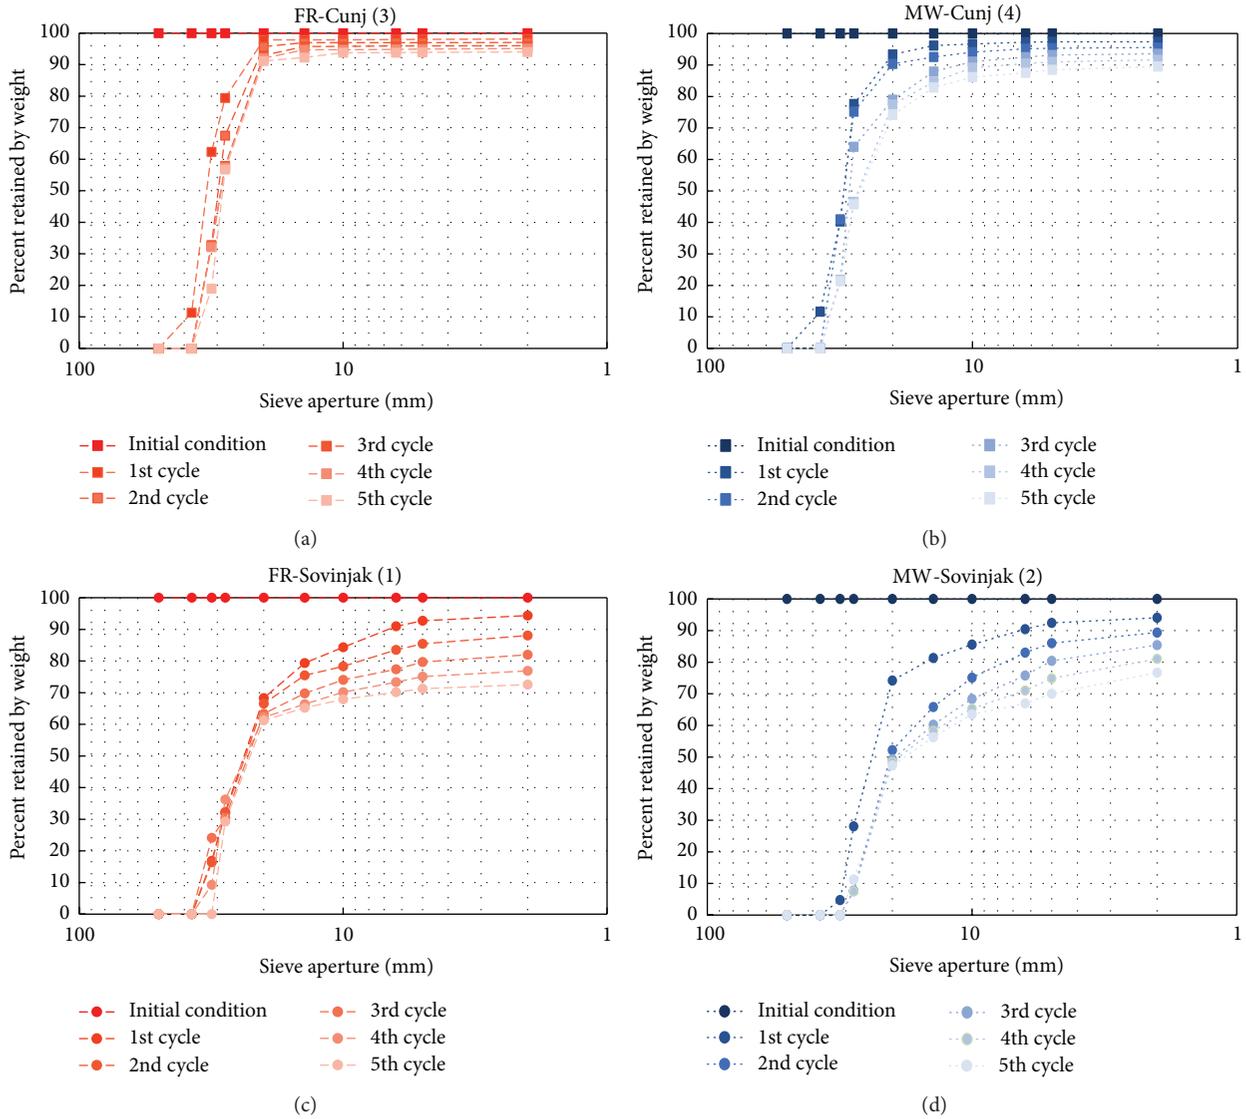
FIGURE 8: Fragment size distribution curves of the retained weight for the siltstone samples of weathering grades (a) I (FR) (3) and (b) III (MW) (4) from a flysch outcrop near Cunj Village and samples of weathering grades (c) I (FR) (1) and (d) III (MW) (2) from a flysch outcrop near Sovinjak Village.

Figure 8 shows the fragment size distribution curves of the retained weight, and Figure 9 shows fragment size distribution curves of the passed weight through all of the cycles of the slake durability test of siltstone samples of weathering grades I (FR) and III (MW) that were collected from flysch outcrops near Cunj Village and Sovinjak Village. The fragment size distribution curve of the retained fragments is required to define the disintegration ratio after each of the five cycles of the slake durability test. The modified degradation ratio after each cycle is also determined based on the fragment size distribution curve of the passed fragments of the sample. The slake durability index, disintegration ratio, and modified disintegration ratio after each of the five cycles are presented in Table 4.

sizes that do not correspond to the high values of the slake durability index. The graphs in Figures 8 and 9 are used to calculate the degradation ratio and the modified degradation ratio after each slaking cycle (Table 4). Figure 11 shows the changes of these parameters through the slaking cycles. After each cycle, the siltstone sample of weathering grade I (FR) that was taken from the Sovinjak outcrop had a lower durability index than the sample of weathering grade III (MW). The other two parameters indicate that the siltstone

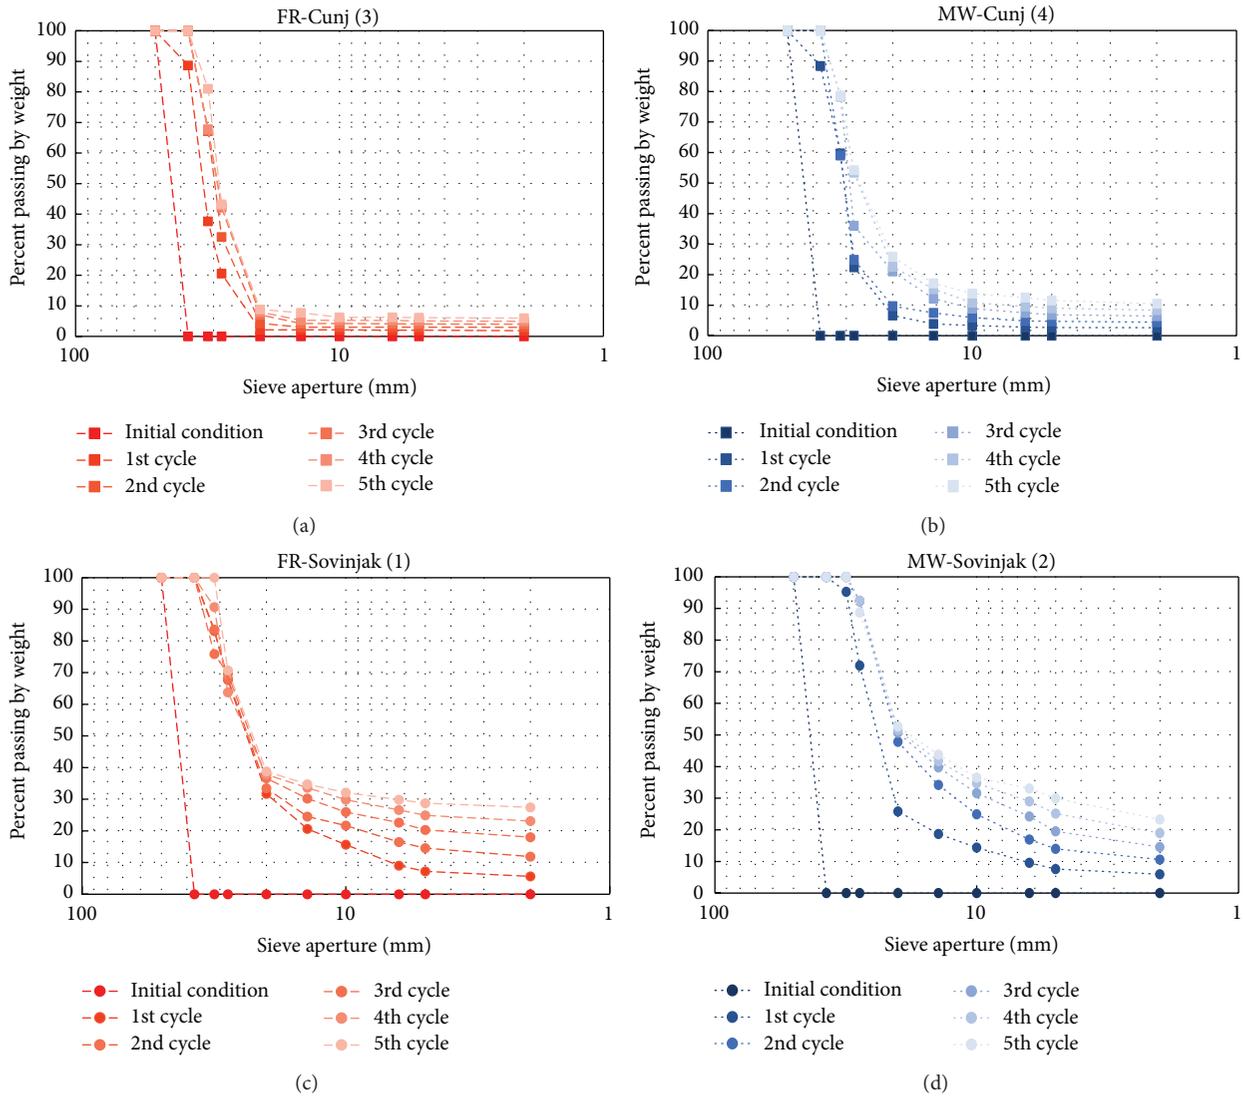
FIGURE 9: Fragment size distribution curves of the passed weight for the siltstone samples of weathering grades (a) I (FR) (3) and (b) III (MW) (4) from a flysch outcrop near Cunj Village and samples of weathering grades (c) I (FR) (1) and (d) III (MW) (2) from a flysch outcrop near Sovinjak Village.

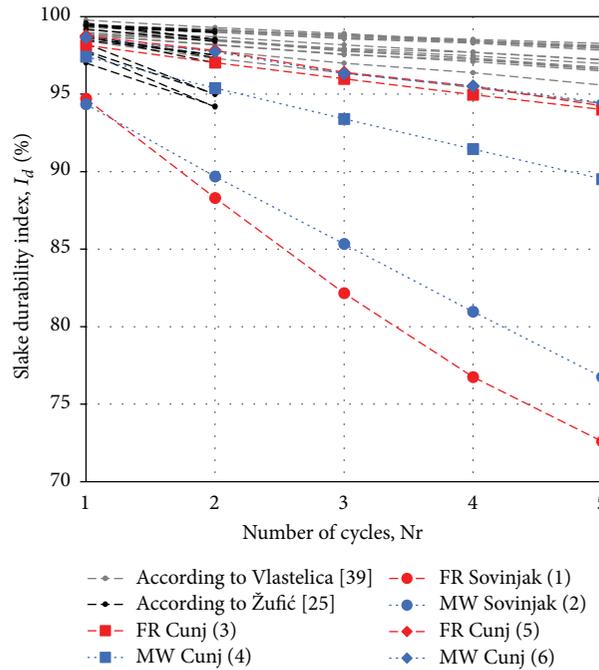
FIGURE 10: Influence of the number of slaking cycles on the slake durability index of the siltstone samples of different weathering grades that were tested in this study and from previous tests of similar samples of fresh siltstone from a flysch rock mass in Istria [25] and marl samples from a flysch rock mass in Dalmatia [39].

Figure 10 shows the number of cycles plotted against the slake durability index. According to the classification of Gamble [8], the samples from the Cunj outcrop can be categorized as highly durable rocks. The I_{d2} values for the siltstone sample of weathering grade I (FR) range from 97.03 to 97.82%, and the I_{d5} values range from 94.01 to 94.24%. The I_{d2} values for the siltstone sample of weathering grade III

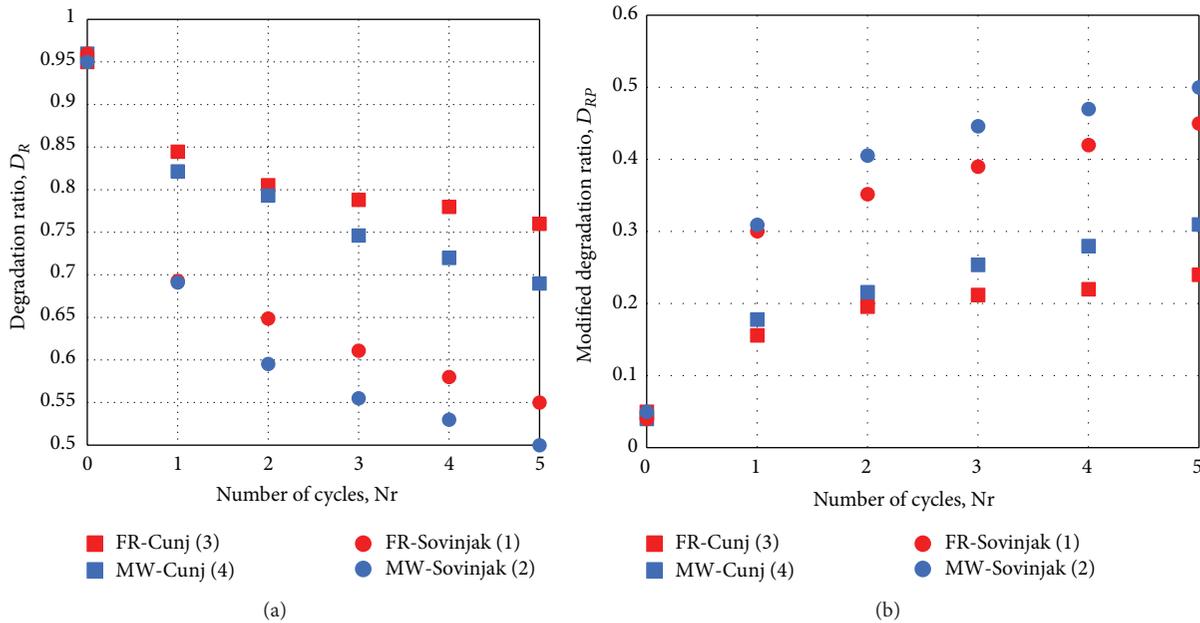
FIGURE 11: (a) Degradation ratio and (b) modified degradation ratio after each slaking cycle for the siltstone samples of weathering grades I (FR) and III (MW) from flysch outcrops near Cunj Village and Sovinjak Village.

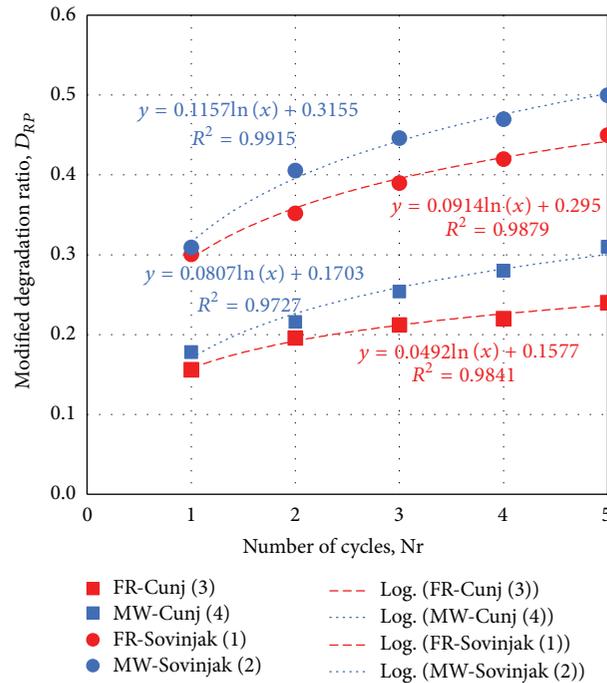
FIGURE 12: Logarithmic curves fitted to the plot of the modified degradation ratio against slake durability test cycles for the siltstone samples of weathering grades I (FR) and III (MW) from the flysch outcrops near Cunj Village and Sovinjak Village.

The change in the calculated D_{RP} values between the slaking cycles is also determined to assess the potential long-term degradation of the investigated samples. A logarithmic curve is fitted to the D_{RP} values of each sample, and high R^2 values are calculated (Figure 12). From this curve, the number of cycles that are required for a sample to reach 50% of the maximum possible degradation ($D_{RP} = 1$), N_{50} , is estimated. The siltstone samples from the Sovinjak outcrop are less durable and more susceptible to degradation than those from the Cunj outcrop, and the N_{50} values differ considerably for the same weathering grade. The N_{50} values for the samples from the Sovinjak outcrop are 9 cycles for the sample of weathering grade I (FR) and 5 cycles for the sample of weathering grade III (MW). The samples from the Cunj outcrop have N_{50} values of 1050 cycles for weathering grade I (FR) and 60 cycles for weathering grade III (MW).
