## Research Article

# Inspection and Numerical Analysis of an Ottoman Railway Bridge in Jordan

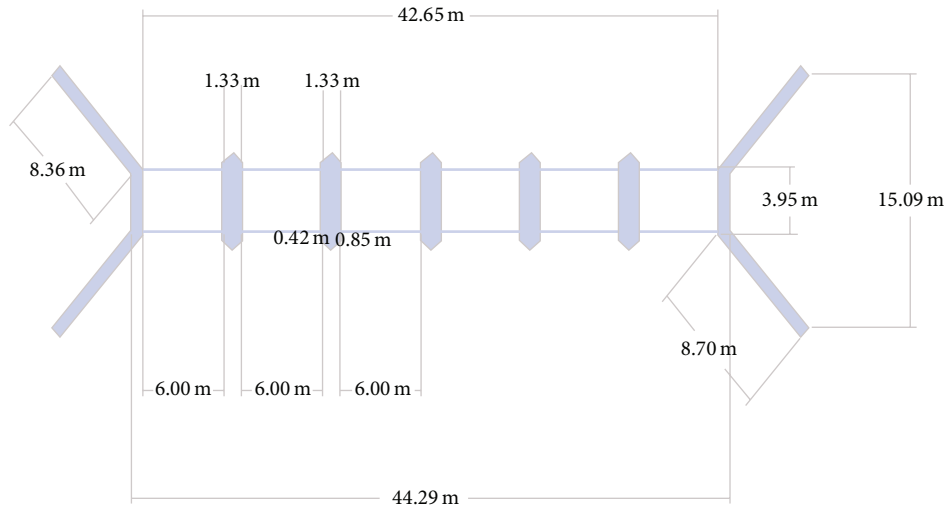
FIGURE 2: Top plan view of the bridge with the dimensions.

The case study bridge is the Marka-Al-Zarqa Railway Ottoman Bridge in the middle of Jordan, which is a multispan arch bridge with backfill as shown in Figure 1. The bridge is supported by six semicircular masonry stone arches equally spanned at 6 m, as shown in Figure 2. The bridge reaches a total length of 44.29 m and has a roadway width of 3.95 m with a parapet on each side. The bridge is supported by five stone piers, two abutments, and four wing walls. The piers on the water upstream side terminate in prominent triangular breakwaters along with the direction of the stream and on the downstream side in polygonal buttresses ending in pyramidal shape as shown in Figure 3. The arch system used in the bridge consists of a keystone of 0.55 m height on the top middle of the arch and a voussoir with 12 stone pieces to the springer on each side of the arch. The rise of the arch is 2.48 m, and the arch continues in barrel vault shape into the other side of the bridge. Ottoman builders built a weep holes above each pier as a drainage system for the rain water which falls on the surface of the bridge deck, which are clear in Figure 3.

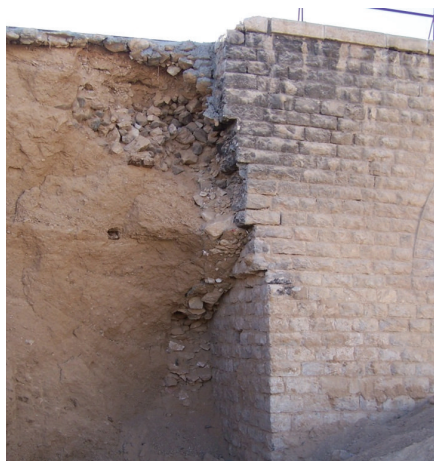
FIGURE 4: Abutment failure that shows the fill materials.

construction. This Ottoman bridge is in very poor structural condition and is facing many structural problems including a failure at one of the bridge abutments, where one can observe easily the bridge fill material (Figure 4). The fill materials of the bridge were consisting of two stone debris types, with some mortar and broken stones in the middle. All fill often

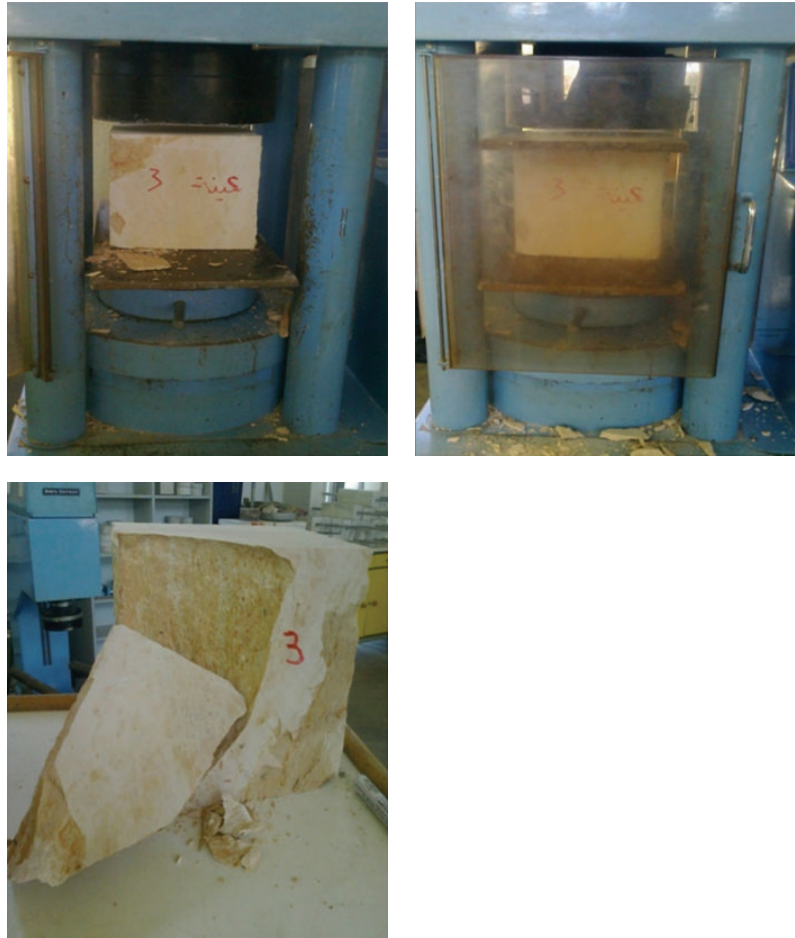
FIGURE 5: Stone sample 3 under compressive strength testing.

Fortunately, the remains of construction stones were found at the site and were taken for experimental testing. Collected samples were of different sizes and shapes. The samples of a stones were first cut in cubes of size  $20\text{ cm} \times 20\text{ cm} \times 20\text{ cm}$ . The sides of the cube were then finely dressed and finished. Three specimens were placed in water for 72 hours prior to the test to reach saturation condition and then tested for uniaxial compression strength in Jordan University of Science and Technology laboratories (typical sample is shown in Figure 5). The results of the three samples are shown in Table 1. Based on test results, the bridge stone compressive strength will be taken as 32 MPa.

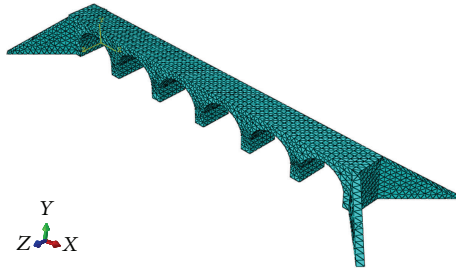
FIGURE 6: The finite element model.

The bridge model was constructed and automatically meshed. The finite element mesh model (Figure 6) had a total number of 28,388 elements and 11,068 nodes. Bridge supports are considered to be fixed at the bottom and at the ends of wing walls.

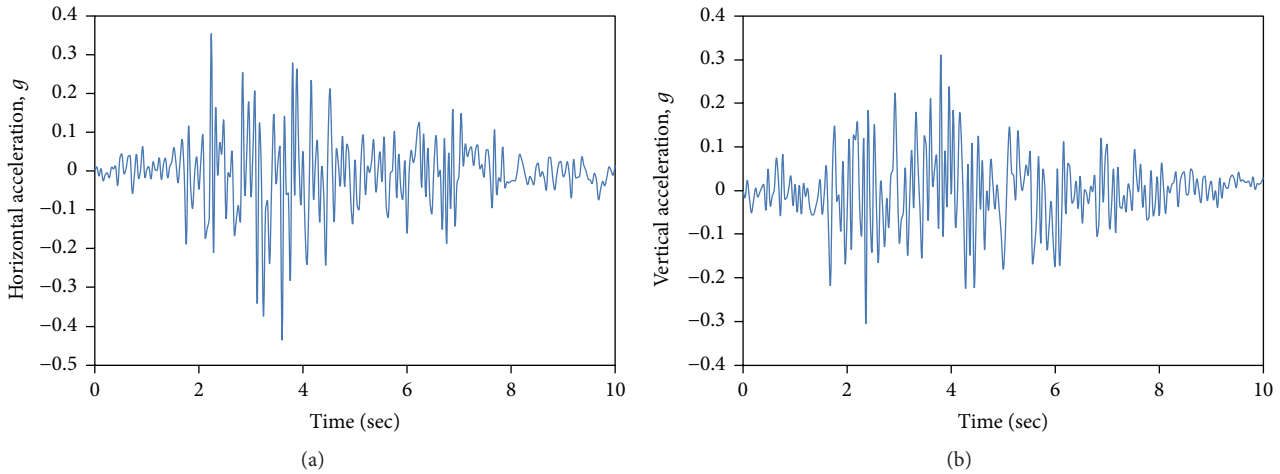
In addition to the static analysis, seismic analysis of the bridge was carried out. Three-directional acceleration record of Koyna earthquake [16, 17] was utilized in time history analysis in order to assess the bridge seismic structural capacity. It is worth pointing out that Koyna earthquake was measured to have about 6.3 degrees magnitude on Richter scale. The strongest documented earthquake in Jordan was 6.3 degrees in magnitude at Al Karāmah, Balqa, Jordan, which is around 100 km from the bridge site. That was 89 years ago, in 1927. However, there is no full record for that earthquake, and the strongest fully recorded earthquake in Jordan is of 5.3 degrees in magnitude at more than 400 km away from the bridge site. Therefore, the authors thought that the well-known Koyna earthquake record can be used in the present study instead for more reliable results. The record of the earthquake is shown in Figure 7.

FIGURE 7: (a) Horizontal and (b) vertical ground acceleration record of Koyna earthquake.

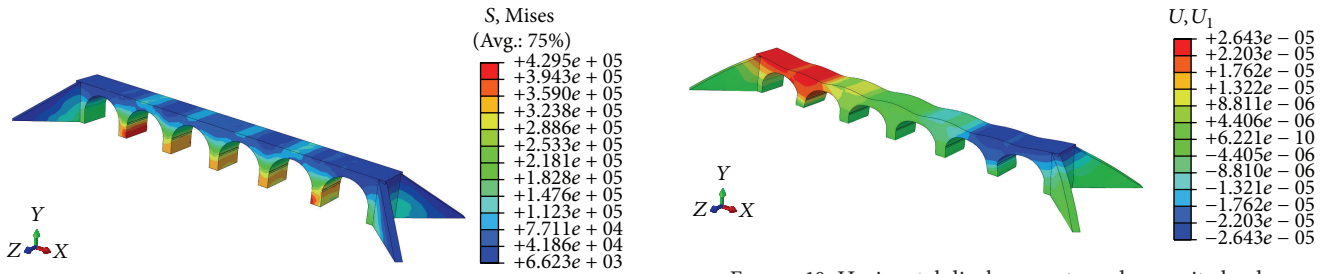
The finite element models have been carried out to determine the locations of the maximum stresses, displacements, and deflections. Figure 8 shows the maximum principal stresses in the bridge under gravity loads (dead and live). It can be seen that the maximum stresses value in the bridge is 0.43 MPa, which is mainly due to compressive stresses at the lower parts of the piers. This value is lower than mortar compressive strength with safety factor about 7.

FIGURE 8: Von-Mises stress in the bridge under gravity loads.

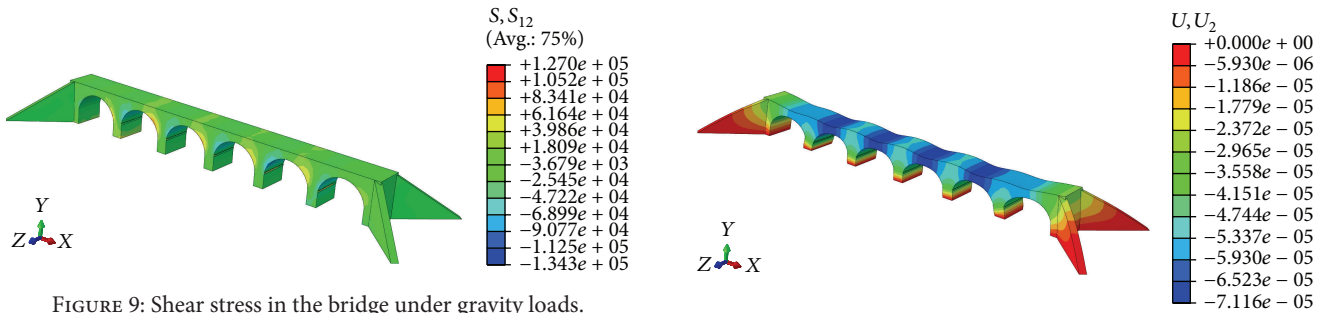
On the other hand, shear stresses results (Figure 9) show that the maximum shear stress under gravity loads is about 0.0448 MPa and it occurs at the mid of the arch vault. Consequently, all of these results are lower than the bridge building materials strength, which indicates the possibility of reusing the bridge under the current vehicles loads used by Jordanian Hejaz railway network.

FIGURE 9: Shear stress in the bridge under gravity loads.

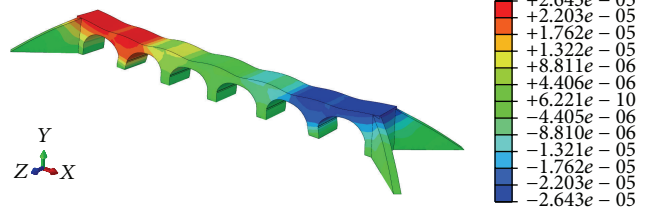
According to the finite element analysis, the maximum horizontal displacements are shown in Figure 10 to happen at the two ends of the bridge, where the gravity loads try to bend the abutments. The maximum recorded value was approximately 0.02 mm, which is negligible compared to bridge dimensions. On the other hand, vertical deflection (Figure 11) was recorded to reach about 0.07 mm, which is still small compared to bridge dimensions. This maximum value occurs at the midspans of the arches.

FIGURE 10: Horizontal displacements under gravity loads.

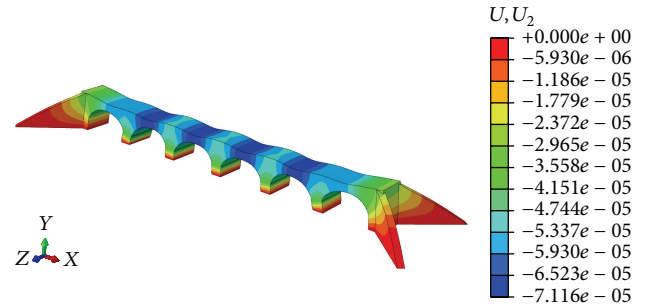
FIGURE 11: Vertical deflection in the bridge due to gravity loads.

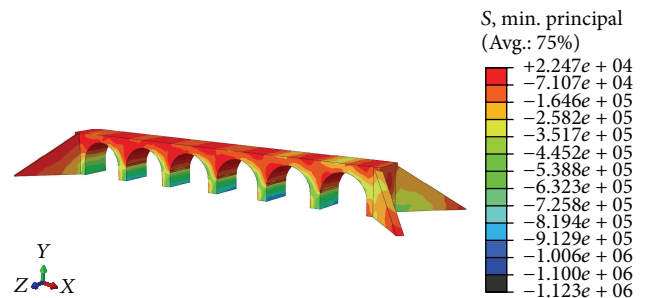
Figures 12 and 13 show minimum principal stresses (tensile stresses) in the bridge due to Koyna earthquake record in  $X$ - $Y$  and  $Y$ - $Z$  directions, respectively. The seismic analysis results have reported that the maximum stresses were with  $Y$ - $Z$  direction (which is the weak direction of the bridge), where the stresses reached about 1.7 MPa. Even in the longitudinal direction of the bridge, the stress reached about 1.1 MPa, which exceeds the tensile strength of the mortar. This could easily lead to serious damage to the bridge mortar and hence to the bridge structural integrity. These stresses happen at the bottom of the piers (at the supports), which indicates that the base shear that initiates from the earthquake is the major factor in these stresses. Slippage may occur between bridge stones due to these stresses which could lead to total collapse of the bridge. This will require different kind of analysis, that is, contact analysis, which is beyond the scope of this paper.

FIGURE 12: Minimum principal stress in the bridge due to earthquake load in X-Y direction.

A case study of an Ottoman bridge was analyzed using a finite element method, including static and dynamic earthquake forces, in order to investigate the behavior of the bridge structure. The static and seismic analyses show that the structural configuration of the bridge is adequate to withstand vertical gravity loads but might suffer damages under strong dynamic earthquake loading. The results showed that the maximum values of stresses and displacements are at the midspan of the main arches under gravity loads. Consequently, these locations should be taken care of in the future strengthening studies. On the other hand, the bottom parts of the piers should be strengthened to resist earthquake loadings. Finite

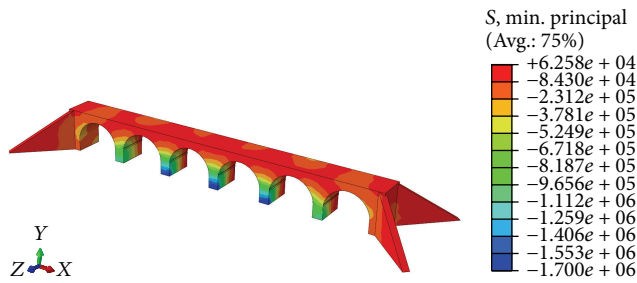
FIGURE 13: Minimum principal stress in the bridge due to earthquake load in Y-Z direction.
