Structural Safety Assessment of Existing Multiarch Tunnel: A Case Study

As a multiarch tunnel, Shitigou tunnel, with a total length of $2 \times 320 = 640$ m, was opened in 2002. The mileage of tunnel is K239 + 895–K240 + 215, and the distance between the two tunnels is 10.75 m. The rock mass grade of Shitigou tunnel is IV and many ponds which are higher than the design elevation of pavement locate near the tunnel axis. The groundwater is mainly of bedrock fissure water, which is hosted in silty mudstone and shaly sand. The source for water supply mainly consists of meteoric water and surface water. After several years of operation, through preliminary examination, many defects especially liner void, liner crack, and water leakage have been found in the Shitigou tunnel, where the soil stability is poor and the geological condition is complex. Accordingly, the systematic structural health assessment for the tunnel should be performed, and corresponding treatment measures need to be taken.

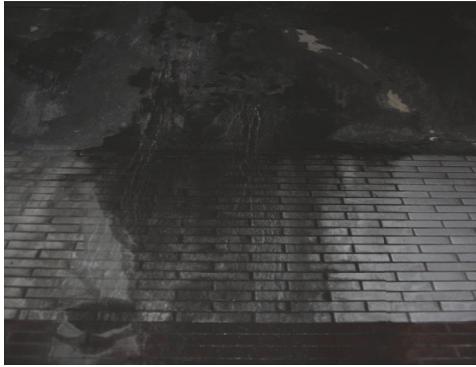
(2) *Assessment Results Analysis.* According to the inspection results, it could be seen that serious water leakage was encountered on the side wall, middle wall, and vault of the right tunnel, especially on site 42 m away from the tunnel entrance. Accordingly, it can be determined that the criteria grade of tunnel seepage for the right tunnel is 1A; that is, the large water seepage that appeared near liner cracks may affect the traffic safety in the near future, for which the corresponding measures shall be taken. Meanwhile, for the left tunnel, the serious water leakage was also encountered on the side wall, middle wall, and vault. Specifically, the drip and leakage with large area were found on the middle wall 55 m–59 m away from the tunnel entrance, as well as on the middle wall 40 m away from the tunnel entrance, as shown in Figure 5. Also, the vault 28 m away from the tunnel entrance had a water dripping area (Figure 6). Accordingly, the criteria grade of tunnel seepage for the left tunnel is 1A.

FIGURE 5: Leakage on middle wall of left tunnel.

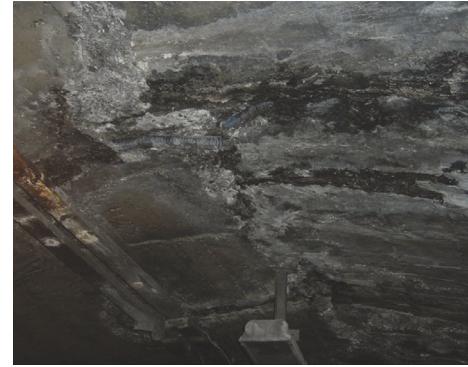
FIGURE 6: Leakage on vault of left tunnel.
