# Mechanical and Parametric Analysis of Cracks in Polypropylene Fiber Concrete U-Shaped Girder

The U-shaped girder is a type of open thin-walled structure, which is used in urban rail transit engineering. Although it employs polypropylene fiber concrete to avoid cracks, the girder is still easier to crack than other traditional structures owing to its special open thin-walled cross section. In this study, a cracking accident of a U-shaped girder, which happened during the prestressed steel tensioning, was studied by field investigation and mechanical analysis through the finite element (FE) method. An outline of the cracks was presented. The nonlinear material properties of the polypropylene fiber concrete and steel were discussed and used in the finite element model. The effects of the main design parameters, such as the flange slab thickness, anchorage position, and prestressed steel layout, were evaluated based on the results of the FE analysis. The results indicate that the extremely low rigidity of the web and oversize of the web longitudinal prestressed steels are the main reasons for the cracks. The risk of cracks can be reduced by increasing the thickness of the flange sla

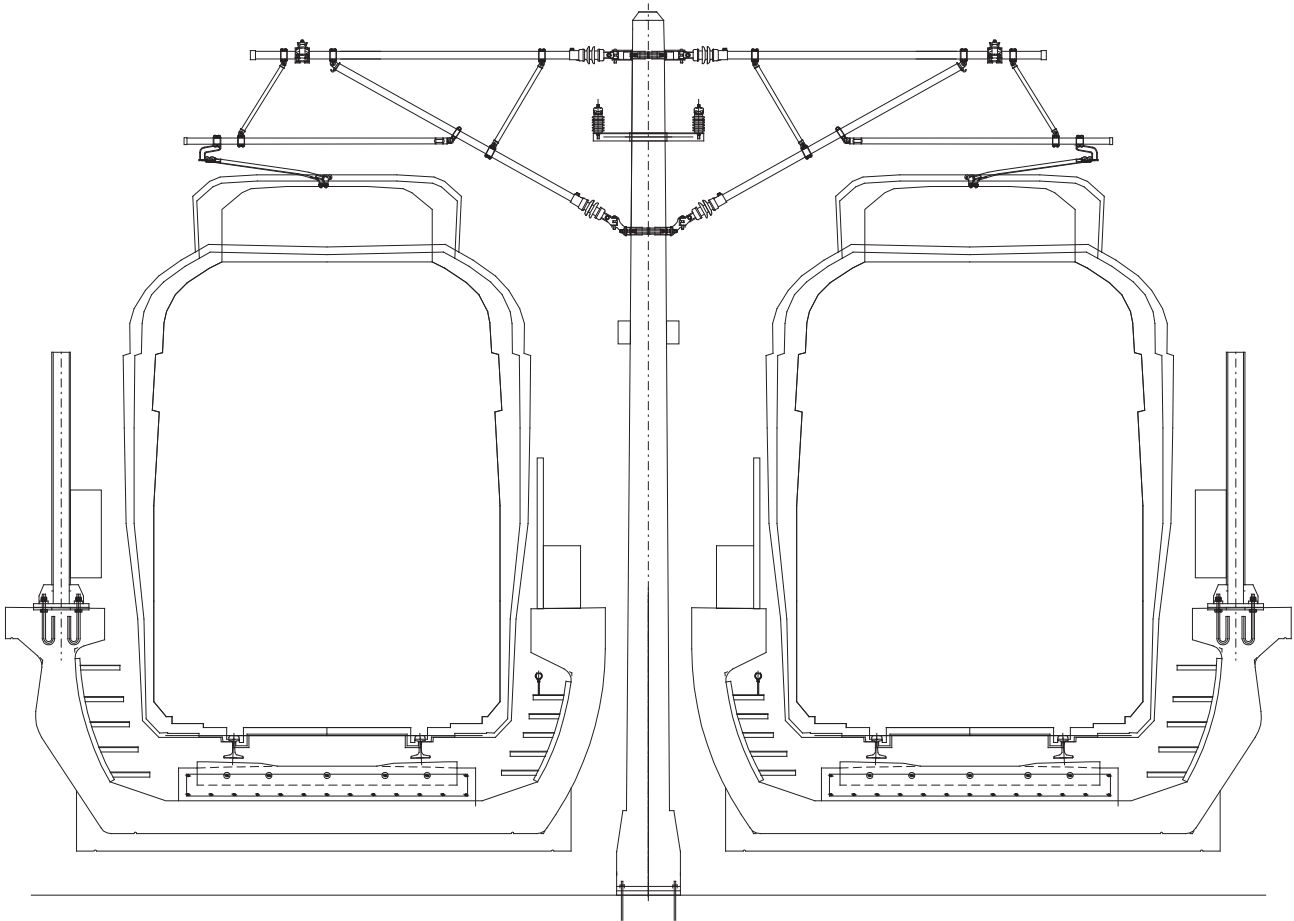
FIGURE 1: Structure diagram of U-shaped girder for urban rail transit.

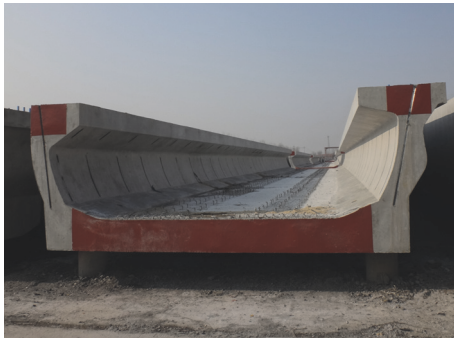
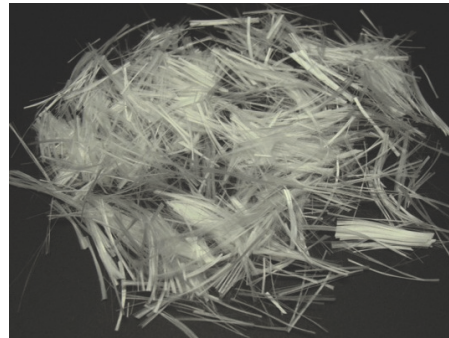
(a) U-shaped girder

(b) Polypropylene fiber

FIGURE 2: Photographs of U-shaped girder and polypropylene fiber.

run more safely [1]. In addition, the U-shaped girder uses prestressed steel and polypropylene fiber (Figure 2(b)), which can obviously increase its load bearing capacity and crack resistance [2]. Furthermore, precast construction is applied for U-shaped girder construction to achieve construction safety, shorten the construction time, and reduce costs. Most importantly, the U-shaped girder is lighter and more artistic than other types of traditional bridge girders.

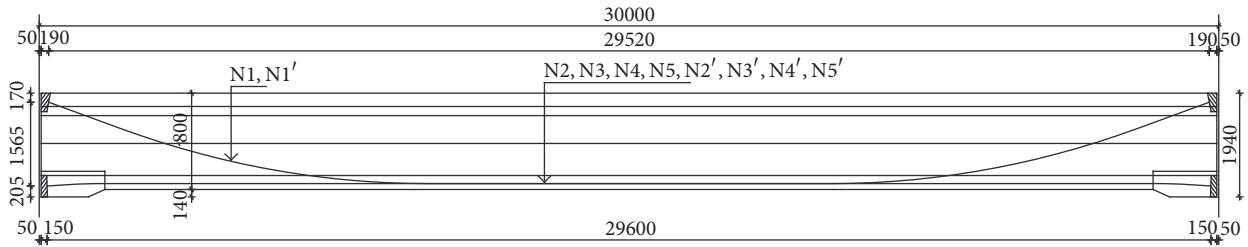
FIGURE 3: Elevation drawing and layout of the longitudinal prestressed steels in U-shaped girder (unit: mm).

**2.1. Girder.** The U-shaped girder on which the cracks were found is a prestressed simply supported concrete structure used in a rail transit project of China, with a span length of 30 m, as shown in Figure 3. In the mid-span of the girder, the height is 1.8 m, the top width is 5.32 m, the bottom width is 3.98 m, and the thickness of the web and bottom slabs is 0.26 m, as shown in Figure 4(a). Polypropylene fiber concrete with a 0.9 kg/m<sup>3</sup> fiber dosage and C55 standard strength grade steel are used in the girder. Longitudinal prestressed steels, which are designed combining longitudinal and vertical bending as required, are set up in the girders. The longitudinal prestressed steels use 270 grade steel strands with a standard strength of  $R_y^b = 1860$  MPa and control tension stress  $\sigma_k = 0.75R_y^b = 1395$  MPa. As shown in Figure 4(b), the longitudinal prestressed steels N1 and N1' are located in the web, the longitudinal prestressed steels N2 to N5 and N2' to N5' are located in the bottom slab, and all the prestressed steels are stressed and anchored at the end of the girder, after the girder is cast. The design parameters of prestressed steels are listed in Table 1. The girders are constructed offsite. They are then trucked or barged to the bridge site and lifted into place with a bridge erecting machine span-by-span.

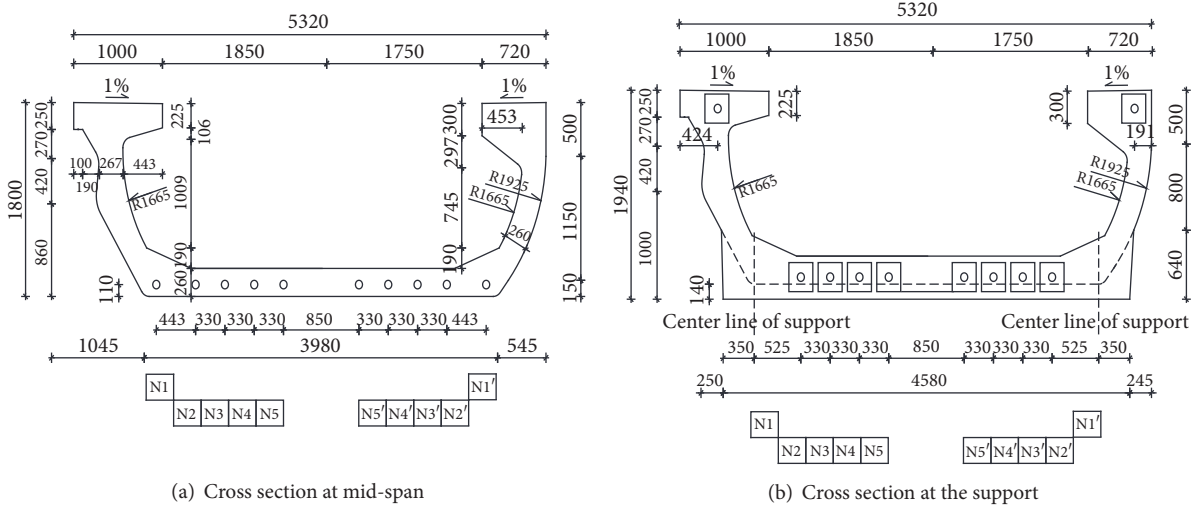
FIGURE 4: Cross section of U-shaped girder (unit: mm).

The U-shaped girder has an open thin-walled structural form to minimize self-weight, and the thickness of the web and bottom slabs is just 0.26 m. Simultaneously, the prestressed steels are designed in the webs and bottom slab to bear the bending moment and shear force, as shown in Figure 4. The biggest problem is that the U-shaped girder is too thin for the prestressing force. The structural dimension and prestressed steel design parameters have a considerable influence on the cause of cracks at the urban rail transit U-shaped girder during its construction phases. Thus, the effects of design parameters such as the flange slab thickness (Parameter 1), anchorage position of the prestressed steels (Parameter 2), and prestressed steel layout (Parameter 3) were investigated using FE analysis for controlling cracks.

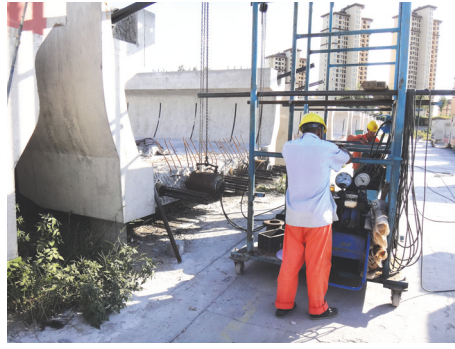
FIGURE 7: Posttensioning construction of U-shaped girder.

**3.1. Construction Sequence and Method.** As shown in Figure 7, the prestressed steels of the U-shaped girder were symmetrically tensioned by a hydraulic jack. Figure 8 depicts the position of the anchorages and the prestressing sequence for posttensioning. The tension procedure for the U-shaped girder was as follows. (1) When the concrete reached 80% of its standard strength, the prestressed steels N1 and N1' were symmetrically tensioned to 600 MPa, and after that the prestressed steels from N5 and N5' to N2 and N2' were symmetrically tensioned to 700 MPa for lifting the girder. (2) When the concrete reached 80% of its standard strength, the prestressed steels N1 and N1' were symmetrically tensioned to 1246.2 MPa, and after that the prestressed steels, from N5 and N5' to N2 and N2', were symmetrically tensioned to 1339.2 MPa for reaching the final design requirements. Thus, as it can be seen, whether by initial or final tensioning, the prestressing sequence contains five steps, that is, ① → ② → ③ → ④ → ⑤.

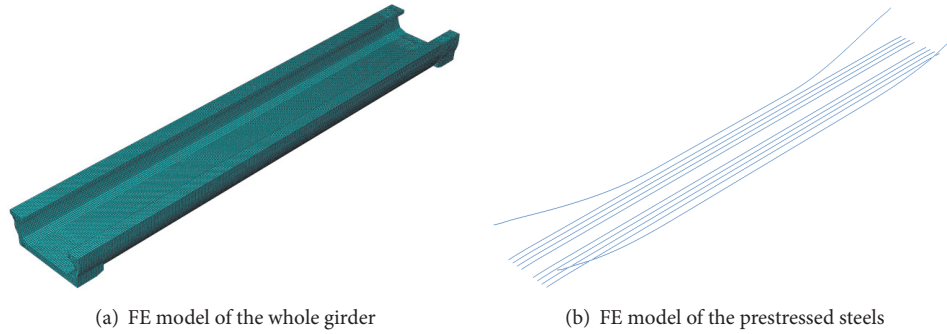
**3.2.1. Introduction to FE Model.** The commercial structural finite element analysis program ABAQUS was used to estimate the risk of cracking in detail. As shown in Figure 9, in the nonlinear FE model, C3D8R elements are used for the polypropylene fiber concrete, and T3D2 elements are used

for all the steels. The U-shaped girder is supported on the tensioning bed, and hinge joint conditions are assumed. In the FE model, the structural design dimension parameters are considered according to the original design, and the construction sequence is also simulated.

FIGURE 9: Finite element model for the U-shaped girder.

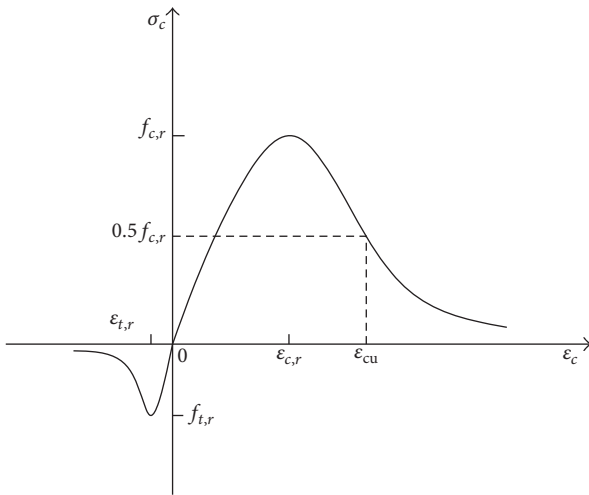
Based on this research achievement [18], the relationship between the polypropylene fiber concrete stress  $\sigma_c$  and strain  $\varepsilon_c$  is presented in Figure 10, where (1) is the relationship under uniaxial compression and (2) is the relationship under uniaxial tension.  $E_c$  is Young's modulus of polypropylene fiber concrete,  $d_c$  and  $d_t$  are the damage evolution parameters under uniaxial compression and tension, which can be calculated using the formulas from the code for design of concrete structures [20] and measured values of polypropylene fiber concrete experiments [18].

FIGURE 10: Stress-strain relationship of polypropylene fiber concrete.

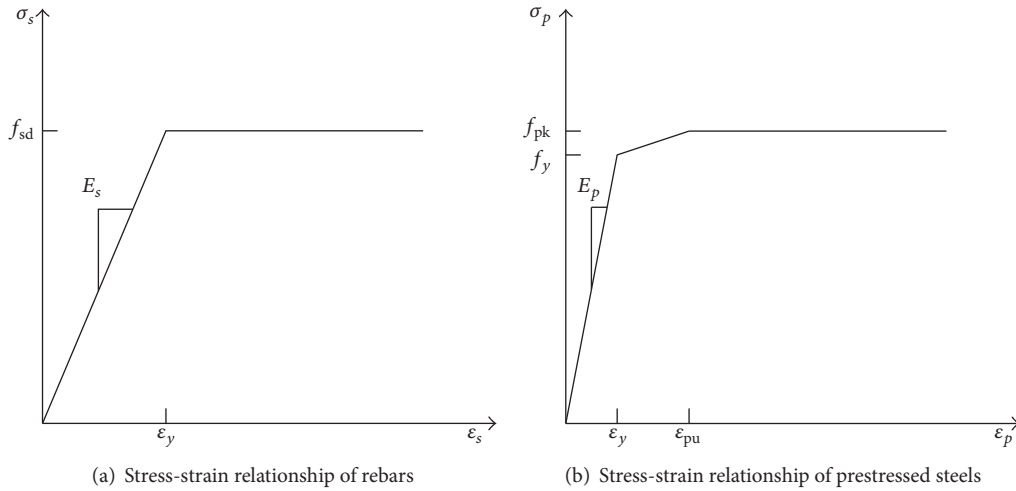
As shown in Figure 11(a), the ideal elastic–plastic model is used for the relationship between stress and strain of rebars [3], where  $f_{sd}$  is the yield strength of rebars,  $\epsilon_y$  is the corresponding strain, and  $E_s$  is Young's modulus of rebars which is  $2.0 \times 10^5$  MPa. As shown in Figure 11(b), a bilinear hardening plasticity relationship is used for the relationship between stress and strain of prestressed steel [3], where  $f_{pk}$  is the limit strength 1860 MPa,  $\epsilon_{pu}$  is the corresponding strain taken as 0.02;  $f_y$  is yield strength,  $f_y = 0.92 \times f_{pk} = 1711.2$  MPa,  $\epsilon_y$  is the corresponding strain, and  $E_p$  is Young's modulus of prestressed steel which is  $1.95 \times 10^5$  MPa. Poisson's ratio of rebars and prestressed steels is 0.3

FIGURE 11: Stress-strain relationship of steels.

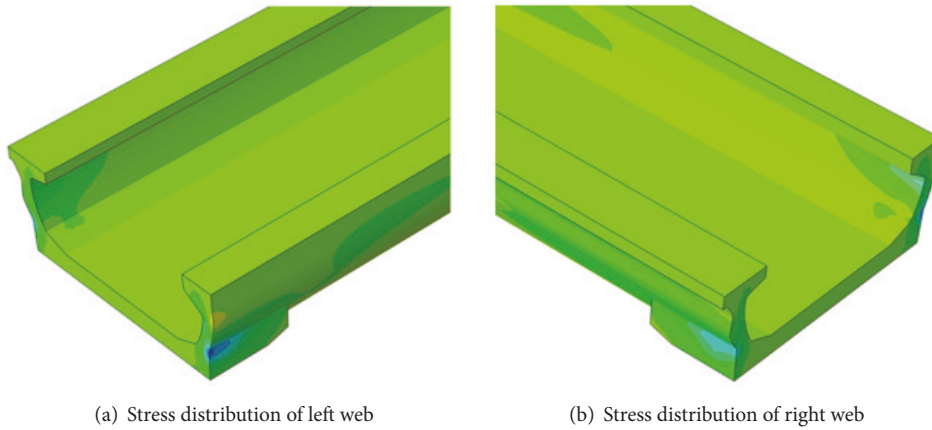
The vertical stress contours in both web sides before and after tensioning of the prestressed steels are obtained from the FE analysis. As shown in Figure 12, before the prestressed steels are tensioned, the maximum vertical tensile stress is just 1.1 MPa in the left web (Figure 12(a)) and 1.2 MPa in the right web (Figure 12(b)). The comparisons show that, after tensioning, the maximum vertical tensile stress is 3.5 MPa in the left web (Figure 13(a)) and 3.6 MPa in the right web (Figure 13(b)), which occurs inside the webs, near the regions

FIGURE 12: Stress contours at the end of U-shaped girder before tensioning with original design.

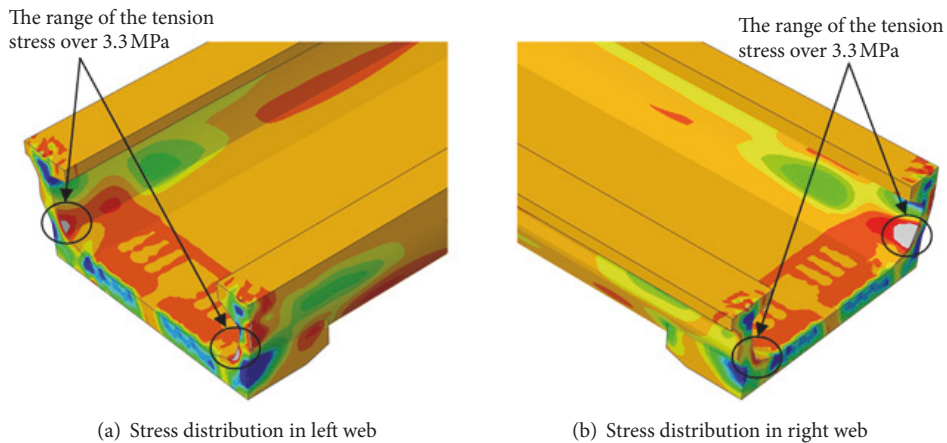
at both ends of the U-shaped girder. The stress exceeds the characteristic value of prismatic tensile strength of concrete  $f_{ct} = 3.3$  MPa [21], which will cause cracks at the end of the webs.

FIGURE 13: Stress contours at the end of U-shaped girder after tensioning, with original design.

**4.2. Anchorage Position (Parameter 2).** From the analysis results of Figure 13, the cracks were near the inboard of the webs. Therefore, the prestressed steels anchorage positions at the webs were changed to discuss the effects on the

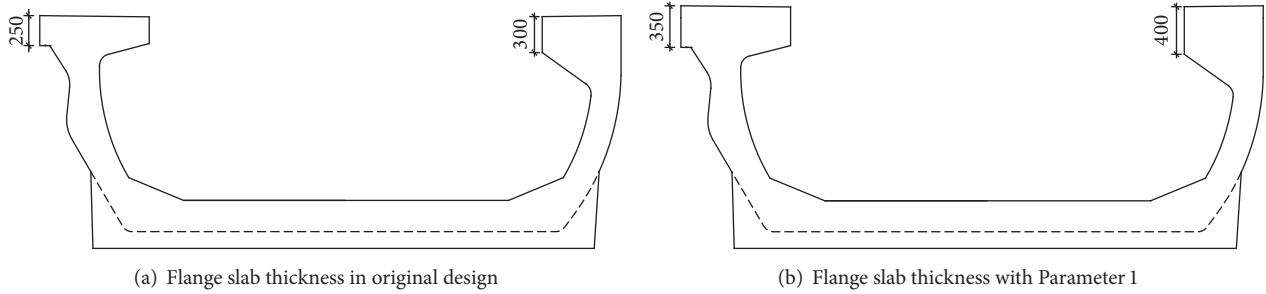
**4.1. Flange Slab Thickness (Parameter 1).** To increase the entire longitudinal rigidity, in this analysis, the thickness of the flange slab was increased by 10 cm. As shown in Figure 14, the thickness of the left flange slab was increased from 25 cm to 35 cm, while the thickness of the right flange slab was increased from 25 cm to 35 cm. Figure 15 showed the stress variation at both webs after tensioning with respect to Parameter 1. It was found that the maximum vertical tensile stress was 2.5 MPa, approximately decreased by 70% of that in the original design. The analysis above verified that increasing the thickness of the web slabs was an effective method to control web slab cracks. However, increasing the thickness of the flange slab also increased the self-weight load, which accounted for a significant proportion of the design load and reduced the carrying capacity of the U-shaped girder.

FIGURE 14: Thickness of flange slab comparison (unit: mm).

FIGURE 15: Stress contours at the end of U-shaped girder after tensioning with Parameter 1.

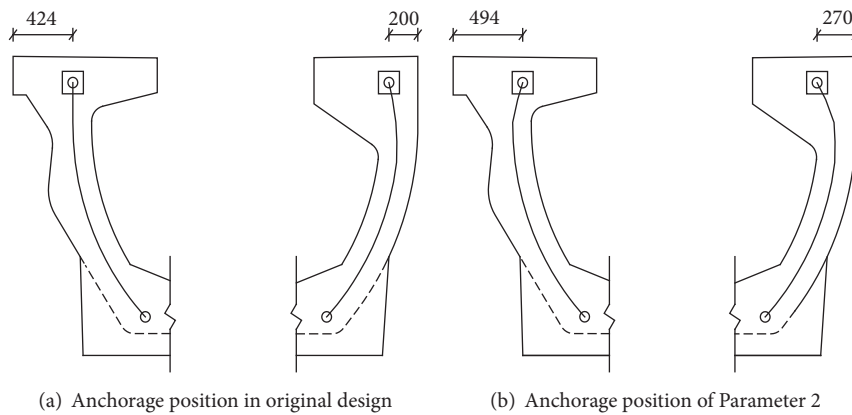
structure. In this analysis, the anchorage positions at the webs were horizontally moved 10 cm to the inboard, as shown in Figure 16. From the results shown in Figure 17, the maximum vertical tensile stress of the webs decreased from 3.6 MPa to 3.1 MPa compared to the original design. While the effects were less obvious than Parameter 1, the change in

anchorage positions did not increase the self-weight of the U-shaped girder. Therefore, it was still an effective technique for controlling cracks.

FIGURE 16: Anchorage position of web prestressed steel comparison (unit: mm).

FIGURE 17: Stress contours at the end of U-shaped girder after tensioning with Parameter 2.
