# Mining-Induced Damage Characteristics of Floors during Fully Mechanized Caving Mining: A Case Study

To study the mining-induced damage characteristics of floors during fully mechanized mining, in situ measurements were performed using the hollow inclusion strain sensors in the No. 100502 (80 m, 180 m) mining face of the Yitang Coal Mine in the Huoxi coal field in the Shanxi Province of China. The in situ measurement results show that the failure depths of the floor rocks in the 100502 (80 m) and 100502 (180 m) mining faces were 12.50~14.65 m and 17.50~19.20 m, respectively. The longer the mining face was, the greater the failure depth and the more severe the deformation and damage of the floor rocks were. The failures of the damaged floor rocks can be divided into two types: pull-pressure strain mutations and abnormal mutations. With the advancement of the mining face, the strain increments of floor rocks at different buried depths showed obvious advanced and lagged responses. Specifically, the advanced response distance decreased with a negative exponential trend, while the lagged response distance generally first increased and then decreased as the depth increased. The results

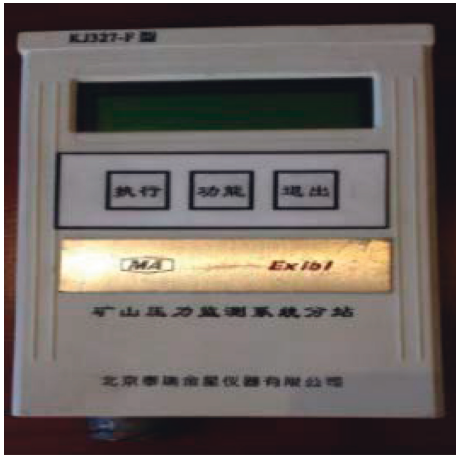
FIGURE 4: KJ 327-F portable digital static-resistance strain indicator.

*2.4. Field Measurement Equipment.* KX-2000 hollow inclusion strain sensors (Figure 3) and KJ 327-F portable digital static-resistance strain indicators (Figure 4) were used in this study for the field measurement. As shown in Figure 3(b), the strain sensor probe consists of 12 resistance strain channels. These strain channels are embedded in an epoxy resin; four strain channels are arranged at intervals of 45° and form a rectangular resistance array, and three sets of resistance strain arrays are attached to the surface of the hollow inclusion at intervals of 120°. The hollow inclusion sensors can measure strains in the range  $\pm 20000 \mu\epsilon$  with a precision of  $\pm 0.1\%$ . Meanwhile, adequate compensation is made to avoid the effect of temperature on the measured strains.

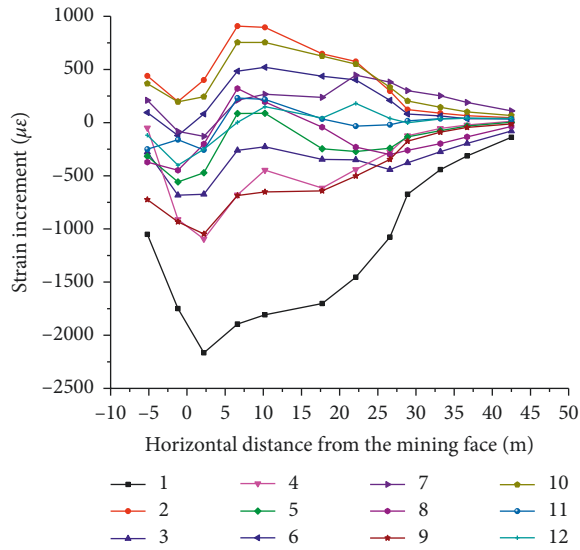
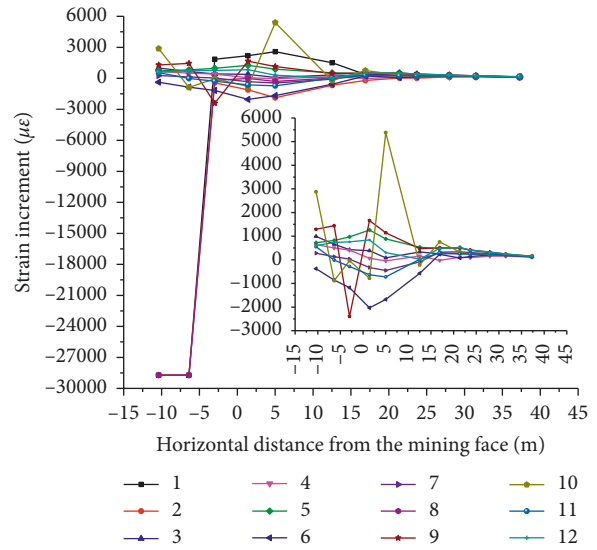
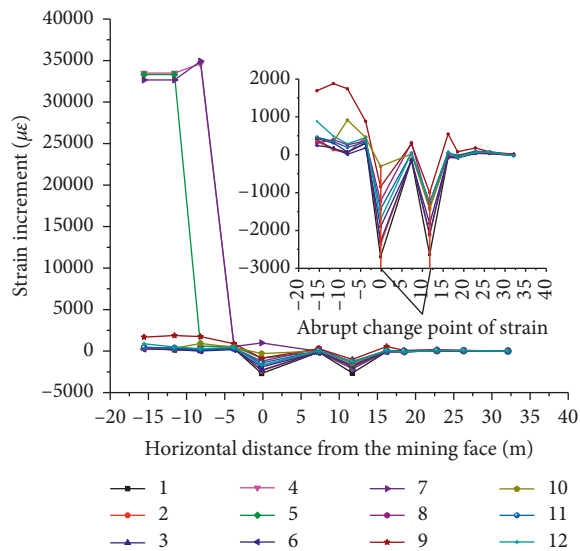
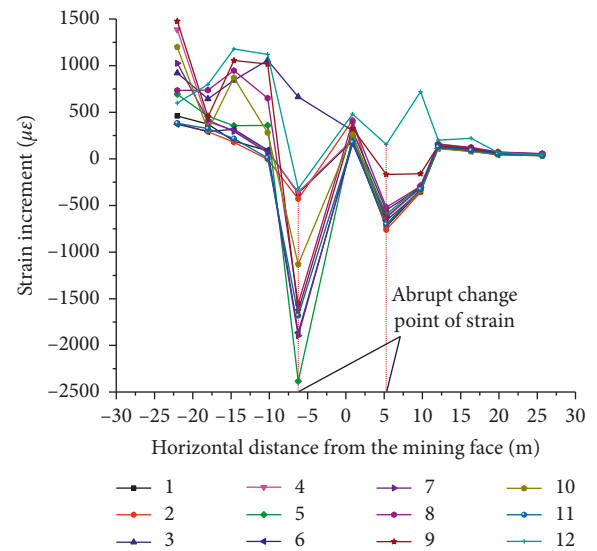
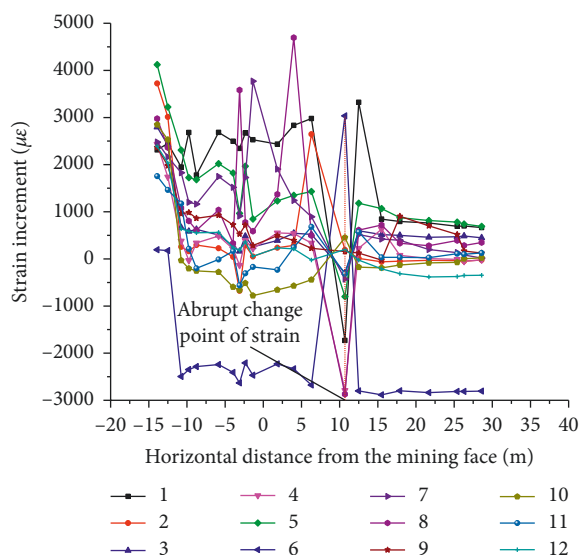
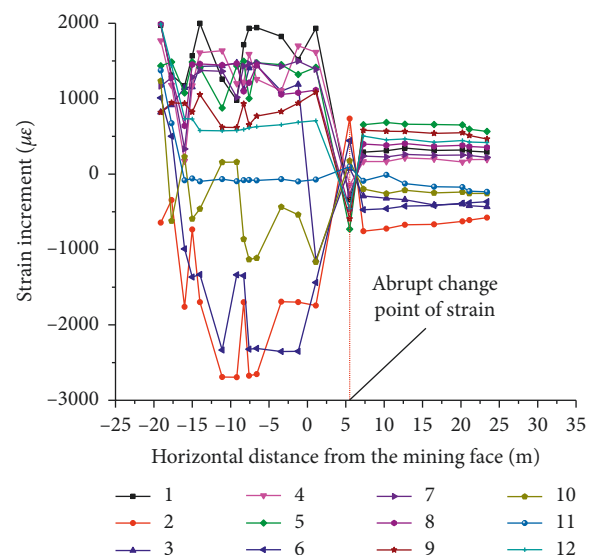
FIGURE 5: Strain increment curves of each sensor in boreholes I and II in the 100502 (80 m) mining face. (a) Sensor #1. (b) Sensor #2. (c) Sensor #3. (d) Sensor #4. (e) Sensor #5. (f) Sensor #6. (g) Sensor #7. (h) Sensor #7 after abnormal data are removed. (i) Sensor #8. (j) Sensor #9.

The strain increment is defined as the difference between the real-time strain and the initial strain of each sensor probe, and the evolution of the strain increment is used to characterize the stress and deformation of the coal seam floor rocks before and after mining. Figures 5 and 6 show the evolutions of the strain increments of the seventeen sensor probes in the four holes in the 100502 (80 m) and 100501 (180 m) faces during the mining process. The abscissa is the horizontal distance from the mining face to the monitoring sensor probe; a positive value indicates that the mining face has not yet passed the monitoring sensor probe, while a negative value means that the mining face has passed the monitoring sensor probe, and the zero point is the position of the sensor probe. The ordinate is the strain increment, and a positive value means that the sensor probe is in a tensile state, while a negative value means that the sensor probe is in a compressive state.

Figures 5 and 6 show that the strain increment of each probe sensor (#1~17) is almost unchanged in the initial stage after mining begins, and fluctuates gradually due to the mining pressure as the mining face advances towards the sensor probe. For example, when the mining face is horizontally 42.5~36.7 m away from sensor probe #1, the strain increment remains generally unchanged, as shown in

Figure 5(a). This consistency occurs because the monitoring sensor probe is far away from the mining face, and such distances exceed the influence range of the advanced support pressure. With the continuous advancement of the mining face, the monitoring sensor probe is affected by the advanced support pressure, and the strain increment changes gradually when the mining face is horizontally 36.7~28.9 m away from the sensor probe. In the subsequent monitoring process, the coal seam floor rocks fracture due to the mining pressure and advanced support pressure, and the corresponding strain increment shows violent fluctuations.

As shown in Figures 5 and 6, the strain increment curves of several sensor probes changed coordinately as the mining face advanced, for example, all the strain increment curves of sensor probes #4, 7, 8, 9, 17, 13, and 14 showed coordinated changes throughout the entire monitoring time. Although there were some sudden strain changes at certain positions, the strain increment curves gradually recovered in subsequent monitoring, which suggests that the rocks in these locations were elastically deformed, and no plastic damage was caused. In contrast, the strain increment curves of the other sensor probes abruptly changed at certain locations in the measurement process without subsequent recovery, which indicates that the coal seam floor rocks at these locations were destroyed. The strain increment curves with abrupt changes could be divided into two types: tensile-compressive strain mutations and abnormal mutations.

where the mining face was horizontally 28.9 m, 12.5 m, 5.5 m, 5.07 m, -3.43 m, 14.72 m, and 11.39 m away from the above buried sensor probes, respectively, the strain increment curves showed sudden changes, which suggests that the surrounding rocks around these buried sensor probes had been damaged. In addition, the strain increments generally converted from compressive strain to tensile strain, and mutations resulted at these locations. That may be attributed to the plastic destruction of the surrounding rocks and sudden stress released at these locations. Taking probes #5 and 6 as examples, when the floor rocks were not damaged, their strain increments ranged from  $+1000 \sim -1000 \mu\epsilon$ , and the rocks at the buried locations were elastically deformed. When the sensor probes were affected by the advanced abutment pressure from mining actions, the floor rocks were gradually damaged, and the strain increments fluctuated violently, ranging from

$+5000 \sim -3000 \mu\epsilon$  and  $+2000 \sim -3000 \mu\epsilon$ , respectively. There were obvious tensile-compressive strain mutations in the strain increment curves at positions where the mining face was horizontally 10.7 m and 5.5 m away from the sensor probes, respectively. In addition, the later monitoring data show that there was no recovery in the strain increment curves, and the subsequent monitoring data of each channel was highly discrete. Therefore, the floor rocks at the buried locations of the two sensor probes had undergone plastic destruction.

reinstate immediately but began to reinstate gradually after the mining face was a few meters past the monitoring holes, showing lagged response properties. For example, the strain increment curves of probe #4 in Figure 5(d) show obvious advanced strain responses before the mining face reached the buried locations of the sensor probe. The strain increments increased slowly when the mining face was horizontally 12.06 m away from the sensor probe, and the strain increments dropped sharply when the mining face was horizontally 5.28 m away from the sensor probe; the strain increments generally exhibited advanced response characteristics. In addition, when the mining face passed over the sensor probe, the strain increments did not recover immediately but reinstated to initial strains after the mining face had horizontally passed the sensor probe by 18.02 m; thus, lagged response characteristics were presented. The advanced response distances and lagged response distances of the strain increment of each probe were counted and shown in Figures 7 and 8.

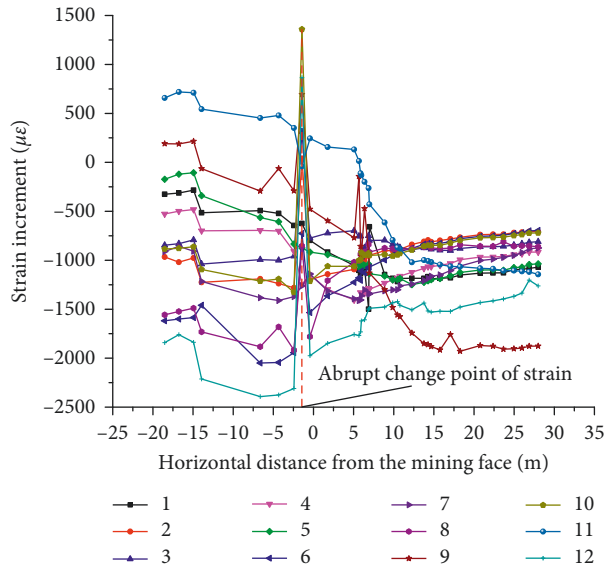
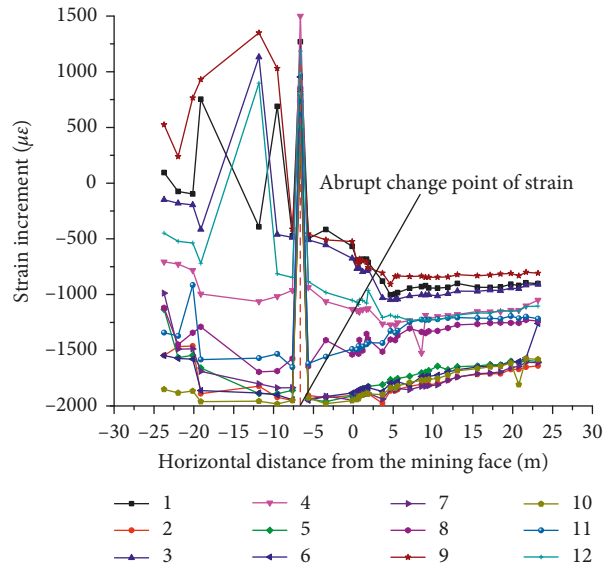
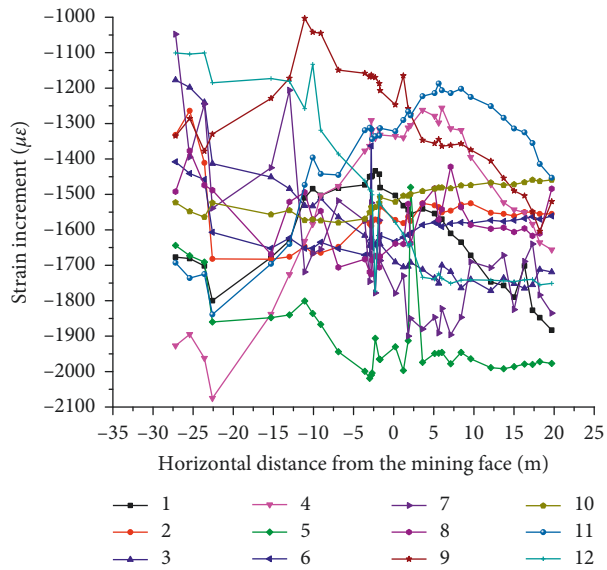
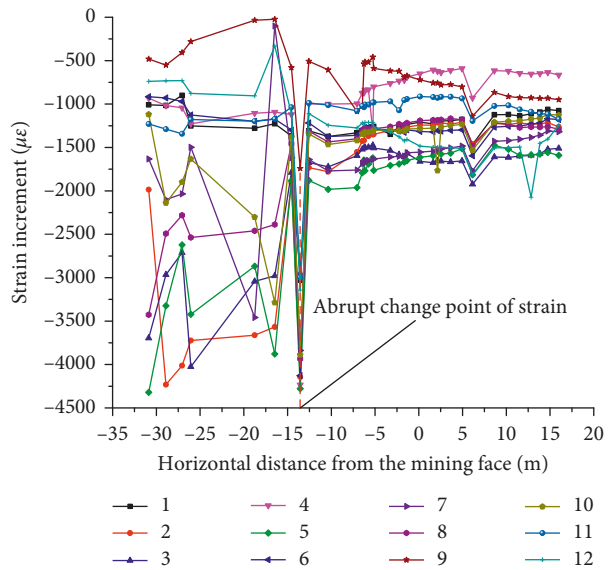
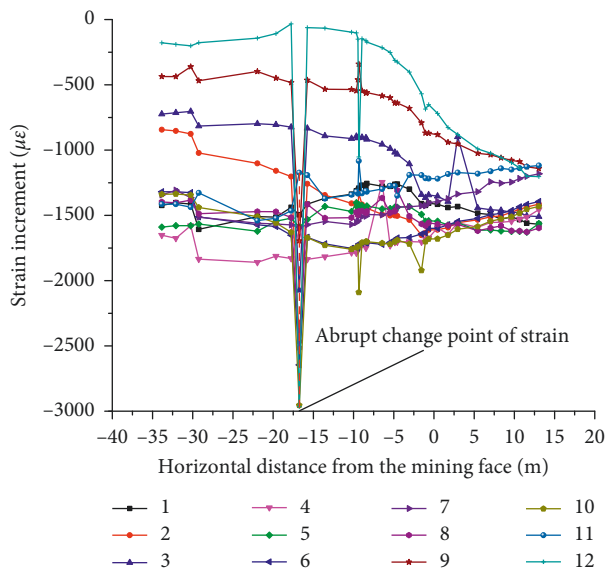
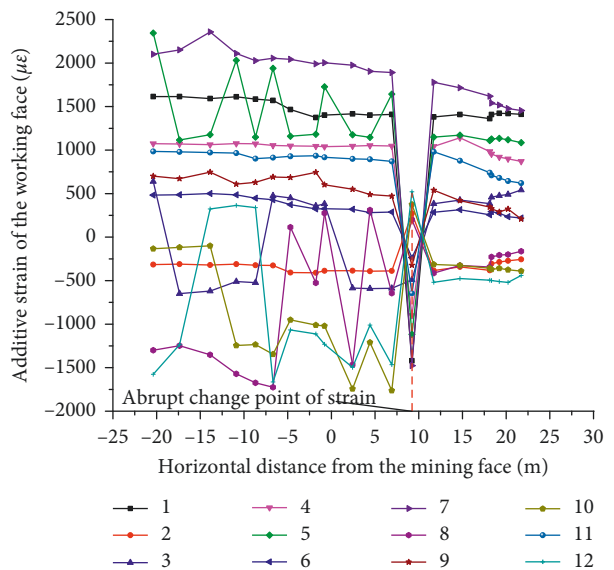
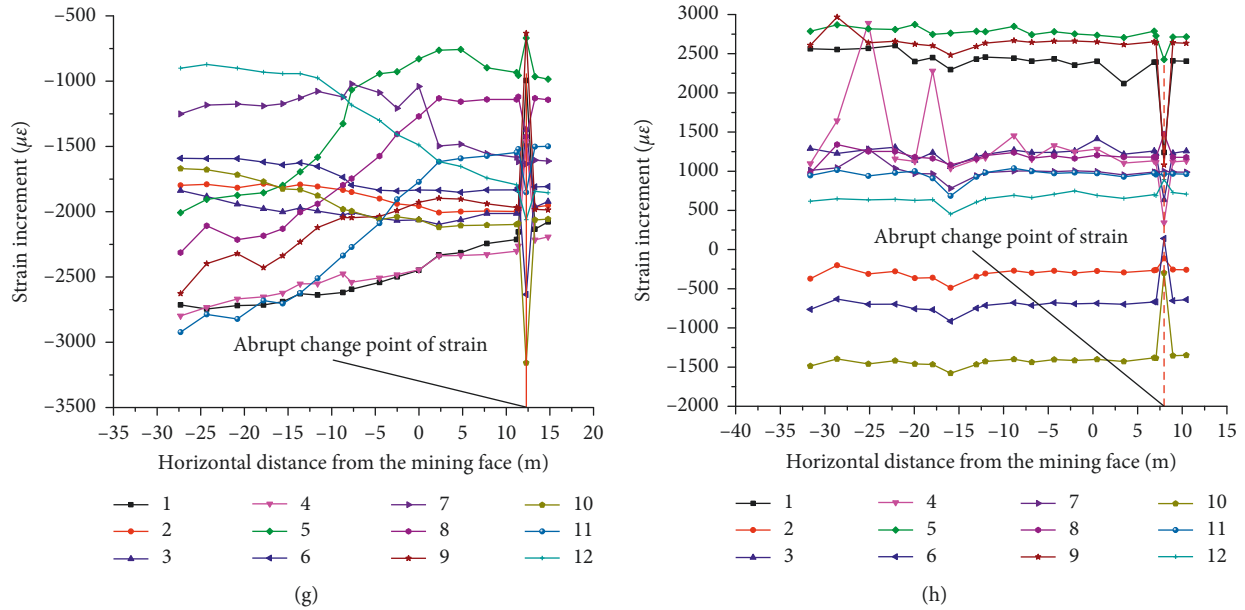
FIGURE 6: Strain increment curves of each sensor in boreholes III and IV in the 100502-180 mining face. (a) Sensor #10. (b) Sensor #11. (c) Sensor #12. (d) Sensor #13. (e) Sensor #14. (f) Sensor #15. (g) Sensor #16. (h) Sensor #17.

As shown in Figures 5 and 6, the strain increment curves of sensor probes #1, 5, 6, 10, 11, 15, and 16 showed coordinated change at the initial stage of monitoring; however, as the mining face advanced continuously, at positions

The strain increment curves of sensor probes #2 and 3 showed abnormal mutations. The strain increment curves of probes #2 and 3 varied slightly at the initial stage of monitoring; however, the strain increment curves fluctuated

drastically, ranging from  $+6000 \sim -3000 \mu\epsilon$ , and when the mining face was horizontally 2.98 m and  $-3.77$  m away from the sensor probes, respectively, the strain increments were beyond the measuring range. In addition, no recovery in the strain increment curves was seen in the subsequent monitoring. These results all indicate that the floor rocks around the sensor probes were fractured and that the strain gauge inside might have touched the sharp rocks; thus, the strain increments changed abruptly, showing abnormal mutation, without recovery.

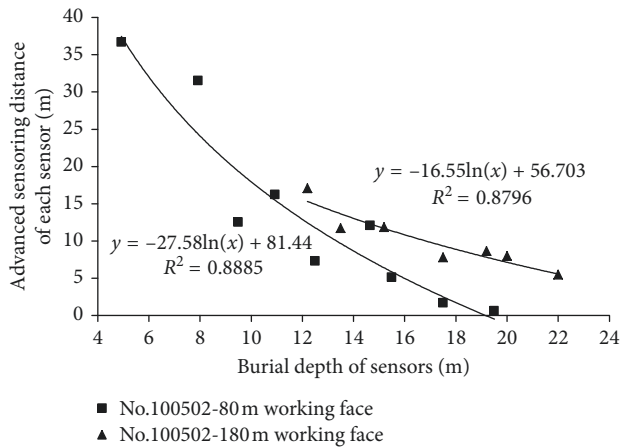
FIGURE 7: Relationship between the buried depths of the sensors and their advanced response distances.

Figure 7 shows that the advanced response distances decreased approximately following a negative exponential function as the burial depth of each sensor probe increased. This decrease occurs because during the transmission of the advanced support pressure to the floor rocks, the stress decreased gradually with increasing transmission distance, and the further the transmission distance, the more stress loss. For the probes at the same burial depths, the longer the mining face was, the greater the advanced response distance. This correlation occurs because mine pressure significantly increased as the length of the mining face increased; therefore, a more intense strain response and a greater advanced response distance resulted.

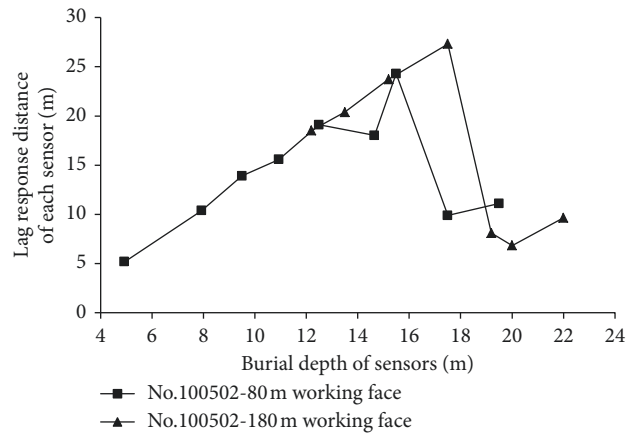
FIGURE 8: Relationship between the buried depths of the sensors and their lagged response distances.

Figure 8 shows that the lagged response distance first increased and then decreased as the burial depth of the probes increased. In addition, the lagged response distance

dropped more rapidly at the declining stage for the mining face with a greater length. The lagged response property occurs because during the advancement of mining face, the pressure of the floor rocks at the locations of the buried probe was not thoroughly relieved until the mining face was a few meters past the monitoring hole.

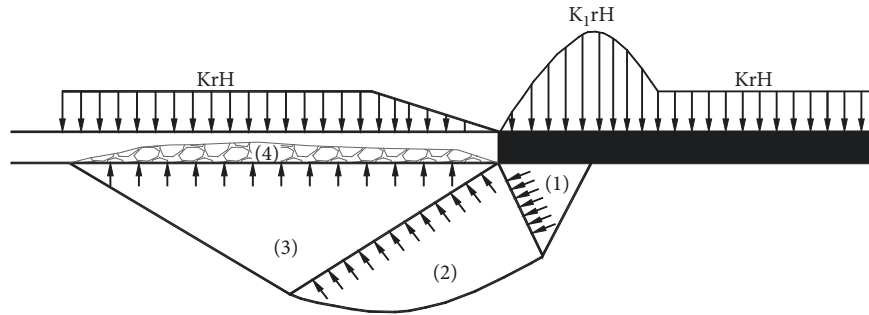
FIGURE 9: Illustration of different force structures in the mining floor. (1) Subjective pressure zone. (2) Transition zone. (3) Passive pressure zone. (4) Floor heaving zone.

From the perspective of force, the advanced and lagged sensing properties of the strain increments of the floor rocks were caused by disruption to the original balance of the ambient stresses. To better explore the mining-induced advanced and lagged characteristics of the strain increment responses of the floor rocks, the force diagram of the rocks in front of the mining face is illustrated in Figure 9. During the advancement of the mining face, the rocks affected by the advanced support force in front of the mining face can be divided into four pressure zones according to their force characteristics: an active pressure zone, a transition zone, a passive pressure zone, and a floor heaving zone. When the mining face had not yet advanced to the

buried locations of the sensor probes, the sensor probes had sensed and changed already owing to the advanced support force; thus, advanced sensing occurred. Meanwhile, when the mining face passed the monitoring hole, the sensor probe was still in the transition zone, and thus still was influenced by the advanced support force; therefore, a lagged response was detected for the strain increment.
