# Service Life Prediction of Shaft Sidewall Exposed to Sulfate Environment

Under the influence of underground water with high concentration of sulfate, several vertical shafts in the Huang-Huai region are seriously corroded but have varying degradation degrees in different parts. Taking the auxiliary shaft of Lin-Huan coal mine as the research subject, the mechanism of this phenomenon was studied. Then, wet-dry alternated and immersion corrosion tests were carried out, and it was found that only the dry-wet alternated accelerate test is representative of the corrosion mechanism that cause the corrosion in the shaft. However, it will cost much time and money for the laboratory test to reach the same degradation depth. To solve this problem, combining with field and laboratory tests, a modified theoretical degradation model was developed to evaluate the residual life of the corroded sidewall. The results indicate that the residual life of the shaft sidewall is 25 years, and the damaged parts have no need for an immediate reinforcement.

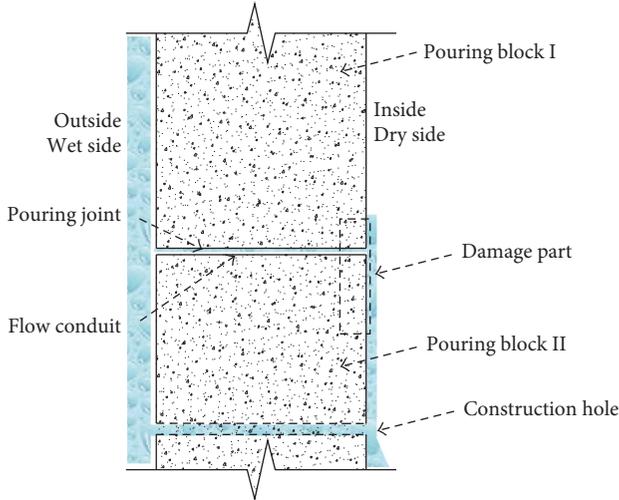
FIGURE 1: A schematic sketch of the field investigation.

The vertical shafts of coal mines are usually at great depths, and unavoidable contact some coal measure strata, which contain lots of corrosive ions. In Lin-Huan coal mine, the auxiliary shaft has varying degradation degrees in different parts. The part with aggressive water flow on is protected by a dense layer and is barely corroded. On the contrary, the moist part near the construction joint is seriously corroded.

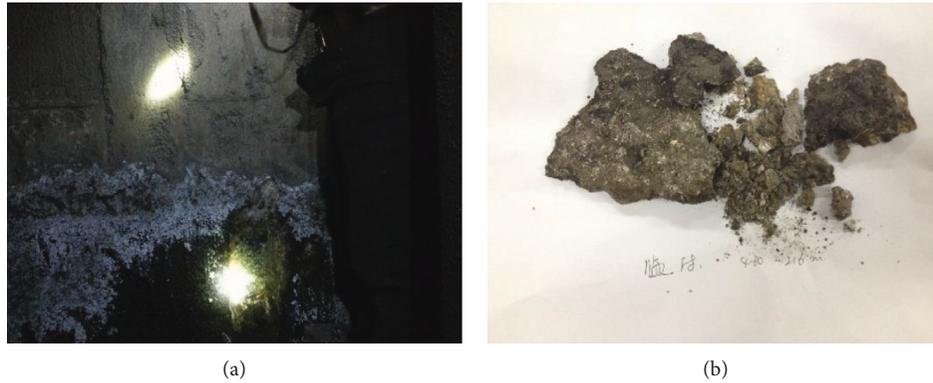
FIGURE 2: Corroded concrete (-271 m).

**2.2. Chemical Composition Analysis.** The most seriously damaged part is located at -271.0 m. At this part, the concrete of the sidewall is obviously bulging and the surface is very loose. As shown in Figure 2, the damaged layer is along the construction joint and is approximately 200 mm in height and 55 mm in depth. As shown in Figure 3, under the dense layer, the concrete seems to be very compact. The rebound test indicated that the compressive strength of the concrete protected by the dense layer is 26.7 MPa; it is almost unaffected by corrosion.

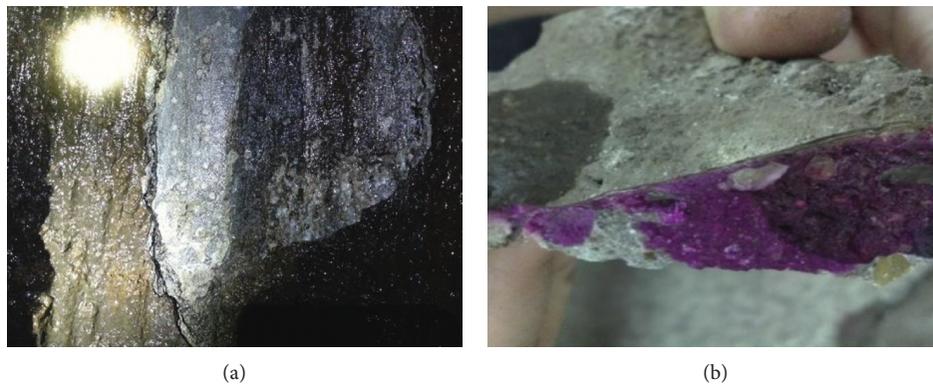
FIGURE 3: Compact concrete with a dense layer (-284 m).

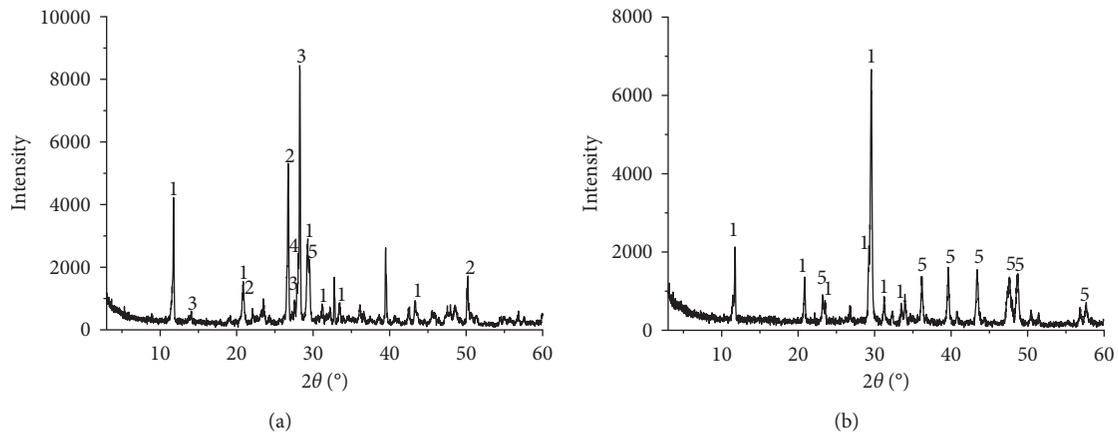
FIGURE 4: XRD analysis of the corroded concrete and the dense layer. (a) The corroded sidewall concrete; (b) the dense layer. 1: Gypsum; 2: quartz; 3: albite; 4: margarite; 5 calcite.

Figure 4(a) shows that the corroded concrete mainly consists of gypsum (CaSO<sub>4</sub>·2H<sub>2</sub>O), quartz (SiO<sub>2</sub>), albite (NaAlSi<sub>3</sub>O<sub>8</sub>), margarite (CaAl<sub>2</sub>(Al<sub>2</sub>Si<sub>2</sub>)O<sub>10</sub>(OH)<sub>2</sub>), and calcite (CaCO<sub>3</sub>). The diffraction peak of portlandite (Ca(OH)<sub>2</sub>), which is one of the major components of normal concrete, was not found. However, gypsum, which is barely contained in normal concrete, is one of the major components. The average concentration of the sulfate ion and pH value in the water samples are 7.67 and 1825.2 mg/L, respectively. According to Bellmann et al. [13], portlandite will react with gypsum at a minimal sulfate concentration of 1400 mg/L (pH = 14.5). With decreasing pH, less concentration of sulfate ions is needed for the reaction to proceed. The reaction formula of this degradation is as follows:

As the diffraction peak of ordinary aggregates, such as quartz, albite, and margarite, was not found in Figure 4(b) and the major components of the dense layer are the same to the supersaturated salt in the aggressive water, the dense layer is supposed to be formed by the precipitation and crystallization from the supersaturated underground water. As shown in Figure 6, due to the compact microstructure of the dense layer, shaft concrete under the dense layer is barely corroded.

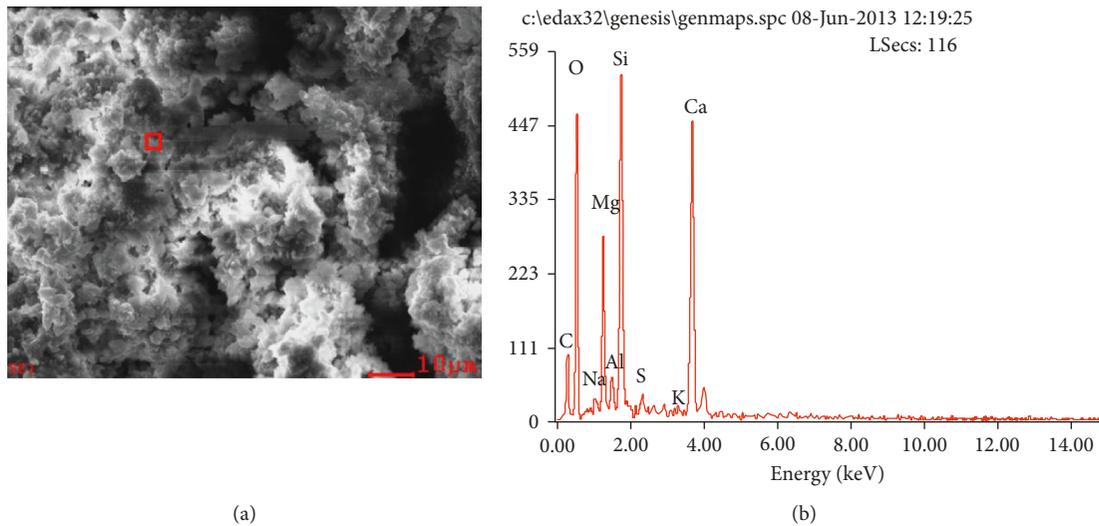
FIGURE 5: SEM and EDS images of the corroded concrete. (a) SEM; (b) EDS.

As can be seen from Figure 5, Ca<sup>2+</sup> in calcium silicate hydrate (C-S-H) gel is partly replaced by Mg<sup>2+</sup> to form hydrated magnesium silicate (M-S-H). Biczok [14] found that the corrosion process of concrete in magnesium sulfate usually included two steps: (1) C-S-H gel reacts with SO<sub>4</sub><sup>2-</sup> and Mg<sup>2+</sup> to produce gypsum, magnesium hydroxide (Mg(OH)<sub>2</sub>), silica gel, and H<sub>2</sub>O; (2) Mg<sup>2+</sup> reacts with silica gel to form M-S-H and H<sub>2</sub>O. The structure of M-S-H is much looser than C-S-H, and the adhesion between M-S-H and the aggregate is smaller. Thus, the deterioration degree of concrete in magnesium sulfate solution is much higher than in sodium sulfate solution [15]:

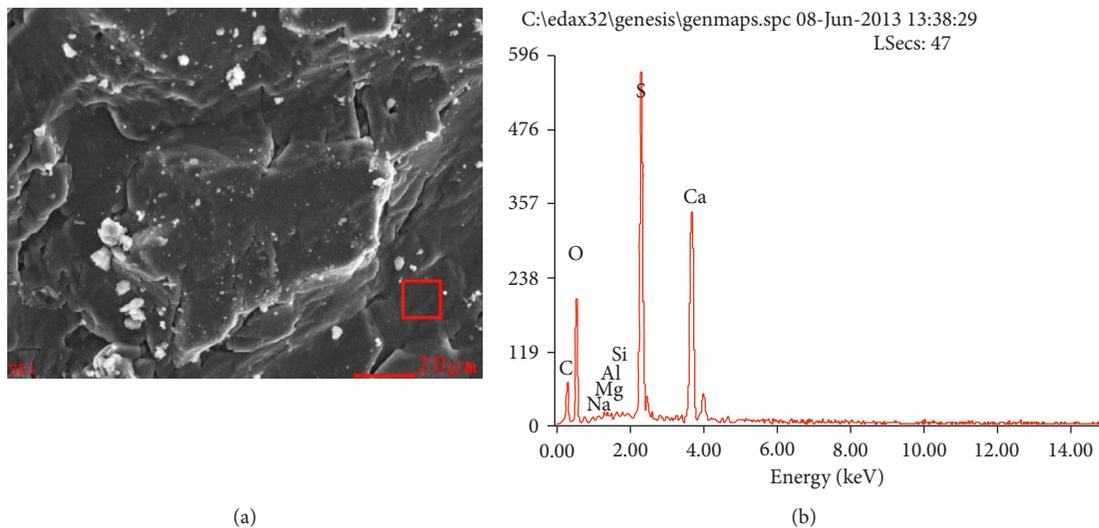
FIGURE 6: SEM and EDS images of the dense layer. (a) SEM; (b) EDS.

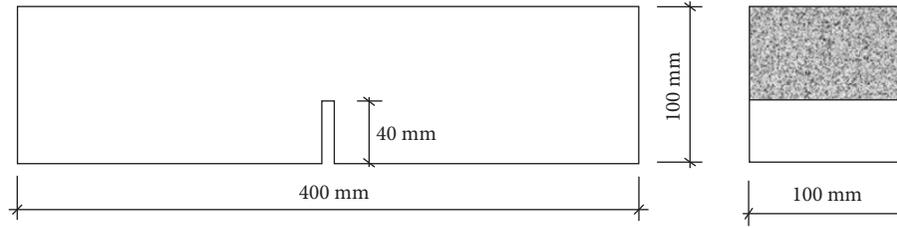
FIGURE 7: Size of the specimens.

The specimens are 400 × 100 × 100 mm<sup>3</sup> cuboids. A plastic board with 2 mm thickness, 100 mm width, and 40 mm height was used to create a notch in the middle of the specimens. The dimension of the concrete specimen is shown in Figure 7. The plastic board was removed in 6 hours. Form removal was carried out after 24 hours. Then, the specimens were cured at 20 ± 2°C and 95% relative humidity until the age of 28 days.

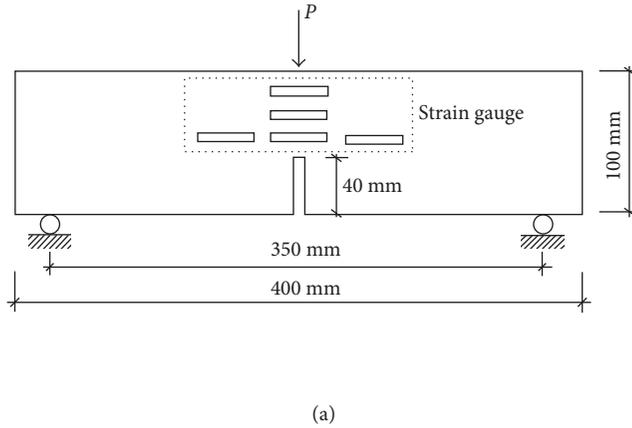
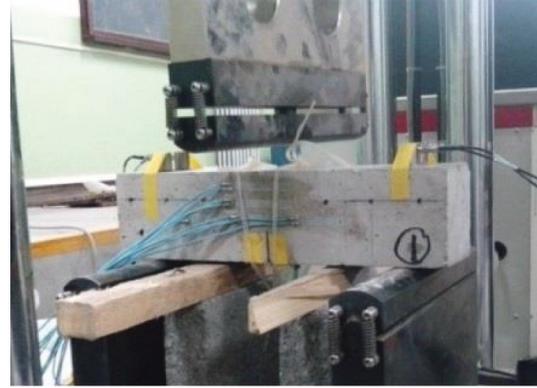
FIGURE 8: Schematic diagram of the three-point bending test.

were adopted. The load speed of loading was controlled by displacement (0.05 mm/min). Five strain gauges were placed on one side of the specimen to monitor the process of crack initiation, as shown in Figure 8.

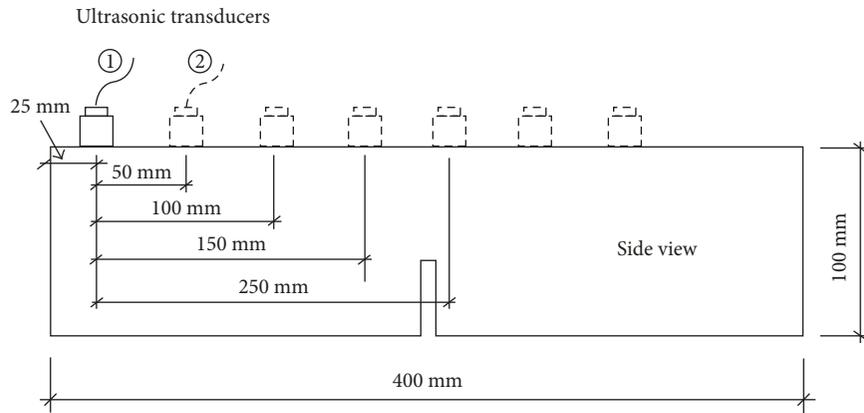
FIGURE 9: Diagram of the ultrasonic single side test method.

The NM-4B nonmetallic ultrasonic detector manufactured by Concrete Co., Ltd. was adopted to obtain the degradation thickness of the specimens. The ultrasonic time is determined by the ultrasonic single side test method, as shown in Figure 9. One of the ultrasonic transducers was fixed at a certain position. When the other one was placed at 50, 100, 150, 200, and 250 mm away, and the corresponding ultrasonic time was recorded.

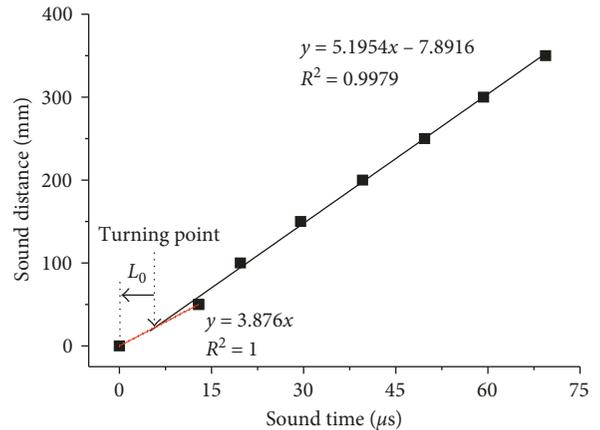
FIGURE 10: Calculation chart for  $L_0$  (Group B, 60 days).

where  $v_f$  is the ultrasonic velocity in the corroded layer,  $mm/\mu m$ ;  $v_a$  is the ultrasonic velocity in the internal uncorroded concrete,  $mm/\mu m$ ; and  $L_0$  is the turning point in the "ultrasonic time-distance" diagram,  $mm$ . Figure 10 is an example.

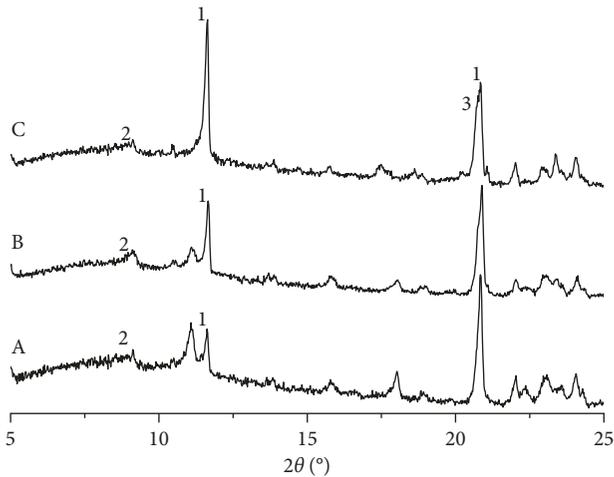
FIGURE 11: XRD results of corroded concrete (150 days). 1: Gypsum; 2: AFT; 3: quartz.

As shown in Figure 11, the content of gypsum from high to low is Groups C, B, and A. A small amount of ettringite was found in Groups B and A. In the wet-dry alternated test, due to the adoration of sulfate solution in the pores during the “wet” process and the evaporation of the solution during the “dry” process, sulfate concentration in concrete pores is actually higher than that in the solution, which not only accelerates the corrosion rate of sulfate but also inhibits the occurrence of ettringite crystalline sulfate corrosion. But ettringite was not found in the field investigations. As can be seen from Figure 12, in the wet-dry alternated test,  $\text{Ca}^{2+}$  in C-S-H gel is also partly replaced by  $\text{Mg}^{2+}$  to form M-S-H, which is similar to field corrosion. Thus, wet-dry alternated accelerated corrosion experiment is more representative to the field corrosion.

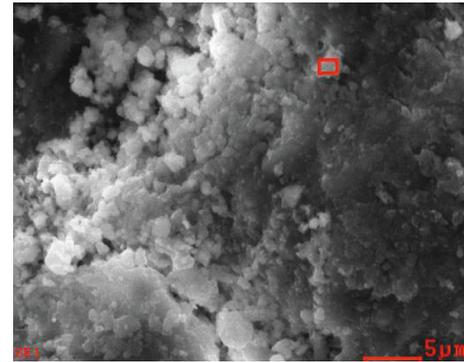
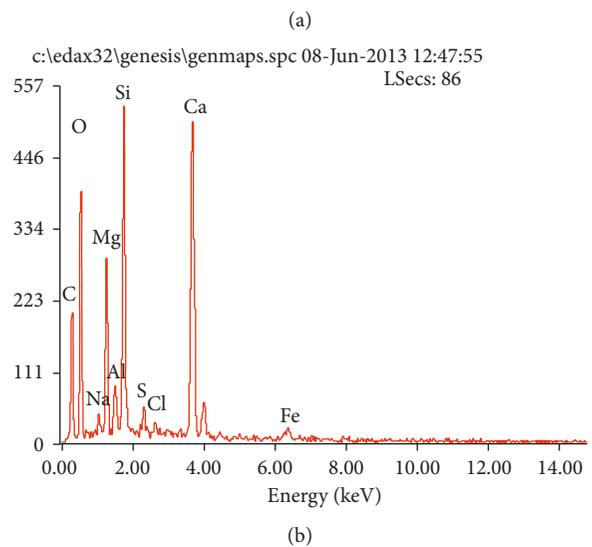
FIGURE 12: SEM and EDS images of the specimen in the wet-dry alternated test (150 days). (a) SEM (50,000x magnification); (b) EDS.

**3.2. Corrosion Mechanism Analysis.** Sulfate solution transports through the pore of concrete, resulting in chemical reactions between sulfate and cement hydration products. Expansive reaction products, such as ettringite and gypsum, generate high stress in the pore, causing spalling and cracking of the concrete. Some reaction products, such as M-S-H and magnesium hydroxide, are not expansive products, but are nonbinders. As concrete specimens with different corrosion mechanisms have different corrosion products and have different degeneration law, the degradation mechanism in the accelerated corrosion test should be the same as that responsible for the in-service deterioration [20]. XRD, SEM, and EDS analyses were performed on the corroded samples to analyze their corrosion mechanism, as shown in Figures 11 and 12.

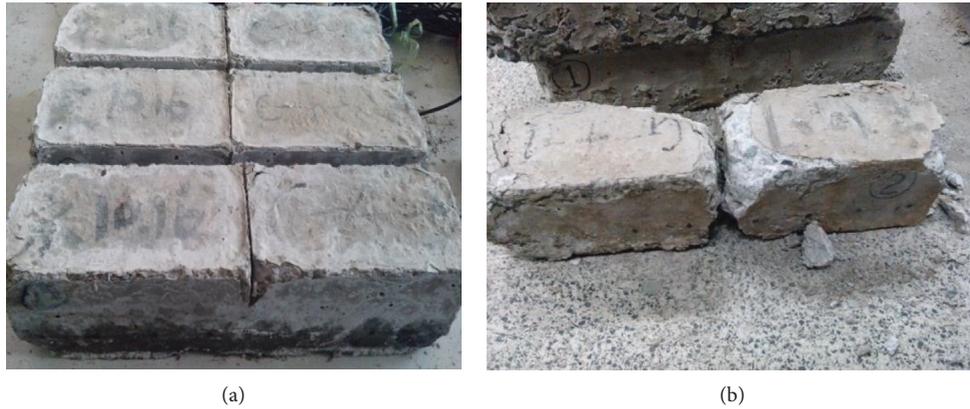
FIGURE 13: Appearances of the corroded specimens (150 days). (a) Immersion test (15%); (b) wet-dry alternated test.

As shown in Figure 13, the surfaces of the specimens immersed in 15% sulfate solution for 150 days are uneven and rough, the edges are slightly damaged, and some of the coarse aggregates are exposed. The specimen placed in the dry-wet cycle testing machine for 150 days is seriously corroded, especially at the edges, and the internal aggregates are exposed.

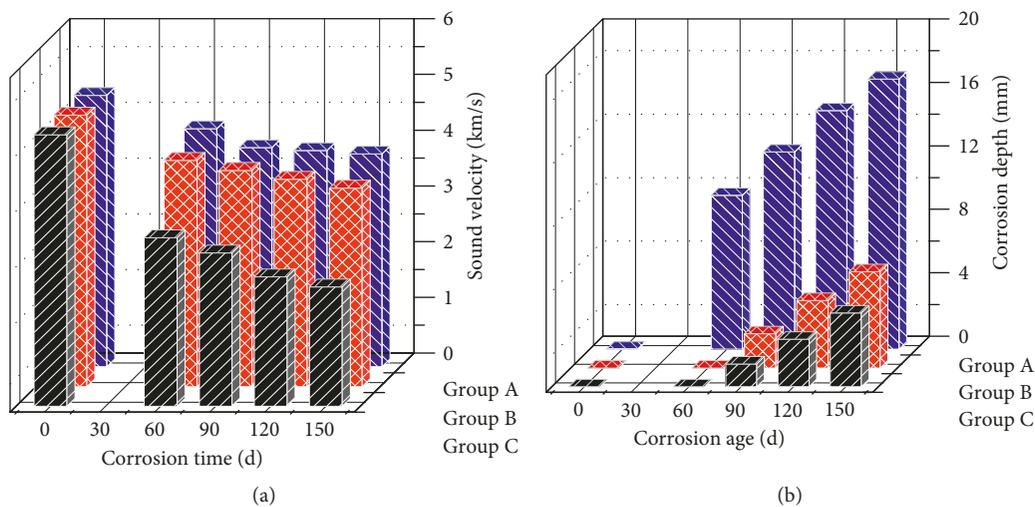
FIGURE 14: Surface ultrasonic velocity and degradation depth at different corrosion time. (a) Surface ultrasonic velocity; (b) degradation depth.

Figure 14(a) shows the surface ultrasonic velocity of the concrete specimens. As the corrosion time is increased, the surface ultrasonic velocity of Group C exhibits a decreasing trend and it is much lower compare to the results from Groups A and B. At the corrosion time of 150 days, the surface velocities of Groups A, B, and C are 3.82, 3.56, and 2.14 km/s, respectively, decreased by 21.6%, 26.9%, and 43.9%. It seems that the corrosion degree of the corrosion layer in the wet-dry alternated experiment is much more serious than that in immersion tests.

Figure 14(b) shows the degradation depth of the corroded specimens. In immersion tests, due to the filling of corrosion products in concrete pores, there is no obvious corrosion before 90 days. Then, the degradation depth increased steadily to the end the experiment. However, in the wet-dry alternated accelerated corrosion test, the degradation depth increased

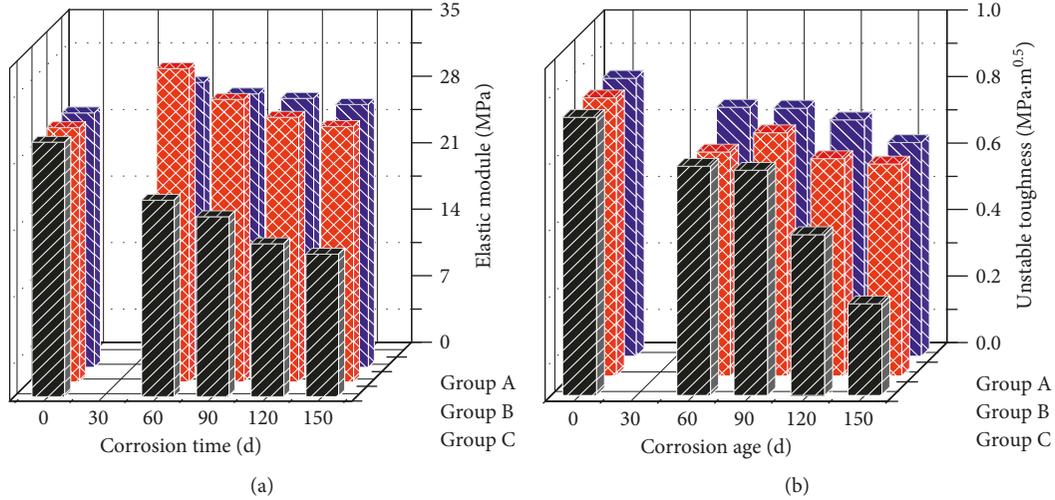
FIGURE 15: Elastic module and unstable fracture toughness at different corrosion time. (a) Elastic module; (b) unstable fracture toughness.

**3.3.2. Elastic Module and Unstable Fracture Toughness.** Figure 15 illustrates the results of elastic module  $E$  and unstable fracture toughness  $K_{IC}^S$  of corroded specimens at different corrosion time.

It can be seen from Figure 15(a) that, with corrosion time increasing, the elastic module of Group A and Group B increases at first and then gradually declines. Due to the high degradation rate, the elastic module of Group C has no increasing stage, and its decline speed is more rapid than Groups A and B. As shown in Figure 15(b), the unstable fracture toughness of Groups A, B, and C shows a similar decreasing trend during the early stages of corrosion. But after 90 days of corrosion, the decreasing trend of Group C is remarkable obvious, whereas, Groups A and B are slow.

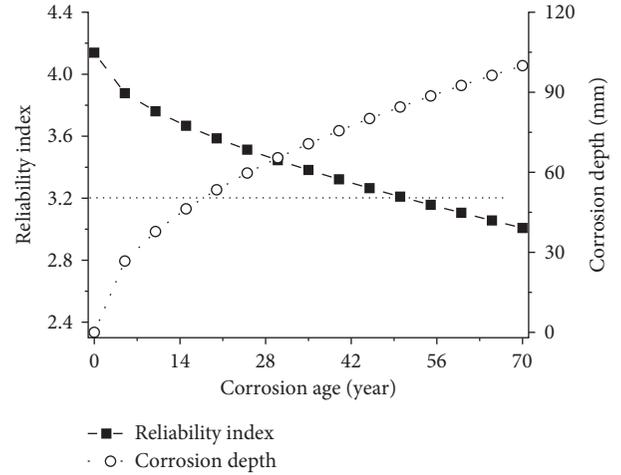
FIGURE 16: Reliability index and degradation depth at different service time.

After calculation, the reliability indexes and degradation depths at different corrosion time are shown in Figure 16. The target reliability index of bearing capacity limited state, which is recommended by MOHURD (Ministry of Housing and Urban-Rural Development of the People's Republic of China), is shown in Table 5 [36].

The sidewall is subjected to a multidirectional pressure, so the failure mode of the shaft sidewall can be assumed to be ductile failure. The auxiliary shaft undergoes a routine check on a daily basis, and the failure risk can be identified with a timely fashion. As the lives of thousands of workers depend on it, the target reliability is set as 3.2. At present, the service time of the shaft sidewall is 26 years, and the reliability index is 3.50. It is safe now, but with the service time increasing, the reliability index will unavoidably decrease. When the reliability index reduces to 3.20, the service time will be 51 years. It is obvious that there is no need to reinforce in the next 25 years.
