## Research Article

# Study on Seismic Performance of Improved High-Strength Concrete Pipe-Pile Cap Connection

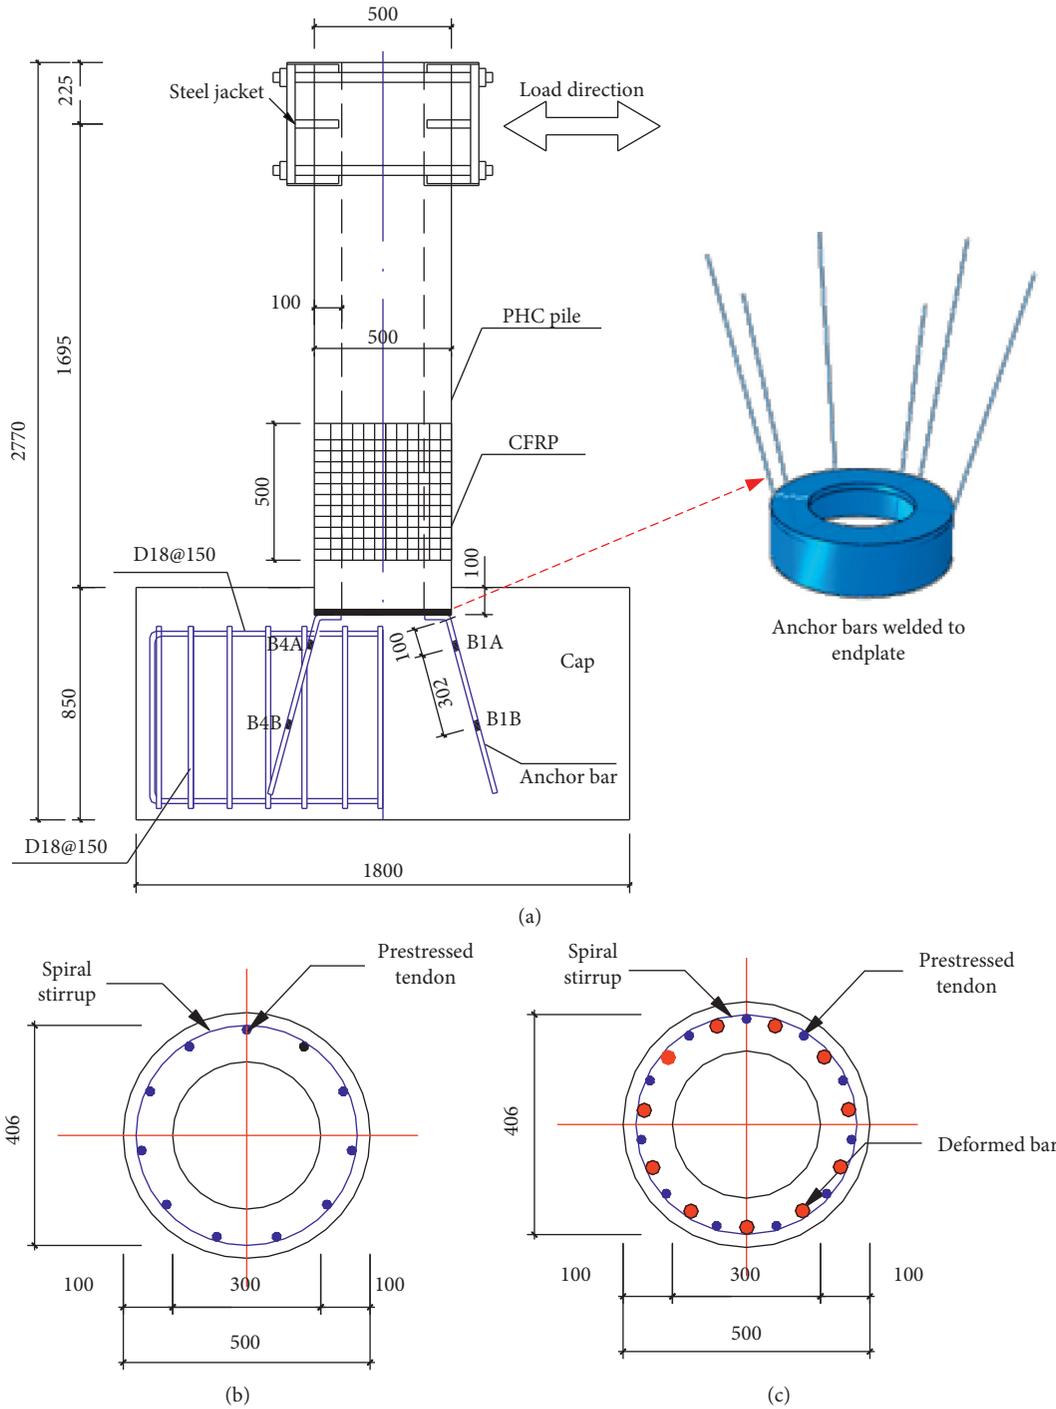
FIGURE 1: Details of specimens. (a) The connection between cap and pile. (b) PHC pile section. (c) PRC pile section.

*2.1. Specimen Design.* Four full-scale specimens were designed; the connections between pile and cap were same, as shown in Figure 1. The number of anchor bars should be not less than six to transfer forces from pile to cap according to Technical Code for Building Pile Foundation (JGJ 94-2008) of China [32]. The thickness of anchor plate is 20 mm, and the steel grade is Q235. Different methods were considered to improve the performance of the connections, such as reinforced with steel bars, steel fiber-reinforced, and CFRP (carbon fiber-reinforced polymer). CT-7 specimen was normal specimen with no improvement, the pile of CT-8 specimen was confined by three layers of CFRP, steel fiber was added into the pile of CT-9 specimen, and the pile of CT-10 specimen was reinforced with deformed bars. Table 1 summarizes the details of the specimens.

The diameter and thickness of the piles are 500 mm and 100 mm, respectively. The length of the pile is 2 m, and it is embedded into cap for 100 mm, as shown in Figure 1(a). Eleven 9.0 mm diameter of prestressing bars with an applied prestress of 994 MPa (70% gross ultimate tensile strength) were used. The stirrup spacing and diameter were 80 mm and 5 mm, respectively. An  $1800 \times 1100 \times 850$  mm cap

section was used, and Figure 1(a) shows reinforcement used for specimens. The cross sections of PHC pile PRC pile are shown in Figure 1(c). Six anchor bars were welded to the anchor plate and then bent outward into the cap in a 75° pattern, as shown in Figure 1(b).

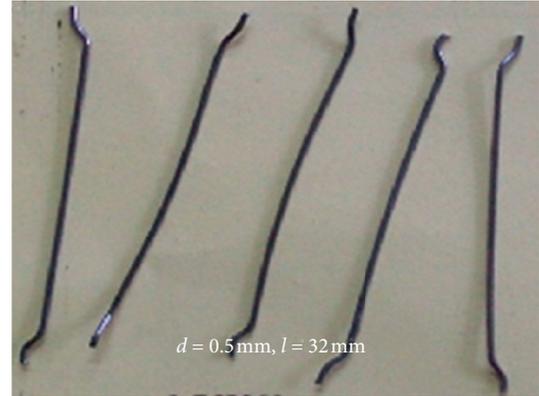
FIGURE 2: The hooked steel fiber.

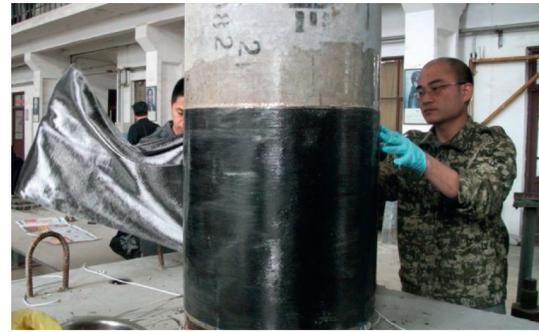
FIGURE 3: Wrapping CFRP sheet.

**2.2. Specimen Preparation.** PHC piles were fabricated with centrifugation, steam, and autoclave curing at factories. PHC piles were steamed at atmospheric pressure for 6 hours at 80°C and steamed at high temperature and pressure for 6–8 hours (1.0 MPa, 180°C). The cap was naturally cured. Because the scale of cap is large, it was not convenient to fabricate them as actual engineering; therefore, the concrete of cap was cast by convert. Microexpensive concrete was cast into both the hollow section of pile and cap simultaneously. Deformed bars are arranged at intervals in PRC pile, as shown in Figure 1(c). The optimal amount of steel fiber was determined according to the study results of [33–35]. The hooked steel fiber (as shown in Figure 2) was used to improve PHC pile; the equivalent diameter, average length, and the ultimate tensile strength are 0.5 mm, 32 mm, and 1000 MPa, respectively. To improve the dispersion uniformity of steel fiber in the mixing materials, the method of dry mixing and wet mixing was adopted. When preparing the specimen CT-8, the surface of pile was made to be rough, and then the CFRP sheet was wrapped around the pile, as shown in Figure 3. The CFRP sheet was wrapped with three layers with a 150 mm overlap in the direction of fibers to ensure proper bond.

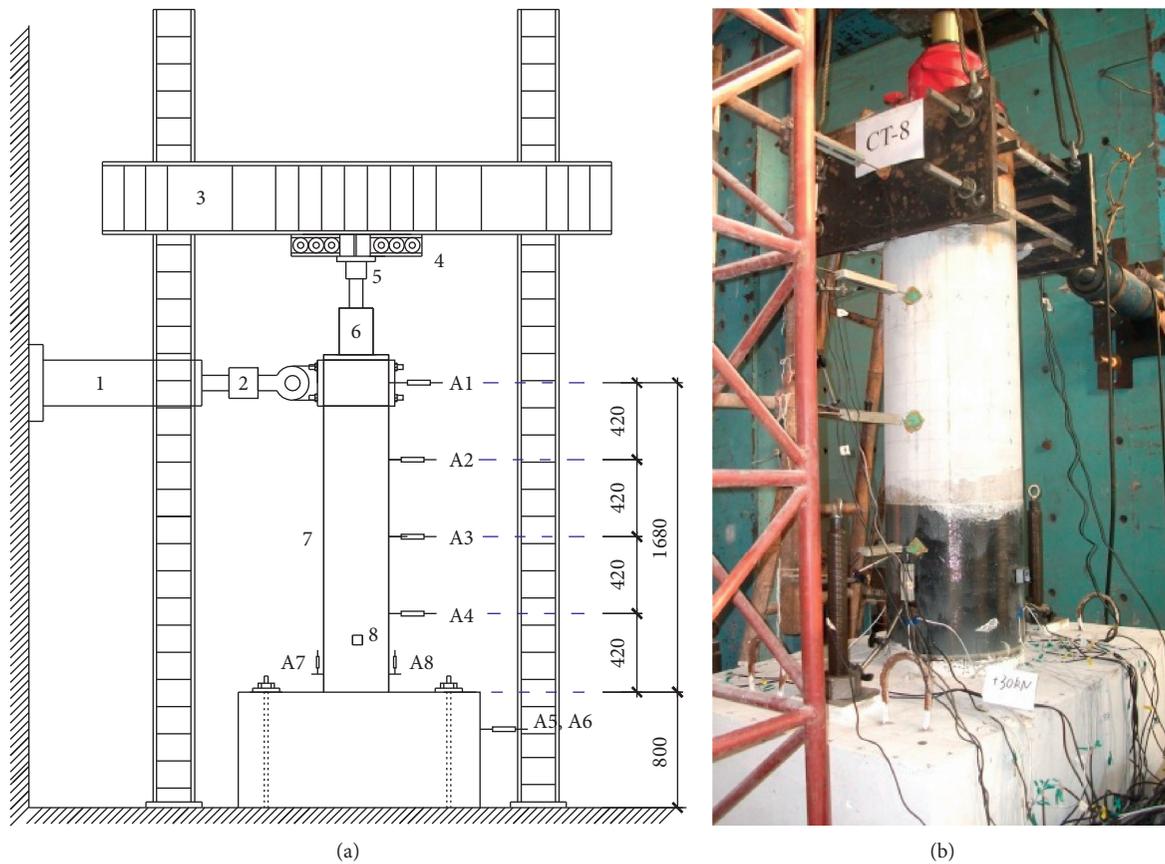
FIGURE 4: Test setup. (a) Diagrammatic test setup. (b) Test photo.

**2.4. Loading Device.** The test setup is shown in Figure 4. The cap was anchored to the strong floor firstly before the axial load and cyclic lateral load were applied on the pile, where “1” is an actuator with 600 kN capacity and push/pull stroke of 300 mm, “2” and “5” are load sensors, “3” is counterforce frame, “4” is sliding plate, “6” is a 1000 kN hydraulic jack, “7” is PHC pile, “8” is inclinometer, and A1~A8 are displacement sensors. Four displacement sensors were placed on one side of the pile at 420 mm spacing from the pile base to monitor the lateral displacements. Rotation of the pile was monitored using two 50 mm range displacement sensors placed on the two sides of the column in the loading plane. The axial load was applied by a 1000 kN hydraulic jack.

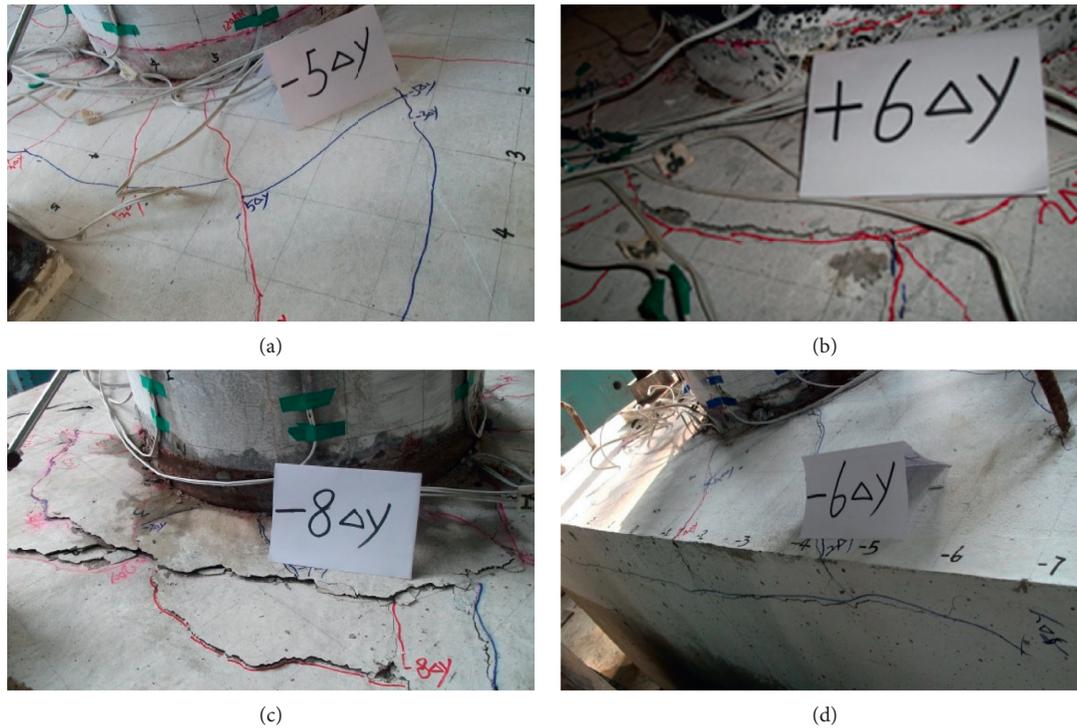
FIGURE 7: Failure mode of specimens. (a) CT-7. (b) CT-8. (c) CT-9. (d) CT-10.

the concrete cover of cap at tensile side tended to spall, the gap between pile and cap was 4 mm, and the pile was pulled out about 8 mm. The failure mode of CT-9 is shown in Figure 7(c).

For Specimen CT-10, as the loads were 120 kN, cracks appeared at the tensile pile and cap. At the  $\Delta_y$  displacement ( $\Delta_y = 6.5$  mm), a crack appeared at the tensile pile hoop and pile body interface, and the width is 0.05 mm. At the  $2\Delta_y$  displacement, two circumferential cracks appeared at the tensile region of pile, which were 150 mm and 320 mm apart from top of cap, respectively. At the  $-2\Delta_y$  displacement, a 0.08 mm wide circumferential crack appeared at the tensile region of pile which was 250 mm apart from top of cap. At the  $3\Delta_y$  displacement, multiple radial cracks appeared on the tensile region of cap, and the maximum crack width was 1.1 mm. A 0.08 mm wide circumferential crack appeared at the tensile region of pile which was 580 mm apart from top of cap. The crack width of 150 mm and 320 mm apart from top of cap was 0.25 mm. At the  $5\Delta_y$  displacement, a crack appeared along long side of the cap, which was about 0.7 m in length and 1.5 mm in width. At the  $6\Delta_y$  displacement, there was an overall uplift trend at the tensile region of cap, the pile has the sign to be pulled out, and the maximum crack width of the cap was 2 mm. At the  $-6\Delta_y$  displacement, the cap had a large-scale uplift, and the specimen could no longer bear the load. The failure mode of CT-10 is shown in Figure 7(d).

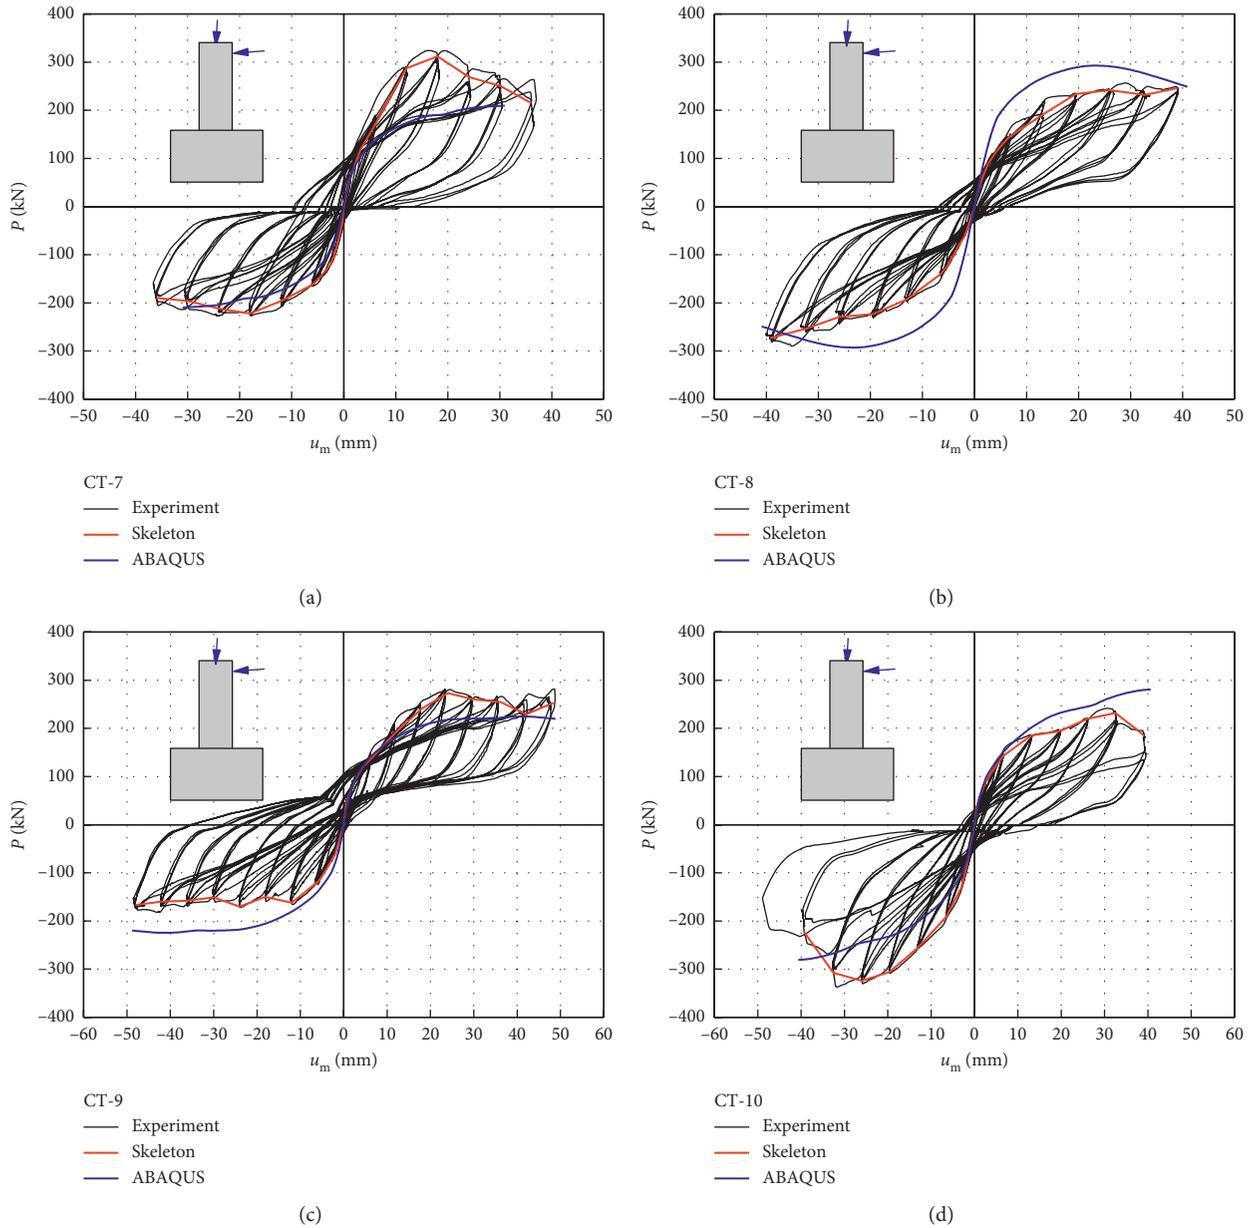
FIGURE 8: Hysteretic load-displacement response for specimens. (a) CT-7. (b) CT-8. (c) CT-9. (d) CT-10.

**4.1. Load-Displacement Hysteretic Curves.** Load-displacement hysteretic curves of specimens are shown in Figure 8. The failure of specimen CT-7~CT-10 was due to the crushing of

cap concrete and slip of anchor bars, which caused the connection to be hinge joint. The hysteretic performance of pile-cap connection was mainly determined by the cap and anchor bars; therefore, the hysteretic curve pinched seriously. After  $3\Delta_y$  displacement, the bearing capacity of specimen CT-7 decreased with the increase of displacement because of the yield of anchor bars. Specimen CT-8 was reinforced by CFRP; it can be seen that the load increases with the increase of displacement. After  $2\Delta_y$  displacement, the positive load does not increase, but the reversed load still increases. Specimen CT-9 was reinforced by steel fiber; because the cap of joint region was damaged, the improved effect to the seismic performance of connection is not obvious. Specimen CT-10 was reinforced by deformed bars, and the bearing capacity declined suddenly due to the rupture of anchor bar. The improvement of CFRP confine, reinforced with steel fiber and deformed bars, could increase the bearing capacity of pile end; otherwise, it made the joint region easy to be damaged. Therefore, the joint region should own enough rotation capacity to make sure the connection will not fail as the rotation is small, and the pile can take advantage of its flexural bearing capacity.

**5.2. Model Verification.** Finite element analysis (FEA) load-displacement curves under monotonic loading are compared with the experimental curves as shown in Figure 8. It can be seen that the FEA results are close to the experimental curves. Table 6 lists the FEA results. There are some certain errors between the FEA and test results about the bearing capacity and stiffness. The main reason is that the FEA could not simulate the action between steel head and endplate, so the prestressing stress was mainly transferred by bond between steel and concrete. Therefore, it would result in the increase of the transfer length of prestressing bar, and the effective prestressing stress of pile will be smaller than

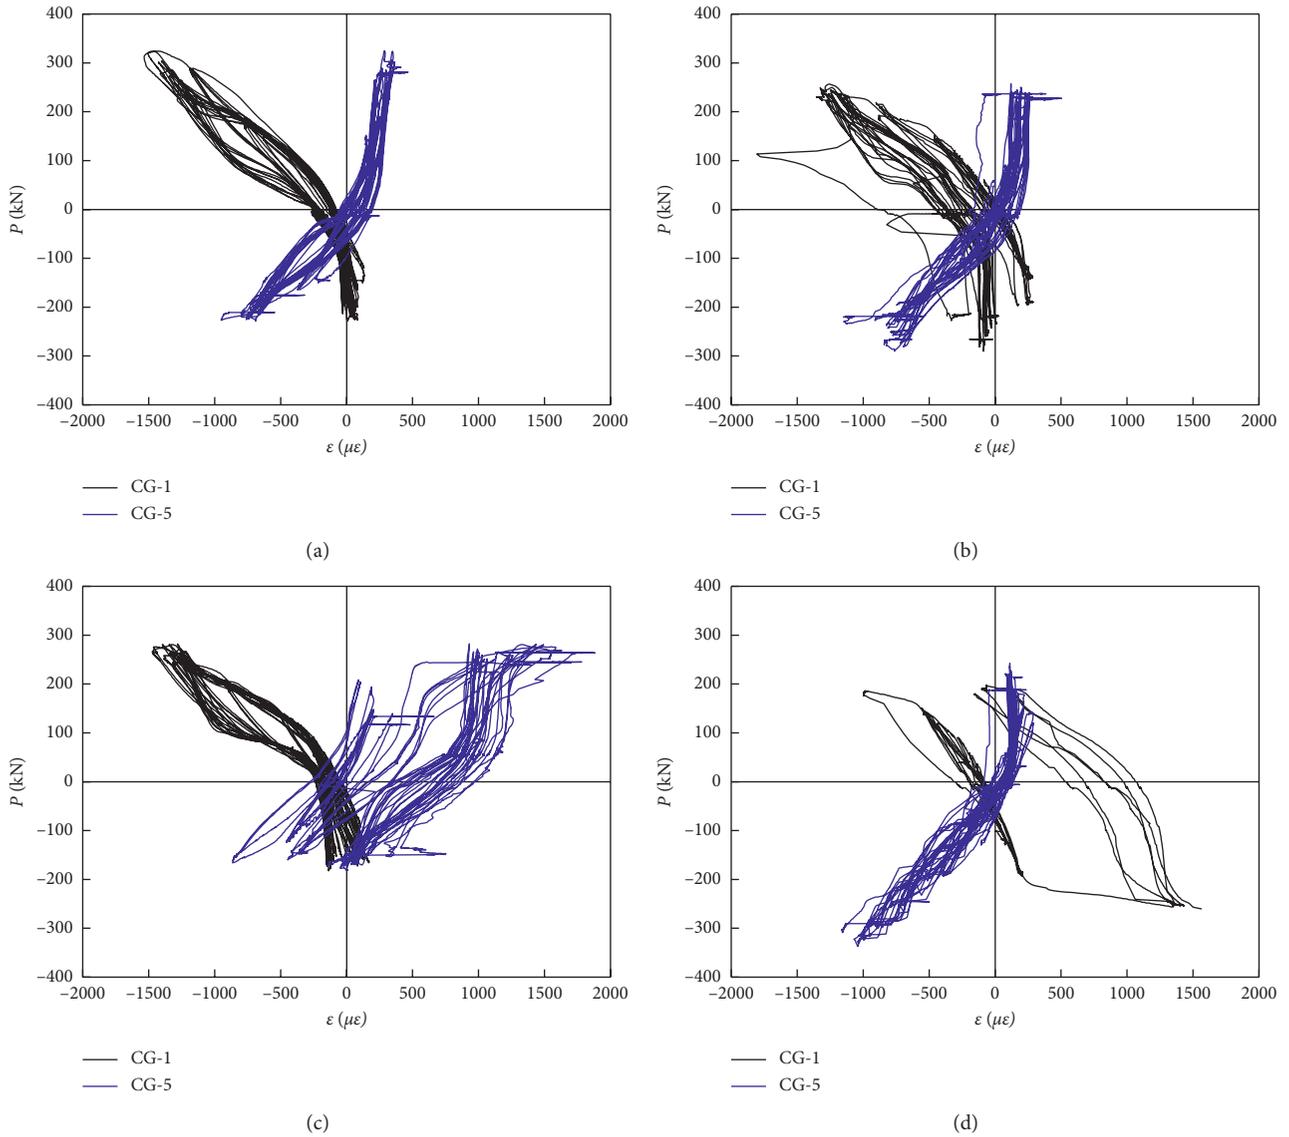
FIGURE 9: Load-stress curves of pile concrete. (a) CT-7. (b) CT-8. (c) CT-9. (d) CT-10.

**4.2. Strain Analysis.** Figure 9 shows the concrete strain of CG-1 and CG-5. It can be seen that the maximum compressive strain of concrete is  $-1780 \mu\epsilon$  which does not reach the ultimate compressive strain of concrete, and the concrete of pile was not crushed. The strain of CG-1 in CT-10 is  $1500 \mu\epsilon$ , which is different from CT-7~CT-9; because a crack appeared at the position of CG-1, the strain gauge was tensioned to be ruptured.

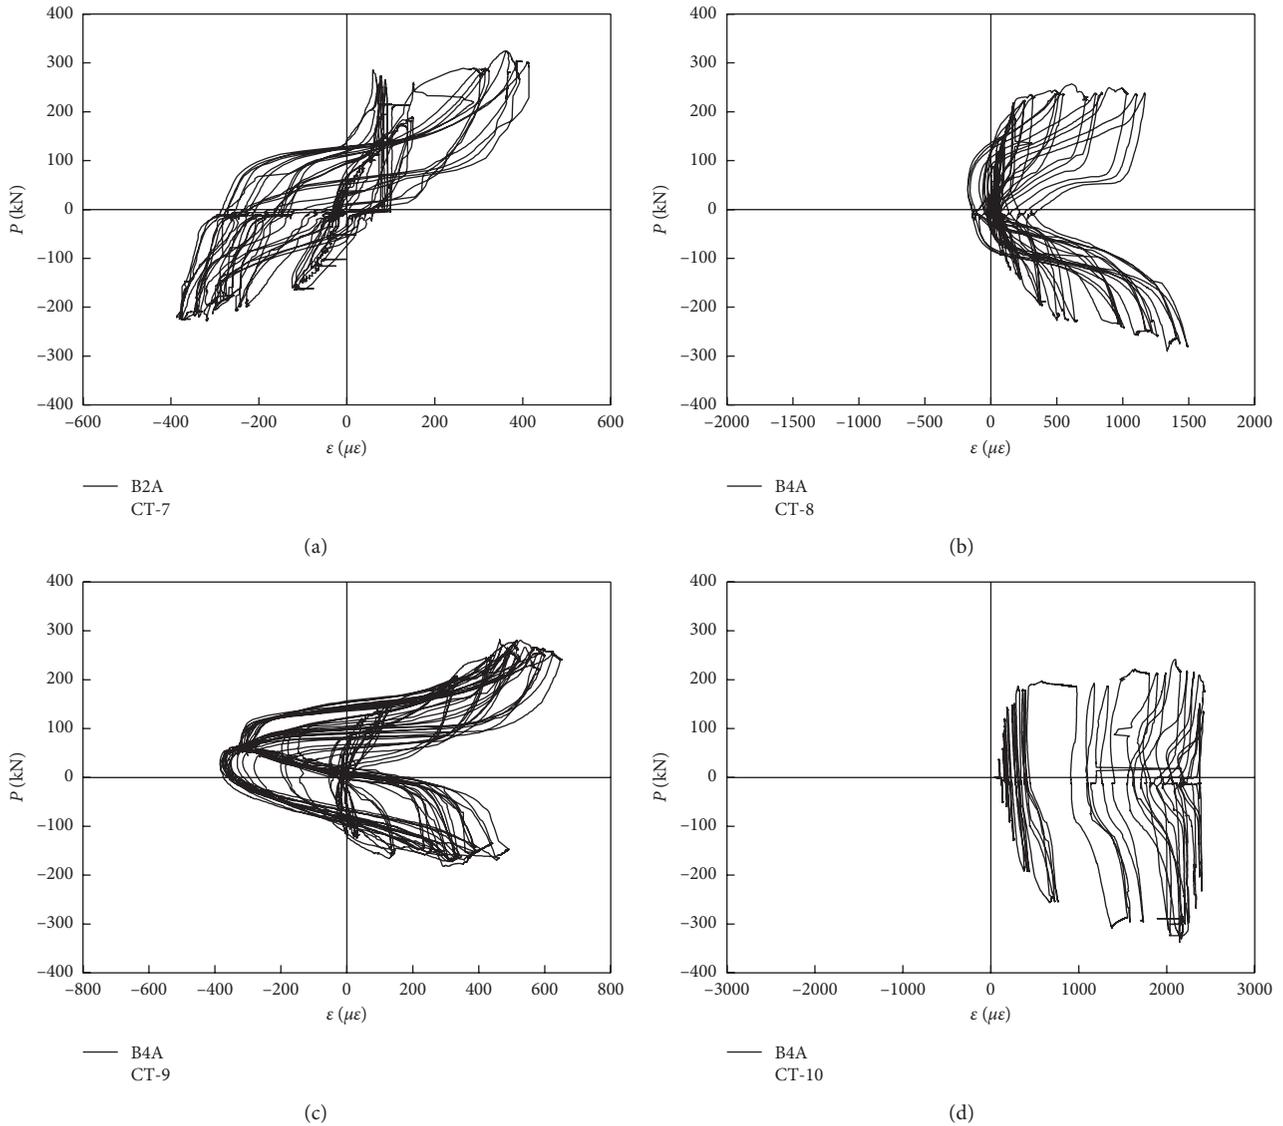
FIGURE 10: Load-strain curves of anchor bars. (a) CT-7. (b) CT-8. (c) CT-9. (d) CT-10.

Figure 10 shows the load-strain curves of anchor bars; point A is the position of maximum stress. It shows that the strains of the specimen CT-7~CT-9 are smaller than  $2000 \mu\epsilon$ , which indicates that the anchor bars below the point did not yield.

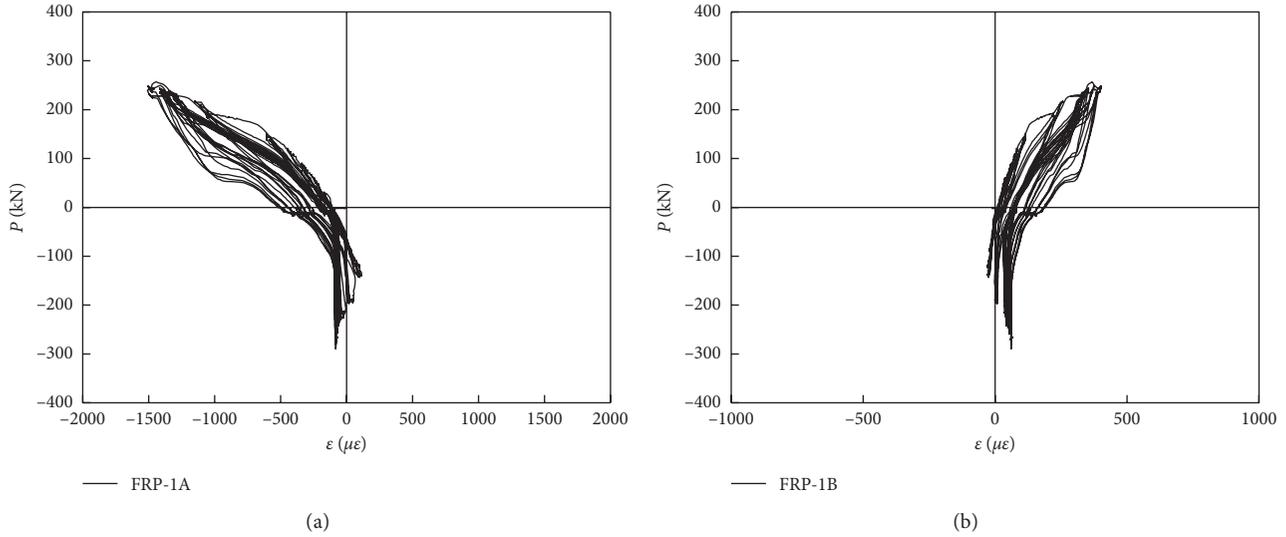
FIGURE 11: Load-strain curves of CFRP. (a) FRP1-A. (b) FRP1-B.

Figure 11 shows the load-strain curves of CFRP, where FRP1-A and FRP1-B are the longitudinal strain and transverse strain, respectively. The maximum strain of FRP1-A is  $-1505 \mu\epsilon$  which is close to the concrete strain of CG-1, which indicates that the bond between CFRP and pile is good. The maximum strain of FRP1-B is  $400 \mu\epsilon$ ; it means that the CFRP confined the concrete, but the effect is not obvious because the failure of CT-8 mainly focused on joint between pile and cap. The circumferential tensile stress of

CFRP was small; therefore, the CFRP did not rupture or exhibit failure of overlap.

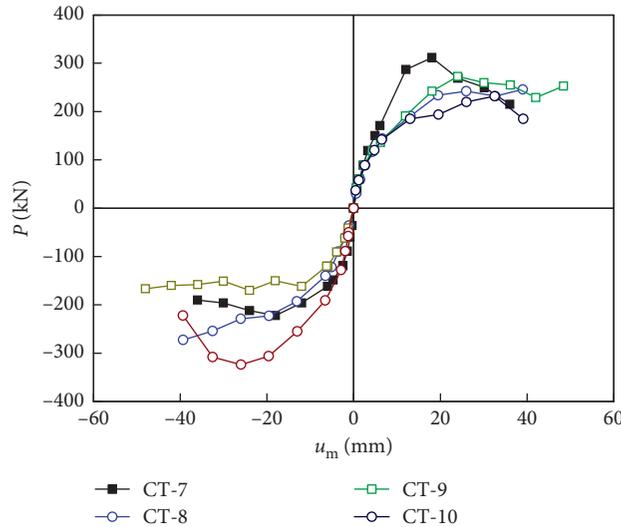
FIGURE 12: Load-displacement skeleton curves.

It can be seen from Figure 12 and Table 5 that the bearing capacity and stiffness of the connections have not been increased after improvement, but the skeleton curves are more flat at the later stage of the loading. The average displacement ductility factors of CT-7~CT-10 are 2.42, 2.32, 3.52, and 2.51, respectively. The displacement ductility factors of CT-9~CT-10 are bigger, and the maximum value

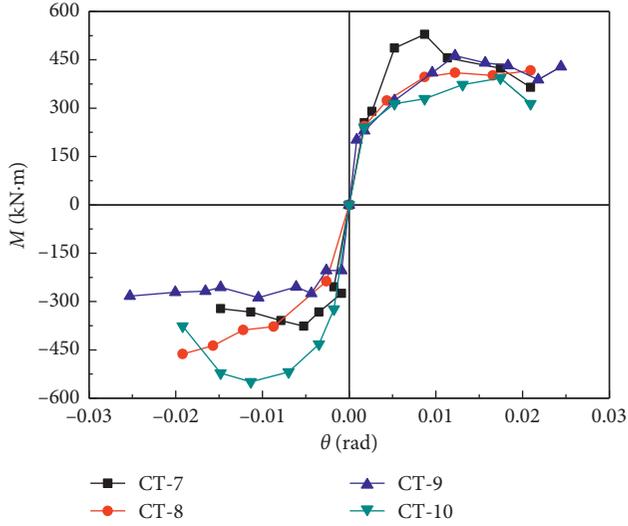
FIGURE 13: Moment-drift angle curves.

**4.4. Moment-Drift Angle of Pile Head.** Figure 13 shows the moment-rotation relationship of pile head; the drift angle was recorded by an inclinometer. The curve of Figure 13 is

similar to Figure 12, which means the drift angle is reliable. It can be seen from Figure 13 that the lateral load decreased with the increase of connection drift angle because the joint region of anchor bars lose restraint of concrete. In addition, as the connection drift angle was 0.014 rad, the concrete cover of cap spalled due to the prying and squeezing force of pile end. Plastic hinge formed at the connection between pile and cap and circumferential crack appeared at pile end, but the damage was not serious. In order to avoid the failure of cap under the prying and squeezing force of the pile end, the connection angle should be less than 0.014 rad.

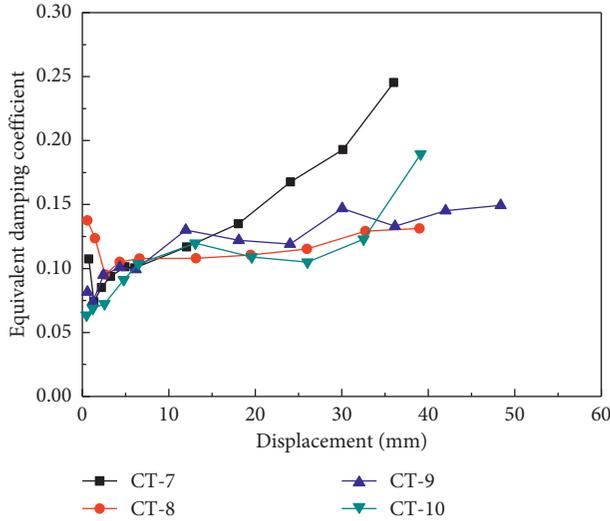
FIGURE 14: Equivalent damping coefficient.

**4.5. Energy Dissipation.** Damage states defined by Pagni and Lowes [40] have been used to evaluate the damage level of the structures; otherwise, the equivalent damping coefficient was used to evaluate the damage level and seismic performance of specimens. Figure 14 shows the equivalent damping coefficient of different displacement. It can be seen

that the equivalent damping coefficient increases with the displacement. Before reaching  $2\Delta_y$  displacement, the equivalent damping coefficient of the CT-7~CT-10 specimen has no obvious difference. At the process of loading to  $3\Delta_y$  displacement, the cap of CT-8~CT-10 damaged more seriously than CT-7, the concrete of cap appeared uplift, and the restraint capacity of joint region weakened, which caused the equivalent damping coefficient of CT-8~CT-10 to be smaller than that of CT-7.

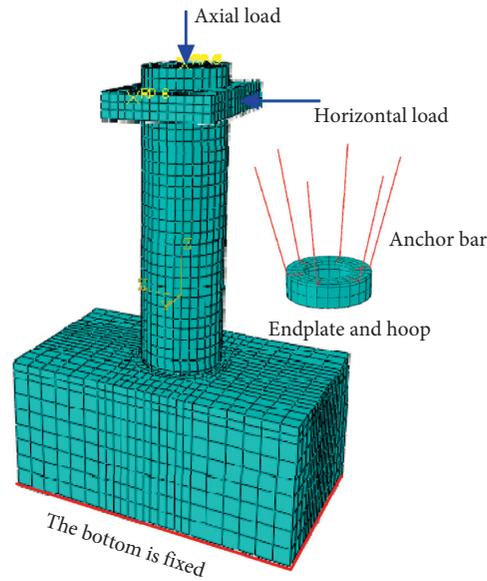
FIGURE 15: Finite element model.

**5.1.2. Element Type, Element Mesh, and Boundary Condition.** Prestressing tendon and stirrup used T3D2 element, and C3D20R element was selected for concrete. CFRP used S4R element. The bond between filled concrete and inner wall of pile was assumed to be good; therefore, the two parts were tied to be together without considering the slip between them. "Hard contact" was used to simulate the contact of steel hoop and cap, endplate and cap, endplate and pile. The saddle and pile and steel hoop and pile were tied to be together, respectively. The prestressing tendon and stirrup were embedded into concrete, without considering the slip between concrete and bars. The prestress was applied with the decreasing temperature method. The CFRP and pile was tied to be together. Boundary conditions and mesh of the finite element analysis model are shown in Figure 15.

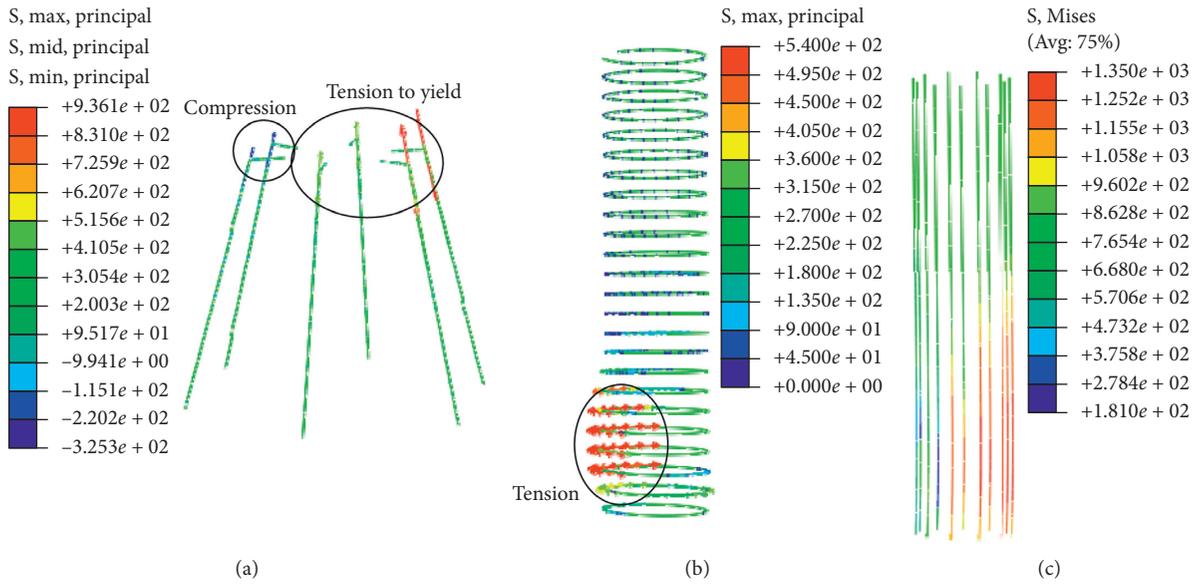
FIGURE 16: The stress distribution of specimen CT-7. (a) Anchor bars. (b) Stirrup. (c) Prestressed bar.

stress. Because the concrete was under compression, the stirrup restrained the lateral deformation of concrete, which caused it to bear high tensile stress. The maximum tensile stress of prestressing bars in the tensile zone is 1451 MPa, which has already yielded.

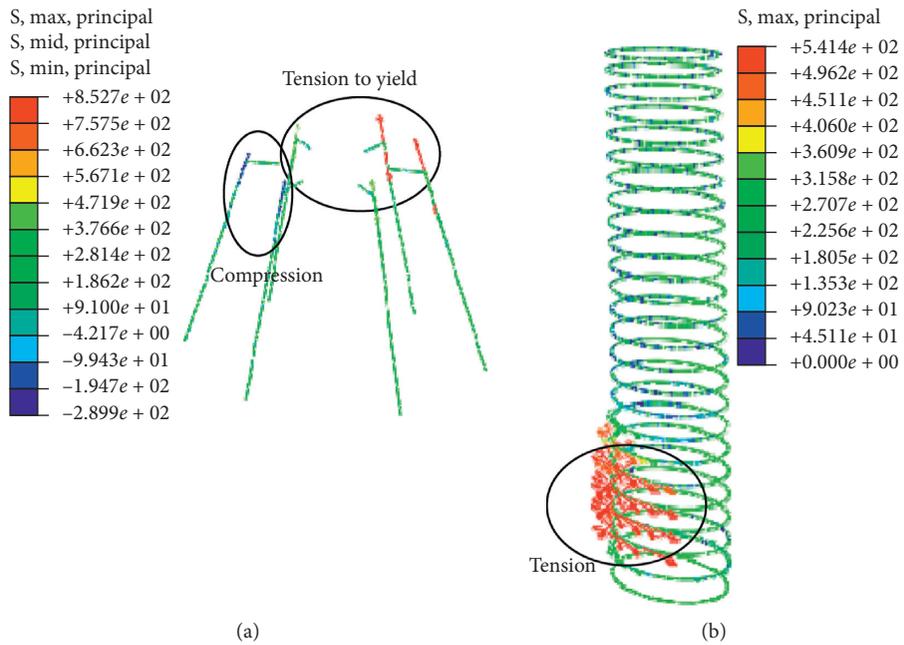
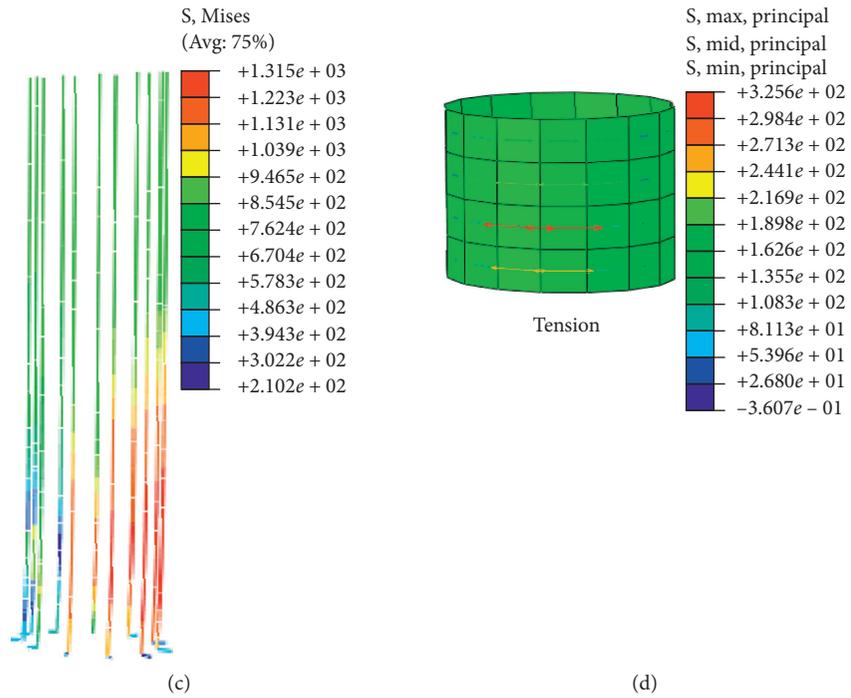
FIGURE 17: The stress distribution of specimen CT-8. (a) Anchor bars. (b) Stirrup. (c) Prestressed bar. (d) CFRP.

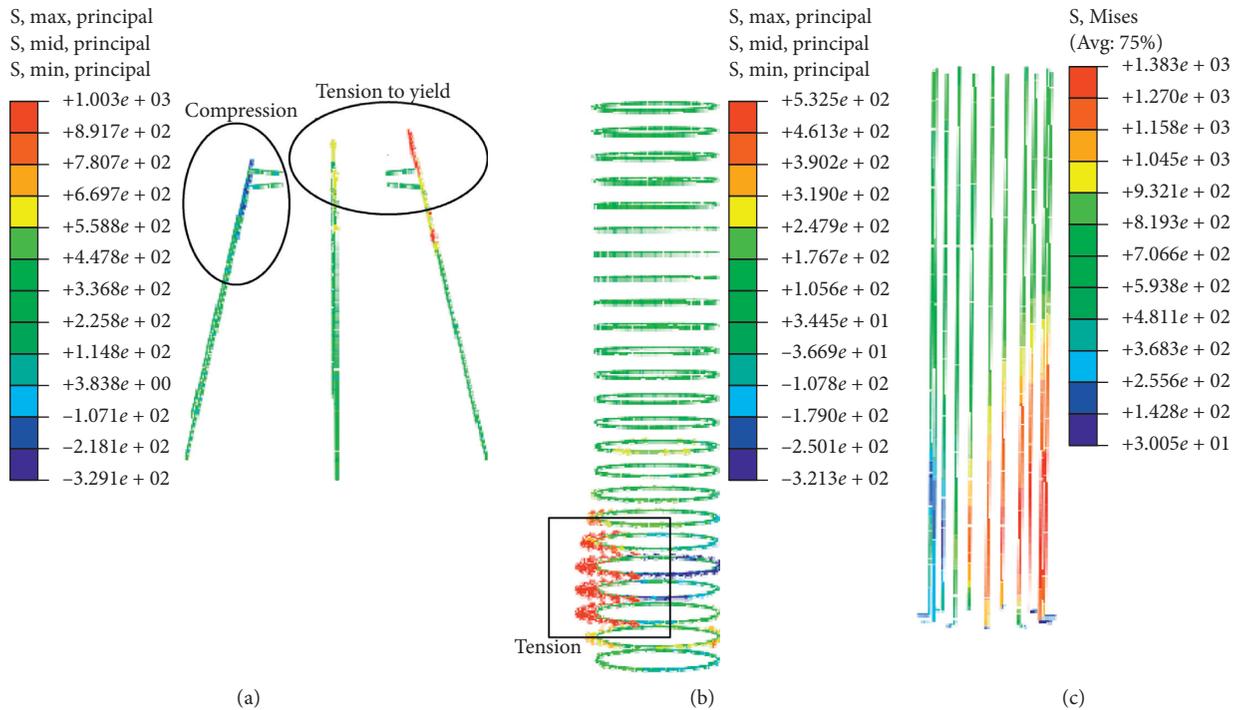
FIGURE 18: The stress distribution of specimen CT-9. (a) Anchor bars. (b) Stirrup. (c) Prestressed bar.

Figure 18 shows the stress distribution of steel bars of specimen CT-9. The maximum tensile stress of anchor bars is 1062 MPa, which is bigger than CT-7. The maximum tensile stress of prestressing bars is 1399 MPa, which is smaller than CT-7. Considering the effect of steel fiber in analysis, the ultimate tensile stress of concrete was increased, which caused the concrete to share a part of the tensile stress of the prestressing bars, and its tensile stress decreased.

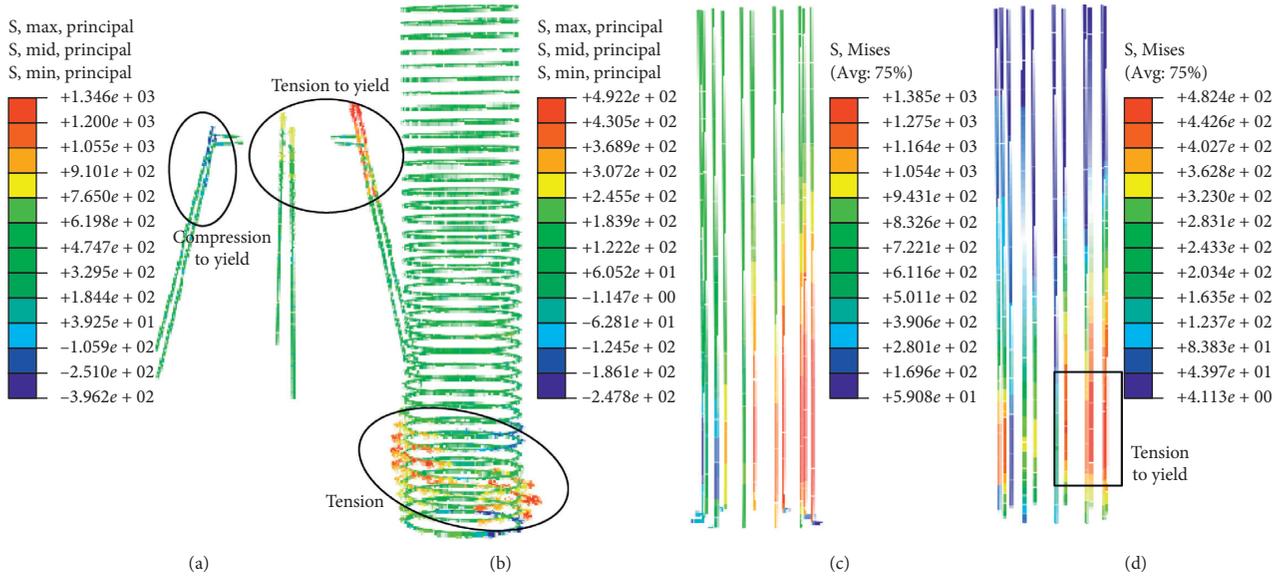
FIGURE 19: The stress distribution of specimen CT-10. (a) Anchor bars. (b) Stirrup. (c) Prestressed bar. (d) Deformed bars.

Figure 19 shows the stress distribution of steel bars of specimen CT-10. The maximum tensile stress of anchor bars is 1386 MPa, which is bigger than its ultimate tensile strength. It can be seen from Figure 19(b) that the stress of

stirrup is smaller than that of specimen CT-7, and the maximum stress appears at tensile and compressive side. Figure 19(c) indicates that the maximum stress of prestressing bars is 1387 MPa due to the existence of deformed

bars. Figure 19(d) indicates that the deformed bars have yielded, and the maximum stress is 496 MPa. Therefore, the tensile stress of prestressing bars decreases after the pile is reinforced with deformed bars. The connection will not fail

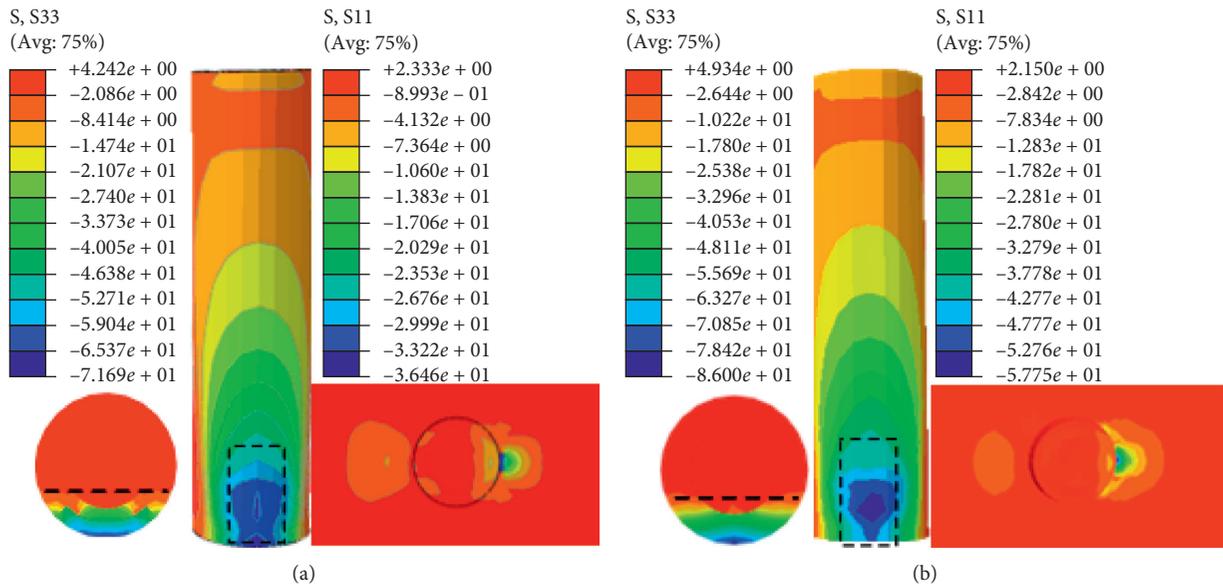
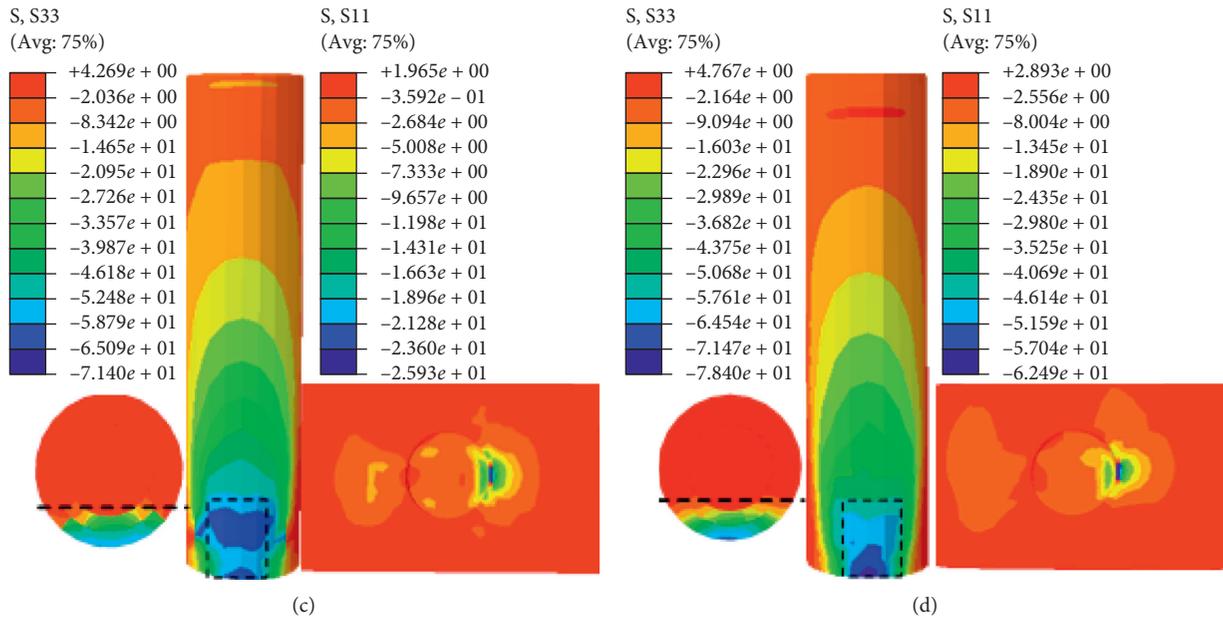
FIGURE 20: Concrete stress distribution of CT-7~CT-10. (a) CT-7. (b) CT-8. (c) CT-9. (d) CT-10.

specimen CT-7; therefore, the ultimate bearing capacity is bigger. In addition, the cap of specimen CT-8 is subjected to bigger squeezing stress than that of specimen CT-7, and the test results showed that the cap of specimen CT-8 is damaged more seriously than that of specimen CT-7.

Figure 20(c) shows that the compressive stress of pile and squeezing stress of cap is almost same with CT-7, but the maximum tensile stress is smaller than CT-7.

It can be seen from Figure 20(d) that the maximum compressive stress of pile is 78.4 MPa, and the maximum

squeezing stress of cap is 62.5 MPa, which is bigger than CT-7. This is because the flexural capacity of pile was reinforced by deformed bars, which caused the flexural capacity of pile cap to be increased; therefore, the compressive stress of pile and squeezing stress of cap also increased.

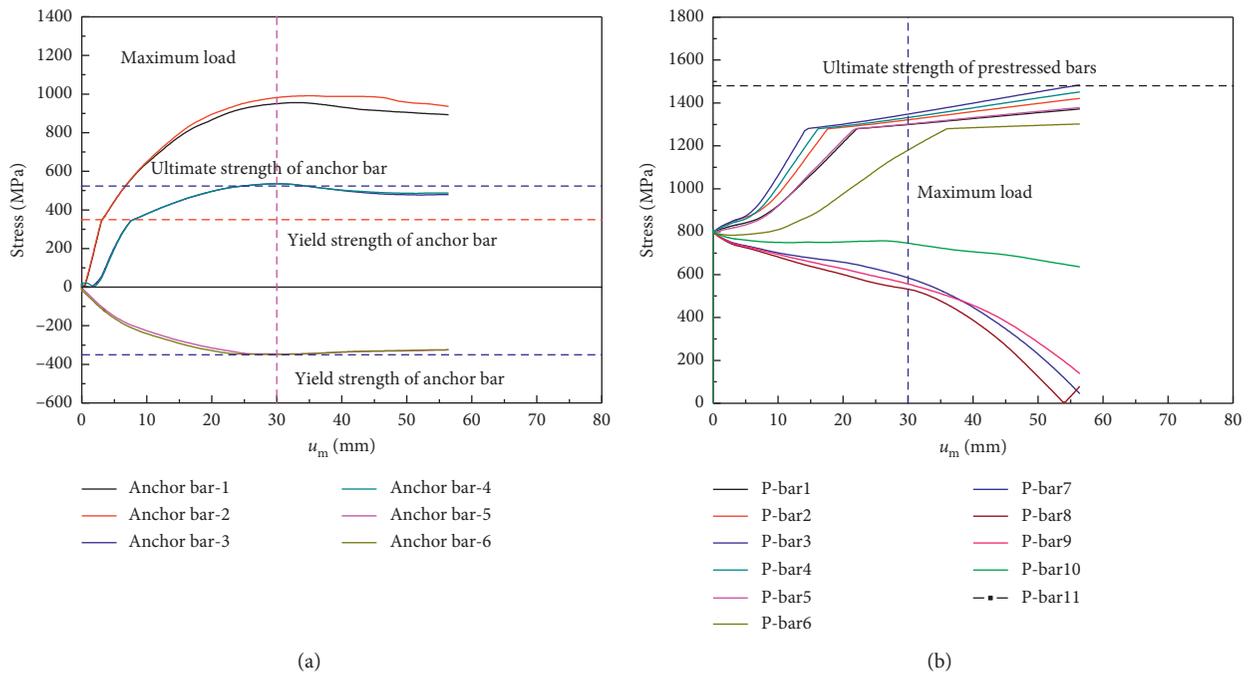
FIGURE 21: Stress-displacement curves of CT-7. (a) Anchor bar. (b) Prestressed bar.

prestressing bars in the tension zone increases with the increase of displacement. The tension stress of prestressing bars in the compressive zone decreases, and the tension stress of three prestressing bars at the maximum compressive zone is eliminated completely.

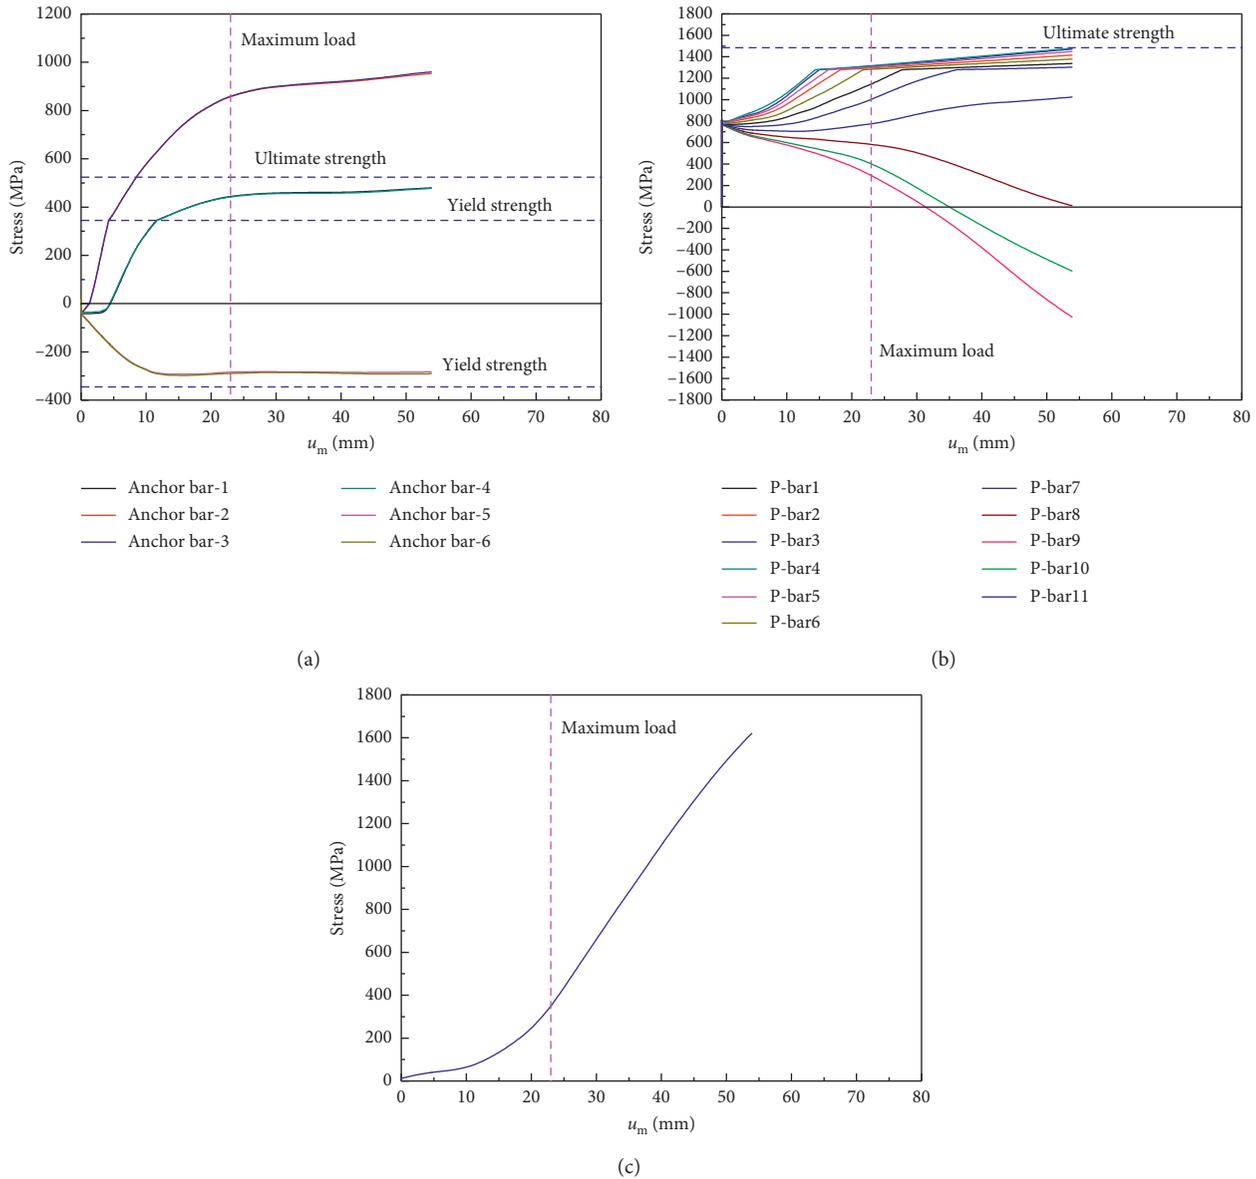
FIGURE 22: Stress-displacement curves of CT-8. (a) Anchor bar. (b) Prestressed bar. (c) CFRP.

The maximum stress-displacement curves of anchor bars, prestressed bars, and CFRP during the loading process of CT-8 are shown in Figure 22. It can be seen from Figure 22 that four anchor bars were under compression at the initiation of loading. As the displacement increased, two of them gradually turned into tension and yielded at last. The two anchor bars of compressive zone did not yield because confinement of CFRP improved the flexural capacity of pile end. Compared with CT-7, the prestress of prestressing bars was eliminated more obviously, which indicates that the compression side of pile undertook greater compressive force. Figure 22(c) shows that the stress of CFRP is 326 MPa

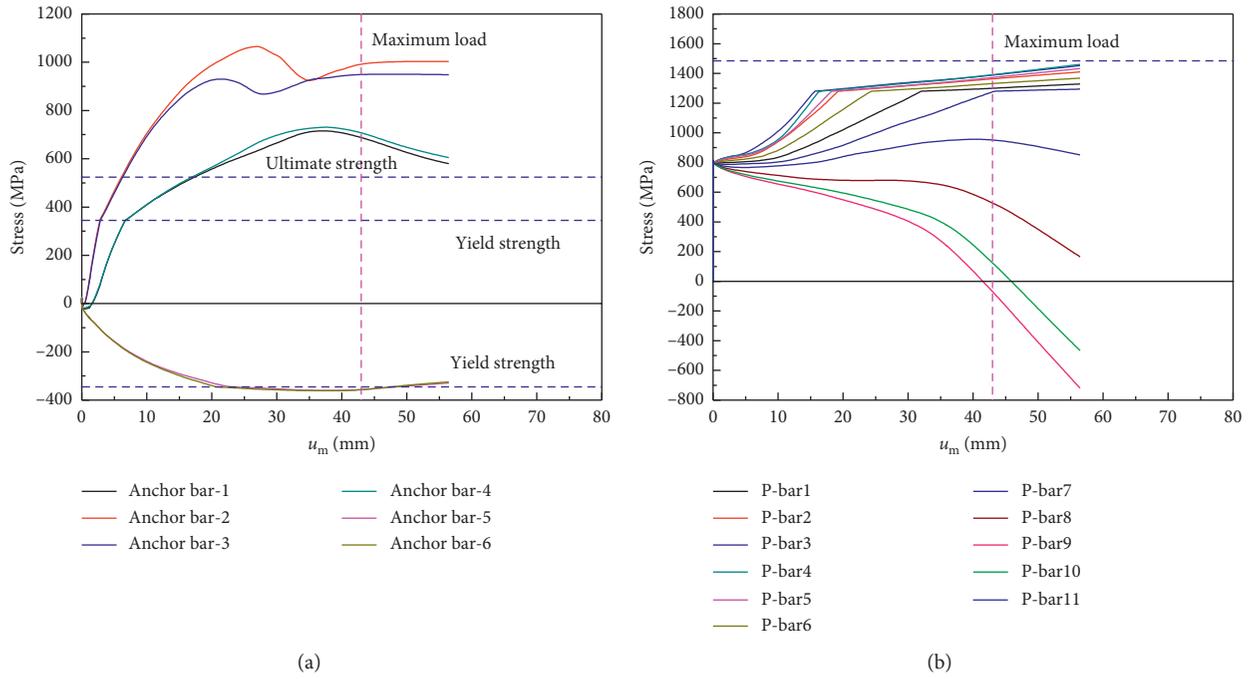
FIGURE 23: Stress-displacement curves of CT-9. (a) Anchor bar. (b) Prestressed bar.
