## Research Article

# Study on Seismic Performance of Improved High-Strength Concrete Pipe-Pile Cap Connection

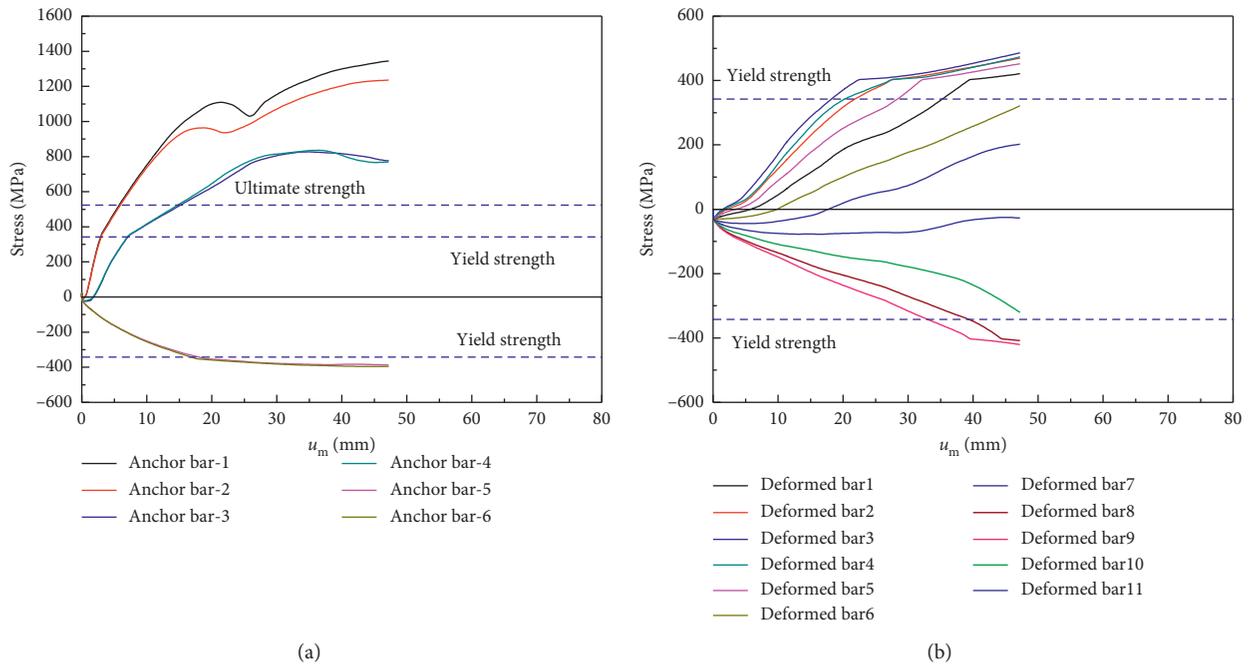
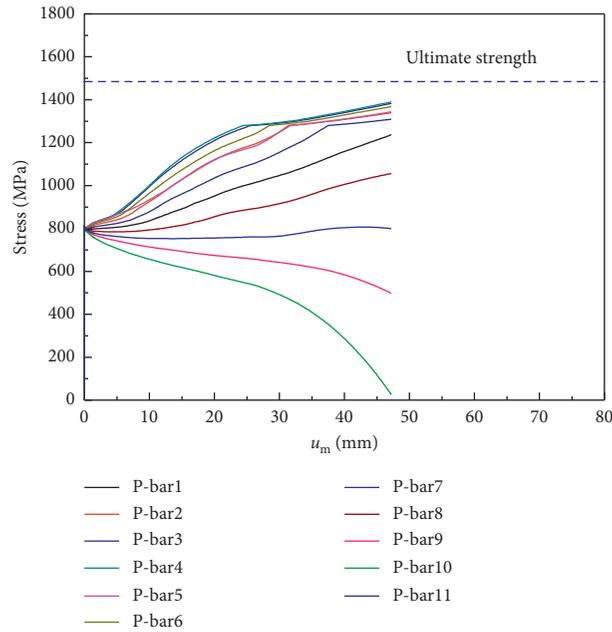
FIGURE 24: Stress-displacement curves of CT-10. (a) Anchor bar. (b) Deformed bar. (c) Prestressed bar.

The maximum stress-displacement curves of anchor bars and prestressing bars during the loading process of CT-10 are shown in Figure 24. It can be seen from Figure 24(a) that the stress of anchor bars of CT-10 is bigger than that of CT-7. Figure 24(b) indicates that the deformed bars were under compression at the initiation of loading, which is caused by prestressing stress and axial loading. With the increase of displacement, a part of deformed bars began to be tensile, and the deformed bars at maximum tensile and compression zone both yielded. Figure 24(c) shows that the tensile stress of prestressing bars decreased during the loading process of CT-10 after reinforced with deformed bars. As researching the ultimate bearing capacity, the prestressing bars did not reach their ultimate tensile strength.
