Research Article

Fire Resistance of Composite Beams with Restrained Superposed Slabs

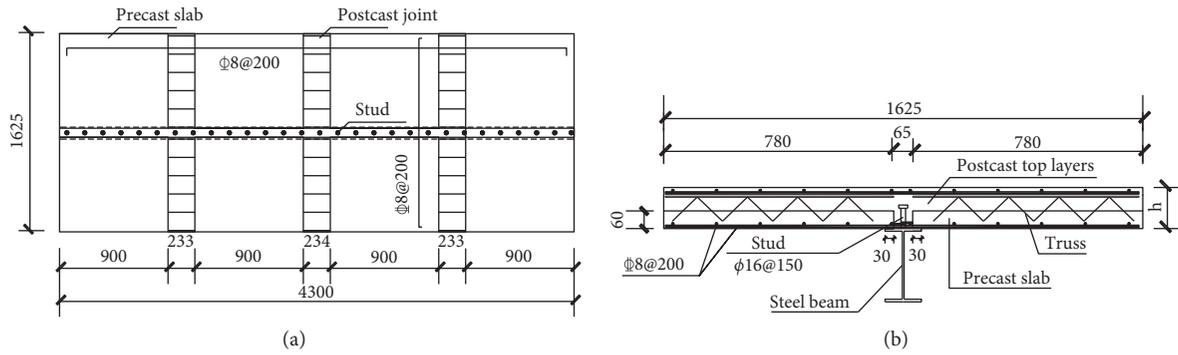
FIGURE 1: Specimen details: (a) plan view and (b) sectional view (unit: mm).

2.1. Specimen Design. Three specimens of composite beams with superposed slabs (SCB-1–3), consisting of a steel beam, concrete superposed slabs, and shear studs, were designed and fabricated according to relevant engineering standards. The total length of the composite beams was 4,300 mm, and the width of the flanges was 1,625 mm. The concrete superposed slabs were composed of a 60 mm thick precast base layer and a postcast top layer. The nominal concrete grade for both layers was C30. A two-layer configuration of rebars running in the two orthogonal directions was used as the main reinforcement in the superposed slabs. The spacings for the bottom and top rebars were 150 mm and 200 mm, respectively. In addition, truss rebars were also arranged in the superposed slabs. The I-section beams were manufactured using Q235B hot-rolled steel with nominal dimensions of HN 250 mm × 125 mm × 6 mm × 9 mm. The nominal diameter of shear studs was 16 mm. The dimensions and reinforcement details of a typical specimen are shown in Figure 1. Table 1 lists the thickness of the postcast top layers in the superposed slabs and the spacing of shear studs which were the main parameters examined in this study.

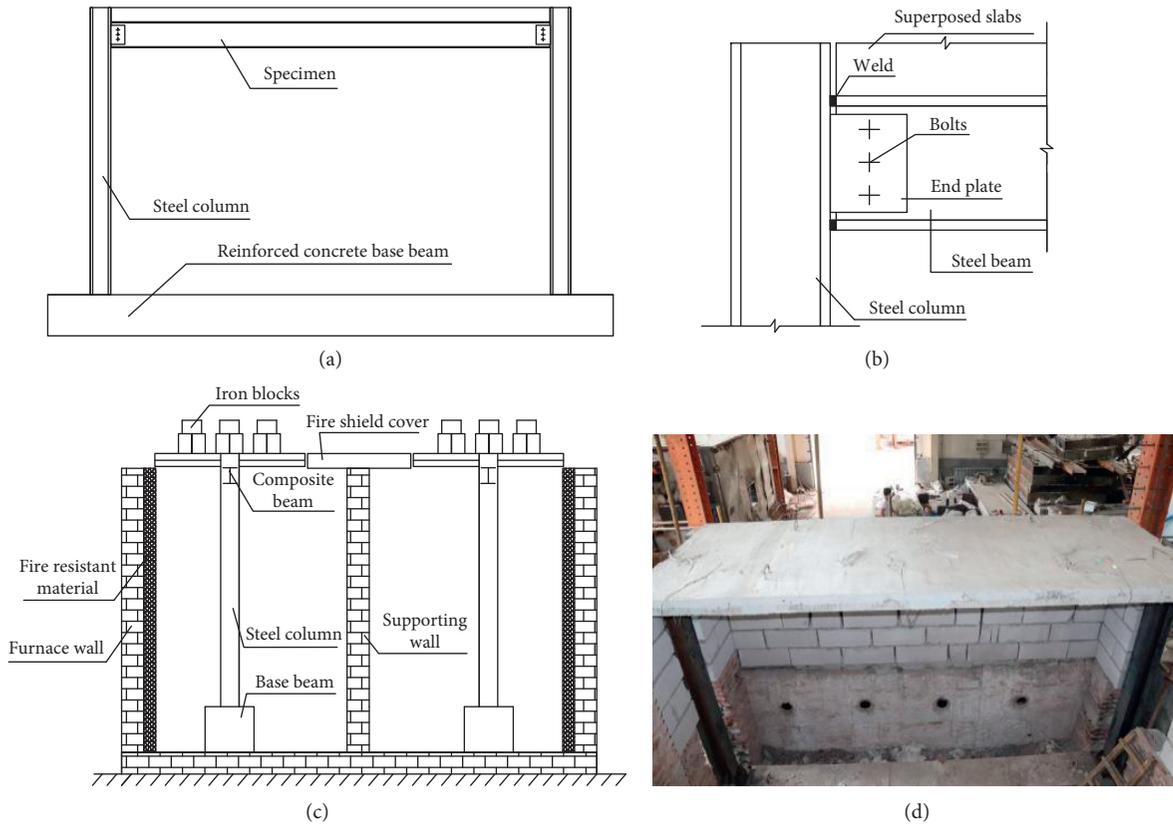
FIGURE 2: Experimental program: (a) specimen restraining scheme, (b) details of restraints, (c) test setup, and (d) composite beam specimen.

2.3. Boundary Conditions. The tests were conducted in the Fire Laboratory of Shandong Jianzhu University. The furnace was modified based on the test requirements and allowed two specimens to be tested at the same time. To restrain the specimens, a reinforced concrete base beam and two steel columns (Figure 2(a)) were fabricated and assembled. During the fire tests, they were covered by fire-resistant mineral wool. The steel columns were 2,800 mm high and fixed to the based beam through steel studs. These columns were made of Q235B steel and their sectional dimensions were HN 200 mm × 200 mm × 8 mm × 12 mm. The specimens were fully fixed to the steel columns through M22 friction high-strength bolts and steel end plates that had dimensions of 210 mm × 160 mm × 10 mm (Figure 2(b)). The test setup and the composite beam specimen ready for testing are shown in Figures 2(c) and 2(d), respectively.

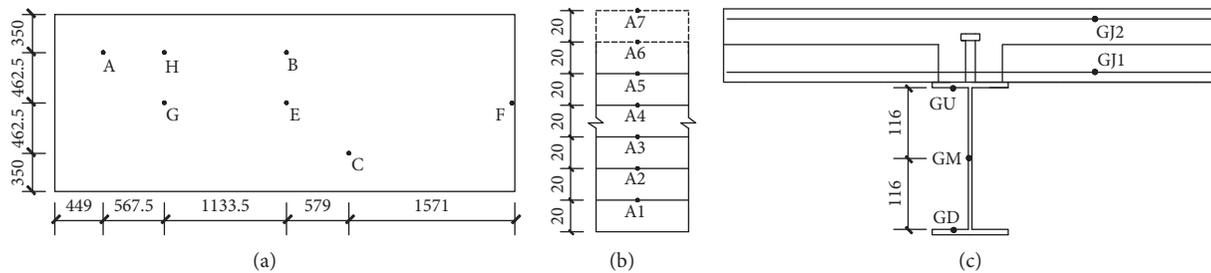
FIGURE 3: Temperature measurement positions: (a) plan arrangement, (b) measurement positions for concrete, and (c) measurement positions for rebars and steel beams.

2.4. Measurements. The temperature distribution and displacements of the composite beam were measured during the fire tests. The temperatures were measured at seven locations (A–C and E–H) of the specimens. Specifically, the thermocouples at the positions A–C and H monitored the temperatures of concrete and rebar while the thermocouples at the positions E–G measured the temperatures of concrete and steel beams. For the concrete, thermocouples were arranged with a 20 mm spacing in the slab thickness direction. Moreover, temperatures were measured for top and bottom layers of rebars, top and bottom flanges of steel beams, and the web of steel beams. The measurement position details are shown in Figure 3.

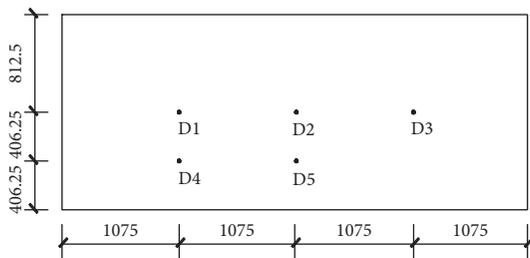
FIGURE 4: Arrangement of LVDTs.

The displacements of the composite beam specimens were measured using five linear variable differential transformers (LVDTs) arranged at selected positions (D1–D5) shown in Figure 4.

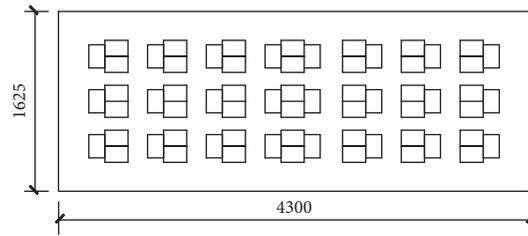
FIGURE 5: Layout of the iron blocks.

2.5. Loading Scheme. In the test, two layers of iron blocks were placed on the top surface of the specimens to simulate a uniformly distributed load (UDL) of 3.5 kN/m². Figure 5 shows the layout of the iron blocks. After the UDL was

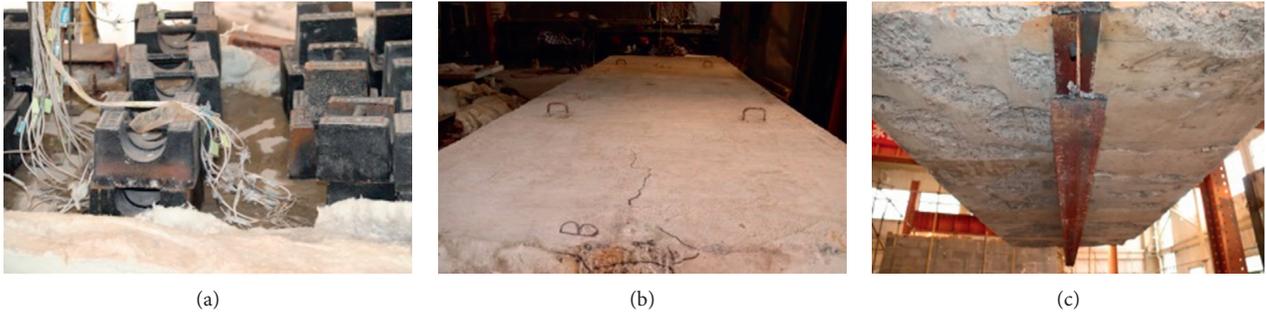
FIGURE 6: Failure modes of SCB-1: (a) water bay, (b) cracks on the top surface of the slab, and (c) local bursts on the bottom surface of the slab.

3.1.1. SCB-1. After being heated for 8 minutes, a bursting sound occurred from the superposed slabs. At 10 minutes of the fire test, an overall vibration of the composite beam, accompanied by a loud sound, was observed. At 27 minutes, water spots began to appear near the ends of the superposed slabs. Along with the temperature rise, the water spots continued to grow, forming a large scope

water bay shown in Figure 6(a). At 52 minutes, the deflection at the midspan had been largely developed. The scope of the water bay gradually shrunk with the increased temperature. At 75 minutes, the heating process was terminated as severe out-of-plane buckling of the slab occurred.

observed on the bottom surface of the concrete slab yet local bursts happened (Figure 6(c)). (5) At the end restraints, the weld joint between the top flange of the steel beam and the

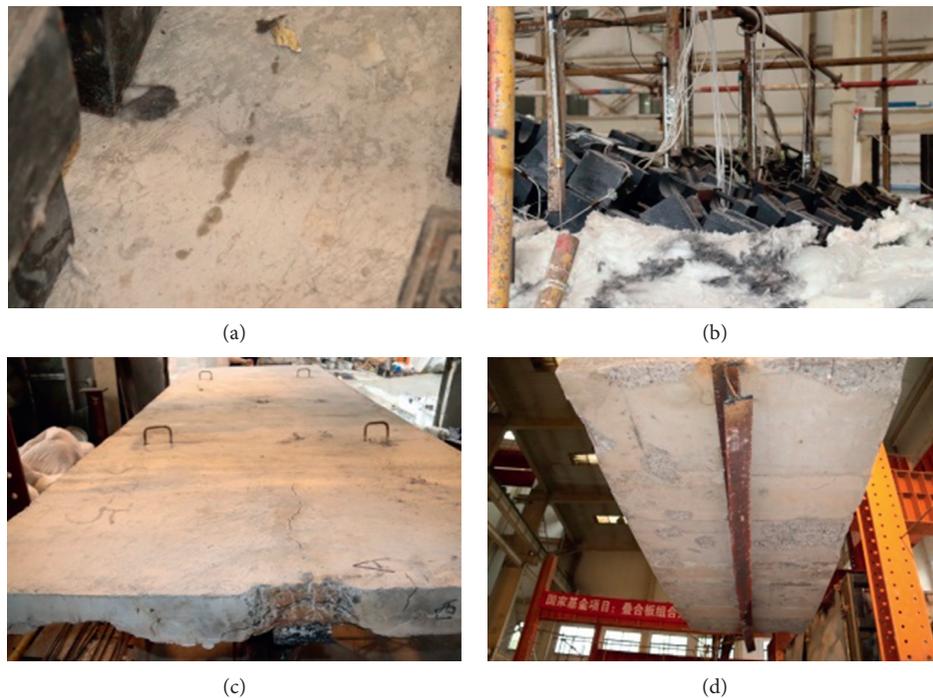
FIGURE 7: Failure modes of SCB-2: (a) water spots, (b) severe out-of-plane instability of the slab, (c) cracks on the top surface of the slab, and (d) local bursts on the bottom surface of the slab.

severe out-of-plane buckling of the slab which is shown in Figure 7(b).

condition. (1) The top surface cracks (Figure 7(c)) appeared from both ends of the slab and grew toward its midspan along the longitudinal direction. The same maximum crack width of 1 mm was also measured from the SCB-2 specimen.

(2) Similar distribution patterns of the vertical cracks were developed on both longitudinal and transverse side surfaces of the concrete slab while local bursts (Figure 7(d)) also took place on its bottom surface. (3) In contrast with SCB-1, the weld joint for both top and bottom flanges of the steel beam fractured and produced the loud sound.

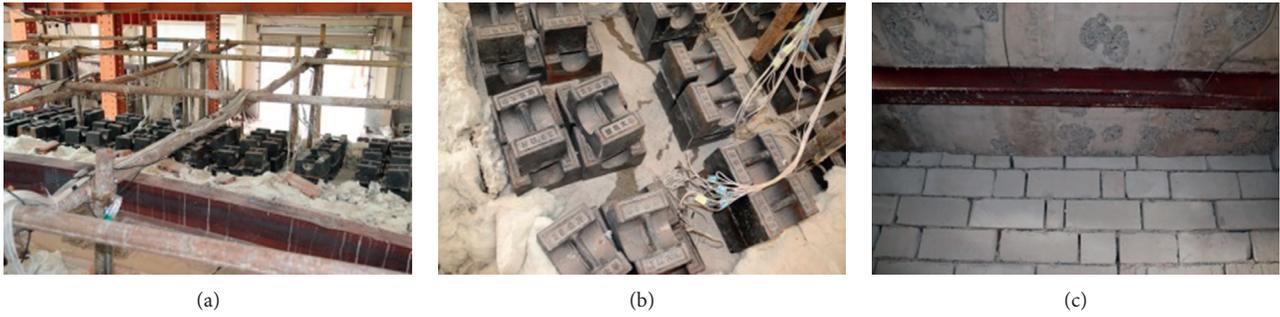
FIGURE 8: Failure modes of SCB-3: (a) vertical deflection, (b) water spots, and (c) local bursts on the bottom surface of the slab.

3.1.3. SCB-3. The overall specimen vibrations, together with loud sounds, occurred twice after 9 and 12 minutes of the fire test. At 18 minutes, a noticeable vertical deflection (Figure 8(a)) at the midspan of the specimen was observed. At 29 minutes, water spots were observed at both ends and midspan of the specimen, as shown in Figure 8(b). At 32 minutes, the out-of-plane buckling was generated in the tested specimen and increasingly aggravated, which ultimately stopped the test at 92 minutes.

Compared to the other two specimens, local concrete bursts (Figure 8(c)) also occurred on the bottom surface of the superposed slab, yet a relatively longer crack with a 1,205 mm length was produced on its top surface. Moreover, the weld joint for both top and bottom flanges fractured, which led to an overall distortion of the steel beam.

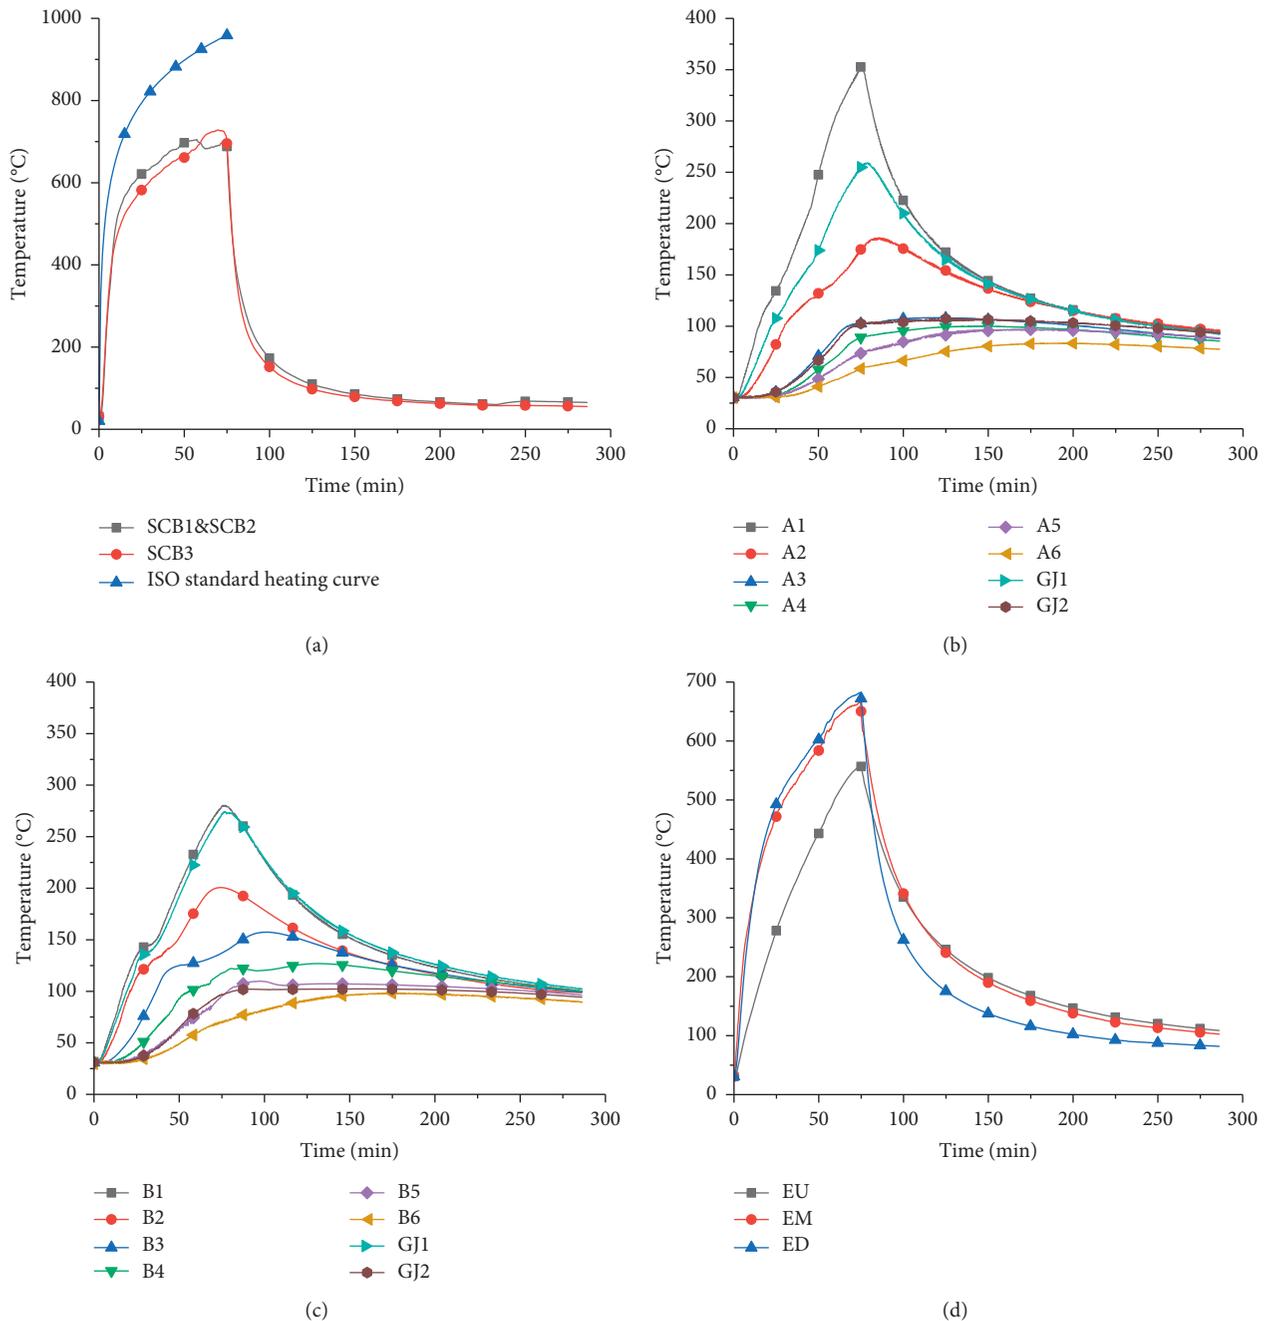
FIGURE 9: Temperature field analysis of SCB-2: (a) comparison of temperature curves, (b) temperature changes at position A, (c) temperature changes at position B, and (d) temperature changes of the steel beam.

3.2. Temperature Field Analysis. The comparison of the actual furnace temperatures of the two tests and the ISO standard heating curve is shown in Figure 9(a), which shows that the trends of the furnace temperature change fairly followed the ISO standard. The rapid temperature rise also suggests that the fire flashover was well simulated. The nearly identical furnace temperature curves of the two tests indicate that a similar temperature distribution in the three specimens could be achieved. The test results of SCB-2 are given below and analysed to present a typical thermal response of composite beams with superposed slabs.

As shown in Figures 9(b) and 9(c), owing to the thermal inertia of concrete, the temperature of the composite beam flange decreased along the height of the superposed slab section. The highest temperature was achieved at the bottom of the superposed slab, whereas the lowest one was found at its top. The most drastic change of the temperature along the slab cross section was found in the region with a distance of 40 mm to the slab bottom. With respect to the cooling, the temperature at the slab bottom went down faster than the ones at other regions in the same slab section. Due to the variation of the temperature distribution, a temperature gradient was produced along the thickness of the superposed slab. As a result, temperature stresses were generated within the slab and led to a tension effect in its top region. Such tensile temperature stresses, with the assistance of the bending moment due to the applied load, created top surface cracks along the longitudinal direction. Note that measurement position A in Figure 9(b) and position B in Figure 9(c) were at the superposed slab and the postcast joint, respectively. It is shown that the temperature gradients at these two positions were almost identical, which indicates that the superposing interfaces between the precast slabs and postcast top layers were not broken. In relation to the reinforcing bars, their temperatures were basically consistent

with the surrounding concrete. The considerable temperature differences between the top (GJ2) and the bottom (GJ1) bars were mainly attributed to their distances to the source of the heat.

Figure 9(d) depicts the temperature changes measured at three positions on the midspan section of the steel beam. Specifically, EU and ED denote the measuring points on the top and bottom flanges, respectively, whereas EM denotes the measuring point on the web. The trends of three temperature changes were approximately the same and the maximum temperature of the steel beam was as high as 682°C. In the heating stage, the temperature of the top flange was lower than the other two positions as it was connected to the superposed concrete slab which absorbed a certain amount of the heat. In comparison, relatively less heat loss was caused on the web and the bottom flange of the steel beam as they were surrounded by hot air. In the cooling stage, the temperature of the bottom flange was lower than the ones of the other two positions. It is noted that the temperature of the concrete slab was higher than the one in the furnace due to its thermal inertia. Compared to the top flange and web, the bottom flange of the steel beam received less heat transfer.

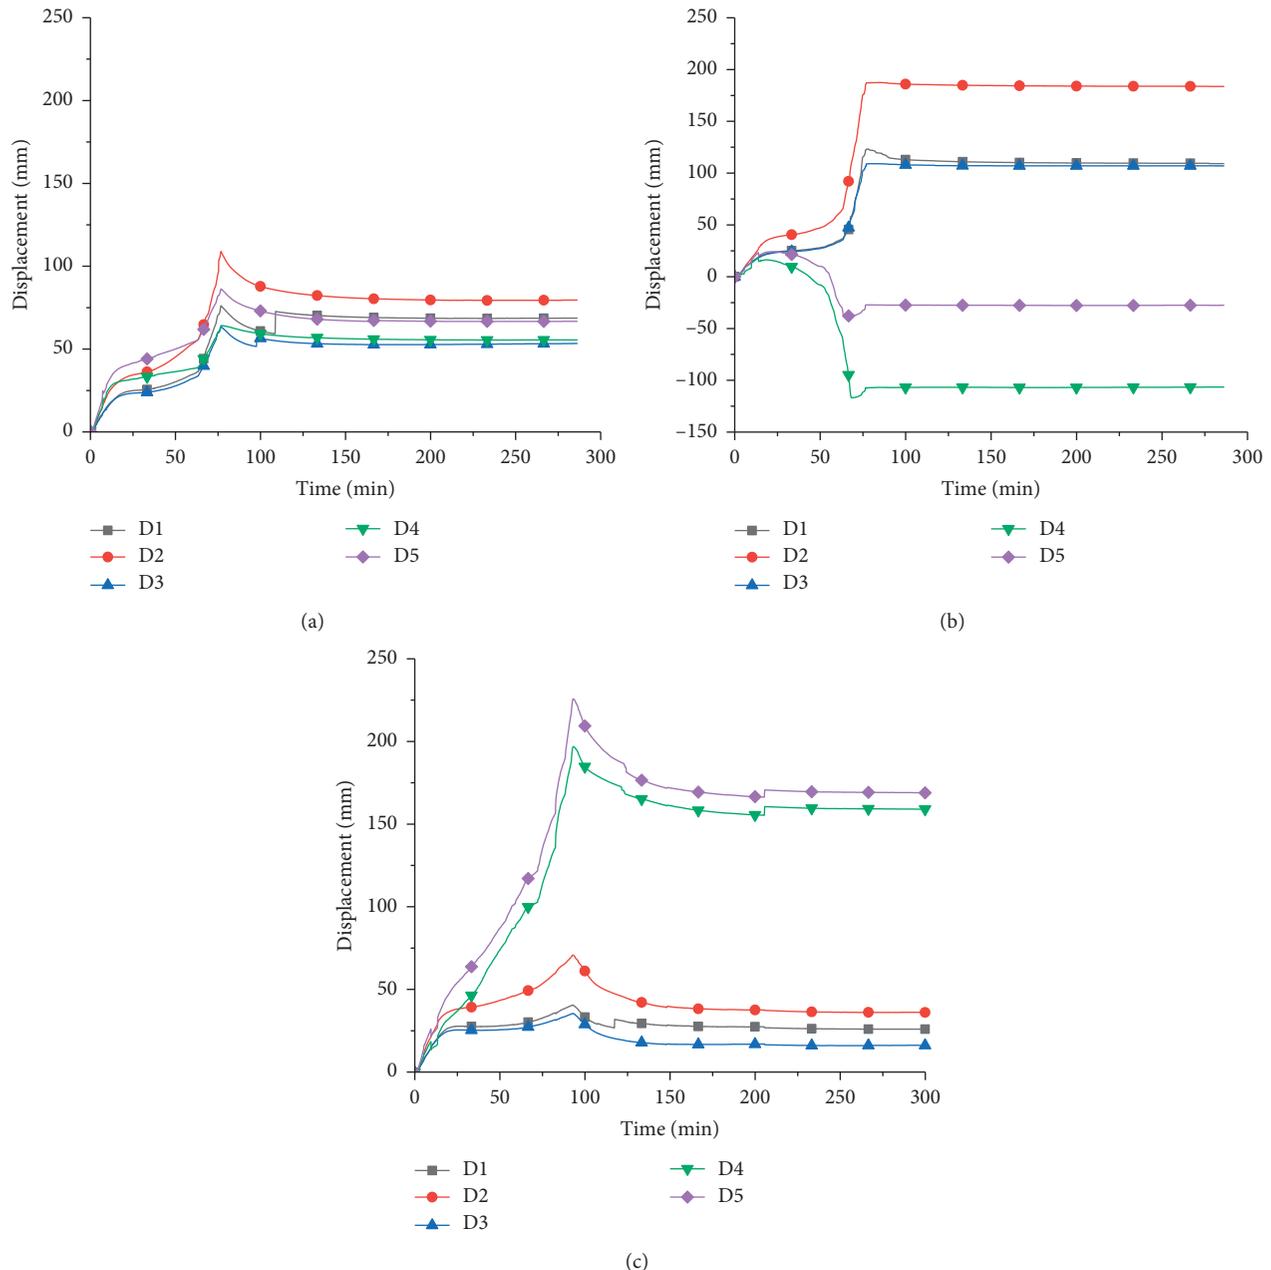
FIGURE 10: Displacement–time curves of (a) SCB-1, (b) SCB-2, and (c) SCB-3.

3.3. Displacements of Specimens. The vertical displacement developments at selected position of three tested specimens are shown in Figure 10. Among these positions, D1, D3, and D4 were located at a distance of 1/4 span to the transverse sides of the specimens, whereas D2 and D5 were located at the midspan. The downward displacements are considered positive in this study. During the test, composite beams with superposed slabs experienced a certain degree of out-of-plane buckling due to the torsion of the steel beams. As D4 and D5 were also located at a distance of 1/4 specimen width to the longitudinal sides of the specimen (see Figure 4), they were greatly affected by such a torsional effect. For SCB-1, as these two positions were on the upward movement side of the torsional axis, their displacement values were smaller than the ones of corresponding positions D1 and D2 which were approximately on the torsional axis. For SCB-2, due to a more severe torsional effect, the displacements at D4 and D5 shift from positive to negative, which indicates that their directions were changed from downward to upward during the test. In contrast to SCB-1 and SCB-2, D4 and D5 of SCB-3 were located on the downward movement side with respect to the torsional axis. As a result, larger displacement values were obtained when compared to D1 and D3.

The test data were collected until 287 minutes from the beginning of the SCB-1 test, in which a maximum displacement of 109.0 mm and a residual displacement of 79.6 mm were recorded, resulting in a deformation recovery ratio of 27.0%. The maximum displacement and the

deformation recovery ratio of SCB-2 were not available due to its severe out-of-plane buckling failure. During the test period of 300 minutes for SCB-3, the maximum and residual displacements were found to be 70.8 mm and 36.0 mm, respectively. Therefore, deformation recovery ratio of 49.1% was achieved, which was significantly larger than SCB-1. It is implied that a smaller spacing of shear studs would have a negative effect on the deformation recovery capacity of the superposed slabs.

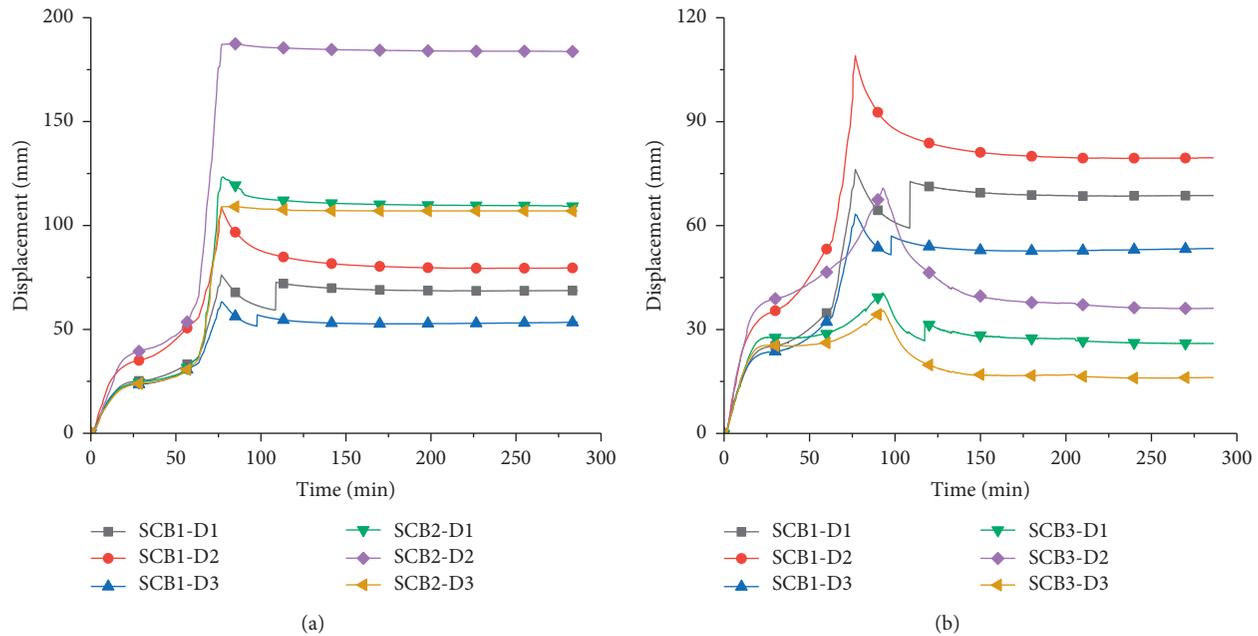
FIGURE 11: Comparisons of displacement developments of (a) SCB-1 and SCB-2 and (b) SCB-1 and SCB-3.

The comparison of the displacement developments of SCB-1 and SCB-2 is presented in Figure 11(a). It is seen that the two specimens exhibited almost identical

displacement increase patterns in the heating stage. Hence, the thickness of the postcast top layer has a negligible effect on the displacement development of the composite beams with superposed slabs. With a further increase of the temperature, the displacements of the SCB-2 grew rapidly due to the out-of-plane buckling.

Figure 11(b) depicts the comparison of the displacement developments of SCB-1 and SCB-3. Although their displacement development patterns were also found to be similar in the heating stage, the two specimens behaved differently in the cooling stage. Moreover, the displacement values of SCB-1 were higher than the corresponding ones of

SCB-3. It was largely because more shear studs with a smaller spacing were able to transfer more heat to the superposed slab, which further weakened its material and enlarged the overall deformation.

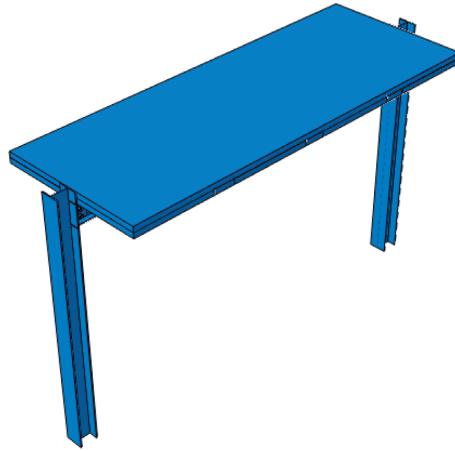
FIGURE 12: Numerical model of the composite beam specimens.

4.3. Load and Boundary Conditions. The temperature field simulation was conducted firstly, after which the loads and boundary conditions were applied. The stresses of the model in the temperature field simulation were introduced as the initial stresses for the followed thermo-mechanical coupling analysis. The bottom ends of the steel columns were fully fixed and a UDL of $3.5 \text{ kN}/\text{m}^2$ was applied to the top surfaces of the superposed slab models. The numerical model of a typical composite beam with superposed slabs specimen is shown in Figure 12.

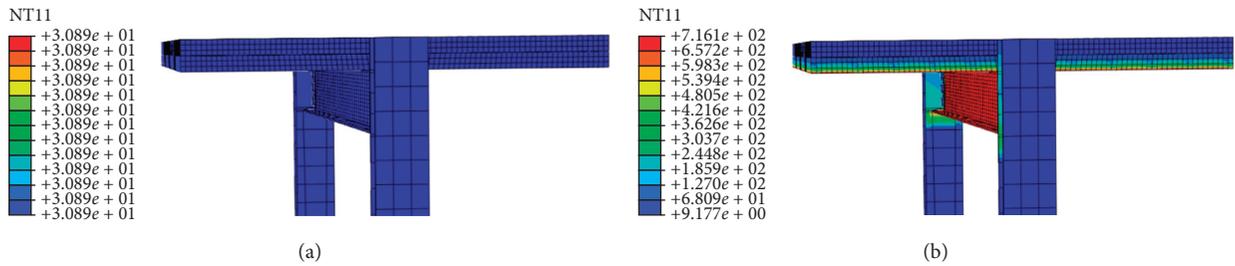
FIGURE 13: Temperature contours of SCB-2 (a) at 0 min and (b) at 75 min.

4.4. Numerical Results. As the temperature distributions of three specimens were similar, only the simulation results of SCB-2 are presented here for illustrating a typical thermal response. The temperature contours of SCB-2 at the beginning of heating and after 75 minutes are shown in Figure 13 while the simulated temperature developments in the specimen are compared against the corresponding test results in Figure 14. It is seen that simulated temperature distributions agree well with the test results.

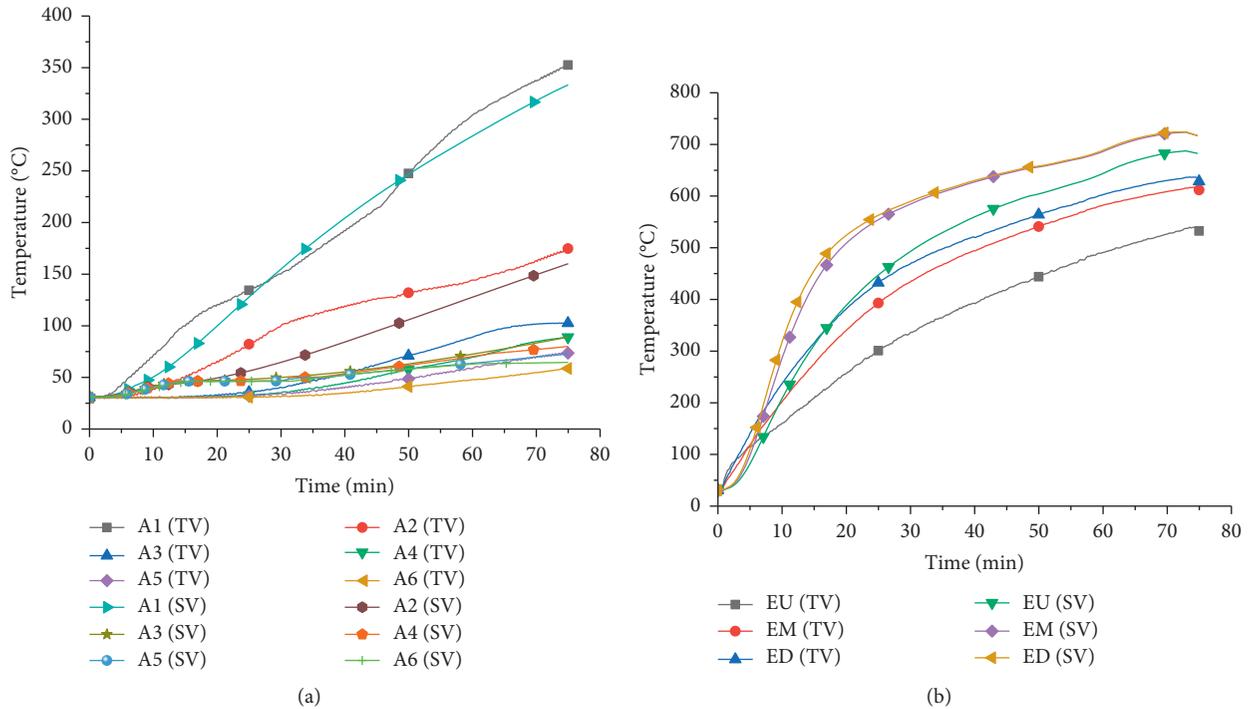
FIGURE 14: Comparison of temperature changes in SCB-2 for (a) concrete slab and (b) steel beam (note: TV = tested value and SV = simulated value; the same applies hereafter).

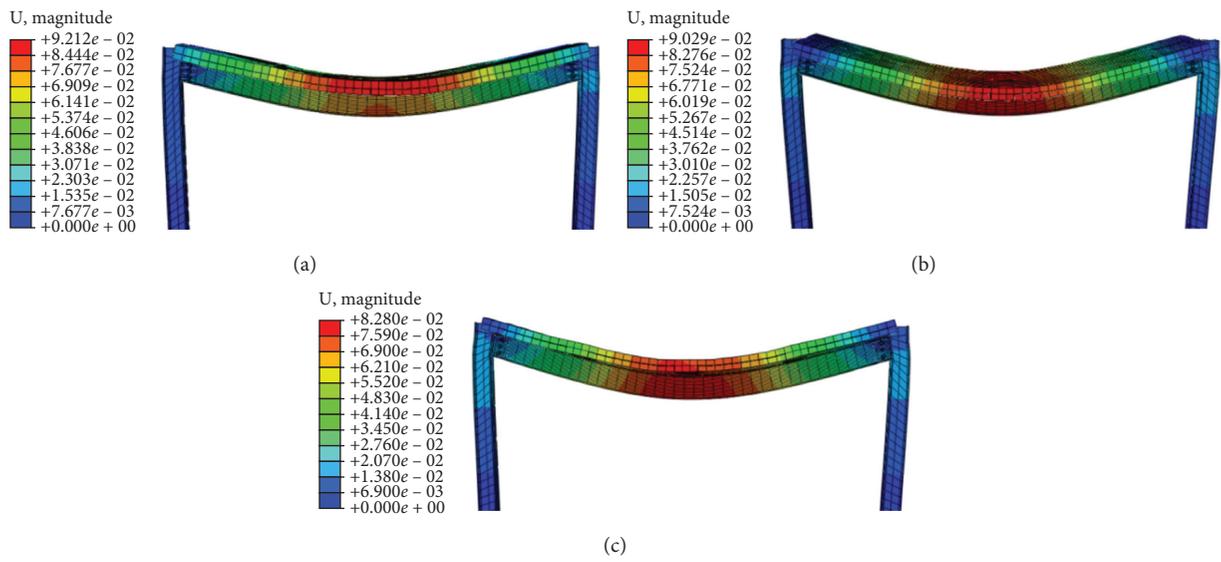
FIGURE 15: Displacement contours of three tested specimens: (a) SCB-1, (b) SCB-2, and SCB-3 (units are in m).

The displacement contours of the three tested specimens at the end of the heating stage are shown in Figure 15, while the simulated displacement developments at selected positions are compared against the corresponding test results in Figure 16. An accurate prediction

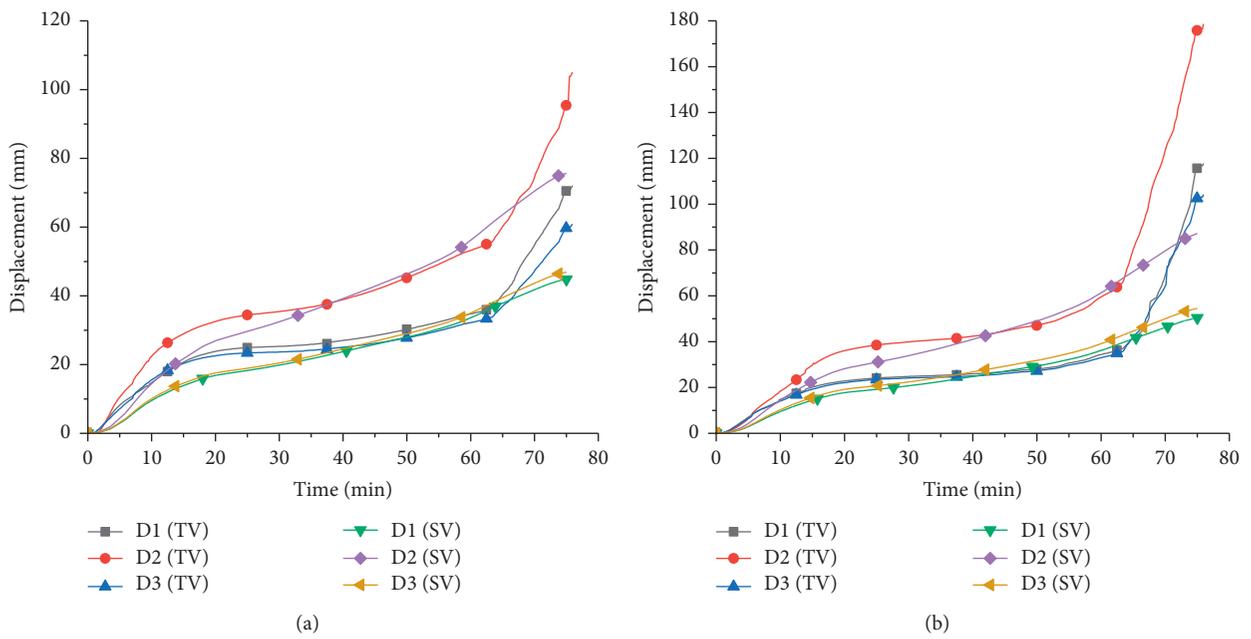
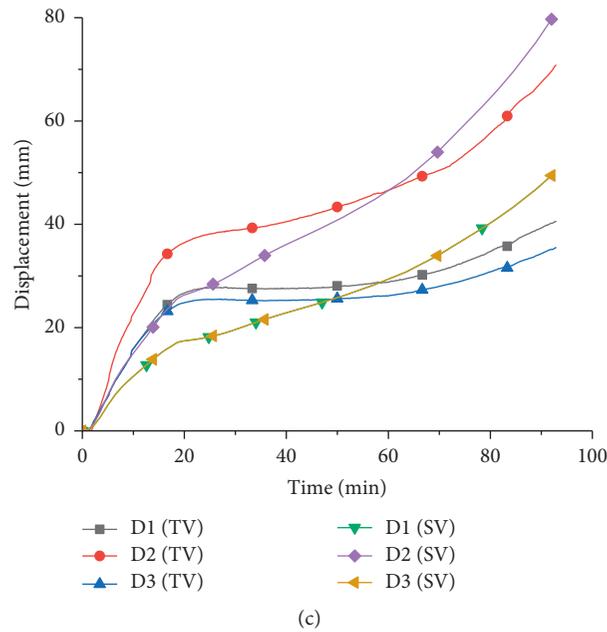
FIGURE 16: Comparison of displacement developments of three tested specimens: (a) SCB-1, (b) SCB-2, and (c) SCB-3.

of the overall displacement developments was achieved by the numerical models.
