ELECTROCHEMICAL MIGRATION IN THICK-FILM IC-S

The phenomenon of silver migration in conductor-insulator systems is well known, but it is less known that several other metals can exhibit migration. This paper tries to give a short summary of the phenomenon as applied to thick-film circuits.

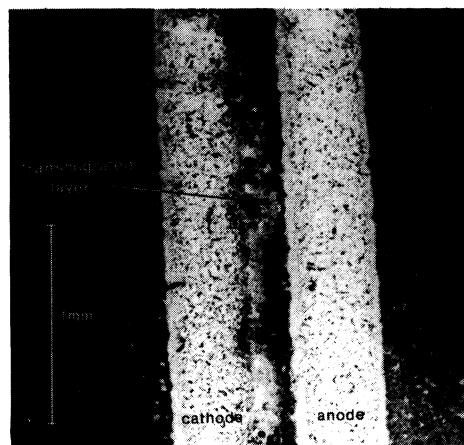
Figure 1 is a backscattered electron image (BEI) of two parallel Pd-Ag conductors. The width of the metallization stripes is 0.5 mm and the separation distance between the stripes is 0.2 mm. The material contrast sets off the outlines of the transmigrated metal layer very well. Separate dendrites are not observable (the cause of this has been mentioned above).

FIGURE 1 SEM photograph of two Pd-Ag conductors (BEI)

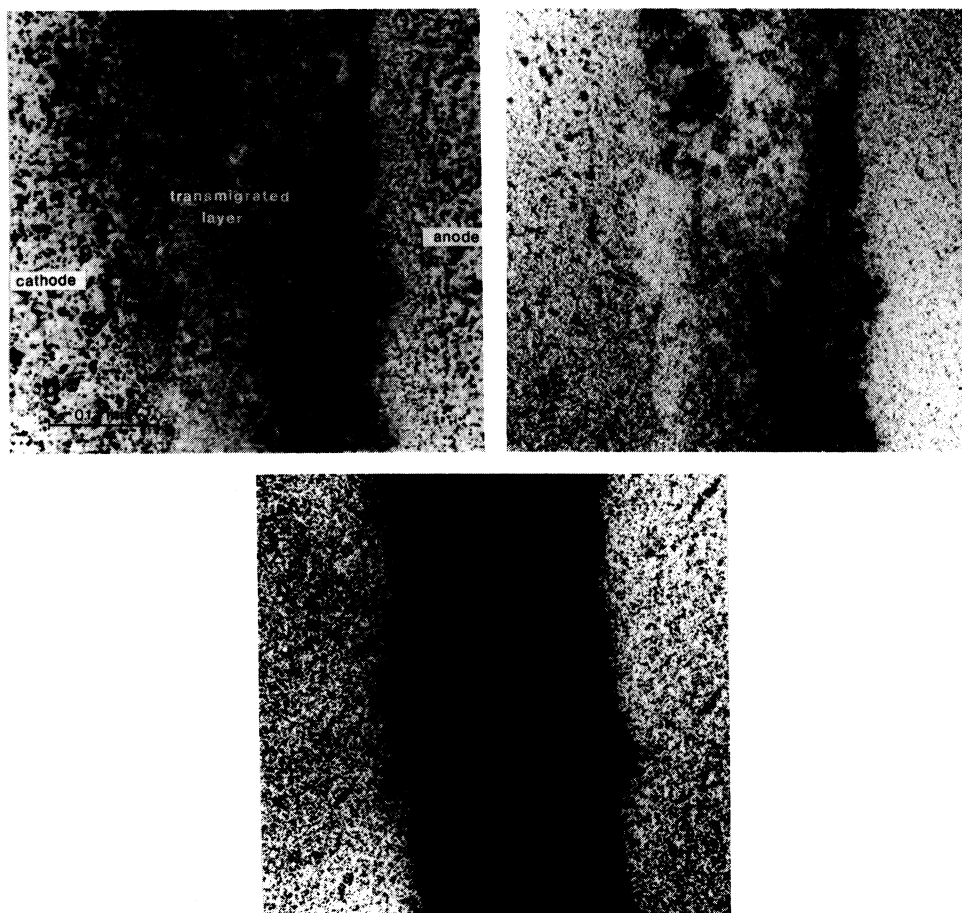
Figure 2(a) is a close up of Figure 1. Figure 2(b) and 2(c) are the x-ray intensity maps for Ag and Pd respectively. The presence of silver in the transmigrated layer can be seen very well, but the palladium did not appear to migrate.

FIGURE 2 Elemental mapping between Pd-Ag conductors. (a) SEM photograph (BEI), (b) AgL_{α} , (c) PdL_{α}

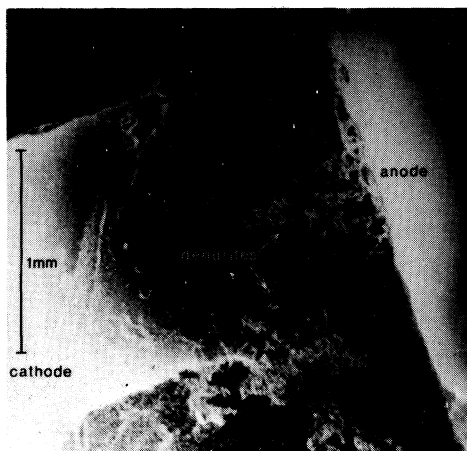
FIGURE 3 Dendrites between soldered Au-Pt conductors. (SEM photograph SEI)

Figure 3 is a SEM view of two silver free conductors covered by silver free solder. (Separation distance 0.8 mm). Transmigrated dendrites are recognizable between them. Figure 4 shows the structure of the dendrites. Figure 5(a) is a close up of a dendrite.

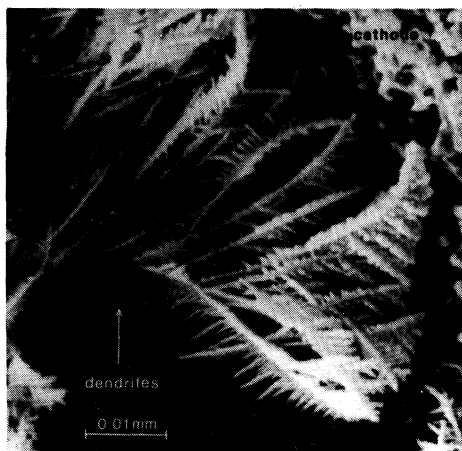
FIGURE 4 The structure of the dendrites (SEI)

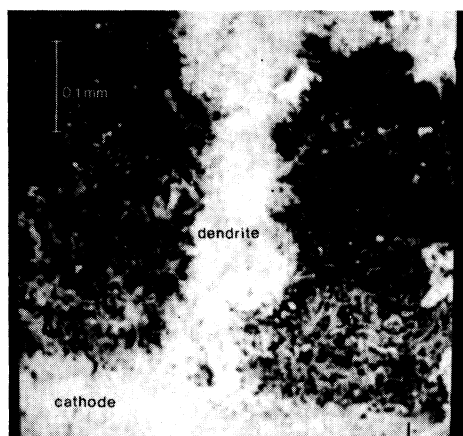
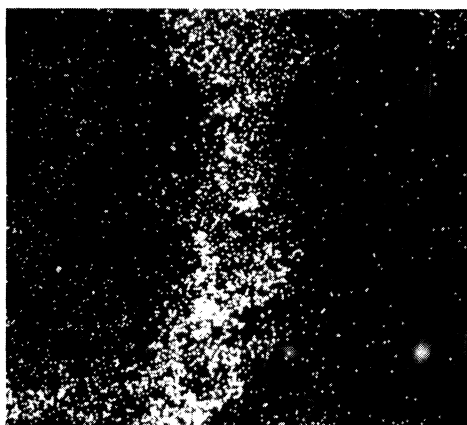
FIGURE 5 Elemental mapping of a dendrite between soldered Au-Pt conductors. (a) SEM photographs (BEI), (b) PbM_{α} , (c) SnL_{α}

The x-ray intensity maps of the same dendrite for Pb and Sn in Figures 5(b) and 5(c) show that both components have migrated.

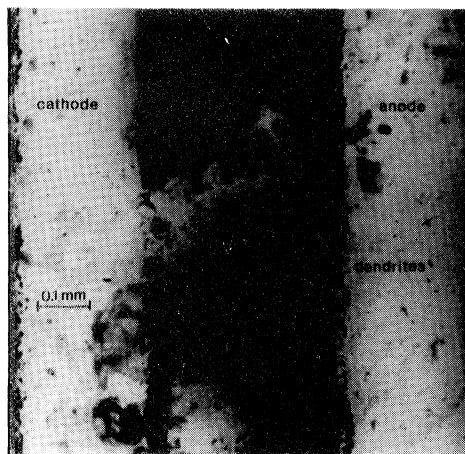
Examinations have demonstrated that copper is also liable to show migration. Figure 6 is a BEI of two parallel copper conductors. The width of the stripes is 0.3 mm, and the separation distance is 0.5 mm. The material contrast shows the transmigrated dendrites. Figure 7a is a secondary electron image (SEI) of the dendrites. Figures 7(b) and 7(c) are the x-ray intensity maps for Cu and Al respectively. These prove the presence of copper in the dendrites that contain a considerable quantity of the metal; thus they can absorb the $Al K_{\alpha}$ X-ray photons emitted by the Al_2O_3 substrate. Figure 8 is an enlarged SEI of a dendrite.

FIGURE 6 SEM photograph of two copper conductors (BEI).

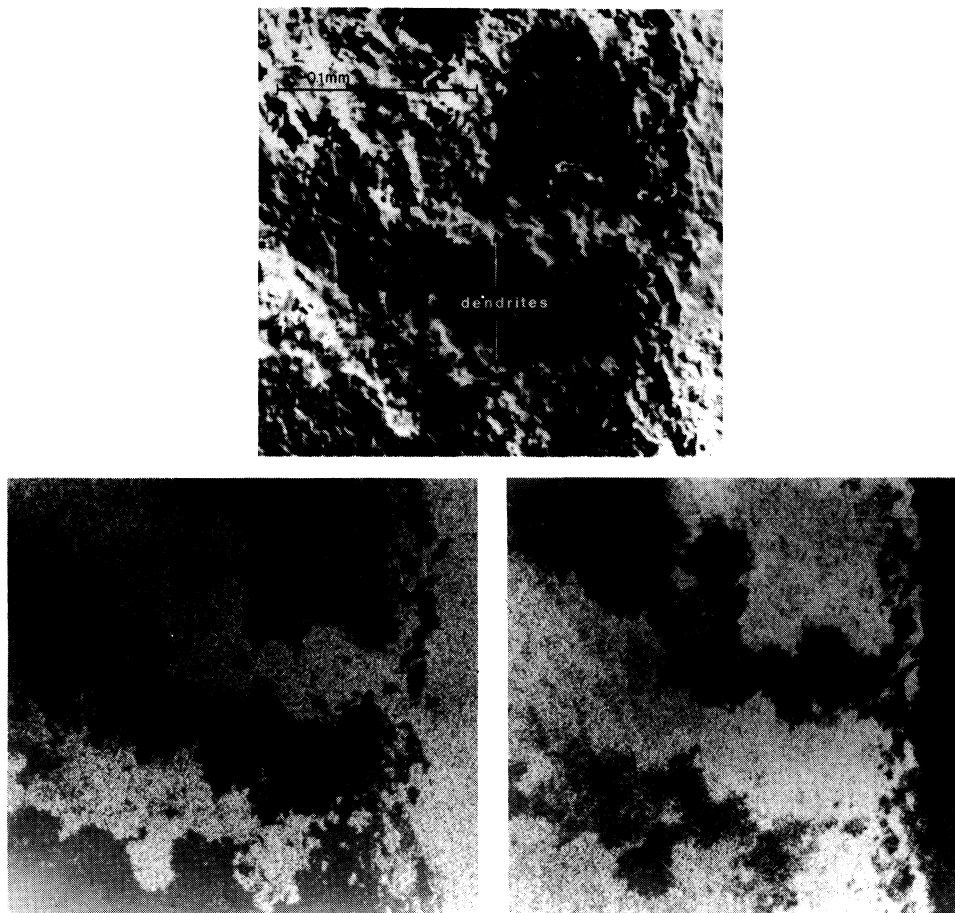
FIGURE 7 Elemental mapping of copper dendrites. (a) SEM photograph (SEI), (b) $\text{CuK}\alpha$, (c) $\text{AlK}\alpha$

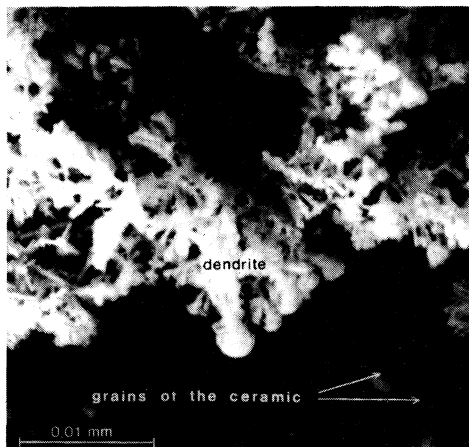
FIGURE 8 Close up of a copper dendrite.

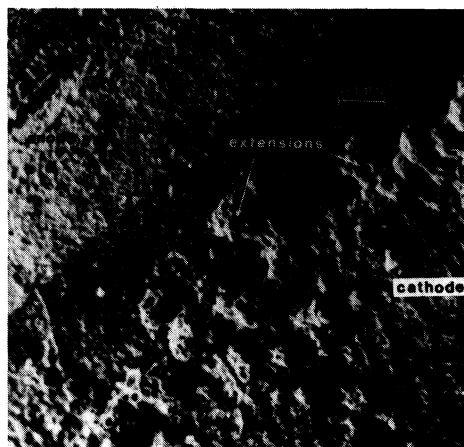
Positive ions may also be present ($x = y = 1$) which will migrate toward the cathode.⁴ Classical dendritic growth is not observed although metallic extensions appear at the cathode, as can be seen in Figure 9 (SEI of two conductors after WD test using 0.1 molar NaCl solution. The stripes and the gap are 0.3 mm wide) Figure 10(a) is an enlargement of Figure 9. The x-ray intensity map for Au in Figure 10(b) demonstrates the presence of gold in the extensions.

FIGURE 9 Gold migration (SEI).

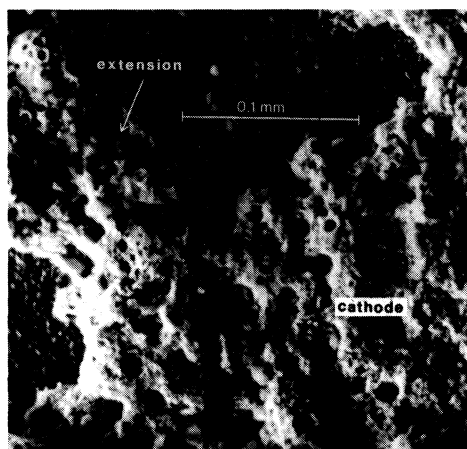
FIGURE 10 Elemental mapping of the gold conductors. (a) SEM photograph — close up of Figure 9. (b) AuM_α
