Research Article

Study on the Stress–Strain Relationships and Deterioration Modes of HTPB Propellant with Prefabricated Cracks

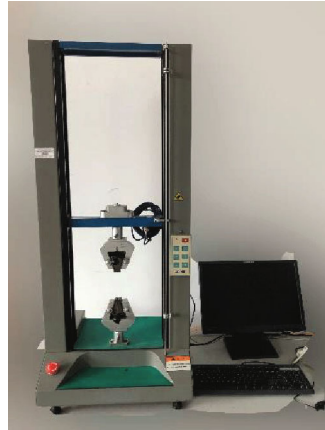
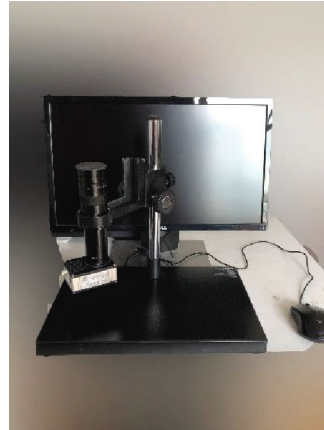
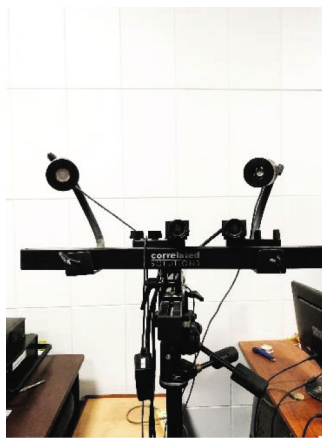
FIGURE 2: Testing equipment.

2.2. Equipment. The high-intensity microscope camera used in the tests was an Osmicro AO-HD228, a model which can achieve magnifications of 45x–400x and take pictures, as shown in Figure 2. The tests used a WDW-10 universal testing machine with a maximum testing force of 0.5 kN, as shown in Figure 2. The full-field strain measurement equipment used in the tests was the correlated SOLUTION VIC-3D System.

shows the size of each specimen. The length was 120 mm, the width was 25 mm, the length of the observed area was 70 mm, the width of the observed area was 10 mm, and the thickness was 10 mm. A penetrating crack with a length of 2 mm was prefabricated in the middle of each specimen, and its width was not measured. The crack fabrication tool constructed in situ and the universal testing machine fixture are shown in Figure 2.

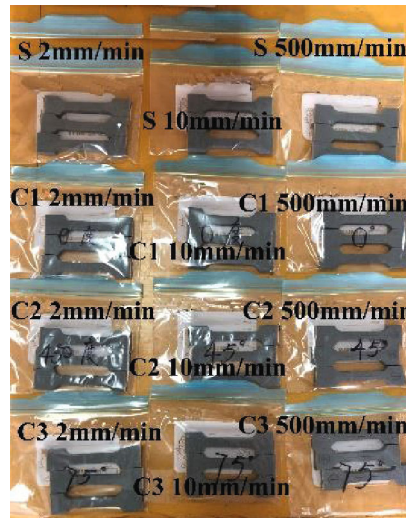
FIGURE 3: Prefabricated crack.

The production of the test specimens followed the “Ministry of Aerospace Industry of the People’s Republic of China Standard QJ924-85” [24]. Figure 3 shows an example specimen after the crack was fabricated.

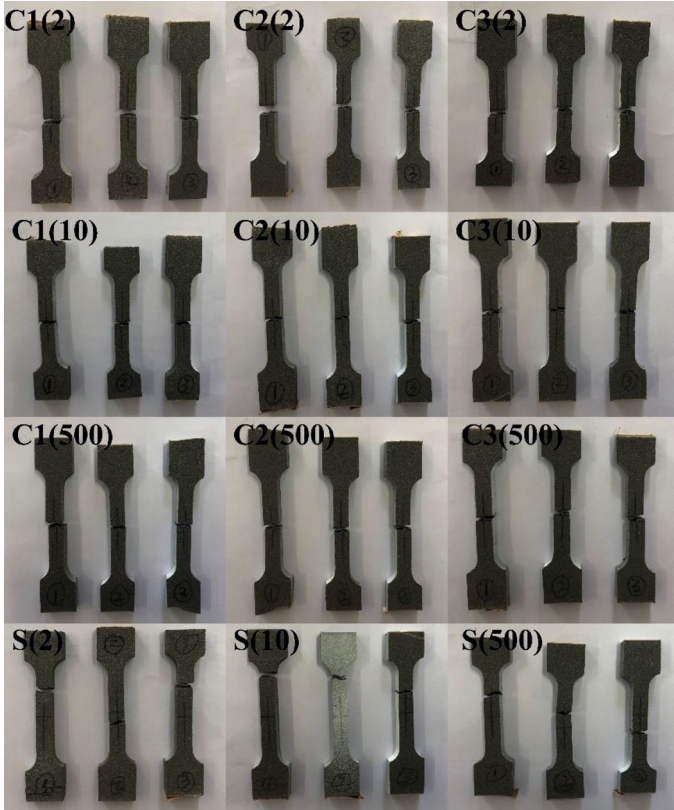
FIGURE 10: Overall shapes of the specimens after fracture.

3.3. Overall Shapes of the HTPB Propellant Specimens after Uniaxial Tensile Failure. The fractures of the C1 (0°) specimens became increasingly smoother as the tensile rate increased, and this smoothness was particularly good. The C2 (45°) and C3 (75°) specimens showed inverse “Z”-shaped cracks at the three rates, and they gradually became flatter as the tensile rate increased. The fracture positions of the cracks were random regardless of the tensile rate; some were in the middle position and some were in the neck. This result also aligned with expectations, as is shown in Figure 10.
