Research Article

Feasibility of Magnetic Resonance Imaging Monitoring of Postoperative Total Knee Arthroplasty without Metal Artifacts: A Preliminary Study of a Novel Implant Model

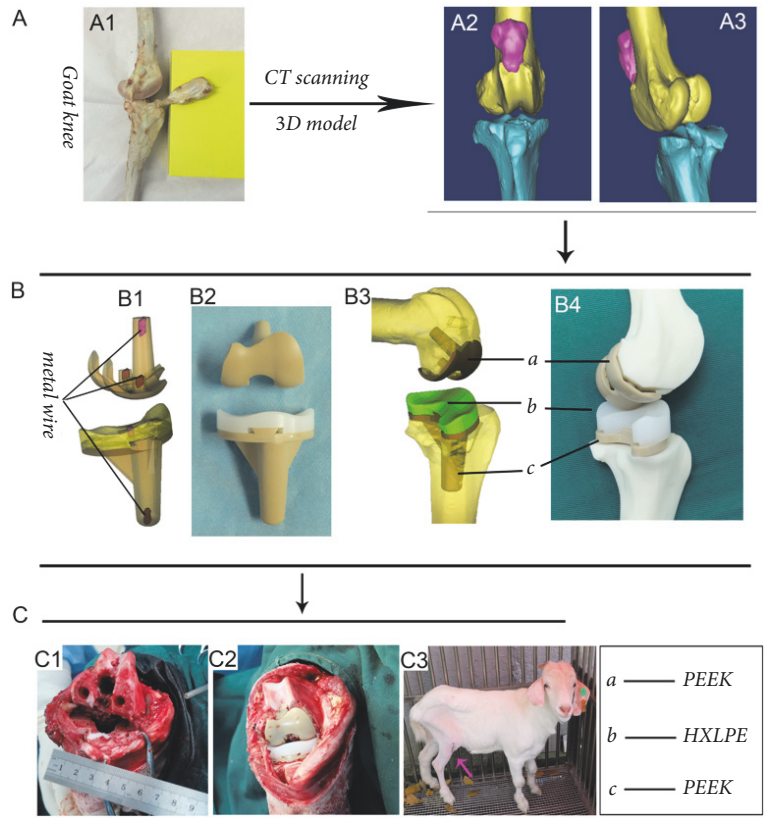
FIGURE 1: Development of a 3-dimensional (3D) model of the goat knee by computed tomography (A1-3). A 3D sketch of the polyetheretherketone- (PEEK-) on-highly cross-linked polyethylene (HXLPE) prosthesis (B1 and 3) and images of the implant (B2 and 4). The red parts in the 3D sketch (B1) represent the fine metal wires. Intraoperative images show the bone cuts and osteotomy of the distal femur and tibial plateau (C1); the prosthesis was fitted, and the bone cement was applied to the femoral and tibial sides to fix the implant (C2). The knee function of the goat is good after total knee arthroplasty (C3).

2.1. Design and Fabrication of the Goat Prosthesis. The goat prostheses and surgical instruments were designed based on CT data (Light Speed 16; GE Medical Systems, Milwaukee, WI, USA) of a standard goat's right hind limb (Figure 1(A1-3)). The PEEK component and HXLPE bearing (Zeniva PEEK ZA-500, Chirulen HXLPE 1020X) were provided by Jiangsu Okani Medical Technology Co., Ltd. (Soochow, JS, China). The prosthesis consists of a femoral component (PEEK) and a tibial tray (PEEK) with an insert bearing (HXLPE) (Figure 1(B1-3)). The tibial components include a tray and insert that lock tightly together. The prosthesis can be detected by radiography from the signals of metal wires inside the PEEK-on-HXLPE implant (Figure 1(B1)). The femoral prosthesis was sterilized by irradiation, and the tibial prosthesis was sterilized by ethylene oxide.

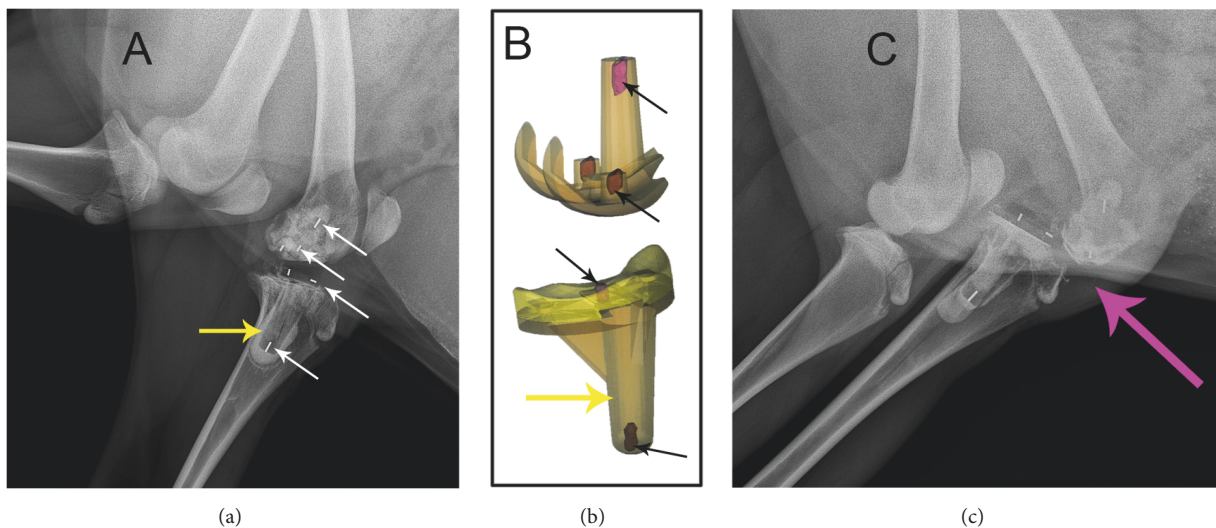
FIGURE 2: Four-week postoperative X-rays illustrating the location of the prosthesis with metal wires after total knee arthroplasty. The metal wires, shown as the high-density signal (the white arrows in (a)), were inserted in the components as the red part in the 3D sketch (the black arrows in (b)). According to the signals of the wires, the position of the tibial component, the spacer, and the femoral component can be roughly predicted. The normal prosthesis alignment position should be like the imaging in (a); however, the imaging in (c) indicated prosthesis component was dislocated or possibly got stuck. The tibia tray of PEEK prosthesis, showing low-density signal in the tibia (the yellow arrow), is cemented in the bone, and the bone cement showed slightly higher density signal than that of PEEK.

3.1. Radiographic Location of the PEEK-on-HXLPE Prosthesis. On the x-rays at 4 weeks postoperatively, the PEEK and HXLPE materials were radiologically transparent and invisible; however, fine metal wires were visualized radiographically so that the position of the prosthesis could be evaluated (Figures 2(a) and 2(b)), which might help us to locate the prosthesis intraoperatively. As shown in Figure 2(c), the wires were not in the correct position, which indicated dislocation of the joint at 4 weeks postoperatively.

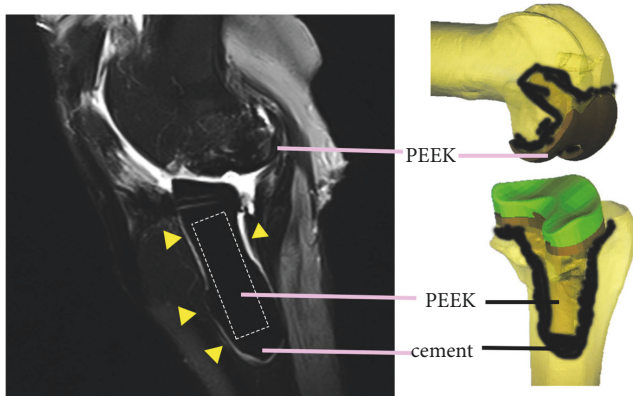
FIGURE 3: Postoperative magnetic resonance imaging illustrating the prosthesis with a low signal intensity without artifacts and marrow and soft tissue with a continuous signal intensity without artifact interruption. The hyperintense signal around the cement on the T2-weighted magnetic resonance imaging scans may represent water and proteins adsorbed on the cement surface or soft tissue edema and inflammation in the early stage of healing (the yellow triangles indicate the hyperintense signals around the cement). The fine metal wires inserted into the polyetheretherketone (PEEK) and highly cross-linked polyethylene (HXLPE) components do not produce obvious metal artifacts.

3.2. Evaluation of the Bone and Soft Tissue Structure around the PEEK Material by MRI. On the 4-week postoperative MRI scans, PEEK and HXLPE materials showed a low signal intensity without artifacts, and the fine metal wires did not generate obvious metal artifacts. The marrow and soft tissue showed a continuous signal intensity without artifact interruption. Increased signal intensity on the T2-weighted MRI scans was observed around the cement, which may represent water and proteins adsorbed on the cement surface or soft tissue edema and inflammation in the early stage of healing (Figure 3).

MRI images of the PEEK-on-HXLPE prosthesis *in vivo* and found that the prosthesis and cement showed a low signal intensity on the T2-weighted MRI scans, marrow and soft tissue showed a continuous signal intensity in T2-weighted MRI scans without artifact interruption, and tissue near the prosthesis and cement showed hyperintensity on T2-weighted MRI scans, which may indicate soft tissue edema and inflammation in the inflammatory phase and wound healing process. These results are accordance with the description of the process of osseous healing of implants on a cellular level [22]. After insertion of a biomaterial, the polymerized fibrinogen was the first tissue around the implant in the early stage of healing; water and proteins are adsorbed on the implant surface, and a coagulum is formed, occluding the vascular leak. The immune system is activated in the inflammatory phase, which is characterized by a high-water content and detectable as a hyperintense signal on T2-weighted MRI scans. During the proliferative phase, new bone formation is initiated by the deposition of osteoid matrix, which is consecutively mineralized at approximately 1 week after implant insertion [22]. Finally, the mineralized tissue, as new bone, is detectable as a region without signals, showing a black appearance on MRI scans. The great advantage of MRI is the ability to follow bone formation from early healing stages when the tissues consist of water and unmineralized structures and have no direct impressions on X-rays.
