Case Report

SEM Analysis and Management of Fracture Dental Implant

*Department of Prosthodontics, Faculty of Dental Sciences, Institute of Medical Sciences,
Banaras Hindu University, Varanasi 221005, India*

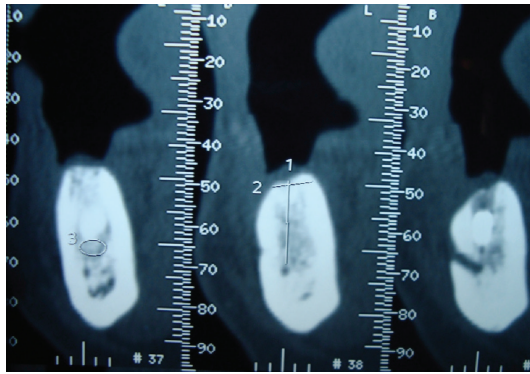
A 45-year-old female patient reported to the department with loss of coronal part of implant-supported prosthesis in the lower left premolar region. Detailed history revealed successful implant placement 3 years back in mandibular left second premolar region. Medical history of the patient was found to be noncontributory. Development of pain and mobility of the prosthesis started since the last few months with loss of mobile segment one week back. On radiographic examination, Dentascan revealed remaining part of the implant fixture to be still embedded in the bone (Figure 1).

FIGURE 1: Preoperative Dentascan.

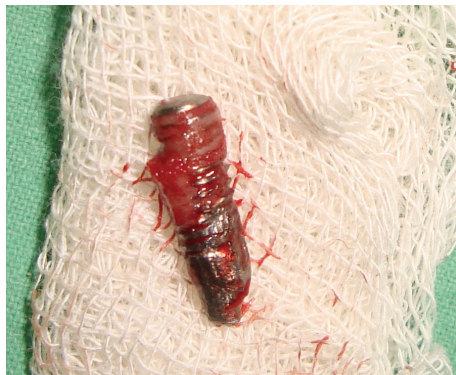
FIGURE 2: Surgically retrieved implant fragment.

The retrieved part of implant fixture (Figure 2) was sent for SEM analysis (Figure 7) for the probable cause of the fracture. Scanning electron micrograph of fracture implant surface shows an extent evidence of intergranular fracture. A large dimple at the centre of the implant surface was found which consists of various wavy lines or striations.

Complete removal of fractured implant was the preferred treatment option for this patient. In this case complete removal the fractured implant was done, placing a newer larger diameter implant immediately in same surgical bed. External diameter of the trephine bur used for the removal of fractured implant was also kept in mind while selecting the diameter of new implant to ensure primary stability. The retrieved fractured implant was further sent for SEM analysis to study the microscopic features and to investigate the cause of implant fracture.

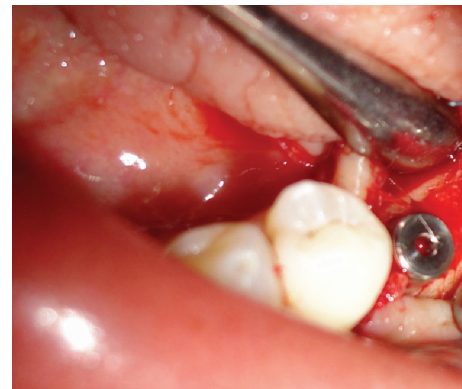
FIGURE 3: Implant placed at mandibular left second bicuspid region.

recommended drills were used in required sequence, the endosseous implant was placed immediately after removing the fracture segment (Figure 3) with initial stability of 40 N, and mucoperiosteal flap was approximated with interrupted sutures. The patient was put on antibiotics, anti-inflammatory analgesics, and oral rinses for a week.

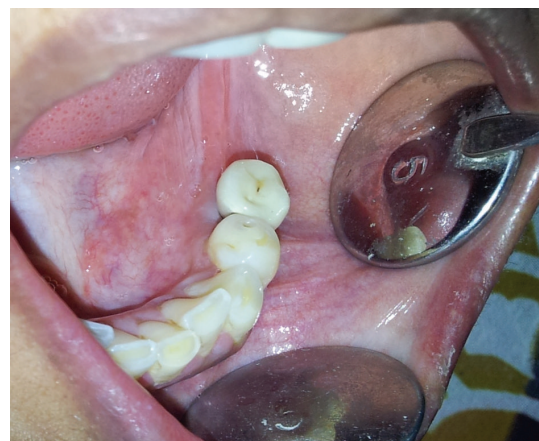
FIGURE 4: Fixed ceramometal prosthesis is placed (occlusal view).

Second stage surgery was done after 4 months. The prosthetic phase was initiated by impression making use of open window technique with polyvinyl silicone impression material (Aquasil Dentsply/Caulk, Milford, DE, USA). Abutment preparation and try-in were done, and working cast was sent to the laboratory for fabrication of ceramometal prosthesis (Dentsply, Ceramco, York, PA, USA). Consecutively, the implant was loaded with cement-retained metal-ceramic crown (Figure 4). Reports of 36-month followup at every 3, 6, and 12 months interval have shown successful results so far (Figures 5 and 6).

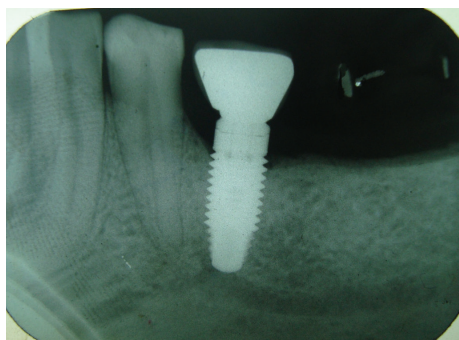
FIGURE 5: IOPA radiograph 3 months after prosthetic rehabilitation.

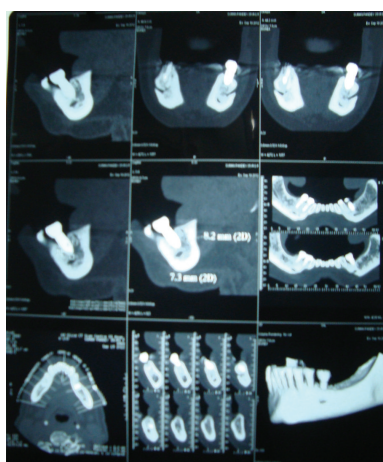
FIGURE 6: Dentascan 12 months after prosthetic rehabilitation.

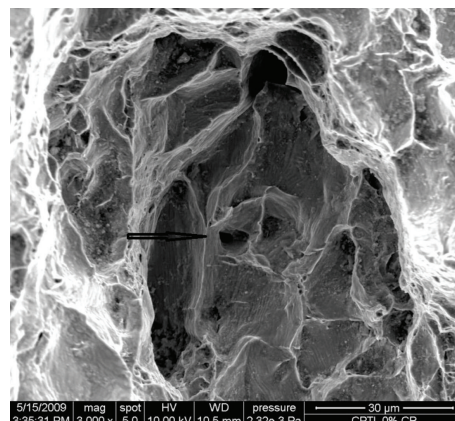
FIGURE 7: Scanning electron micrograph shows intergranular fracture of implant (large dimple at the center of implant surface is shown by arrow).

SEM image of fractured implant surface was shown in Figure 7. Although the fractured surface is rather complex, the surface shows to an extent evidence of intergranular fracture. A large dimple at the centre of the implant surface was found which consists of various wavy lines. These lines are considered to be the slip bands formed by repeated loading in the mouth. Excessive overloading produces increase in number of dislocation, which, by virtue of their interactions and stress field, gives rise to higher state of internal stresses and consequently leads to fatigue fracture. Shemtov-Yona et al. [19] also proposed that the nontypical fatigue behavior observed for 3.3 mm implant diameter is probably the result of stress concentrations generated along the structure's surface.

Dental implant fracture is an infrequent yet important cause of implant therapy failure, and adequate measures should be adopted to prevent it. In this case, it was concluded that cause of implant fracture was found to be metal fatigue due to repeated overloading and use of small diameter implant.
