## Case Report

# Provisional Crown Dislodgement during Scuba Diving: A Case of Barotrauma

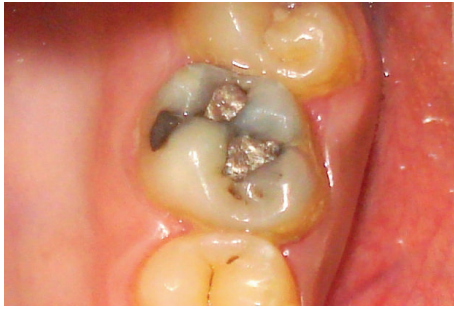
FIGURE 1: Amalgam restoration with secondary caries in the maxillary left first molar.

A 25-year-old man presented with a chief complaint of spontaneous pain on the left side of his face for the past 3 days. History revealed intermittent pain to hot and cold stimuli for the past 1 month. The medical history was noncontributory. Clinical examination revealed an amalgam restoration with secondary caries in the maxillary left first molar (Figure 1). The tooth was tender to vertical percussion. Tooth mobility was within physiologic limit, and the gingival attachment apparatus was normal. Vitality testing of the involved tooth with heated gutta-percha (Dentsply Maillefer, Ballaigues, Switzerland) and dry ice (RC Ice; Prime Dental Product, Mumbai, India) caused an intense lingering pain, whereas electric pulp stimulation (Parkel Electronics Division, Farmingdale, NY, USA) caused a premature response. The preoperative radiographic evaluation showed evidence of radiolucent area in relation to maxillary left first molar approaching the pulp space with periodontal ligament space widening in relation to the mesial root (Figure 2). A diagnosis of symptomatic irreversible pulpitis with symptomatic apical periodontitis was made, and endodontic treatment was suggested to the patient.

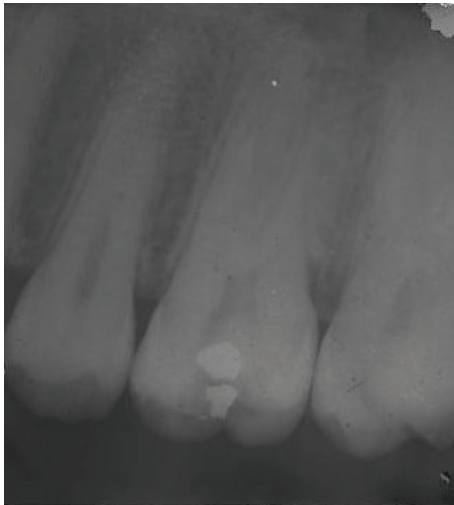
FIGURE 2: Radiolucent area approaching the pulp space with periodontal ligament space widening.

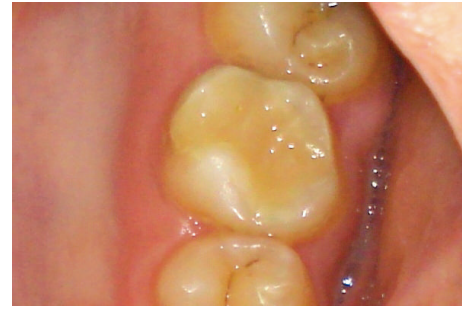
FIGURE 3: The tooth was restored with a posterior composite resin.

Informed consent was taken. The tooth was anesthetized by using 1.8 mL 2% lignocaine containing 1 : 200,000 epinephrine. Endodontic treatment was completed and the tooth was then restored with a posterior composite resin core (Z350; 3M ESPE Dental Products, St. Paul, MN, USA) (Figure 3).

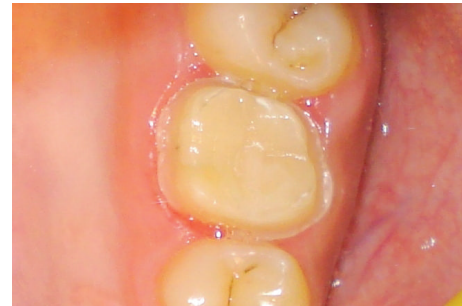
FIGURE 4: The tooth was prepared to receive metal-ceramic crown.

The tooth was prepared 1 week after endodontic treatment to receive a metal-ceramic crown in a conventional manner with the aim of obtaining a 6-degree convergence between walls (Figure 4). Gingival displacement was done, and two impressions were made: an alginate impression to prepare a provisional crown and another with hydrophilic polyvinyl siloxane impression material (Virtual; Ivoclar Vivadent, Schaan, Liechtenstein) to prepare metal-ceramic crown, poured using type IV dental stone (Kalrock; Kalabhai, India). The shade was determined with a shade guide. The patient was given a provisional crown, which was made from a bis-acryl material (Integrity; Dentsply Caulk, Konstanz, Germany) and was cemented with zinc phosphate cement (DeTrey Zinc; Dentsply DeTrey GmbH, Konstanz, Germany) (Figure 5). Excess cement was removed with a scalpel. The patient was recalled after 7 days to receive the final crown.

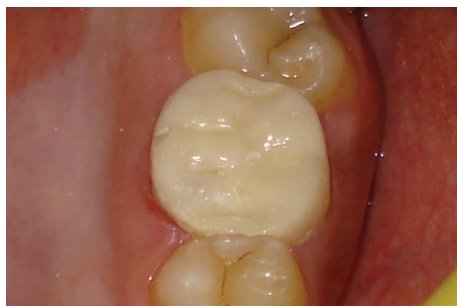
FIGURE 5: Provisional crown cemented with zinc phosphate cement.

The possible reason for dislodging of provisional crown cemented with zinc phosphate could be associated Boyle's law, which states that, at a constant temperature, the volume of a gas varies inversely with the surrounding pressure. As pressure increases, the volume of a confined gas decreases. Vice versa, volume increases as pressure decreases [9]. The problem arises when the enclosed spaces containing gases cannot expand or contract to adjust the internal pressure to correspond to the outer pressure. During the mixing process

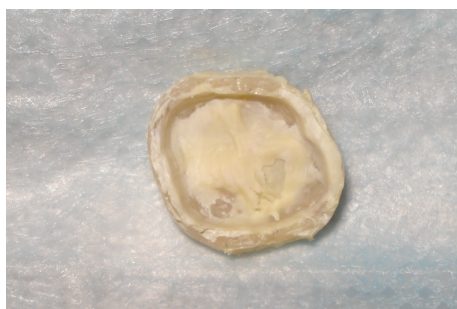
However, the patient presented with dislodged provisional crown (Figure 6). He gave a history of SCUBA diving at a destination where he went for previously unplanned vacation. He reported that the provisional crown came out while he was diving at about 27 to 35 meters deep. After the crown dislodged, he had to keep it under his tongue until he returned to the surface to avoid aspiration or swallowing.

FIGURE 6: Dislodged provisional crown.

of luting cement, air may become incorporated into the mixture, forming voids [11]. The expansion or contraction of these microbubbles during pressure cycling, which eventually led to disruption and weakening of cement layer, could affect the retention [12]. Davidson et al. [13] found that microcracks appear as a result of volumetric contraction in luting cements and, when subjected to the pressure cycling, may have produced tensile stresses that exceeded the cohesive and adhesive strength of the material, resulting in the significant reduction in tensile bond strength.

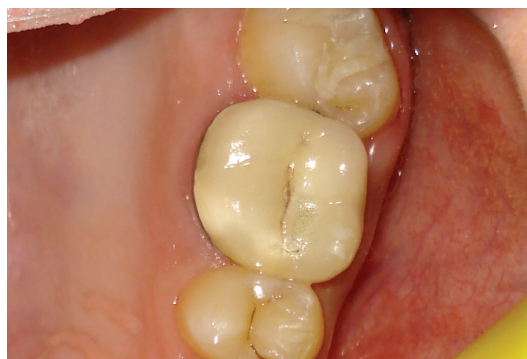
FIGURE 7: The metal-ceramic crown was cemented with self-adhesive resin cement.

was tried in to assess the marginal fit and contacts. The patient previewed and approved the shape and the shade of the crowns. The crown was cemented with self-adhesive resin cement (Multilink Speed; Ivoclar Vivadent AG, Schaan, Liechtenstein) in accordance with the manufacturer's instructions (Figure 7). Postoperative care instructions were given to the patient and recall appointments were scheduled.
