Case Report

Selectable Implant Removal Methods due to Mechanical and Biological Failures

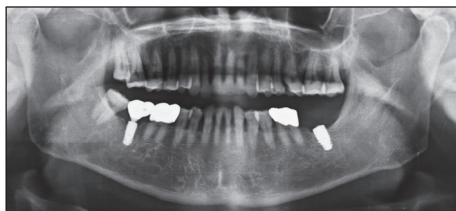
FIGURE 1: Preoperative radiographic view (panoramic X-ray image). Implant of #37 area shows the broken abutment screw off the implant fixture inside.

2.1.1. Presurgical Examination. A 70-year-old male requested Department of Periodontology to remove the implant fixture at second molar region of left mandible (Figure 1). The patient stated that a local clinic had attempted and failed to remove the broken abutment screw off the implant fixture inside. Furthermore, the implant fixture was instead damaged and fractured in the previous process. The patient was then referred to this hospital for the implant removal. Traces of round bur usage for screw removal, serious damage on upper part of the fixture, and gingival defect were observed. The patient was diagnosed with broken abutment screw through clinical and radiographic examination inside the implant fixture, and an implant removal was planned with the patient's consent.

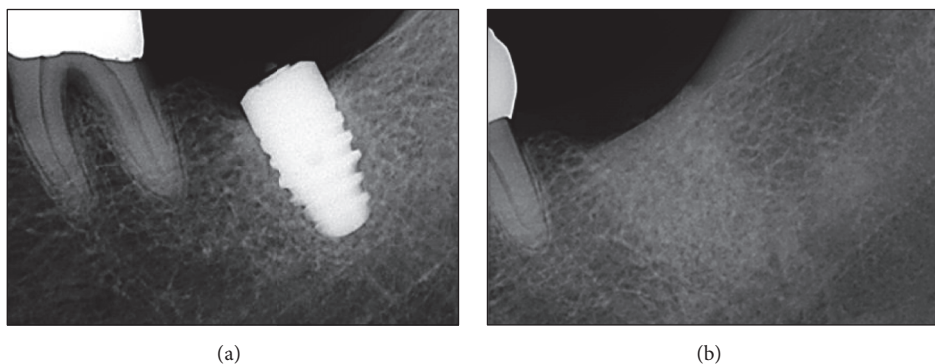
2.1.3. Follow-Up Examination. Periapical X-ray image verified the complete implant removal after the surgery (Figure 3). Two weeks after the surgery, the patient showed normal healing phase as the stitches were removed. Two months after the surgery, completely cured soft tissues of the surgical site were verified; thus reinstallation of an implant was planned and carried out four months later (Figure 4).

FIGURE 3: Postoperative radiographic view (periapical X-ray image). (a) Implant fixture with a fractured abutment screw. (b) Implant removal site filled with a bone grafting material.

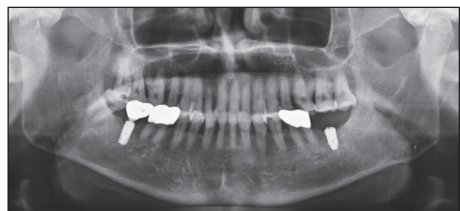
FIGURE 4: Postoperative radiographic view (panoramic X-ray image). Implant reinstallation on #37 region four months after the implant removal.

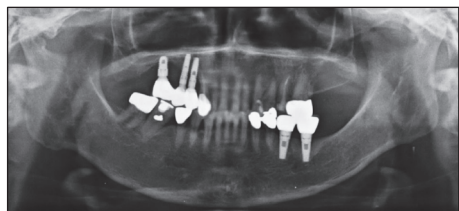
2.2.1. Presurgical Examination. A 66-year-old female who had discomfort on implants of first premolar, second premolar, and first molar region of right maxilla came to Department of Periodontology (Figure 5). Those were treated at a local clinic seven years prior to this visit. She experienced discomfort due to recurring implant prosthodontics falling-out. Peri-implantitis derived from the failing implants gave her frequent pain. The radiographic examination verified the radio-lucency lesion around the implant fixtures, and gingival recession was observed in the clinical examination. Upon the patient's strong demand of removing the implants and consent, surgical procedure was scheduled.

FIGURE 5: Preoperative radiographic view (panoramic X-ray image). Implants of right maxilla area show a severe alveolar bone loss lesion.

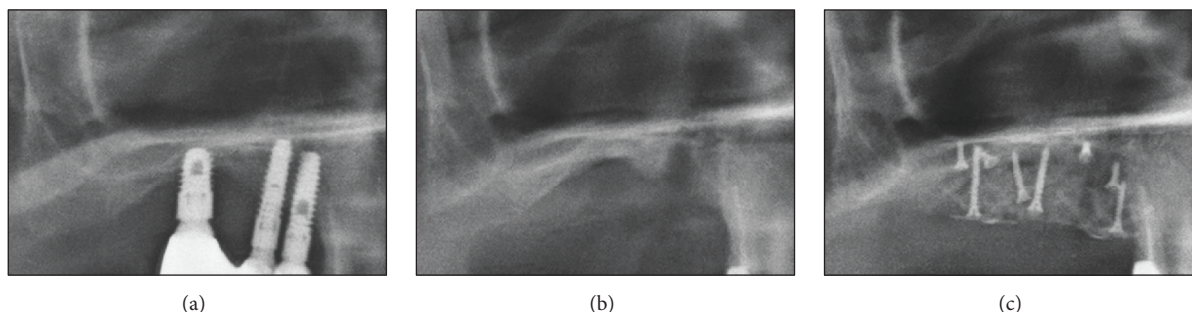
2.2.3. Follow-Up Examination. Panoramic X-ray image verified successful implants removal (Figures 8(a) and 8(b)). Stitches were removed two weeks after the surgery, and normal healing phase was observed four months after the surgery. The vertical alveolar ridge augmentation using Bio-Oss 1.0 g (Geistlich Pharma AG, Wolhusen, Switzerland) and

FIGURE 8: Postoperative radiographic view (periapical X-ray image). (a) Implant fixture with severe surrounding alveolar bone loss. (b) Implant removal site. (c) Vertical augmentation of an alveolar ridge.

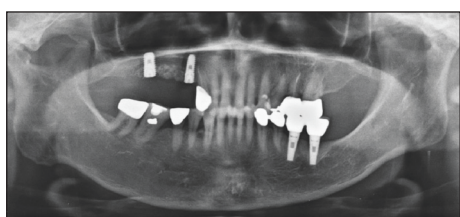
FIGURE 9: Postoperative radiographic view (panoramic X-ray image). Implant reinstallation on #14 and #16 regions four months after the implant removal.

(Dentium, Seoul, Korea) to secure vertical height (Figures 7 and 8(c)). Four months after this treatment, two implants were reinstalled at first premolar and first molar regions (Figure 9).
