## Case Report

# Retained Intrauterine Device (IUD): Triple Case Report and Review of the Literature

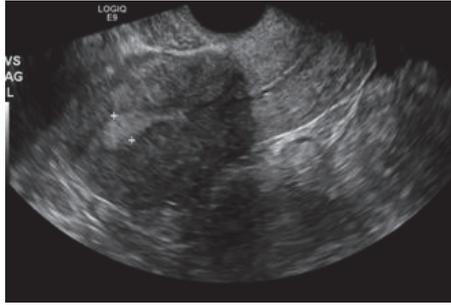
FIGURE 1: CASE 1, pelvic ultrasound: empty uterine cavity with no evidence of intrauterine device (IUD).

kg/m<sup>2</sup>), who presented with severe dysmenorrhea monthly since IUD placement and desires to switch to NuvaRing. The patient had Mirena IUD placed one year prior at outpatient clinic immediately after an elective termination of pregnancy. She presented with complaints of bleeding and pain. On initial speculum exam, the IUD strings were visualized, but attempts to remove it were unsuccessful. Additional speculum exam revealed strings through the vagina mucosa coming through the posterior fornix and not the cervix. Pelvic ultrasound (Figure 1) showed an empty uterine cavity with no evidence of IUD. Subsequent CT of the abdomen and pelvis (Figure 2) revealed T-shaped IUD, located midline within the posterior pelvic mesentery/cul-del-sac, superior to the posterior aspect of the anteverted uterus, and adjacent to the distal rectosigmoid colon. A diagnostic laparoscopy was performed (Figure 3) for retrieval and removal of malpositioned IUD and lysis of associated adhesions.

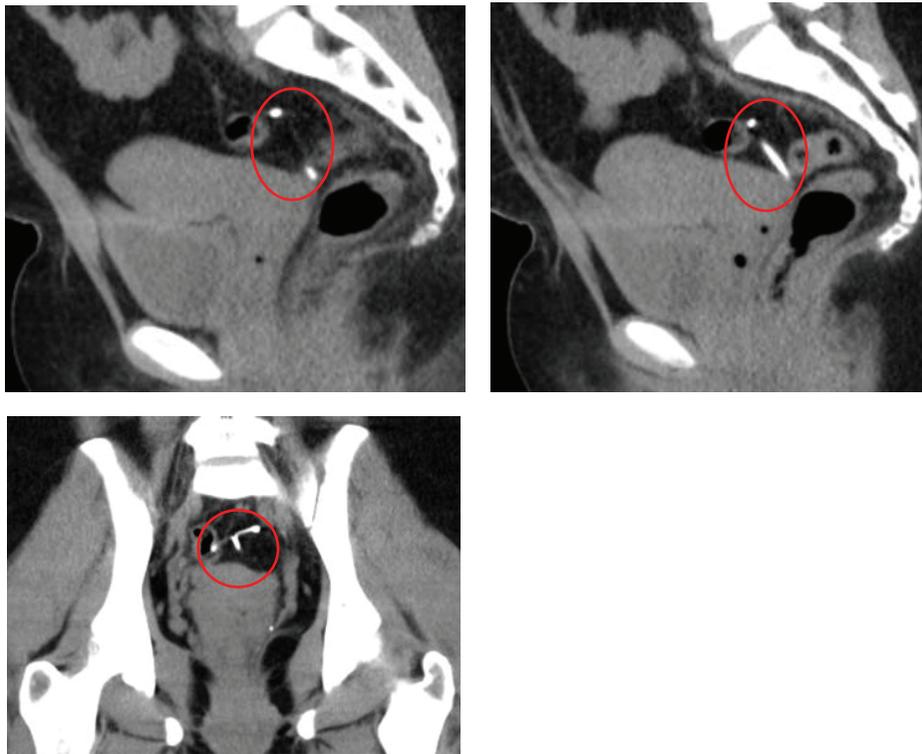
FIGURE 2: CASE 1, pelvic CT: showing anteflexed anteverted uterus with IUD outside the uterus in the cul-de-sac.

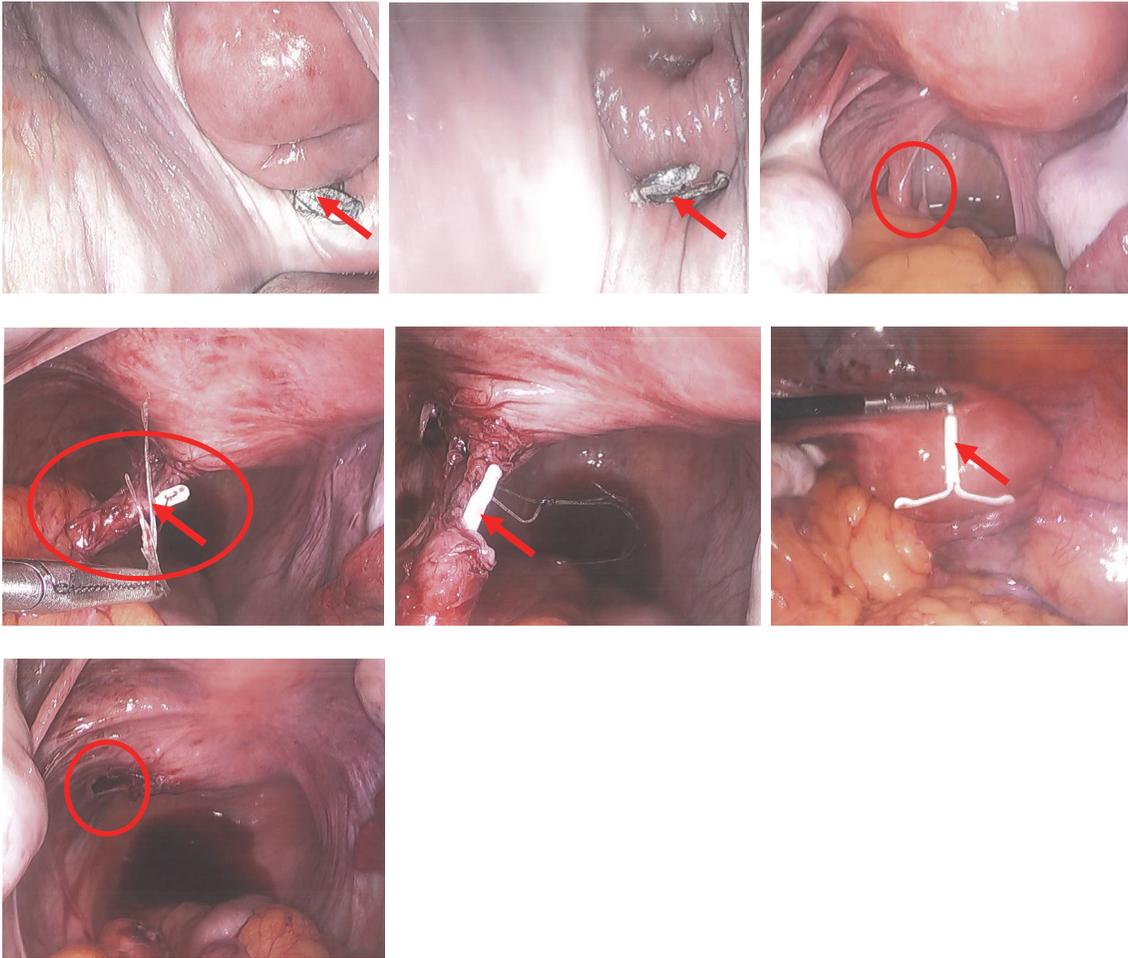
FIGURE 3: CASE 1, laparoscopic removal of Mirena IUD from posterior cul-de-sac.

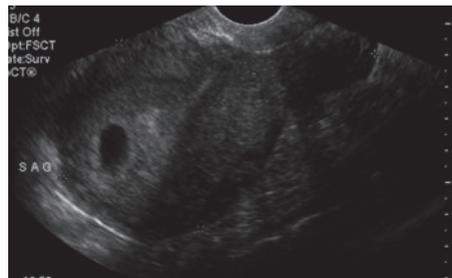
FIGURE 4: CASE 2, pelvic ultrasound (5/7/15): there is no sonographic evidence of IUD (intrauterine contraceptive device) identified within the uterus. The uterus measures about 11.3 x 6.4 x 7.3-cm in size, with its cervical length measuring about 4.40-cm. A single live intrauterine gestation of 6 weeks of menstrual maturity with EDD of 12/31/2015.

A 34-year-old female, Gravid 5, Para 4004, at 27 weeks and 3 days gestation, with two previous cesarean sections, presented with leakage of fluid per vagina. The patient has a past history of ParaGard IUD placement, which was not seen in initial obstetrics sonogram at 6 weeks of gestation (Figure 4). The clinical diagnosis was that the IUD had been expelled. Other obstetrics ultrasound during the pregnancy showed an intrauterine device. The patient was admitted with the findings of premature preterm rupture of membranes and suspected chorioamnionitis. A low transverse cesarean delivery section and bilateral tubal ligation were performed. On postoperative day 5, the patient experienced fevers with suspected intra-abdominal processes. A CT scan revealed a displaced IUD, with the tip penetrating the lumen of the bladder, located in the anterior portion of the bladder, near the space of Retzius (Figure 5). Cystoscopy confirmed that the IUD did not penetrate mucosa. Patient underwent laparotomy for removal of ParaGard IUD from the serosa and muscularis layer of the bladder (Figure 6) and the layers were then repaired.

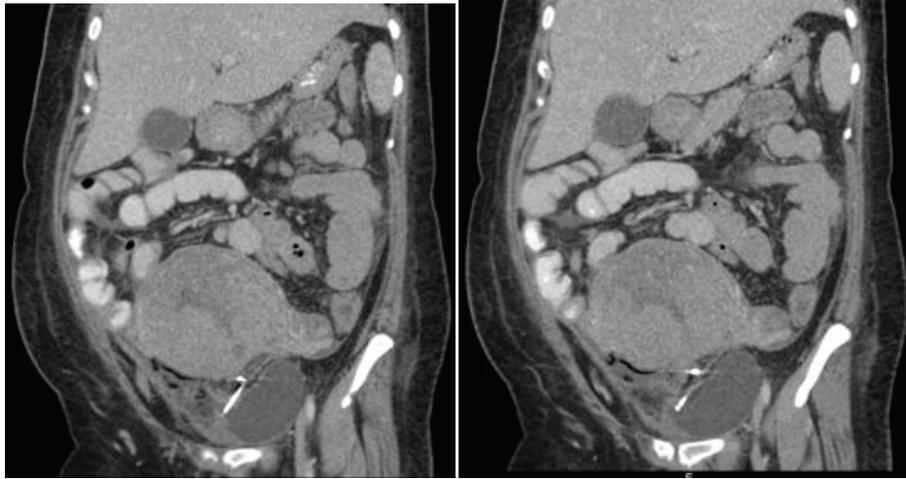
FIGURE 5: CASE 2: pelvic CT (10/15/2015) that was done postpartum day 5: a CT scan revealed a displaced IUD with its tip appearing to have penetrated the lumen of the bladder. It was located in the anterior portion of the bladder near the space of Retzius.

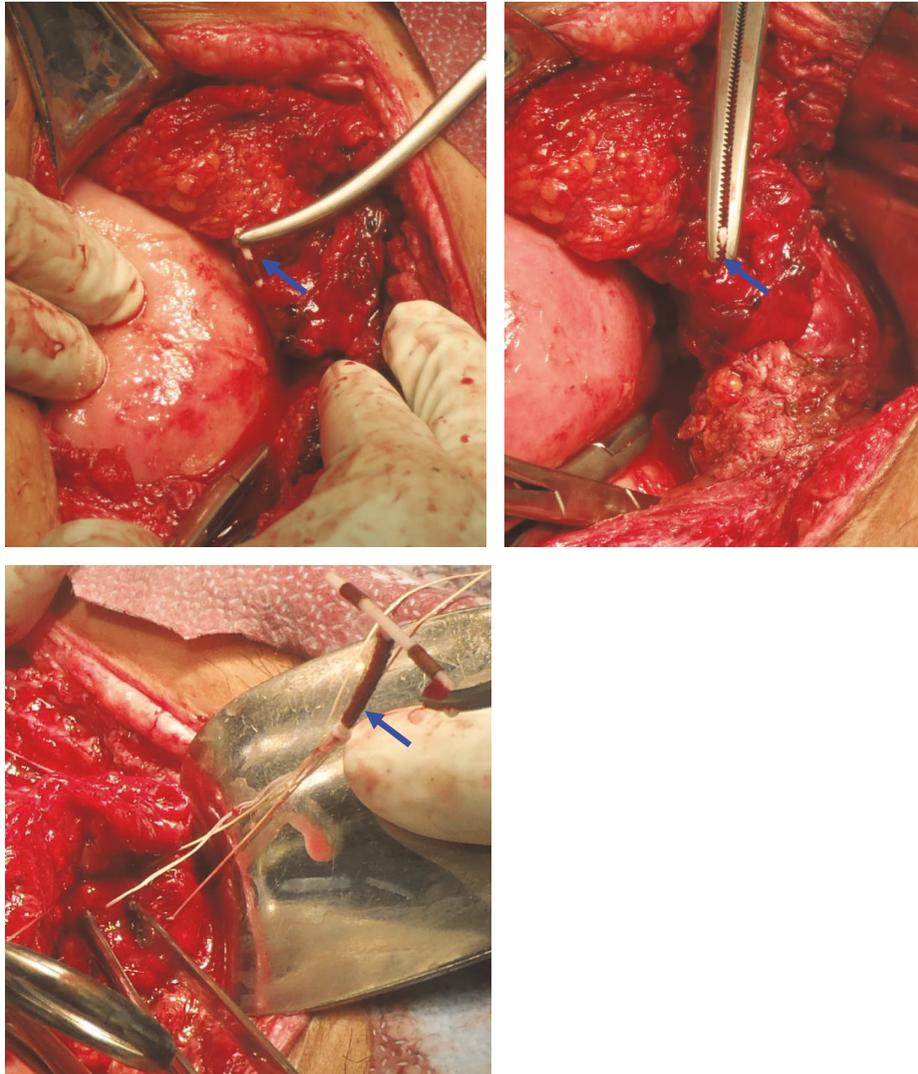
FIGURE 6: CASE 2, exploratory laparotomy and removal of ParaGard IUD from the seromuscular layer of the bladder.

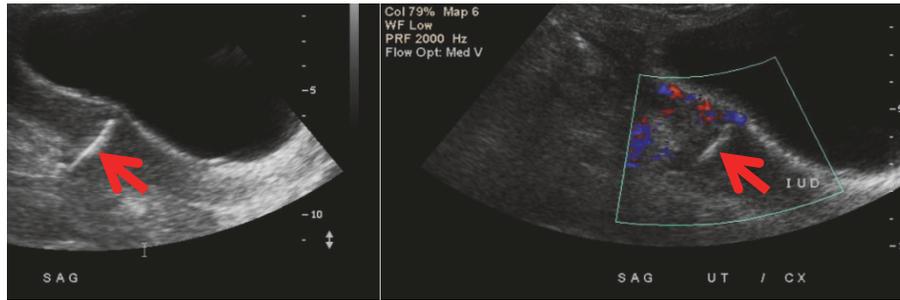
FIGURE 7: CASE 3, ultrasound imaging showing the embedded IUD.

Initial sonogram (Figure 7) imaging showed the IUD running across the length of the cervix. Patient was then scheduled for diagnostic hysteroscopy and IUD removal in the operating room. Using the hysteroscope, IUD was visualized deep in the posterior uterine wall. Multiple attempts to remove the IUD with the use of hysteroscopic grasper were unsuccessful. In addition, with use of forceps under ultrasound guidance, the IUD could not be removed. Hysteroscopy was repeated after failed attempts of removal; however, the IUD strings were no longer seen. Intraoperative transvaginal ultrasound (TVS) showed the IUD in the posterior uterine wall in the lower segment with no free fluid in the cul-de-sac. The surgical procedure was aborted.

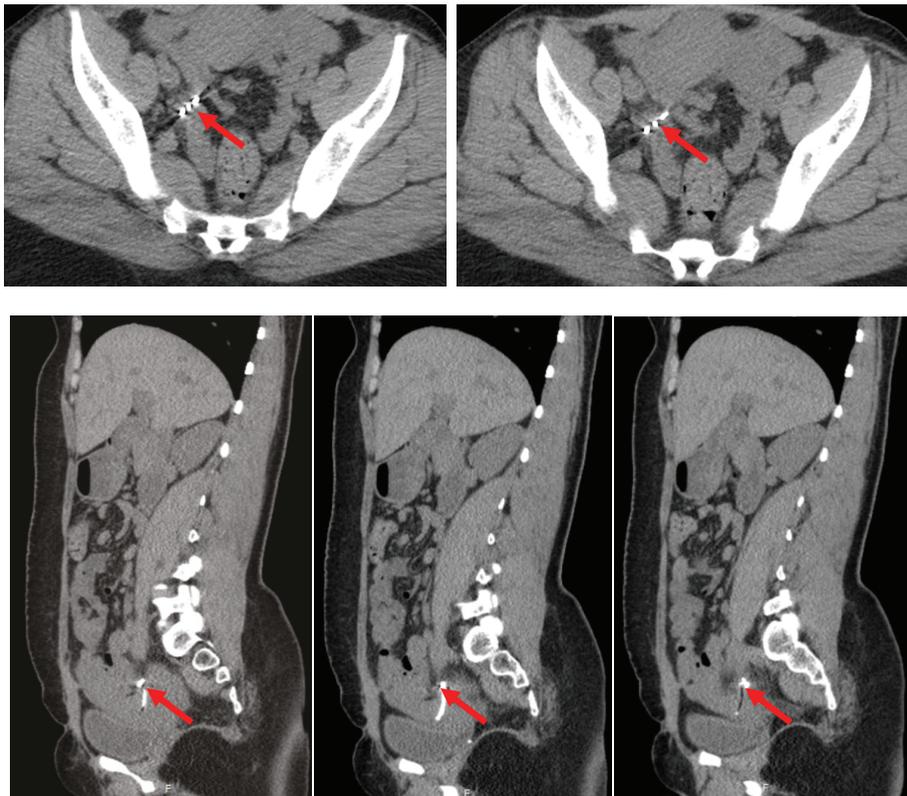
FIGURE 8: CASE 3, CT imaging showing the embedded IUD.

abdomen and pelvis (Figure 8) showed an anteverted uterus. The IUD appeared to extend vertically up towards the right from the level of the cervix, which is outside the uterine body. The patient was scheduled for diagnostic laparoscopy for IUD removal.
