## Case Series

# Impurities in Drug Vials Intended for Intravitreal Medication

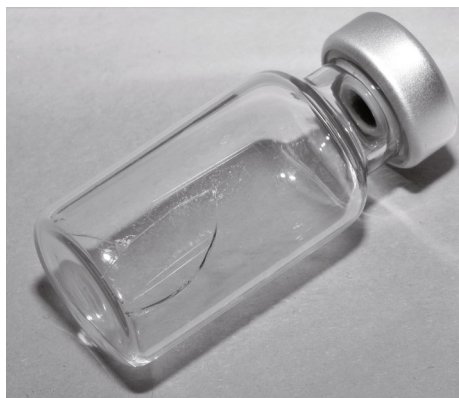
In the first case, the injecting physician noticed fine break lines in the glass while drawing Aflibercept solution out of the vial (Figure 1). Previously, there were no issued reported during transport or preparation. The glass fragment was not dislocated; nevertheless, the sterility could not be regarded as assured. The manufacturer suspected a quality problem in the glass but stated that it had received no other reports of glass vials breaking or losing their integrity.

FIGURE 1: After a light and short contact with the filter cannula, fine continuous cracks on the glass vial were seen. Although no Afibercept solution had escaped, the active ingredient—possibly no longer free of contamination—was not used.

In all three cases, the medication of the initial vial was no longer used. In accordance with professional obligations, a notification was made to the competent authority (Federal Institute and Drugs and Medical Devices). The product was sent to the pharmaceutical manufacturer (con-

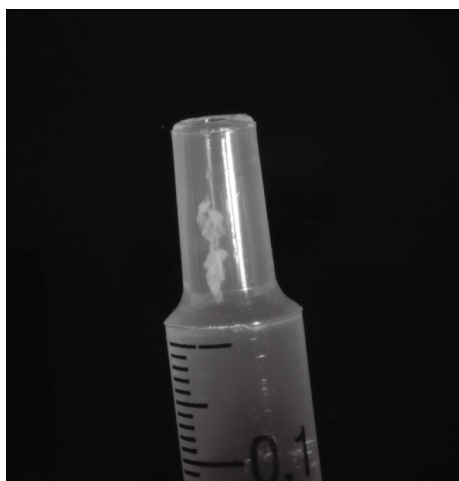
For the second case, the attentive surgeon noticed a small contamination on the outside of the syringe tip while she was replacing the filter cannula with the injection needle (Figure 2). The suspicion arose that the particle/fibres came from the inner surface of the attached filter cannula, because it had not been noticed before. That was the reason why the drug manufacturers did not think they were responsible, as they purchased the enclosed filter cannula from a third-

FIGURE 2: After removing the filter cannula, a kind of clot was observed that had not previously been seen on the syringe supplied.

party supplier. Therefore, it was not further investigated what exactly the bearing material consisted of.
