## Case Report

# Late Nontraumatic Dissociation of the Femoral Head and Trunnion in a Total Hip Arthroplasty

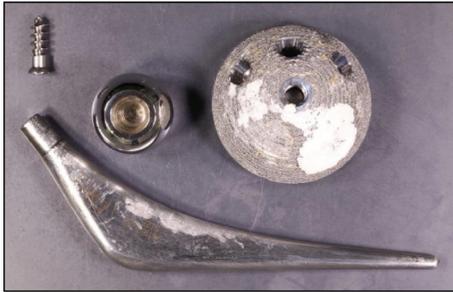
FIGURE 1: Retrieved components from the original total hip arthroplasty.

We performed a revision left total hip replacement via a posterior approach, using the new model DePuy C-Stem AMT, 36 mm head and Pinnacle 60 mm shell with polyethylene liner. We noted mild wear on the trunnion, prompting concomitant stem revision, and black debris around the inner surface of the head, likely to represent mild metallosis (Figure 3). The cup and C-Stem were both well fixed. There was no evidence of wear or impingement affecting the outer articulating surface of the head or metal liner. The soft tissues were grossly unaffected.

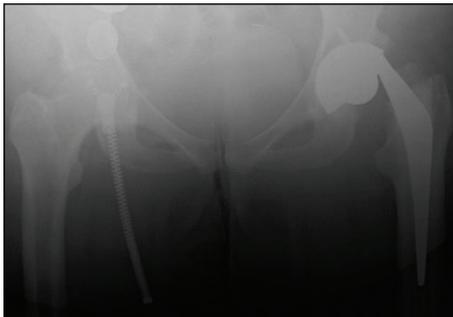
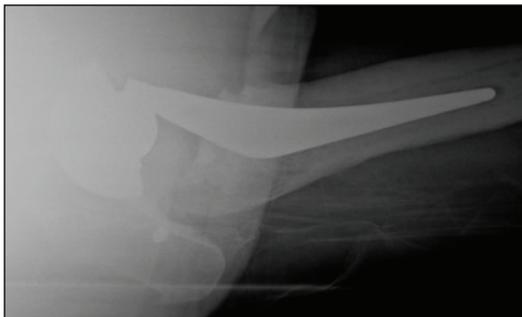
FIGURE 2: (a) AP and (b) lateral radiographs of the dissociated THA.

In October 2013, more than 10 years after her initial operation, she stood from a seated position and heard a loud “clunk,” followed by pain in the hip associated with difficulty mobilising. Radiographs demonstrated a complete dissociation of the modular femoral head from the stem, which was dislocated (Figure 2). The femoral head remained in its cup. There was no evidence of osteolysis or loosening of the cup or stem. She was systemically well with serum inflammatory markers only marginally elevated (CRP 11 mg/L; normal value <10 mg/L).

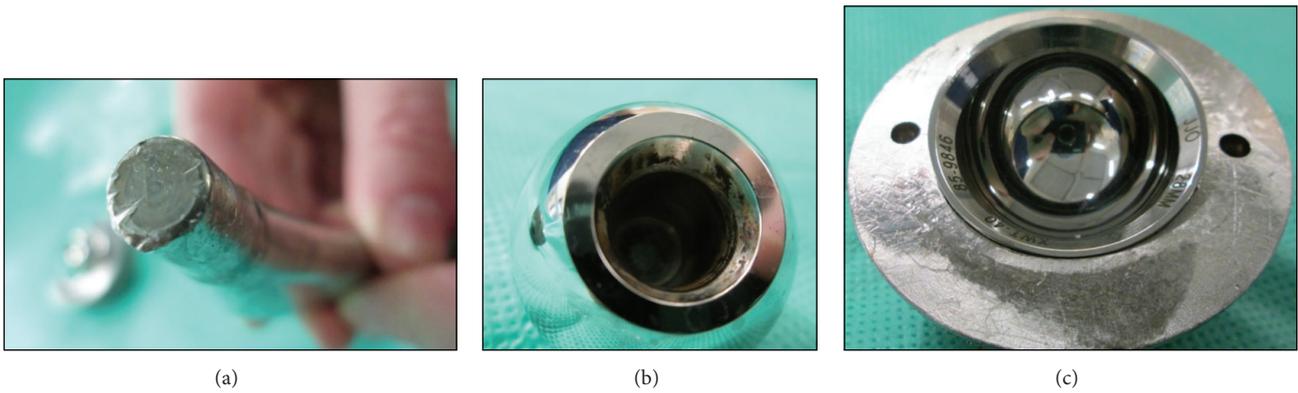
FIGURE 3: (a) Visible wear and damage on the trunnion (the significant deformation at the tip was caused by surgical removal of the well-fixed stem), (b) black debris in the articulating surface of the femoral head, and (c) minimal wear or damage to the metal liner.

when handling and inserting the components during surgery to avoid potential inadvertent damage to the bearing surfaces and trunnion, as well as careful component selection and intraoperative testing to minimise impingement. With ongoing research in wear mechanisms and components design we will likely see reductions in this type of complication future, but we would encourage the long term follow-up of these patients, maintaining a high index of suspicion for signs of wear and potentially imminent complications.

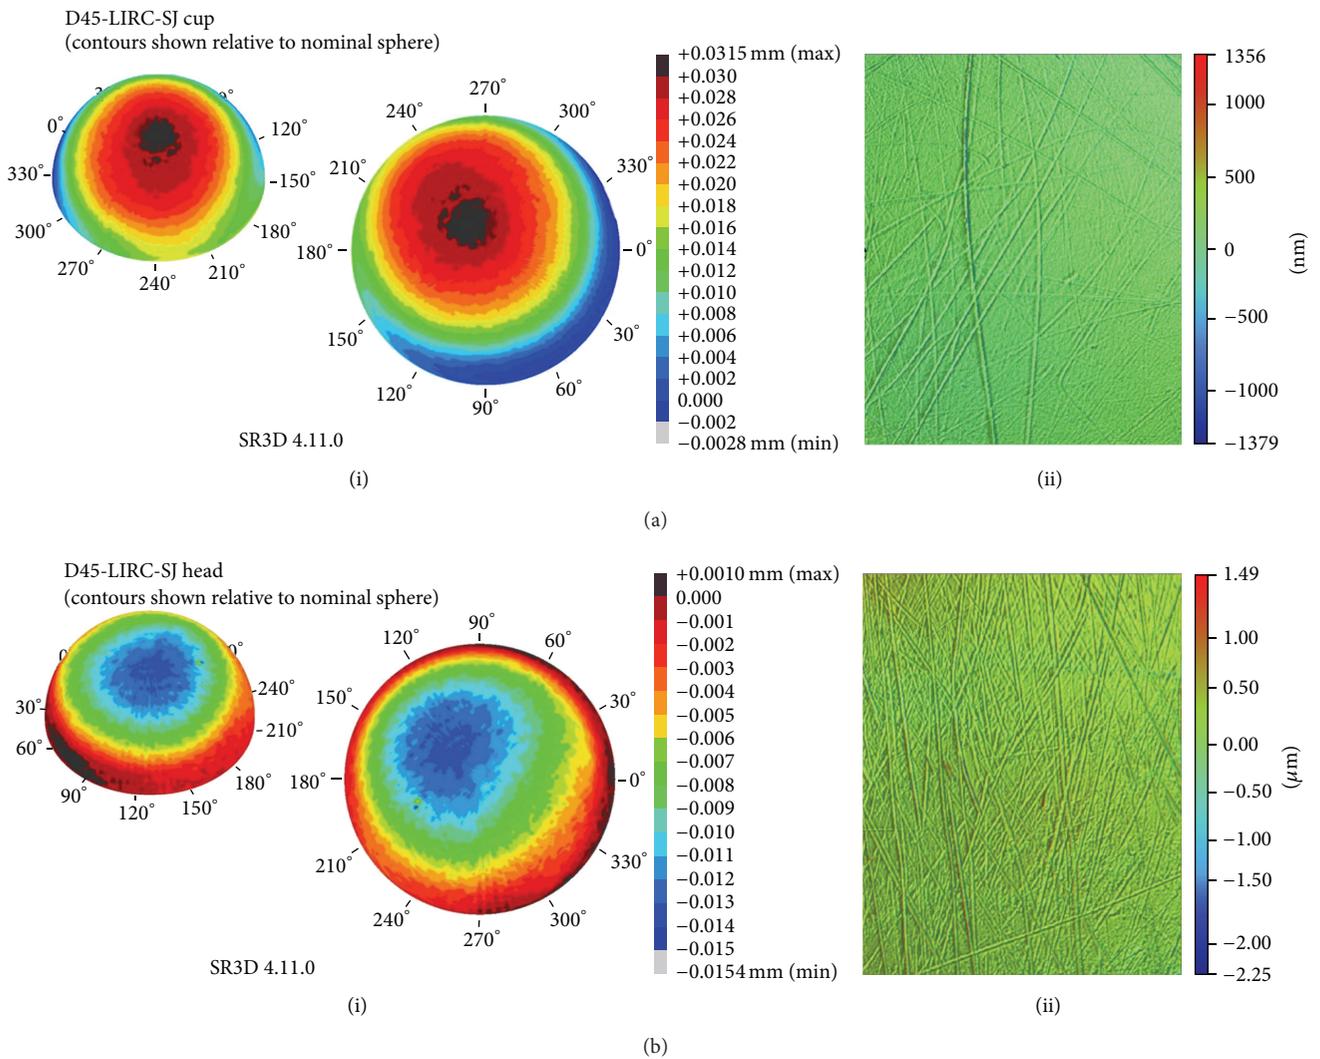
The removed components were sent to the London Implant Retrieval Centre (LIRC) for metrological analysis using coordinate-measuring machine (CMM) dimensional measurements and optical interferometry roughness measurements (reference D45-LIRC05J) (Figure 4). Acetabular cup analysis demonstrated roughness measurements of up to  $0.023 \mu\text{mRa}$ . Femoral head analysis demonstrated roughness measurements of up to  $0.082 \mu\text{mRa}$ . Unfortunately the methods utilised at this centre prohibit analysis of the head-taper junction.

FIGURE 4: Graphical representation of (a)(i) cup wear profile, (a)(ii) cup surface roughness, (b)(i) femoral head wear profile, and (b)(ii) femoral head surface roughness from the LIRC analysis.
