Case Report

Complication with Removal of a Lumbar Spinal Locking Plate

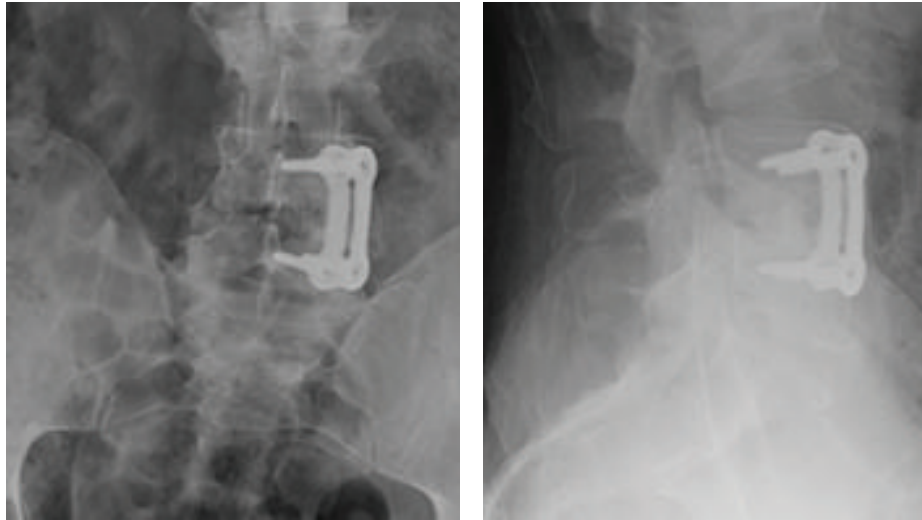
FIGURE 1: AP and lateral radiographs of lower lumbar spine showing the anterolateral locking plate at L4-5 (Synthes 4.5 mm anterolateral spinal locking plate, with 5.5 mm titanium locking screws, West Chester, Pennsylvania, United States).

his previous L5 to sacrum fusion. He underwent extensive debridement of the L4/5 disc and paraspinal tissues, as well as an L4/5 anterior discectomy and fusion with femoral allograft secured with a Synthes Spine titanium anterolateral locking plate (Figure 1). Cultures taken at the time of this surgery indicated a methicillin sensitive staphylococcus aureus infection, and postoperatively the patient was treated with intravenous Ancef, 1 gram every 8 hours for a total of six weeks.

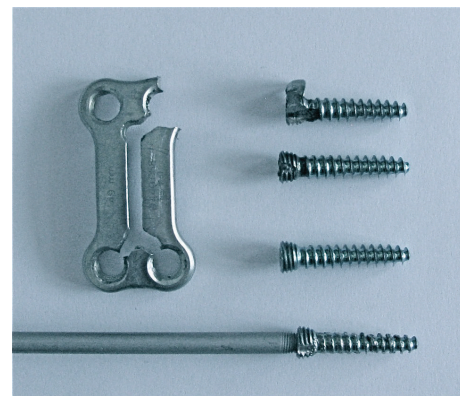
FIGURE 2: Photograph of the plate after removal, demonstrating the cold welding of the screw head to the plate (top screw: this was the one release with a peripheral burr cut, top right hole of plate), the trajectory of the burr holes made to release the plate (middle two screws, requiring burr cuts from the center of the plate to each hole, bottom two holes), and the cold weld of the reverse threaded screw driver to the screw head (bottom screw, top left hole).

Complete hardware removal was considered essential to treat this patient's infection. To protect the great vessels, they were mobilized and retracted medially as much as possible. A combination of various sized metal malleable retractors was secured between the vessel and area of burring. A high speed burr (Stryker TPS) was used with both an aggressive

4 mm round tip burr and a 3 mm neuro tipped cutting burr. Each tip was replaced frequently before they became dull. Cuts were started inside the plate and directed towards the screw head to break the screw plate hoop stresses. This inside-out technique avoided the vessel walls which were in contact with the outer edges of the plate. The final screw was drilled from the periphery to the screw head because it was located farthest away from the vessels with adequate space available for the drill bit. Once the plate threads were released the screw was easily removed (Figure 2). The L4/5 fusion was solid with no signs of pseudoarthrosis, so no further stabilization was utilized. Final cultures continued to grow the same MSSA, and postoperatively we initiated a 6-week course of nafcillin, 2 grams every 4 hours. The patient is now over eight years out

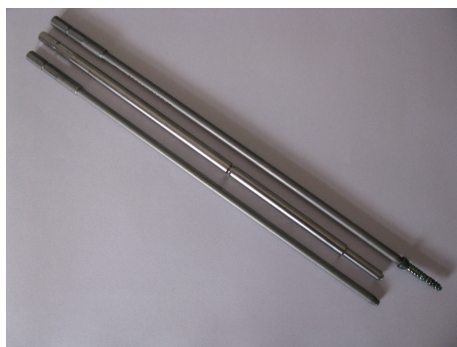
FIGURE 3: Image of the three reverse threaded screw drivers used. The top driver was successful in removing the screw but cold-welded to the interface. The bottom two drivers broke distally when used unsuccessfully on the remaining screws.

One year after his L4/5 fusion, the patient developed increasing pain in his lower back along with laboratory studies consistent with recurrent infection. Radiographic studies indicated changes at the L1-3 fusion mass, indicating the infection may not be isolated to the previous L4/5 disc. We planned a staged surgical debridement, hardware removal, and reconstruction, first at the L1-3 site, followed by debridement, hardware removal, and reconstruction at the L4-5 site. Exploration of the L2 corpectomy site confirmed a pyogenic infection extending into the psoas. After this was debrided aggressively, we reconstructed the L1-3 space with tibial allograft, followed by posterior segmental instrumentation. Cultures again grew methicillin sensitive staph aureus, and the patient was placed on IV vancomycin and gentamicin. Ten days later, a paramedian approach was used to access to the L4/5 locking plate, where purulence was again noted. Using the standard screw driver we were unsuccessful in our attempt to remove any of the screws and stripped the screw interfaces. We were successful in removing one screw with a reverse threaded screw driver, but we subsequently broke a total of 3 reverse threaded drivers attempting to remove the final three screws (Figure 3).
