Case Report

A Case Report of Implant Fracture of Extensively Porous-Coated, Distally Fixated Cementless Long Stem: Detailed Course of Stem Bending Development

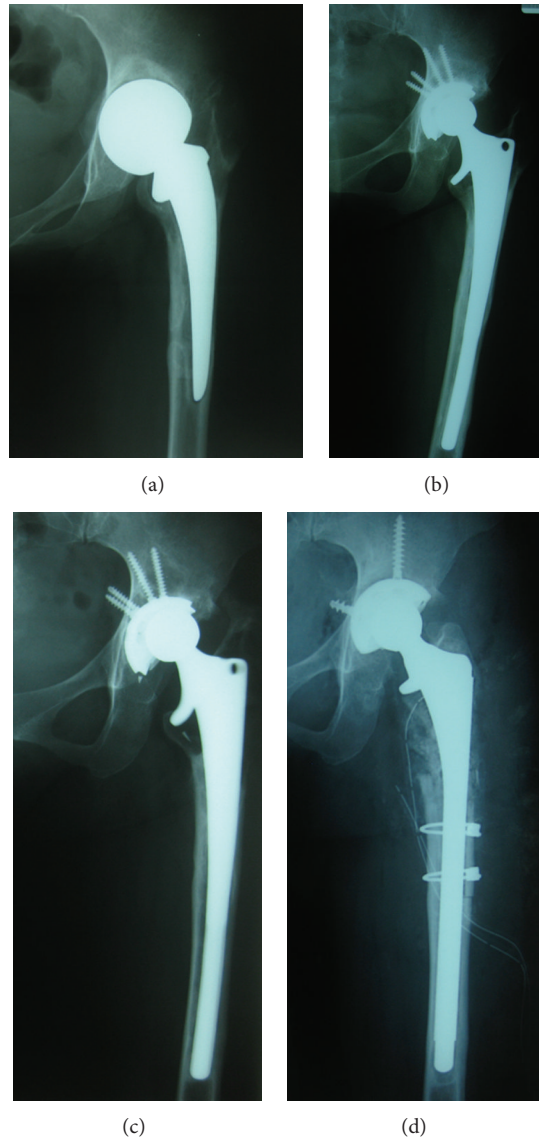
FIGURE 1: (a) Bipolar hemiarthroplasty (BHR) loosened aseptically and migrated superiorly. (b) Total hip arthroplasty (THA) was performed as a conversion from BHR to THA 22 years ago. Cup was unknown (Zimmer, Warsaw, IN, USA) and stem was BIAS long stem (Zimmer). (c) Stem prosthesis of primary THA loosened aseptically. (d) Revisional THA (cup, trilogly, stem, versis beaded full coat plus; inner head, 26 mm cobalt-chrome) (Zimmer) was performed because of aseptic loosening of THA 9 years ago.

The patient was a 48-year-old woman, measuring 58 kg in weight and 155 cm in height, with a body mass index (BMI) of 24 kg/m². She underwent a revisional THA for aseptic loosening, 9 years after which a stem fracture occurred. The case history was complex. First, she received a compression hip screw (CHS) for an intertrochanteric fracture suffered in a traffic accident at the age of 20, which was soon followed by a bipolar hemiarthroplasty (BHR) procedure because of failure of the CHS. Thereafter, aseptic loosening of the BHR was noted and she underwent conversion from BHR to a cementless THA (Zimmer, Warsaw, IN, USA) at the age of 26 (Figures 1(a) and 1(b)). At 39 years of age, a revisional THA (Trilogy cup, versis beaded full coat plus stem, 26 mm cobalt-chrome inner head, Zimmer) was performed because of aseptic loosening of the previous THA (Figures 1(c) and 1(d)). This cobalt-chrome alloy stem was extensively porous-coated, with a diameter of 12 mm and length of 200 mm.

During the operation, a strut allograft bone graft was required because of a comminuted fracture in the proximal portion of the femur that occurred during extraction of the stem, even though an extended trochanteric osteotomy (ETO) was performed. After the operation, the comminuted fragments and strut allograft were gradually absorbed. Additionally, a late acute homogeneous infection occurred 7 years after the revisional THA. The infection completely resolved following two operations for debridement and application of antibiotics-loaded cement beads, and the prosthesis was preserved. Thereafter, posterior dislocations occurred several times, the final one 7 months before the stem fracture.

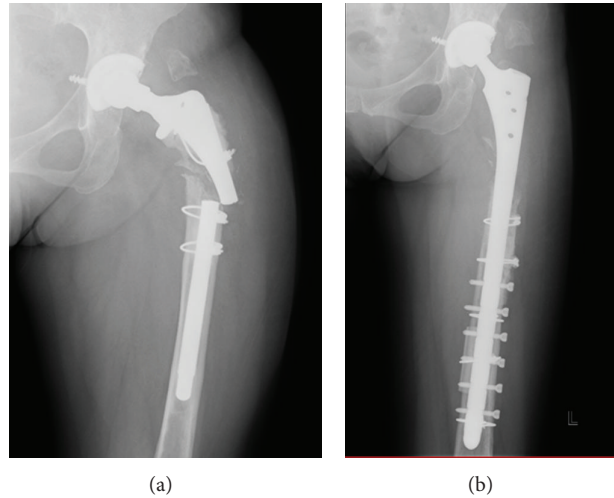
FIGURE 2: (a) During walking with a single axillary crutch, the stem was suddenly fractured at the site of well-fixed proximal level. (b) Re-revisional THA was performed with Delta-lock system (stem, titanium-6 aluminum-4 vanadium alloy; head, 26-mm Cobalt-chrome-molybdenum alloy (Nakashima Medical Co. Ltd., Okayama, Japan)); cup was not changed.

Two years later after the infection was finally healed, the stem was suddenly fractured while the patient was walking

with a single axillary crutch (Figure 2(a)). She underwent a re-revisional THA with a Delta-lock system (Nakashima Medical, Okayama, Japan) without a change of cup (Figure 2(b)). The section pictures of retrieved implant revealed a clear step in the medial side, suggesting that medial side was lastly fractured (Figures 3(a) and 3(b)). The new titanium-6 aluminum-4 vanadium alloy stem diameter was 14 mm and the length was 280 mm, fixed with six screws.

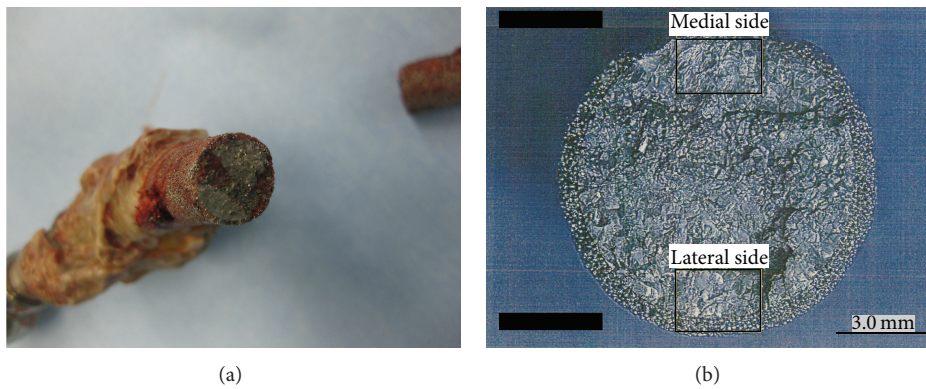
FIGURE 3: (a) The picture of retrieved implant. Lower left is medial side of the implant. (b) Extended section picture of proximal part. There was a clear step in the medial side, suggesting that lateral side was the starting point of fracture and medial side was lastly fractured.

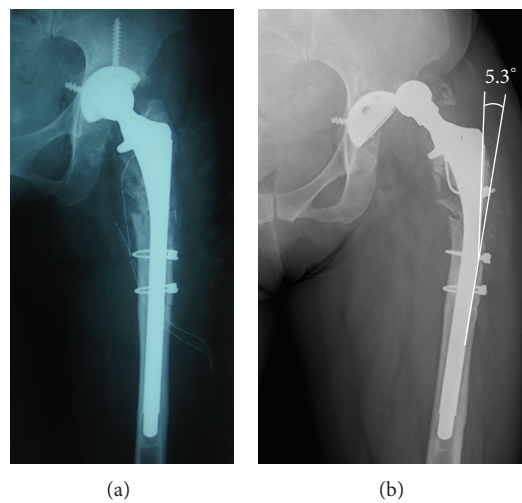
FIGURE 4: (a) The stem lateral bending was 0° immediately after revisional THA. (b) The stem bending was stronger than before, with the bending degree being 5.3° at final dislocation.

Immediately after the revisional THA was performed, stem bending was 0° (Figure 4(a)), which gradually progressed (Figure 5). The degree of stem bending immediately after the first dislocation was 1.9° . After the final dislocation, the degree of bending (5.3°) was more pronounced than before (Figures 4(b) and 5). The bending angle immediately

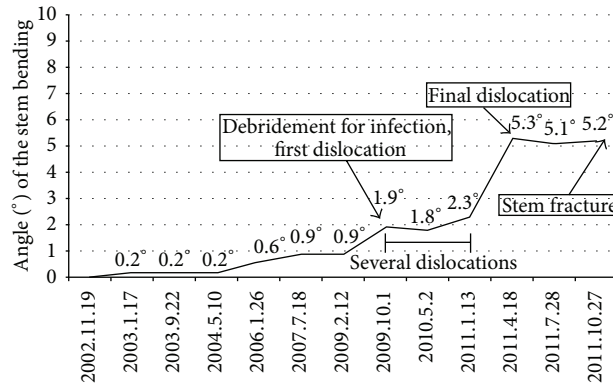
FIGURE 5: The stem bending was 0° immediately after the revisional THA. The stem bending gradually progressed during first five years. The stem bending immediately after the first dislocation was 1.9° and then the stem bending at final dislocation was 5.3°. The stem bending before the stem fracture was 5.2°.

before stem fracture was 5.2°. No bending was seen on lateral views obtained by radiography at any time. A scanning electron microscope (SEM) examination showed striation in the medial and lateral sections. SEM-energy dispersive X-ray spectroscopy (SEM-EDX) revealed that there was much higher oxygen at the medial and lateral sections as compared with the central section, suspecting that there had been in vivo corrosion before sudden implant fracture (Figure 6).

In our case, we considered that the cyclic loading with poor proximal bone support, distal fixation, and small diameter (12 mm) were the potential risk of this implant fracture the same as previous reports, because the development course of stem bending had revealed that the bending have been immediately and gradually occurred after implantation. However, we supposed that the repeated operations and dislocations might have aggravated the implant fatigue, as the stem bending got worse after debridement and subsequent several dislocations. We also supposed that two-times debridement (direct curettage to prosthesis) might accelerate the in vivo corrosion suspected by SEM-EDX examination. Prediction of stem fracture from the bending angle is not easy, because this angle is affected by the stem length of the nonfixation area and the level of rigid fixation. However, when deterioration of stem bending occurs, it may indicate a forthcoming stem fracture attributable to sudden fatigue.

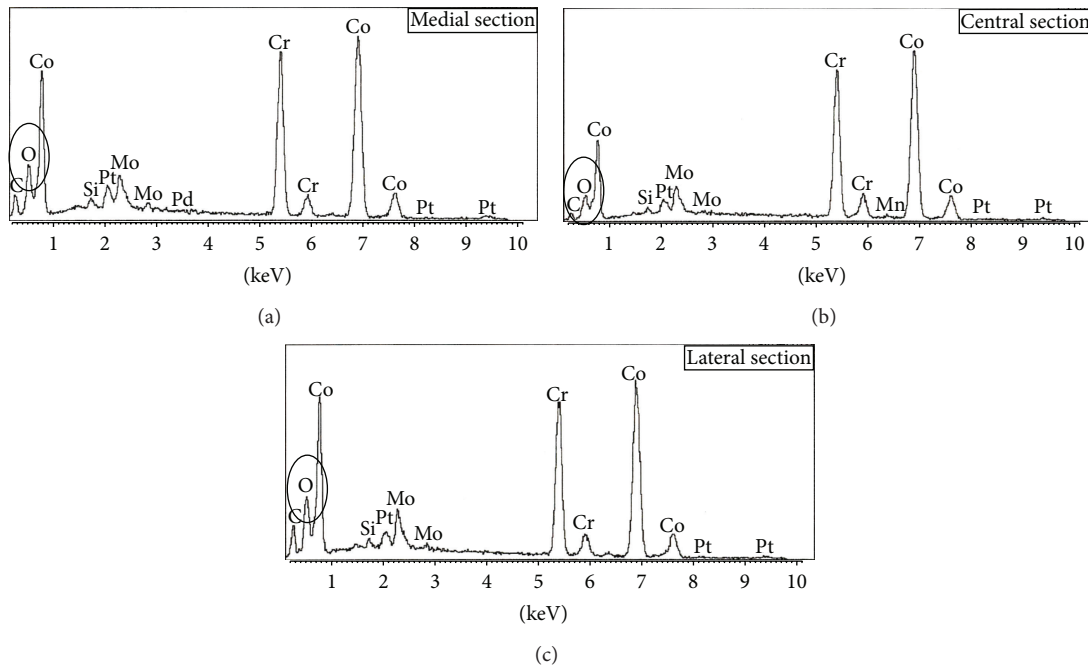
FIGURE 6: The results of scanning electron microscope- (SEM-) energy dispersive X-ray spectroscopy (SEM-EDX). (a), (b), and (c) showed the results of SEM-EDX at medial section, central section, and lateral section, respectively. Much higher oxygen at the medial and lateral sections was detected compared with the central section.
