Case Report

Fatal Cobalt Toxicity after a Non-Metal-on-Metal Total Hip Arthroplasty

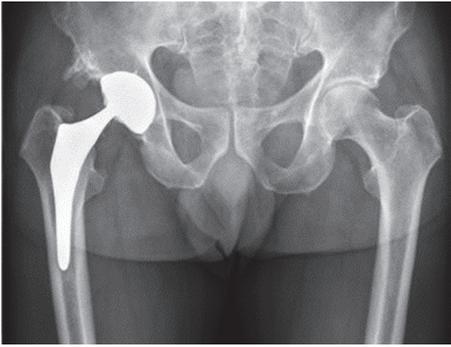
FIGURE 1: AP radiograph demonstrating eccentric positioning of the femoral head component of the right total hip arthroplasty without evidence for subsidence of the stem and loosening of the components.

and he was not able to bear weight on his right leg. Clinical examination revealed pain on the lateral side of the hip upon flexion and inguinal pain during rotation. Alternative axial loading and traction to the hip joint were painful (positive push-pull test). Plain radiographs demonstrated a normal configuration of the acetabular component, albeit with an eccentric positioning of the head within the socket; there was no evidence for osteolytic lesions, subsidence of the stem, or loosening of the components (Figure 1).

A skeletal scintigraphy excluded aseptic loosening of the prosthesis and no increased intensity around the femoral and acetabular components was observed. No signs of infection were present in whole blood samples. Considering the typical complaints and findings on clinical examination a fracture of the ceramic liner was suspected, and a revision procedure was performed.

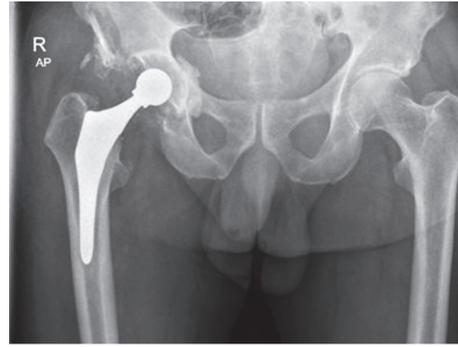
FIGURE 2: AP radiograph, 6 weeks following revision arthroplasty, demonstrating a polyethylene cup combined with a cobalt-chromium (CoCr) femoral head.

Intraoperatively, more than 20 ceramic pieces of the broken liner were detected and thoroughly removed and the surgical wound was repeatedly flushed. Macroscopically, all ceramic particles were removed. The joint capsule demonstrated hypertrophic changes for which synovectomy and debridement were performed. The femoral stem and acetabular shell did not show any signs of loosening. The acetabular shell was removed and replaced by a polyethylene (PE) SHP cup (Scientific Hip Prosthesis; Biomet, Warsaw, Indiana, USA) combined with a 28 mm cobalt-chromium (CoCr) alloy femoral head, with a matching taper (Figure 2).

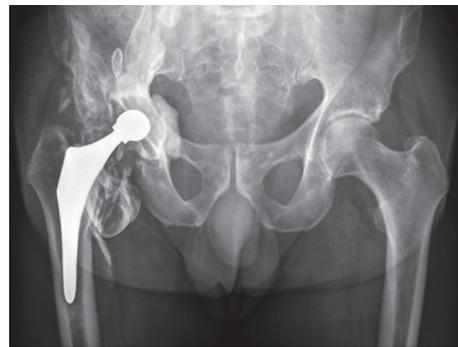
Postoperatively, he recovered well. At 6 weeks follow-up, the patient perceived an excellent function of the hip and there were no signs of radiological abnormalities. Six months after the revision procedure, the patient developed more pain in the right hip. To exclude progression of his multiple myeloma, a fluorine-18-fluorodeoxyglucose-positron emission tomography with computer tomography was performed, which showed no active osteolytic lesions but revealed metabolic activity in the right hip and gluteus muscle. Additional plain radiographs showed a well-fixed reversed hybrid total hip prosthesis and impressive periarticular densities around the components combined with flattening of the femoral head component with loss of its sphericity

FIGURE 3: AP radiograph, one year postoperative. Periarticular densities around all components with flattening of the femoral head.

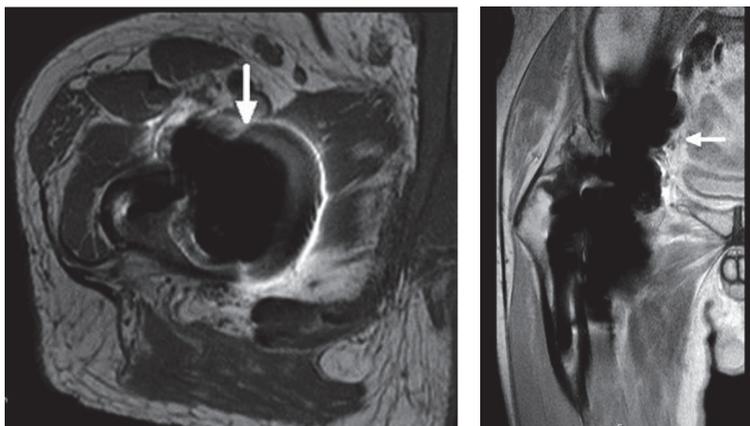
(Figure 3). Therefore, a magnetic resonance image (MRI) with metal artefact reduction sequence (MARS) was obtained which demonstrated metal wear debris with comprehensive pseudotumor formation surrounding the components of the total hip prosthesis (Figure 4). A second revision procedure was proposed to the patient but had to be postponed due to an ischemic cerebrovascular accident, for which both acetylsalicylic acid and dipyridamole were initiated. Hypothyroidism was diagnosed for which thyroxine supplementation was prescribed.

FIGURE 4: MARS-MRI of the right hip with metal wear debris with comprehensive pseudotumor formation (arrow).

remnants and the metal femoral head, severe and ultimately fatal cobalt toxicity occurred with dilated cardiomyopathy and neurotoxicity (hearing loss and visual impairment). The authors have obtained written informed consent from all subjects involved in this case for print and electronic publication of the case report.
