Case Report

Periprosthetic Fracture of Greater Trochanter in Total Hip Replacement Stemming from Pin Site Placement in Navigation-Assisted Surgery

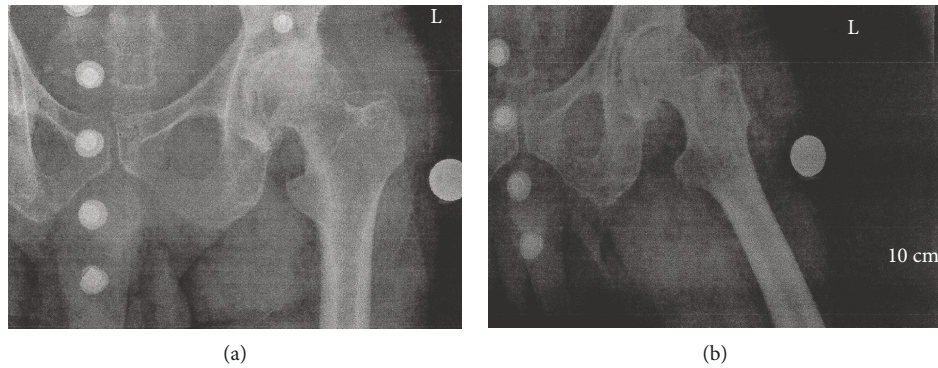
FIGURE 1: Preoperative AP and lateral X-rays showing stage IV osteoarthritis of the left hip.

The patient is a healthy 66-year-old male that presented with a five-year history of restricted motion and pain of the left hip associated with Kellgren-Lawrence stage IV arthritis (Figure 1).

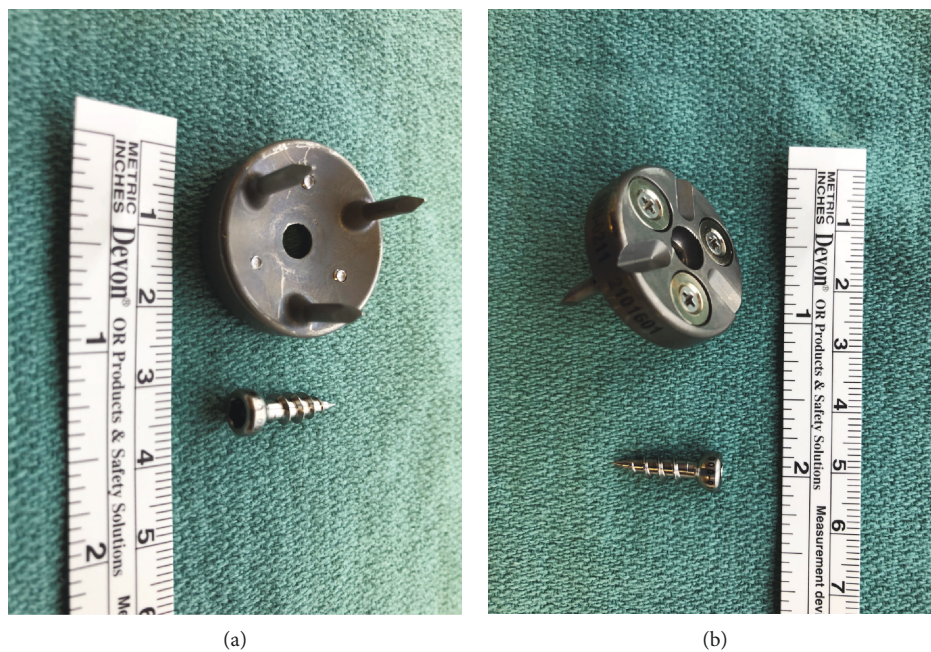
FIGURE 2: Tracker mount and pins utilized in CAS.

Navigation for the total hip was utilized to optimize radiographic alignment position offset and lengthening parameters. This was done by first acquiring predetermined landmarks to determine the center of the joint after stabilization of the camera in the anterior superior crest with two pins. Once the femoral head center was established, the CAS was digitized to acquire the femoral shaft to triangulate the pelvis, acetabulum hip center, and femur. While the femoral tracker was placed for the best camera visualization, effort was also taken to place the tracker on the flat lateral side of the trochanter. The CAS camera and tracker placement consists of a camera mounted on the superior crest of the ileum. The femoral tracker is fixed to the lateral greater trochanter. Usual placement is three cm below the tip of the greater trochanter on the posterior lateral border. Figure 2 displays the pins and femoral tracker base that the camera is placed on.

Moreover, the construct of the base of the greater trochanteric tracker disc (2.4 cm by 7 cm) utilized in this case poses potential additional complications. The base mount includes 4 3/32 inch diameter pins in variable lengths from 1/4 to 3/8 inch. The tracker base is affixed with a single cancellous screw, which creates an additional stress riser (Figure 2). Though each isolated component does not create significant stress, a summation of all components at the level of the cortical bone under tension creates a stress riser [26]. When examining subsequent cases to determine a cause other than the abovementioned stress riser, it is conceivable that added traction of the proximal femur to provide visualization to the tracker may cause excessive stress to the trochanter. When not using CAS, this added tissue retraction is not necessary. Therefore, the process of using CAS, in addition to the hardware of CAS on the trochanter, may be the tipping point for fracture propagation.

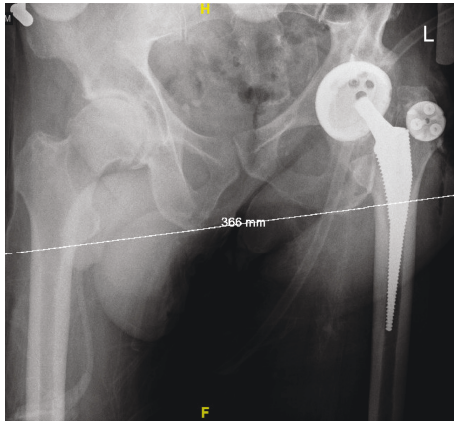
FIGURE 3: Intraoperative X-ray of the left hip demonstrating satisfactory positioning of the implants. The tracker base for the camera is visualized on the greater trochanter of the femur.

An intraoperative pelvis X-ray (Figure 3) was taken as a record to ensure accuracy, because CAS is a new technology. Intraoperative X-ray confirmed appropriate placement of the implant and was consistent with computer values of 43 degrees abduction and 20 degrees anteversion; offset was 0 and leg length was +2 mm. The target acetabular placement was 35-50 degrees abduction and 15-20 degrees anteversion. There were no intraoperative complications or any obvious evidence of compromise to the greater trochanter or the canal when a trial reduction was performed. In addition, the leg was taken through a full range

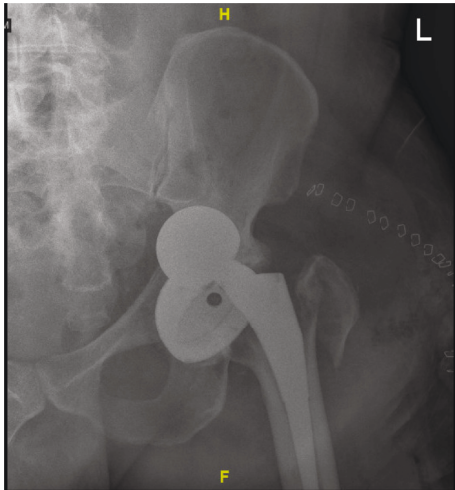
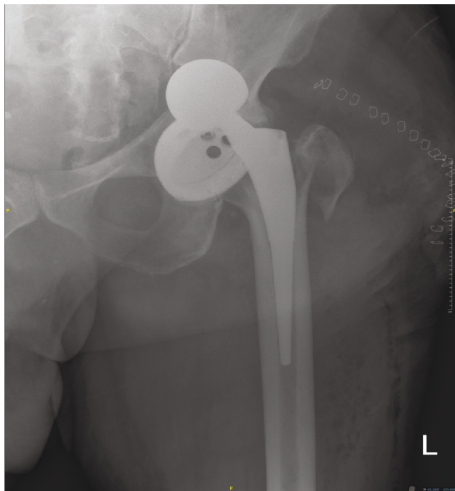
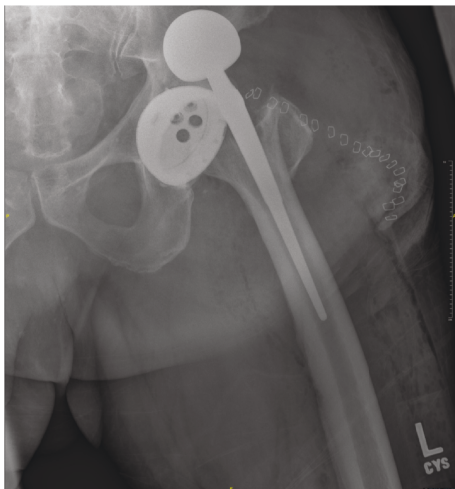
FIGURE 4: AP and lateral X-ray of the left hip 1 postoperative day after insertion of implants demonstrating anterior dislocation of left femoral head prosthesis and fracture of the greater trochanter.

Furthermore, in this case, it is most likely that the fracture of the greater trochanter led to the anterior dislocation of the femoral head prosthesis. Intraoperatively, it was determined that the acetabular component was aligned. CAS values for the cup and femur were 43 abduction and 20 degrees

Limitations of this case report include that it is unknown if the fracture occurred first or the hip dislocation of the hip occurred first. However, if we assume normal position and hip dynamics, it can be presumed that if the fracture had not occurred, the dislocation would have been prevented. In addition, the patient had no significant trauma postoperatively, and even if the patient did dislocate their hip due to poor component position, the periprosthetic fracture should

not have occurred. Furthermore, the stresses due to the navigation pins are strong enough to cause the fracture of the femur, because of the stress riser from the pin site placement. Therefore, this report suggests that the tracker should possibly be placed more posteriorly, where there are less tensile forces from abductors in order to avoid fractures of the femur. Moreover, additional research and development may be needed to determine the placement of pins to allow CAS to have utility, but decrease the amount of biomechanical stress on the bone. This may include development of an alternative strategy to mount the camera and tracker without the use of pins to avoid additional stress to the femur or injecting a gel or glue into pinholes following the removal of the pins to prevent the propagation of potential fractures.

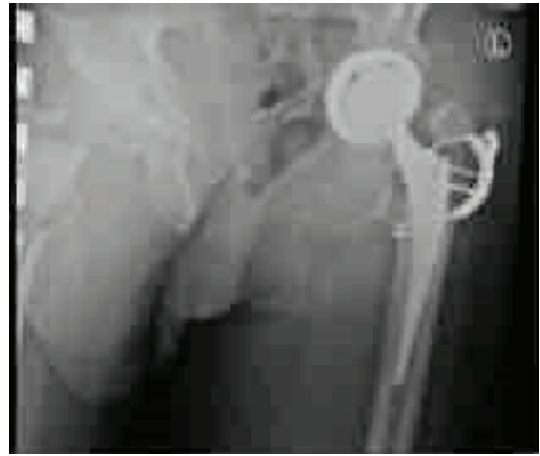
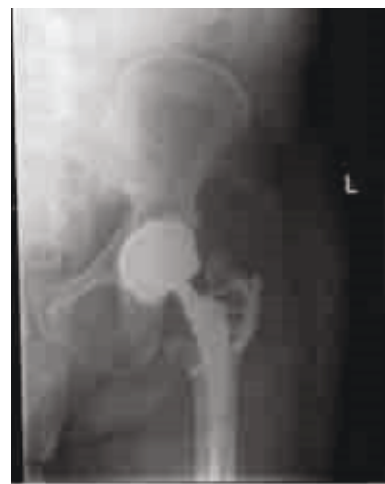
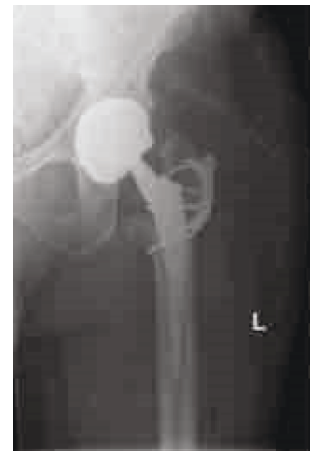
FIGURE 5: Pelvic X-ray of the left hip one postoperative day of THA revision demonstrating satisfactory positioning of the implants and placement of trochanteric cable plate. Wire was placed around the inferior portion of the Zimmer 51 mm short stature plate at the lesser trochanter and below. A second wire was placed at the upper trochanter at the implant junction. A third wire was placed around the greater trochanter.

Postoperatively, X-ray findings confirmed correct alignment (Figure 5). Postoperatively, the patient was placed on anterior hip dislocation precautions, which included refraining from leaning backwards, rotating the knee outward, sudden forceful movements, and avoiding stress on the incision site. At a six-week postop, the patient began full weight bearing and did not complain of any lateral trochanteric pain. A six-week postoperative X-ray demonstrated (Figure 6) optimal position of the plate without evidence of mechanical failure, breakage, or erosive changes. Two view hip series demonstrated proper alignment of the implant, fracture healing without callus formation, and a reduced fracture. Range of motion of the hip was approximately 90% of the maximum rotation and flexion. Gross evaluation

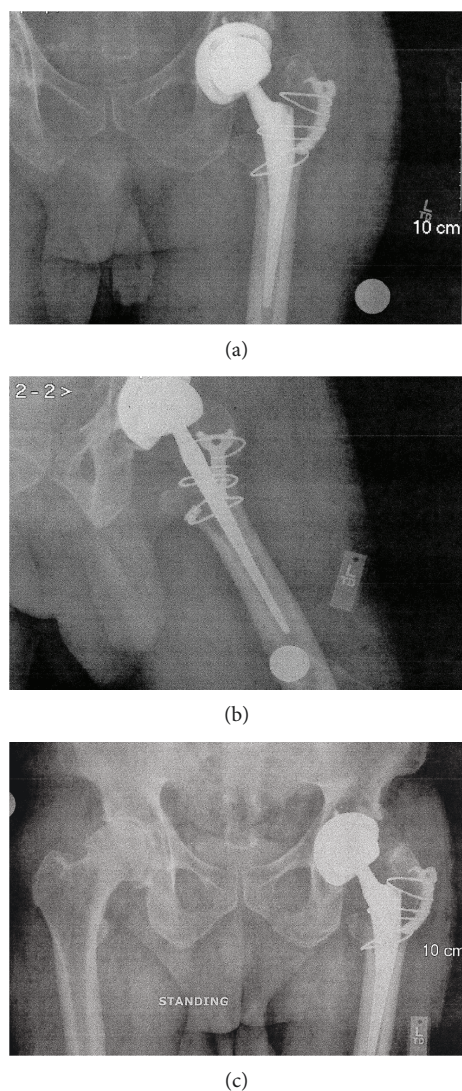
FIGURE 6: AP and lateral hip and standing pelvic X-ray at a six-week postoperative visit that demonstrate satisfactory positioning of the implants and trochanteric cable plate.
