Case Report

Dislocation of a McMinn-Like Prosthesis with Distinctive Metallosis and Fracture of the Os Ilium

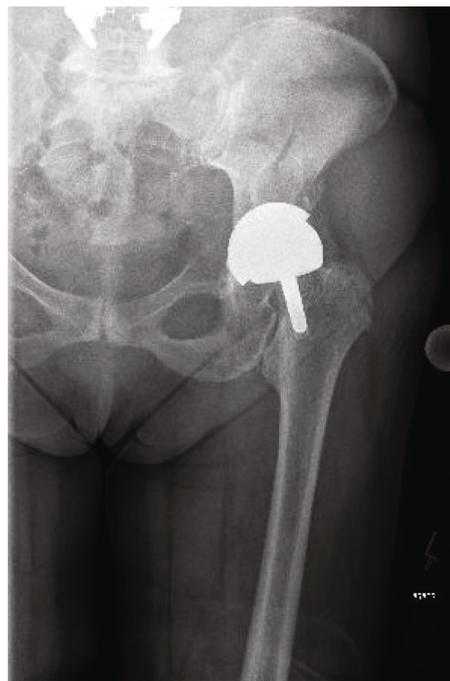
FIGURE 1: Initial X-ray of the fracture. After a stumble fall, the patient presented herself to an orthopedist. An anteroposterior X-ray of the pelvis was conducted and showed a fracture of the pelvis with a dislocation of the prosthesis.

The patient contacted our outpatient clinic because she had tripped over the stairs in her house. Afterward, she had constant and severe pain in the hip. The resident doctor conducted computed tomography (CT) and native x-rays on the hip to reveal the affected part (Figures 1 and 2). The CT showed the full extent of an acetabular fracture and the extension to the iliac bone. Since the fall, the patient has been immobilized on two forearm walking aids and dependent on regular painkillers, taking paracetamol 3 grams a day.

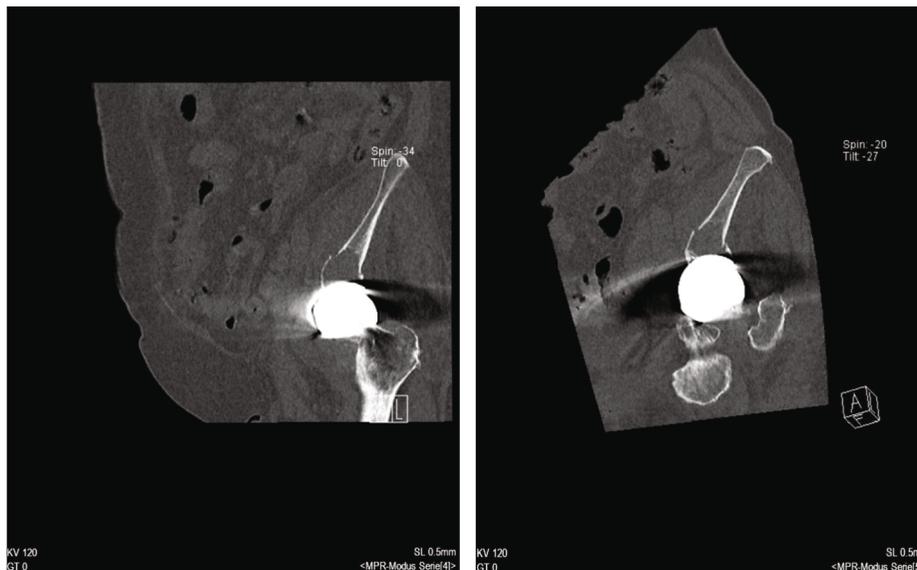
FIGURE 2: Preoperative CT of the pelvis. (a) shows the large osteolysis in the sagittal plane. (b) is the corresponding coronal plane of the patient's left hip.

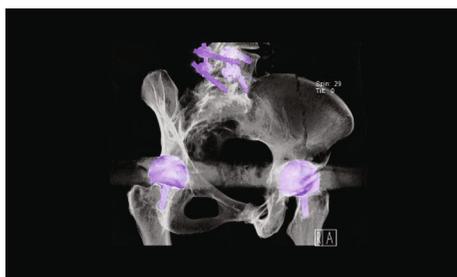
FIGURE 3: CT volume rendering of the pelvis. The reconstruction of all CT planes gives an overview of the fracture of the Os ilium and the extent of the cyst.

Pronounced osteolysis is observed in the femoral neck. The anterior edge of the cup was no longer visualized for osteolytic reasons. The ilium, the pubis, and the sciatic bone were lined with pronounced osteolytic linings (Figure 3). Surprisingly, in the case of osteolytic ilium fracture, no relative movement of the ileum is observed, showing that the pelvis osteosynthesis treatment could be dispensed. The acetabulum was debrided, and the metallosis was shown here at the smaller pelvis, carefully and extensively debrided (Figure 4).

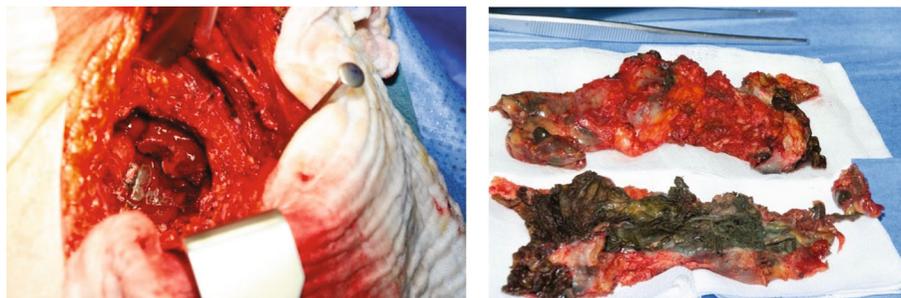
FIGURE 4: Metallic pseudotumor. (a) shows the intraoperative metallosis with pronounced osteolysis. (b) shows the resected metallic tissue after a complete surgical debridement.

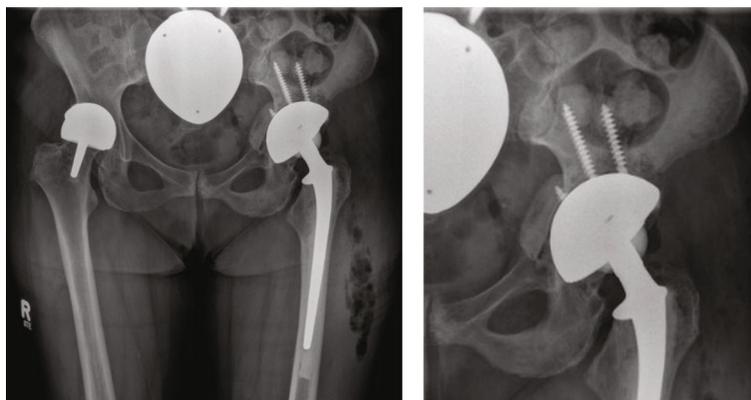
FIGURE 5: Surgical reconstruction after implantation of a cemented THA. (a) is an anteroposterior X-ray of the pelvis that shows the postoperative situation. On the left side, the patient carries a McMinn-like prosthesis without any symptoms or functional deficits. In (b), the bony acetabular reconstruction is observed. The cup was fixated with three screws to increase rotatory stability.

Two femoral heads from the inhouse bone bank were prepared for the construction. Two larger bone lids were shaped as a pan-base plastic, partially replaced the anterior pillar, and splinted in the acetabulum. The larger defects were filled with the remaining bone, resulted in a relatively stable bony bed. Then, a Trabecular Metal Acetabular Revision Shell (Zimmer Biomet, Warsaw, IN, USA) with an outer diameter of 60 mm was inserted, screwed into the dorsal of the abutment with 4 screws. An Endo-Mark III cup (Waldemar Link GmbH, Hamburg, Germany) 49/32.5 mm

was cemented into this. Carried out is the femoral implantation of a Lubinus Classic Plus shaft (Waldemar Link GmbH, Hamburg, Germany), size 4, 126° CCD angle, 150 mm long (Figure 5).

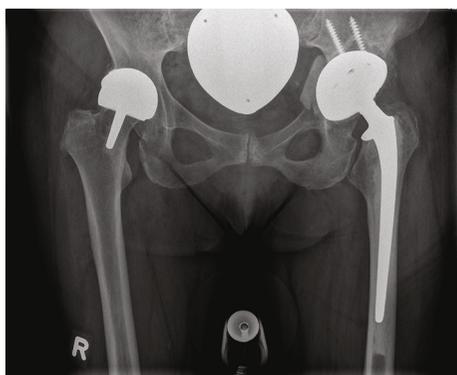
FIGURE 6: Follow-up X-ray 6 months after surgery. The anteroposterior view of the pelvis shows the correct placement of the implants and a bony healing of the Os ilium.

In the follow-up examination 6 months after surgery, the patient mobilized herself freely and with full weight bearing on the left leg (Figure 6). Function of the left hip was within physiological range.
