## Case Report

# Massive Chondrolysis and Joint Destruction after Artificial Anterior Cruciate Ligament Repair

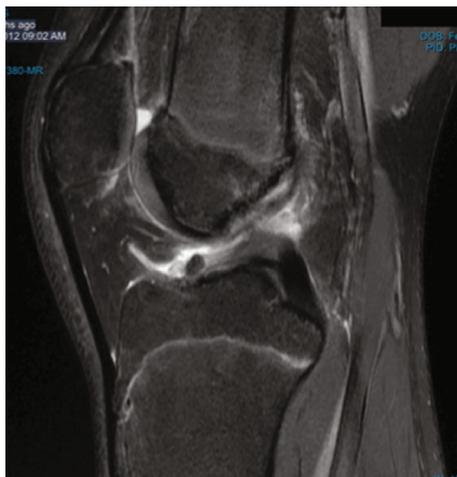
FIGURE 1: MRI demonstrating initial ACL rupture in 2012.

Mr. BP, a 16-year-old male, had a soccer injury in 2012 sustaining a left anterior cruciate ligament (ACL) and lateral meniscal tear (Figure 1). He subsequently had an ACL reconstruction performed by an orthopaedic surgeon (BM) who used the ipsilateral hamstring tendons for the ACL graft and repaired the lateral meniscus. A year later in 2014, Mr. BP sustained another injury to his left knee when dismounting from a dirt bike resulting in an intrasubstance ACL graft rupture and medial meniscus tear. He underwent a revision ACL reconstruction performed by another orthopaedic surgeon (EJ) using the contralateral (right) double hamstring tendons in addition to a Ligament Augmentation and Reconstruction System (LARS). The left medial meniscus was repaired with the omnispan meniscal repair system, and the frayed free edge was debrided conservatively to a stable margin.

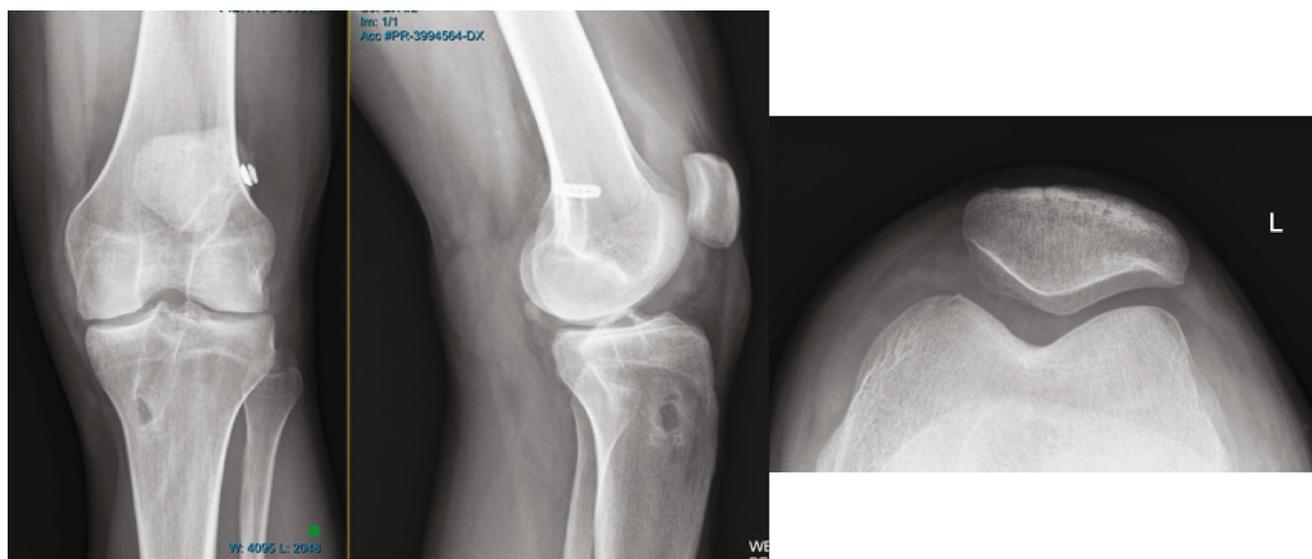
FIGURE 2: Radiograph in 2016 of BP's left knee.

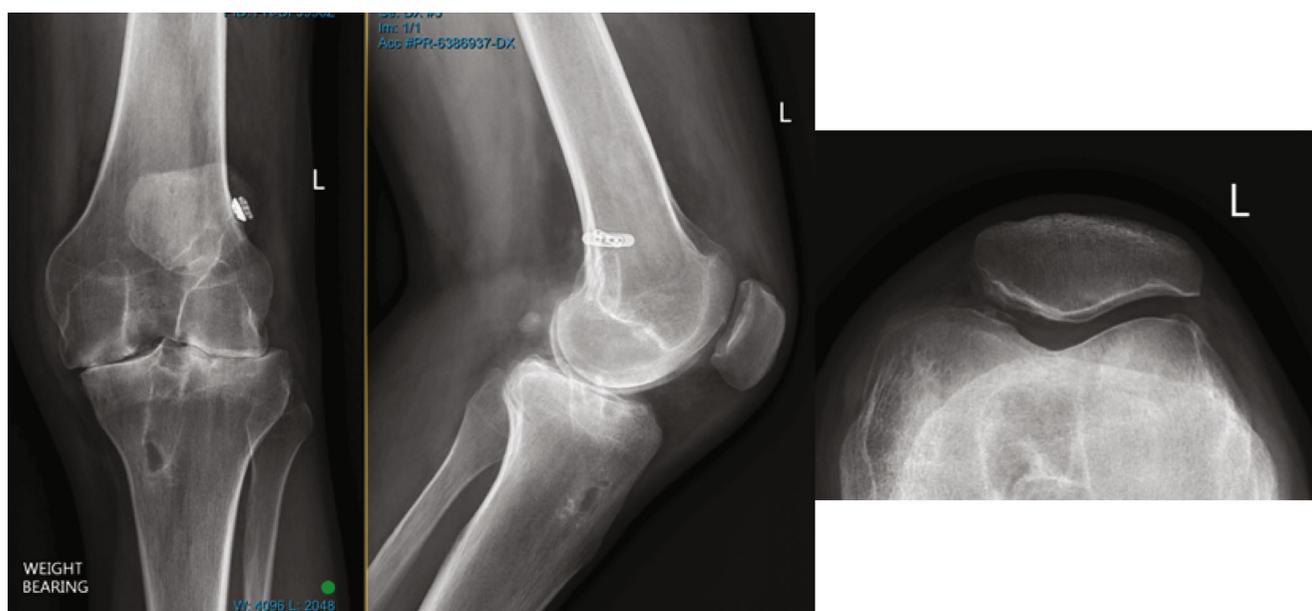
FIGURE 3: Radiograph in 2019 of BP's left knee. Note the significant interval change from 2016 images.

In March 2019, 6 years from the initial injury, Mr. BP (23 years) represented to PK for worsening pain and clunking with movement of his left knee. The pain was now both throughout the day and night and worse with work and not relieved with simple analgesia. On examination, the left quadriceps muscle was severely wasted, and the left knee had a positive pivot shift test and mild lateral ligament pseudolaxity. A radiograph at the time showed severe chondrolysis with bone-on-bone disease in a pattern across all three compartments (Figure 3).

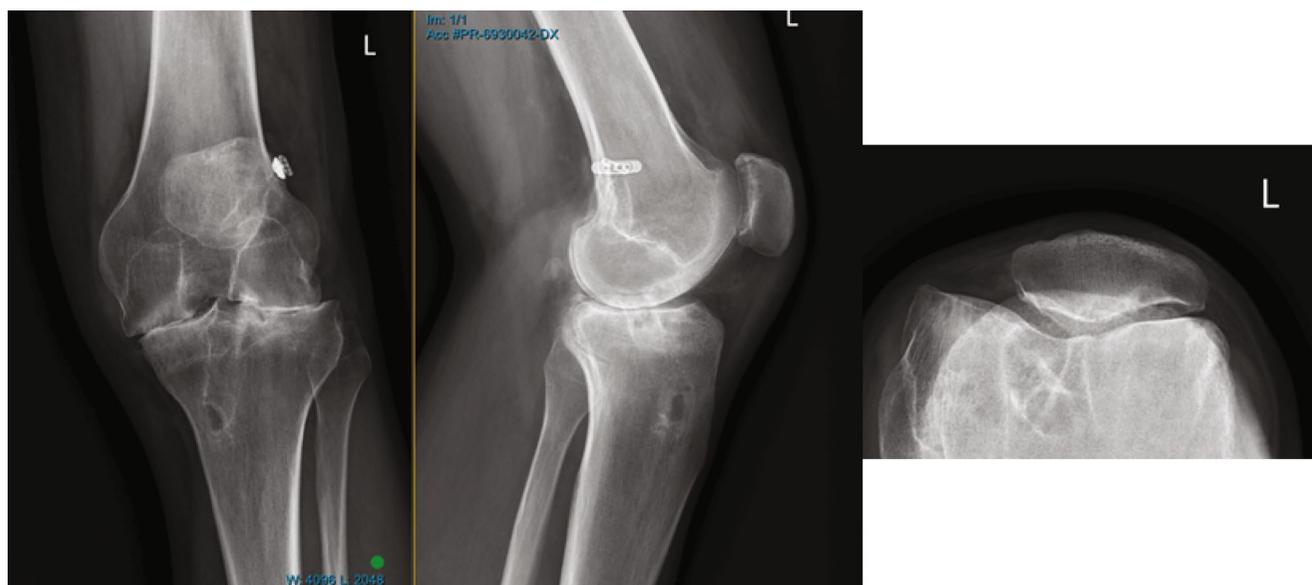
FIGURE 4: Radiograph of the left knee 7 months later in 2019.

In October 2019, Mr. BP's condition deteriorated further secondary to pain and immobility. An ultrasound guided Synvisc-One (Hylan G-F 20) injection of the left knee with 2 ml of Celestone Chronodose and 8 ml of 0.5% bupivacaine without complication. A progress radiograph (Figure 4) showed further narrowing of the medial and lateral compartments with increasing sclerosis and subarticular cysts compared to the MRI in 2018.
