Case Report

Osteolysis following PE Wear of a Hastings Head on a Monoblock Hip Stem

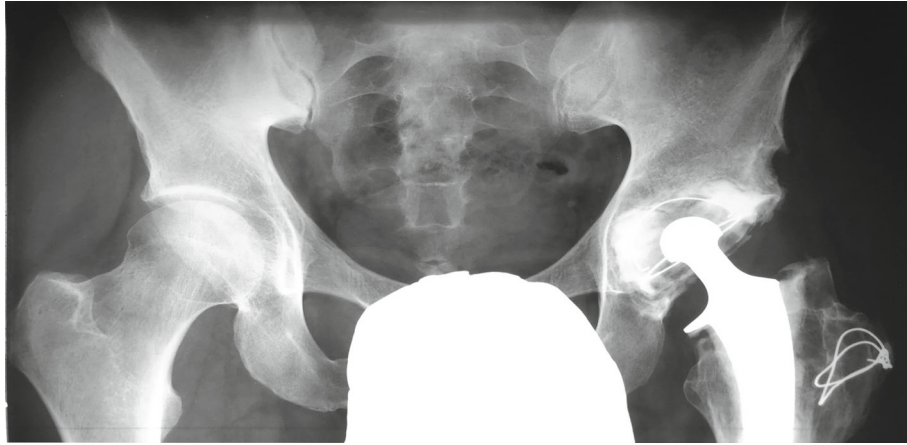
FIGURE 1: X-ray after primary total hip replacement (1975).

An 85-year-old male had a conversion osteotomy for dysplasia of his left hip in 1967. Due to increasing arthritis, the hip was replaced in 1975 implanting a collared cemented monoblock stem (Sheehan-Howmedica) with a nominal 22.225 mm head and a cemented PE cup (Figure 1). In 1987, the PE cup was revised due to loosening and converted to an uncemented Harris-Galante cup (Zimmer Biomet, Warsaw, USA) with a PE liner. In 2010, the PE cup liner

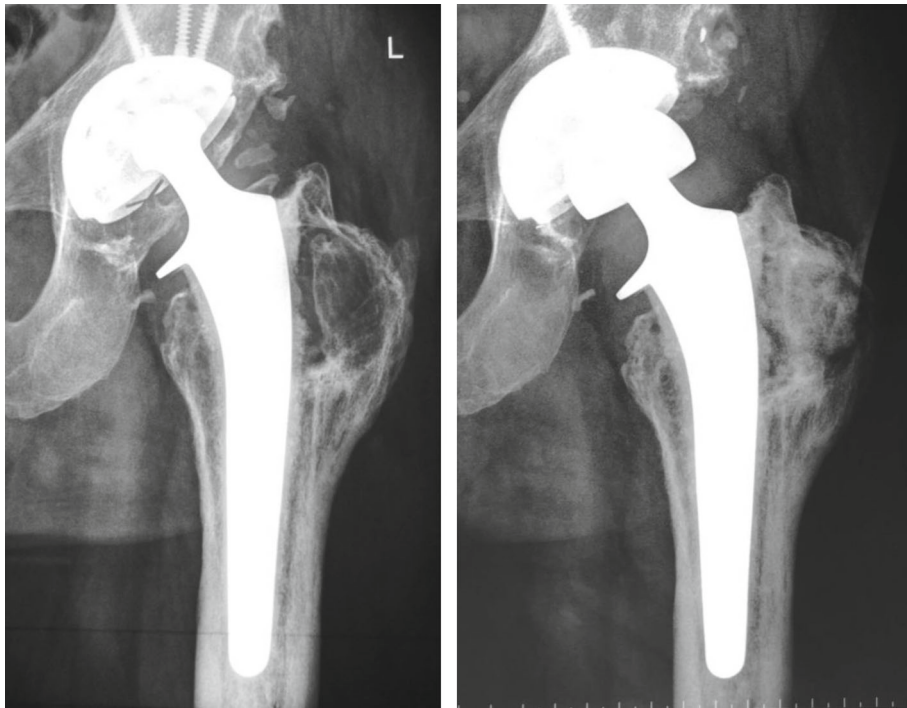
FIGURE 2: X-ray prior to the second revision showing major osteolysis of the greater trochanter due to PE insert wear (a) (2009); situation after the second revision surgery, in which the greater trochanter was bone grafted, screws were removed, and a 36 mm PE liner was cemented into the uncemented cup (b) (2012).

was revised due to major osteolysis of the greater trochanter (Figure 2). The greater trochanter was bone crafted, some screws were removed, and a 36 mm PE liner was cemented into the existing well-fixed cup and combined with a 36 mm Hastings bipolar head, articulating on the original stem. The histology showed no acute inflammation.

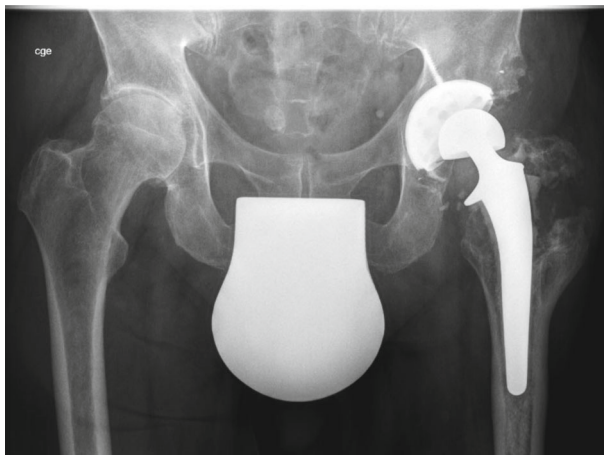
FIGURE 3: X-ray prior to the third revision surgery (2020).

The patient presented early 2020 with inguinal pain radiating to the thigh. The diagnosis revealed major osteolysis of the proximal femur with disconnection of the greater trochanter in a fibre-stable situation, in combination with chronic proliferative synovitis, hypertrophic scarring, and trochanteric bursitis. These findings led to a third revision (Figure 3). The monoblock stem was revised to a cemented

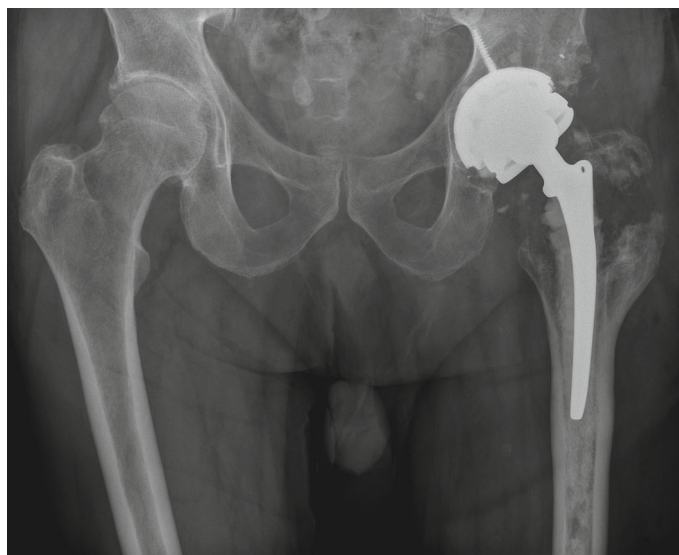
FIGURE 4: X-ray after the third revision surgery (2020).

Weber stem (size F 80) (Figure 4). The cemented PE cup liner was removed using a screw, and a bipolar Advantage cup (Zimmer Biomet, Warsaw, USA; size 50) in combination with a 28 mm ceramic head (M) was cemented into the still well-fixed uncemented Harris-Galante cup from the primary implantation, which was the only component maintained during revision (Figure 5). Additionally, a synovectomy, arthrolysis, necrectomy, and scar excision were performed.

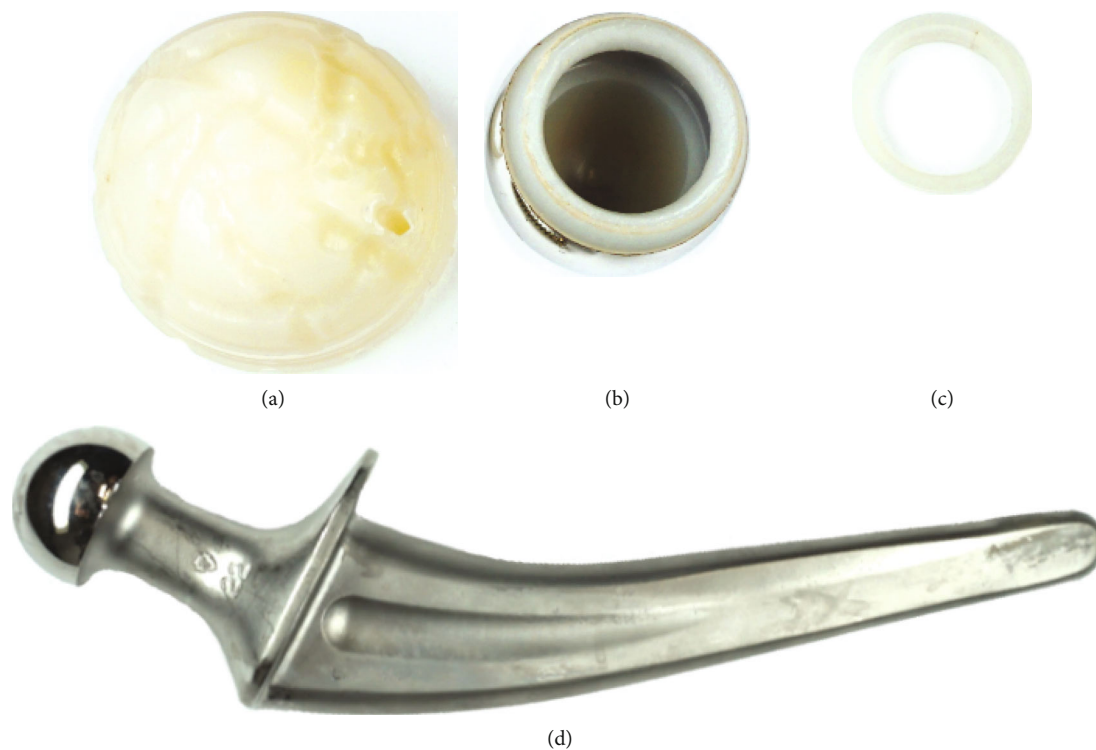
FIGURE 5: Explanted cup liner (a), bipolar head (b) with a constraining ring (c), and the monoblock stem (d).

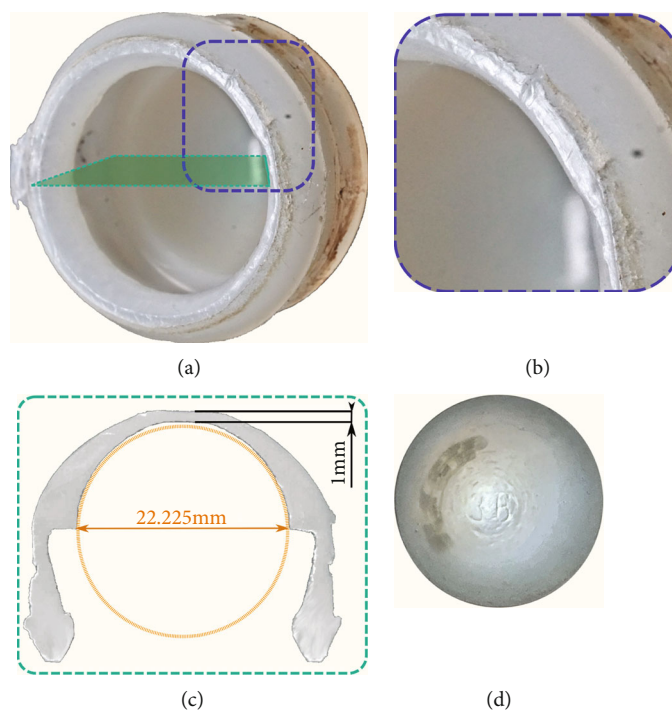
At the pole, the bipolar inner PE liner was worn down to a thickness of only 1 mm (Figure 6(c)). The device identification markings on the inside of the bipolar metal surface were imprinted into the bottom of the PE liner (Figure 6(d)). The rim of the PE head liner showed signs of stem impingement (Figure 6(b)). Dried blood had penetrated between the outer metal and the inner PE liner. The articulating surface of the cup liner showed scratches and pitting throughout without extended polished areas indicative of relative movement and wear (Figure 7). The stem exhibited polished areas close to the tip of the stem indicating some movement in the cement mantle (Figure 5(d)). The articulating head showed a roughened area (Figure 8). The undamaged smooth surface area of the head showed a roughness R_a of $0.139 \mu\text{m}$ with a maximum peak to valley height R_z of $1.170 \mu\text{m}$. In

FIGURE 6: Disassembled PE liner of the bipolar head (a) with signs of stem impingement around the opening (b); a 22.225 mm (nominal diameter) sphere fitted into the cross section in the supposed unworn position (c); imprinting of the bipolar head metal surface on the bottom, indicating cold flow of the PE (d).

As a consequence, movement of the joint seemed to occur predominantly inside the bipolar head with a small range of motion of only about 30 degrees, which corresponds to less than 50% of a free moving bipolar head. The limited range of motion led to the observed damage at the rim of the PE head liner due to impingement. Hastings bipolar heads are deemed to be compatible with a femoral head diameter of 22.225 mm [2]. In the presented case, the roughened femoral head caused major PE wear and consecutive “carving” of the head into the head liner. The head liner is designed to be slightly thinner centrally by the manufacturer but not to the extent seen in the retrieval [6]. The gap to a circle with the nominal head diameter indicates the amount of PE wear (Figure 6(c)), which most likely induced the osteolysis requiring the revision. The observed negative clearance between the femoral head and the PE head liner, which increased the friction and PE wear rate, was probably caused by swelling of the PE in combination with embedding of the head. Marked PE wear of the cup liner was not observed. The stem movement in the cement mantle, indicated by the polished areas on the stem, might have been enhanced by the higher bearing friction and resulting higher moments.

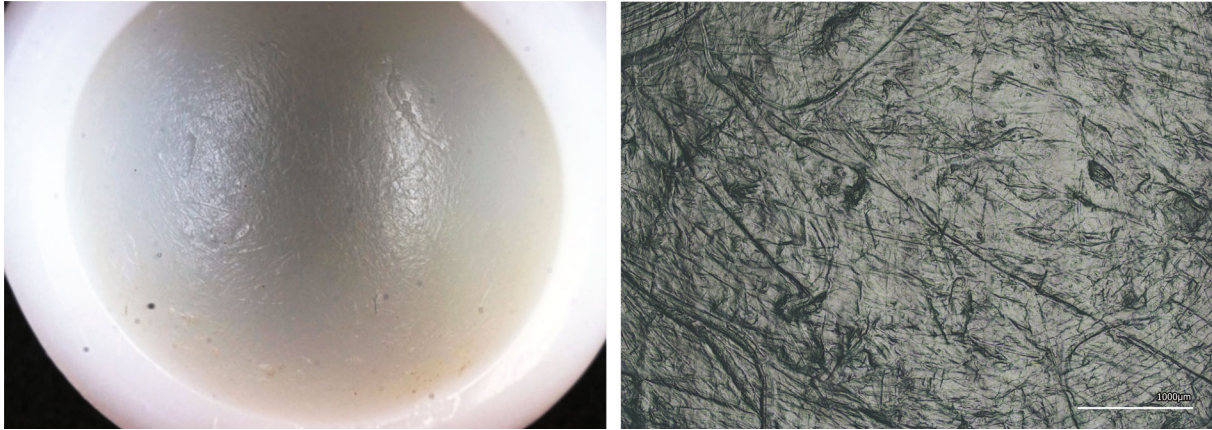
FIGURE 7: (a) View of the articulating surface of the PE cup liner with multidirectional scratches and (b) pitting magnification of the local surface damage.

intended articulation of the bipolar head against native cartilage for which, in contrast to an articulation against a liner, the exact head diameter is not that important since the native cartilage is flexible. The wear pattern of the PE cup liner with mostly pitting and scratching and very little polished areas indicates that there was almost no movement between the bipolar head and the cup liner as a consequence of the measured negative clearance (“jamming”). An originally existing small clearance might have been eliminated due to the swelling of PE in body fluids and a resulting volume growth. During revision surgery, the bipolar head could hardly be moved inside the PE cup liner.

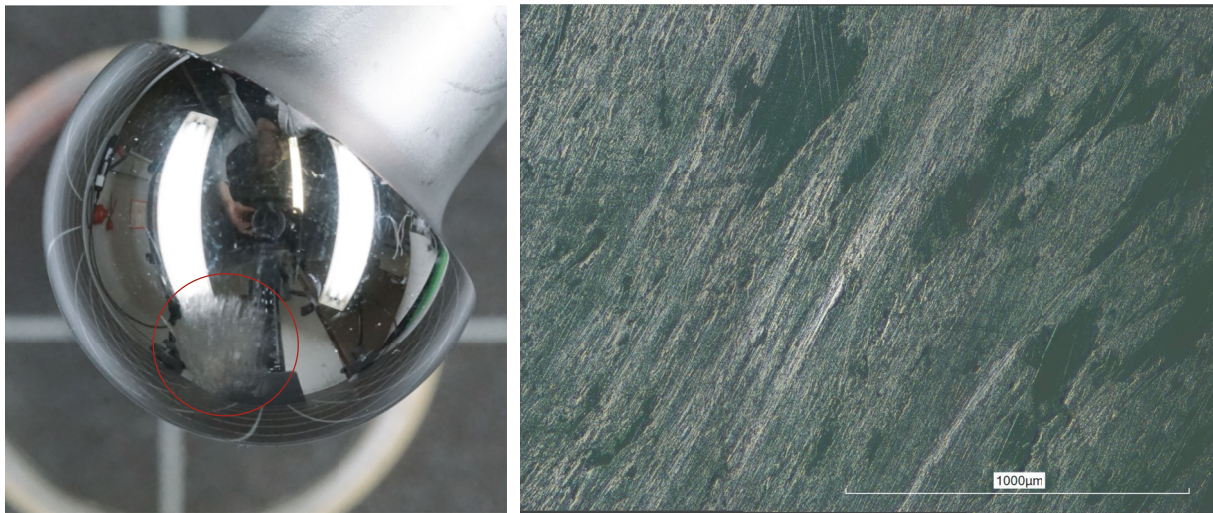
the roughened area, these values were more than 10 times increased (R_a : $1.888 \mu\text{m}$, R_z : $23.956 \mu\text{m}$).

FIGURE 8: (a) Heavily scratched area of the head with (b) magnification of the local surface damage.

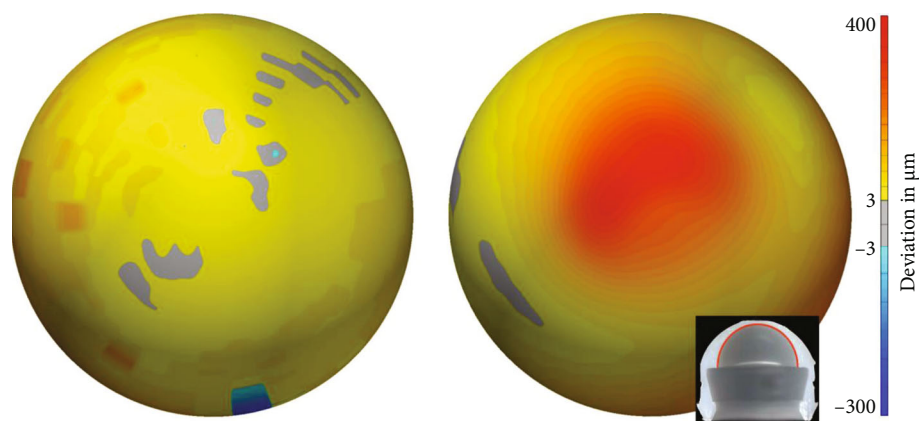
The diameters of the bearing partners were determined by fitting a best-fit sphere to the respective point clouds of the coordinate measurements, excluding worn areas (PolyWorks|Inspector 2019, InnovMetric, Québec, Canada) (Table 1 and Figure 9).

The estimated diameter of the femoral head was 22.194 mm, slightly smaller than the nominal head diameter of 22.225 mm for Charnley-Kerboull's monoblock-type stems. The estimated inner diameter of the PE liner of the bipolar head was 22.070 mm. This results in a negative diametral clearance of $-124 \mu\text{m}$ ("jamming") on the inner articulation of the bipolar head. The estimated outer diameter of the metal bearing surface of the bipolar head was 36.054 mm. The estimated diameter of the polyethylene cup liner was 35.936 mm. The deformed area from the screw was excluded in the fit. This results in a negative diametral

clearance of $-124 \mu\text{m}$ between the outside of the bipolar head and the PE cup liner (“jamming”).

FIGURE 9: Deviation from a perfect sphere of the PE contact area of the cup liner (a) ($d = 35.936$ mm) and the head liner (b) ($d = 22.070$ mm). Red areas indicate PE wear, and blue areas indicate deposit.

For the analyzed bipolar head, an outer diameter of 36.054 mm was measured. This is a clear indication that it was not compatible with the 36 mm cup liner. The slightly larger diameter as nominal results from the
