Research Article

Investigation on Crack Coalescence Behaviors for Granite Containing Two Flaws Induced by Cyclic Freeze-Thaw and Uniaxial Deformation in Beizhan Iron Mining, Xinjing, China

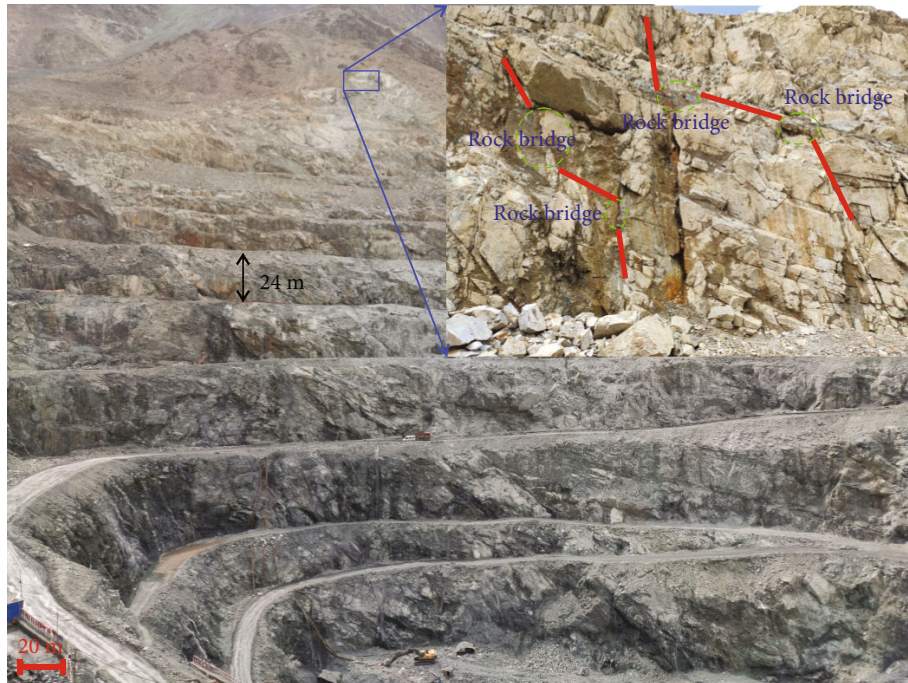
FIGURE 2: Photo of the western open pit slope, plenty of locking structural rock mass develop in the slope, the rock bridge is often named as “locking segment”.

2.2. Description of Shale Material. The rock was obtained from the Beizhan open pit slope located at the Xinjiang province, northwest of China (Figure 2). The lithology of the rock is granite, which is distributed at the west boundary of the open pit slope, as shown in Figure 1. There are three sets of joints on the west slope, plenty of joints are intermittent, that form a locking section on the rock mass, this kind of structural body has a strong effect on the stability of the rock slope, as shown in Figure 2. The rock cores were drilled and prepared in a cylindrical shape with a diameter (D) of 50 mm and a height (H) of 100 mm according to the ISRM-suggested methods. Both ends of the samples were polished to ensure the error of unevenness is less than 0.05 mm and parallelism of both ends is less than

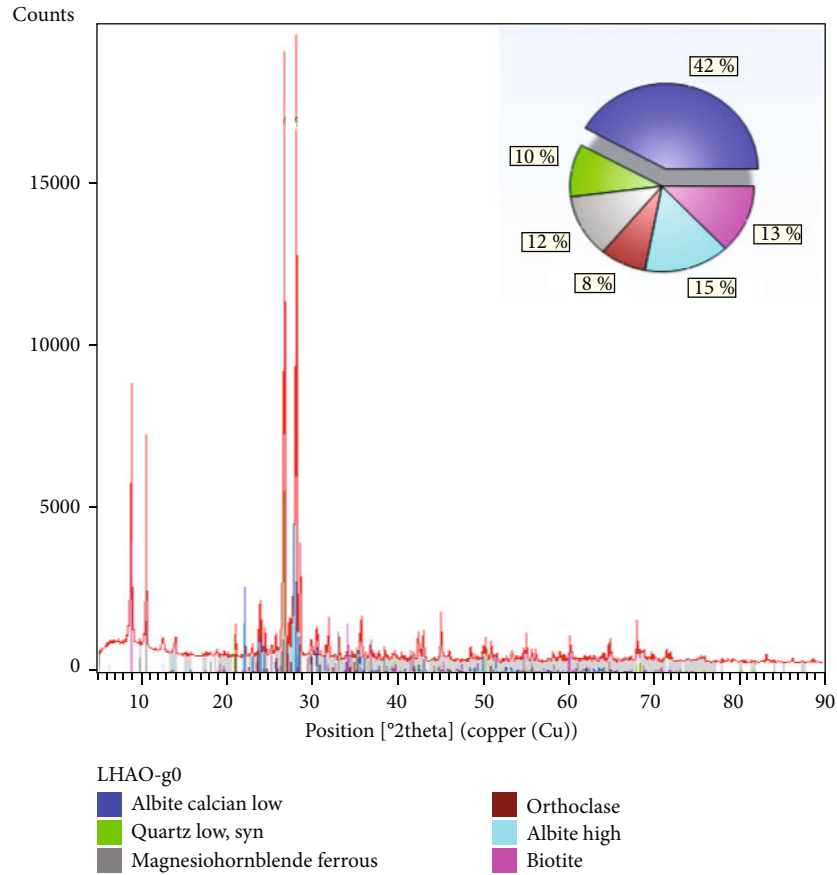
FIGURE 3: XRD analysis of the mineral composition of the rock power before F-T treatment.

0.1 mm. From the results of X-ray powder diffraction (XRD) in Figure 3, the granite was mainly composed of albite (75%), quartz (10%), magnesiohornblende (12%), orthoclase (8%), and biotite (13%) minerals. By SEM imaging analysis

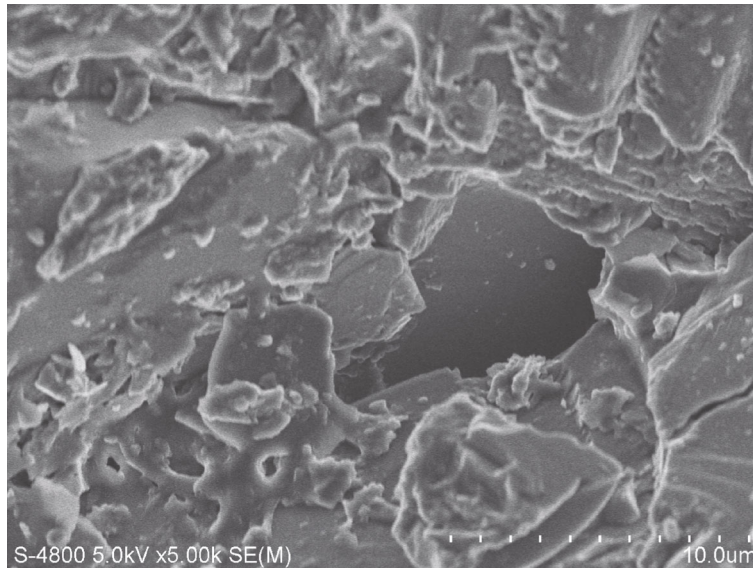
FIGURE 4: SEM results for granite with a magnification of 5000x before F-T treatment.

(Figure 4), it can be seen that some microcracks develop at the interfaces of minerals; in addition, some large pores and many small pores can be observed during the formation of granite.

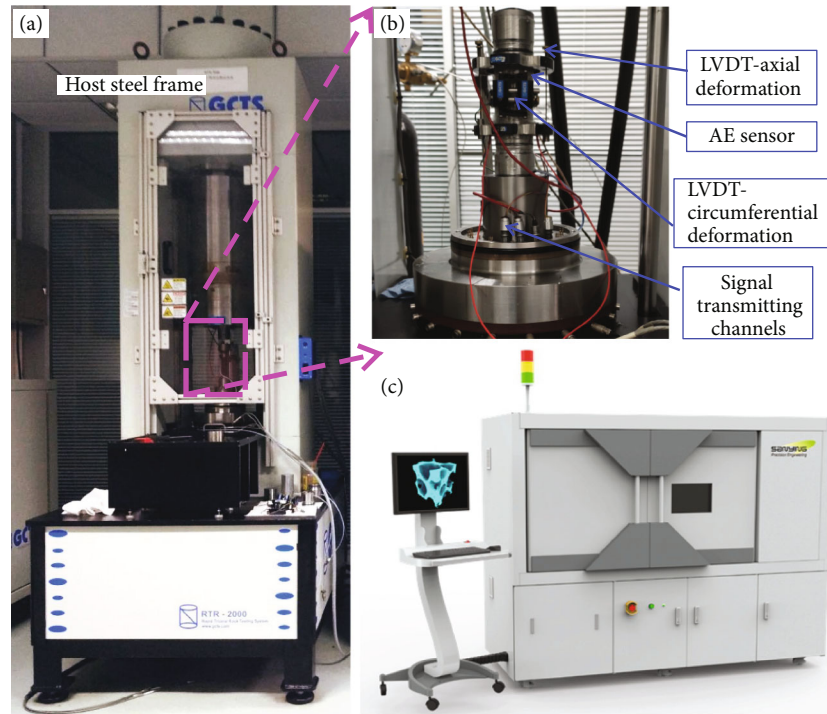
FIGURE 6: The experimental devices used in this work. (a) The rock mechanics machine. (b) The LVDT systems used to measure the axial and lateral deformation. (c) The 450 kV industrial CT system used to obtain the crack pattern of marble.

After the uniaxial tests, X-ray CT scanning for each sample was conducted in order to obtain the failure CT images inside the sample. In this study, a high-resolution CT machine of nanoVoxel-3000 with a source voltage of 160 kV and source current of 200 A was used for imaging, as shown in Figure 6(c). For a sample, five CT images were

obtained from the top, middle, and bottom of the marble sample, the corresponding positions are 58, 54, 50, 46, and 42 mm, respectively. Based on the CT images, the internal failure morphology of the marble samples can be well revealed. The testing device used in this work is shown in Figure 6.

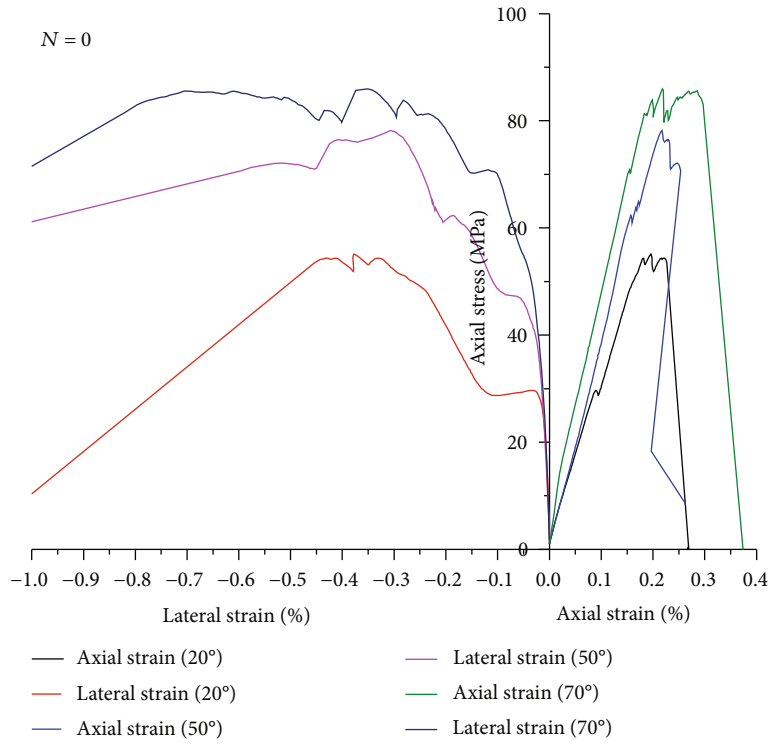
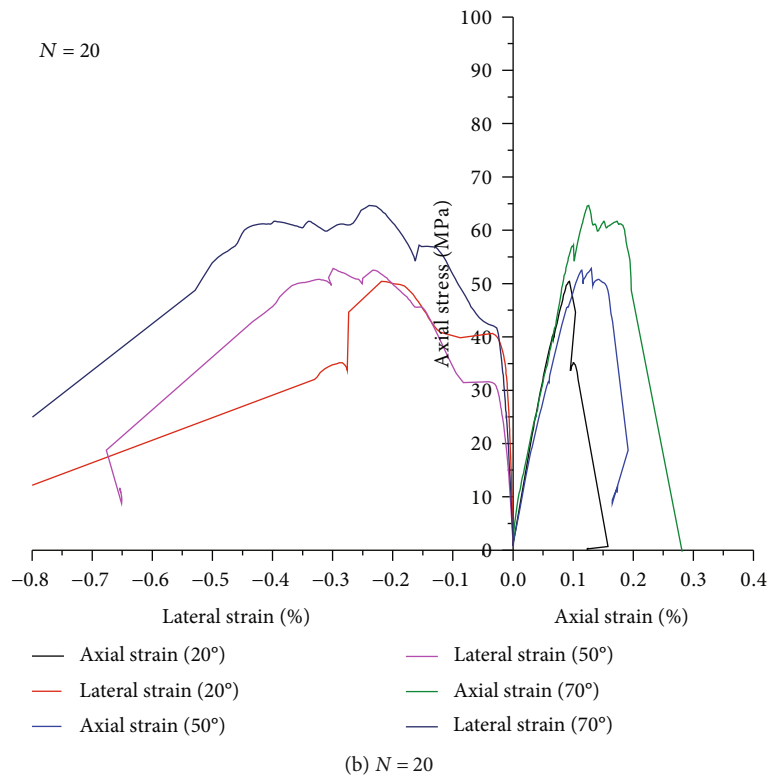
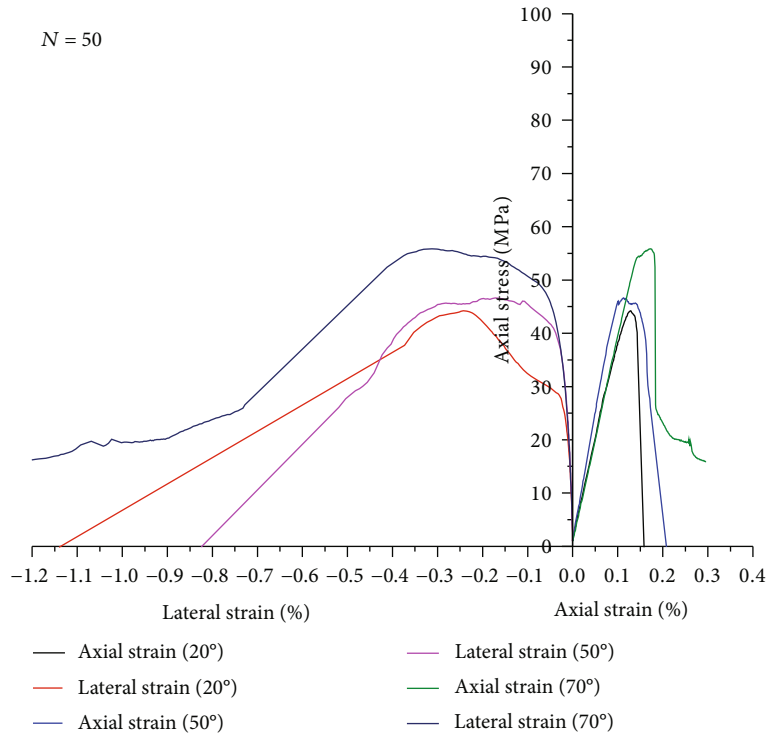
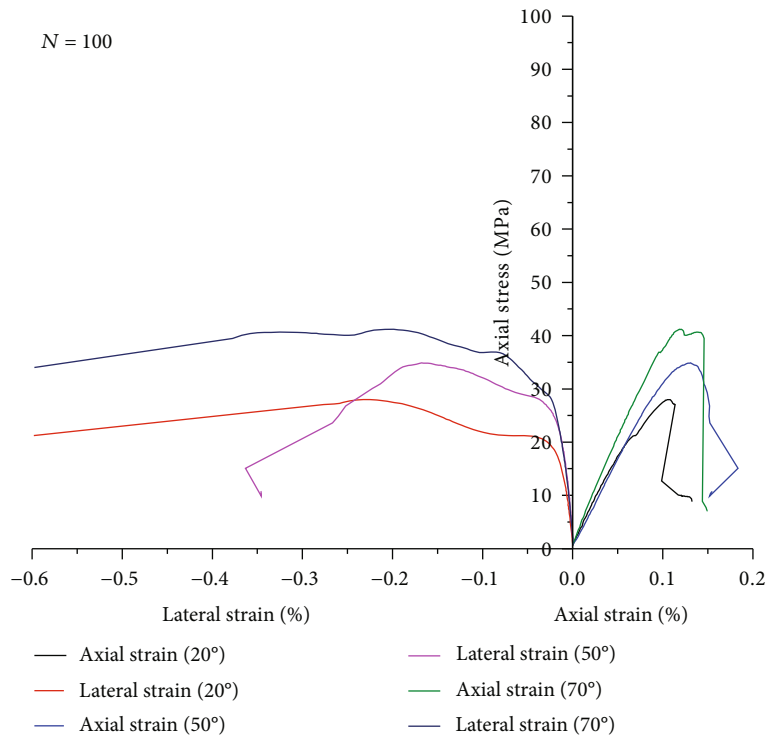
FIGURE 7: The typical axial and lateral stress–strain curves for the samples containing two flaws. (a–d) The number of F-T cycles is 0, 20, 50, and 70, respectively.

inside the granite samples. When a sudden failure occurs, crack initiates and the cracks continuously propagate when the energy accumulated to a certain level. After the peak stress, the sample fails abruptly and the stress-strain curve drops to zero quickly. From the morphology of the stress-strain curves, it can also be seen that the number of the stress drop points is large for samples subjected to 0 and 20 cycles. For the samples that are subjected to 100 F-T cycles, the stress-strain curve grows smoothly, and no obvious stress drop point can be observed.

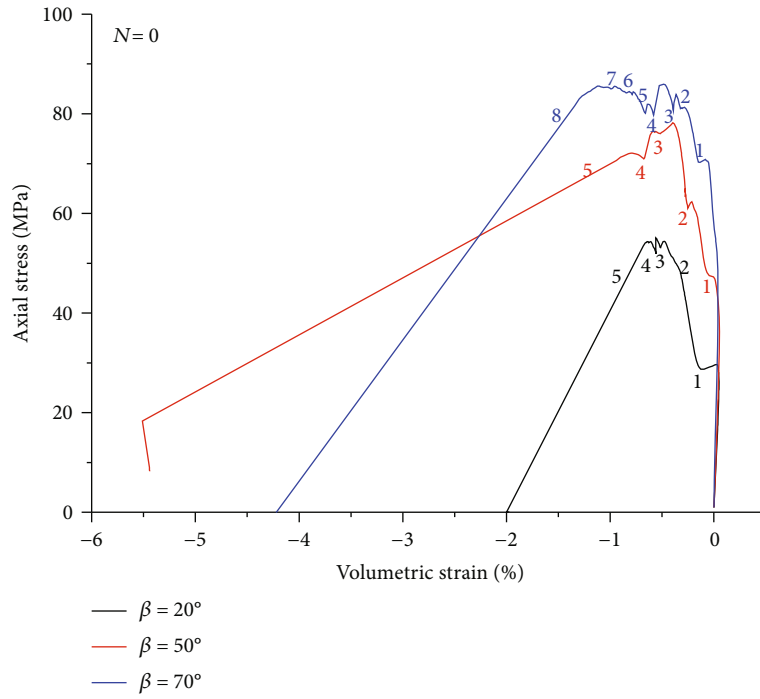
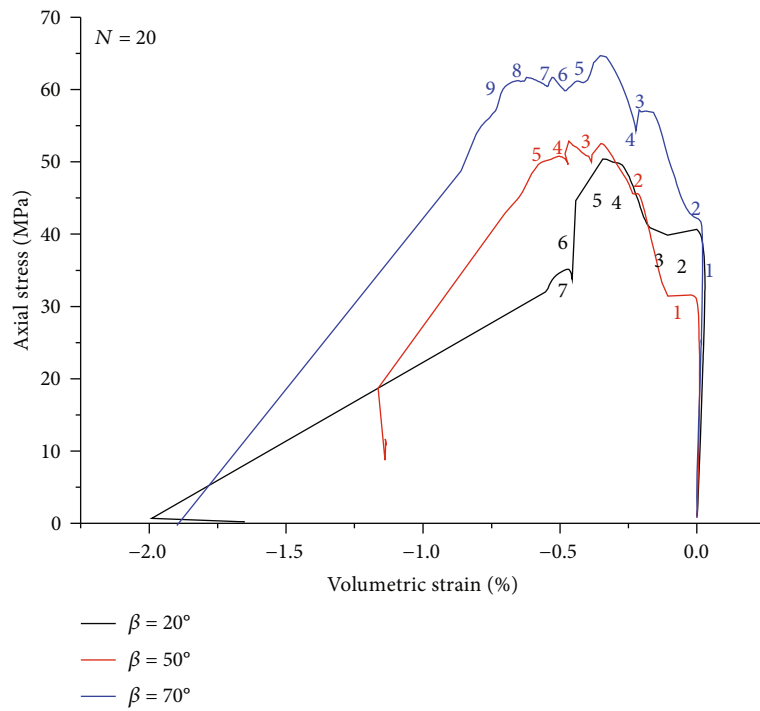
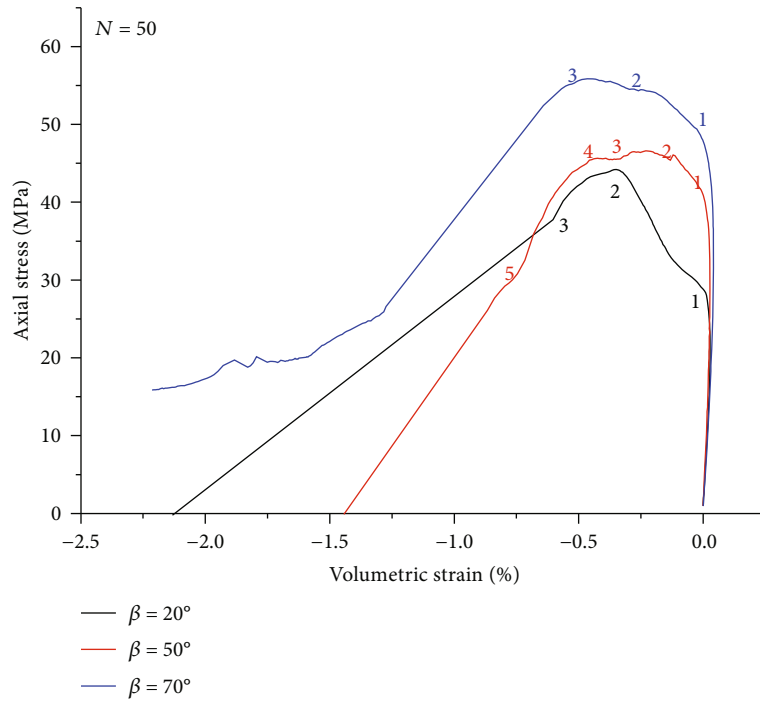
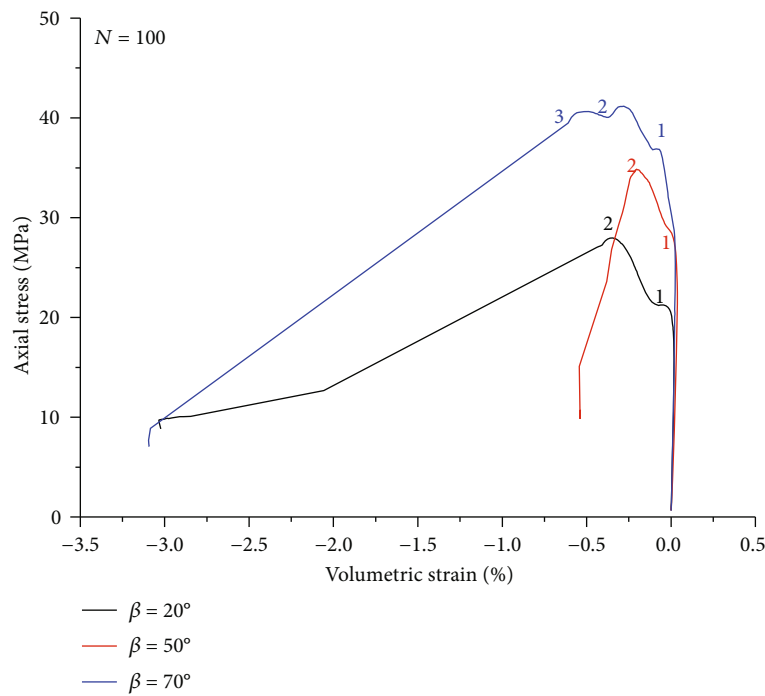
FIGURE 8: The typical volumetric stress–strain curves for the samples containing two flaws. (a–d) The number of F-T cycles is 0, 20, 50, and 70, respectively.

In order to well reflect the influence of axial and lateral deformation on the volumetric changes, the volumetric strain (ε_v) is calculated according to the axial strain (ε_1) and lateral strain (ε_3) as $\varepsilon_v = \varepsilon_1 - 2\varepsilon_3$. The volumetric strain reflects the combination effect of axial and lateral deformation. Figure 8 depicts the volumetric stress-strain curves for the samples subjected to different F-T cycles. The stress drop point can be observed clearly from the

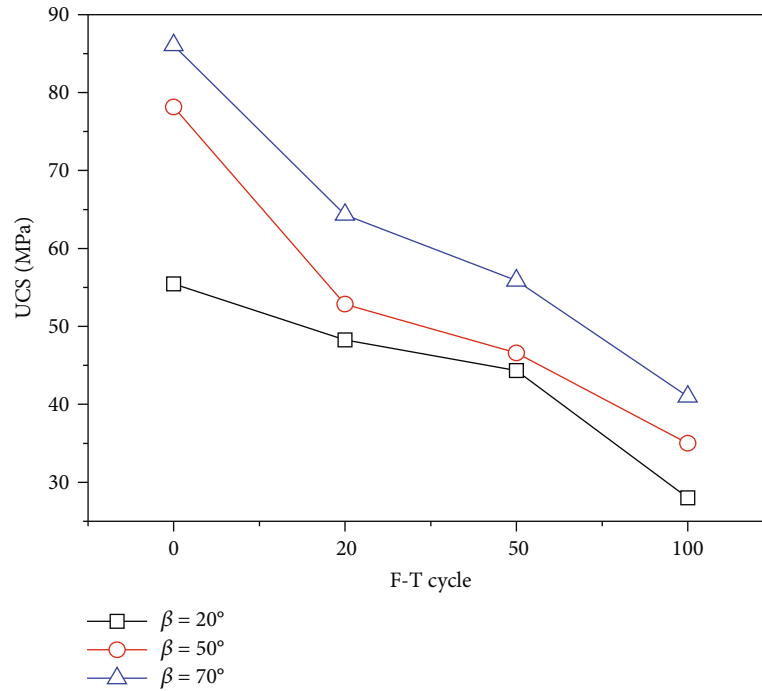
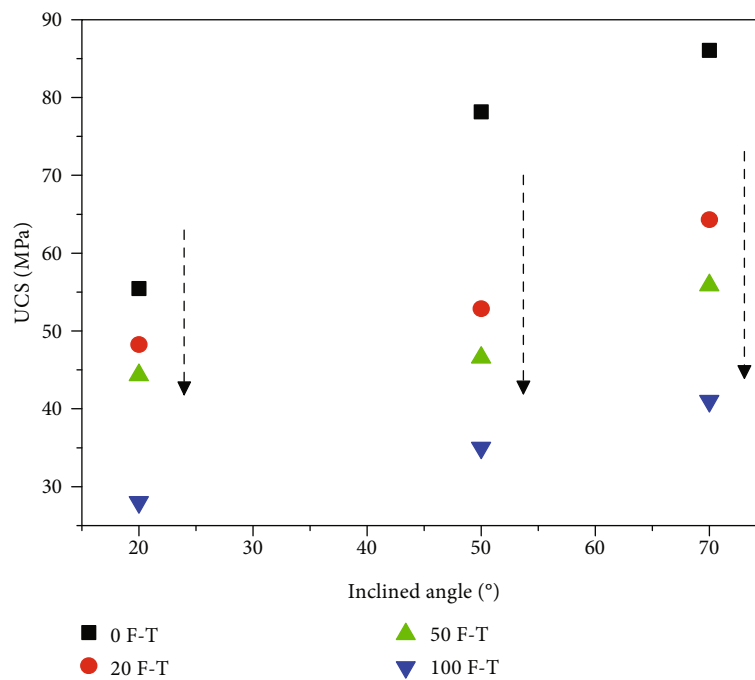
FIGURE 9: Uniaxial compressive strength (UCS) of the tested granite samples. (a) Changes of UCS with freeze-thaw cycles. (b) Changes of UCS with the approach angle defined in Figure 5(a).

strength characteristics. Figure 9 plots the relationship between the UCS and F-T cycles. The UCS decreases with the increasing of F-T cycles. For a sample that is subjected to high F-T treatment, damage induced by the frost heaving force inside the flaws is most severe, and the strength of the sample is the minimum accordingly. In addition, the UCS is affected by the approach angle, and UCS is the largest for the samples having a 70° approach angle.

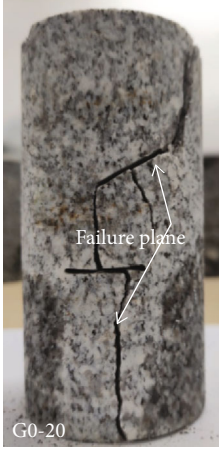
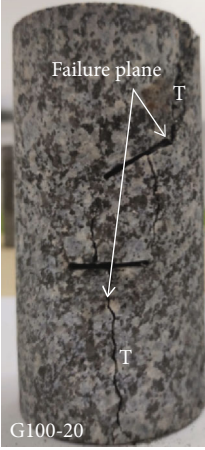
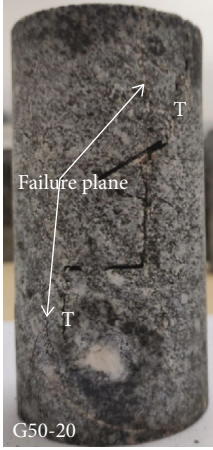
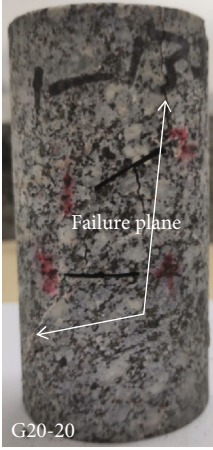
TABLE 2: Crack propagation and coalescence for the samples with an inclination flaw of 20°.

Crack coalescence patterns	<ul style="list-style-type: none"> (i) Tensile cracks initiated from the flaw tips and almost parallel to the major stress direction (ii) failure by only tensile or tensile+shear cracks (iii) crack propagation from the left part of the inclined flaw to the middle of the horizontal flaw (iv) plenty of cracks exist at the rock bridge 	<ul style="list-style-type: none"> (i) Crack propagation from the left of the inclined flaw and propagation to the middle of the horizontal flaw (ii) crack propagation from the right tip of the horizontal flaw to the middle of the inclined flaw (iii) tensile failure occurs at the rock bridge and failure 	<ul style="list-style-type: none"> (i) Crack propagation from the middle of the inclined flaw to right tip of the horizontal flaw, multiple tensile cracks initiated from the left of the horizontal flaw (ii) shear crack initiated from the left tip of the inclined flaw (iii) failure by only tensile crack (iv) two cracks exist at the rock bridge 	<ul style="list-style-type: none"> (i) Crack propagation from the left of the inclined flaw to the middle of the horizontal flaw (ii) failure by only tensile crack (iii) crack propagation from the right of the horizontal flaw to the middle of the inclined flaw (iv) number of cracks at the rock bridge gets to the minimum

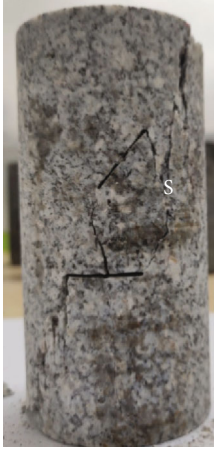
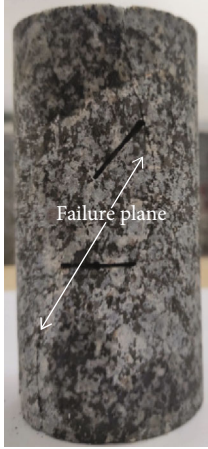
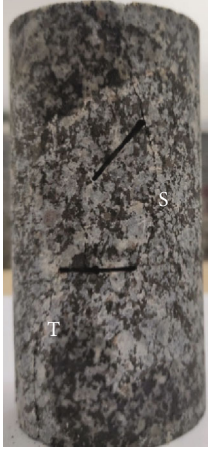
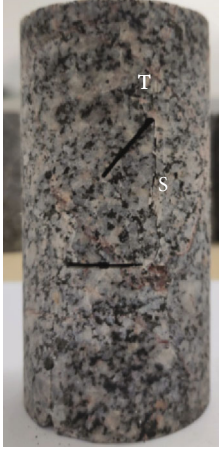
TABLE 3: Crack propagation and coalescence for the samples with an inclination flaw of 50°.

Crack coalescence patterns	<ul style="list-style-type: none"> (i) Tensile cracks were initiated from the right tip of the inclined flaw, anticrack propagation to the right tip of horizontal crack (ii) Tensile crack propagation from the middle of the horizontal flaw to the left tip of the tip of the inclined flaw (iii) Shear cracks were observed and induced failure (iv) Flaw aperture thickness both decreases for the two flaws (v) Many cracks develop at the rock bridge segment 	<ul style="list-style-type: none"> (i) Tensile cracks were initiated from the left tip of the inclined flaw, and propagation to the middle of horizontal crack (ii) Shear crack was initiated from the middle of the inclined crack and induced failure (iii) No cracks between the right tip of the inclined flaw and horizontal flaw (iv) Number of cracks at the rock bridge decreases 	<ul style="list-style-type: none"> (i) Failure only by tensile cracks (ii) Tensile crack from the right tip of the inclined flaw and propagation to the right tip of horizontal crack (iii) Tensile crack propagation from the left tip of the inclined flaw to the middle of the horizontal flaw (iv) No decrease in flaw aperture thickness (v) Crack at the rock bridge decreases 	<ul style="list-style-type: none"> (i) Tensile cracks were initiated from the left tip of the inclined flaw and propagation to the middle of horizontal crack, anticrack propagation to the right tip of inclined crack (ii) Number of cracks at the rock bridge decreases sharply and it got to the minimum

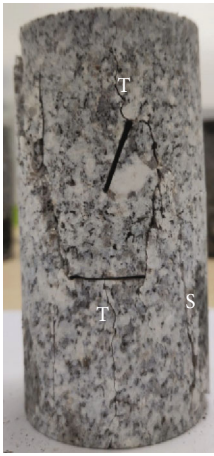
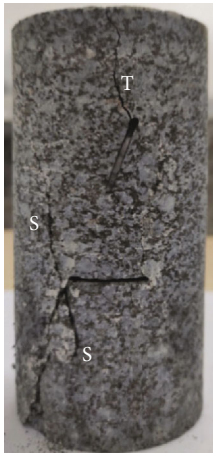
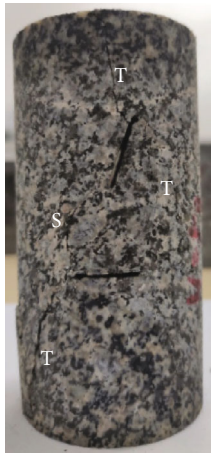
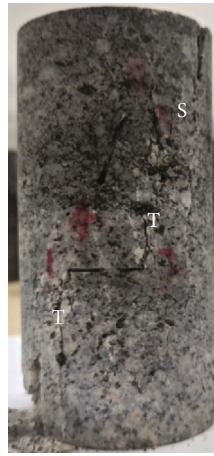
TABLE 4: Crack propagation and coalescence for the samples with an inclination flaw of 70°.

Crack coalescence patterns	<ul style="list-style-type: none"> (i) Tensile crack was initiated from the right tip of the inclined flaw (ii) No cracks between the left tip of the inclined flaw and the left tip of the horizontal flaw (iii) Shielding of the horizontal flaw against vertical stress (iv) Plenty of tensile cracks at the rock bridge segment 	<ul style="list-style-type: none"> (i) Tensile cracks were initiated from the right tip of the inclined flaw, one anticrack propagation from the left of the horizontal crack (ii) Two tensile cracks were initiated from the left tip of the horizontal flaw (iii) Cracks at the rock bridge segment decreases as F-T cycle increases 	<ul style="list-style-type: none"> (i) Tensile cracks were initiated from the left tip of the inclined flaw and propagated to the left of the horizontal flaw, two anti-cracks propagation from the right of the horizontal crack (ii) Number of cracks at the rock bridge segment decreases 	<ul style="list-style-type: none"> (i) Tensile cracks were initiated from the left tip of inclined flaw and propagated to the right of the horizontal flaw (ii) Tensile cracks were initiated from the two tips of the horizontal flaw (iii) Number of cracks at the rock bridge gets to the minimum

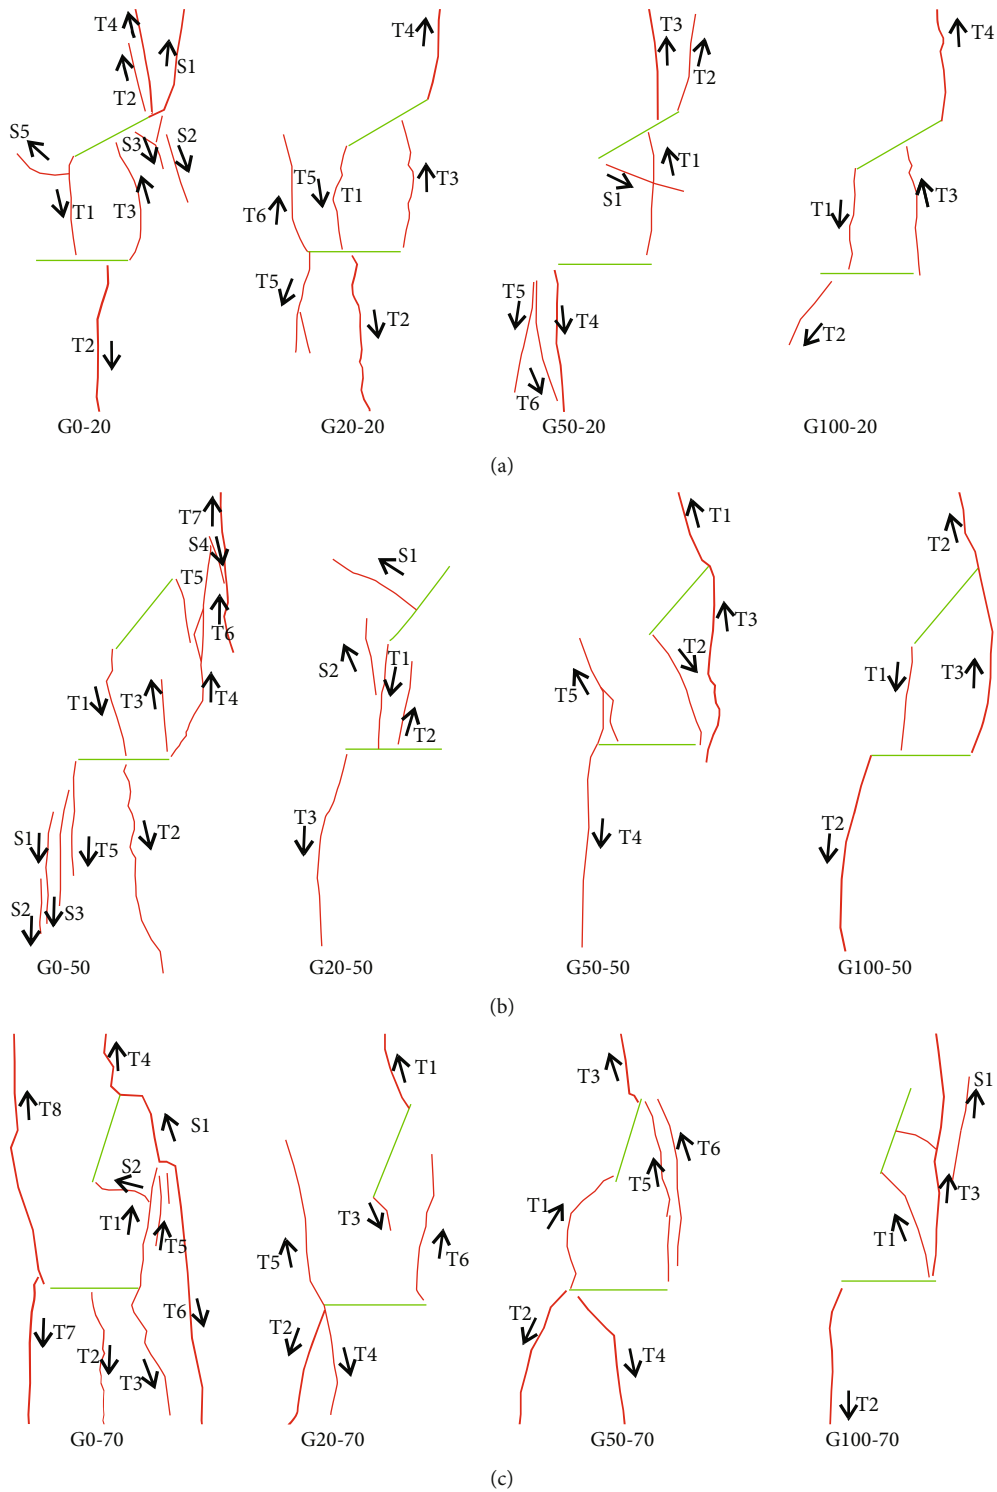
FIGURE 10: Sketch of the crack coalescence pattern observed around the rock bridge segment in the granite samples: (a) Samples have an inclined flaw of 20° subjected to 0, 20, 50, and 100 F-T cycles. (b) Samples have an inclined flaw of 50° subjected to 0, 20, 50, and 100 F-T cycles. (c) Samples have an inclined flaw of 70° subjected to 0, 20, 50, and 100 F-T cycles. The thick green lines represent the flaws, and the thin red lines denote the cracks emanating from the flaws. The shear cracks and tensile cracks are marked with S and T, respectively, with the following subscript number denoting the order of cracking.

In Figure 10(a), tensile cracks almost initiate from the left tip of the inclined angle and propagate to the horizontal flaw (T1 of G0-20, T1 of G20-20, and T1 of G100-20) for $N = 0, 20,$ and 100 . For $N = 50$, a shear crack was initiated from the left tip of the inclined flaw (S1 of G50-20). The crack number at the rock bridge area decreases with increasing F-T cycles.

In Figure 10(b), the approach angle (β) is 50°. Cracks were initiated from the left tip of the inclined flaw and propagate towards the horizontal flaw (T1 of G0-50, T1 of G20-50, and T1 of G100-50). Anticrack (the propagation direction is opposite to the convention) is observed for T5 of G0-50, and a large crack band is located at the right tip of the inclined flaw. For the horizontal flaw, cracks were initiated at the left tip and almost parallel to the major stress direction and multiple shear cracks were observed for $N = 0$ sample. The crack density at the rock bridge area is the largest for the $N = 0$ sample and smallest for the $N = 100$ sample.

In Figure 10(c), the approach angle (β) is 70°. For this sample with a high approach angle, anticracks are easily formed, and this kind of crack is consistent with the results of Huang et al. [18]. For $N = 0$ sample, tensile crack was initiated from the right tip of the inclined flaw and no cracks

between the left tip of the inclined flaw and the left tip of the horizontal flaw. For $N = 20$ sample, tensile cracks were initiated from the right tip of the inclined flaw, one anti-

crack propagation from the left of the horizontal crack, and two tensile cracks were initiated from the left tip of the horizontal flaw. For $N = 50$ sample, tensile cracks were

initiated from the left tip of the inclined flaw and propagated to the left of the horizontal flaw, fracture surface forms to communicate the left tip of the inclined and horizontal flaw. The crack pattern is the simplest for $N = 100$

sample, tensile cracks were initiated from the two tips of the horizontal flaw.

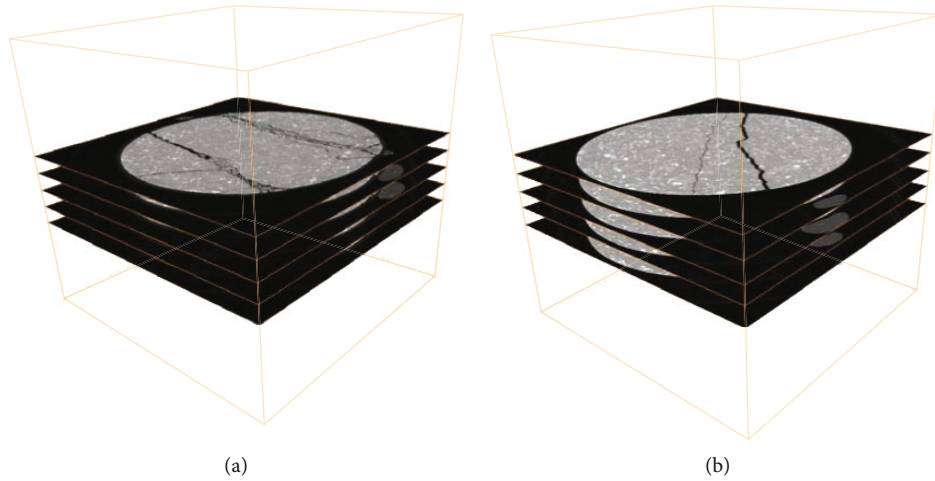
FIGURE 11: Scheme the positions of reconstructed CT slices to describe the brittle fracture of rock bridge, taking two samples for example (a) $\beta = 20^\circ$, F-T = 0 cycle; (b) $\beta = 70^\circ$, F-T = 100 cycle.

Generally, the crack pattern of rock samples can only be observed from the sample surface with the naked eye. However, with the help of the high-resolution X-ray CT technique, the crack pattern inside the deformed sample can be detected [30]. In this work, posttest CT scanning was used for the granite samples containing two flaws subjected to F-T cycles and uniaxial compression. Because we are mainly focus on the crack morphology at the rock bridge area, the length of rock bridge is 20 mm before compression, and there, five CT slices were obtained for each sample, as shown in Figure 11. The scanning position is 44 mm, 47 mm, 50 mm, 53 mm, and 56 mm at the middle part of the rock sample.

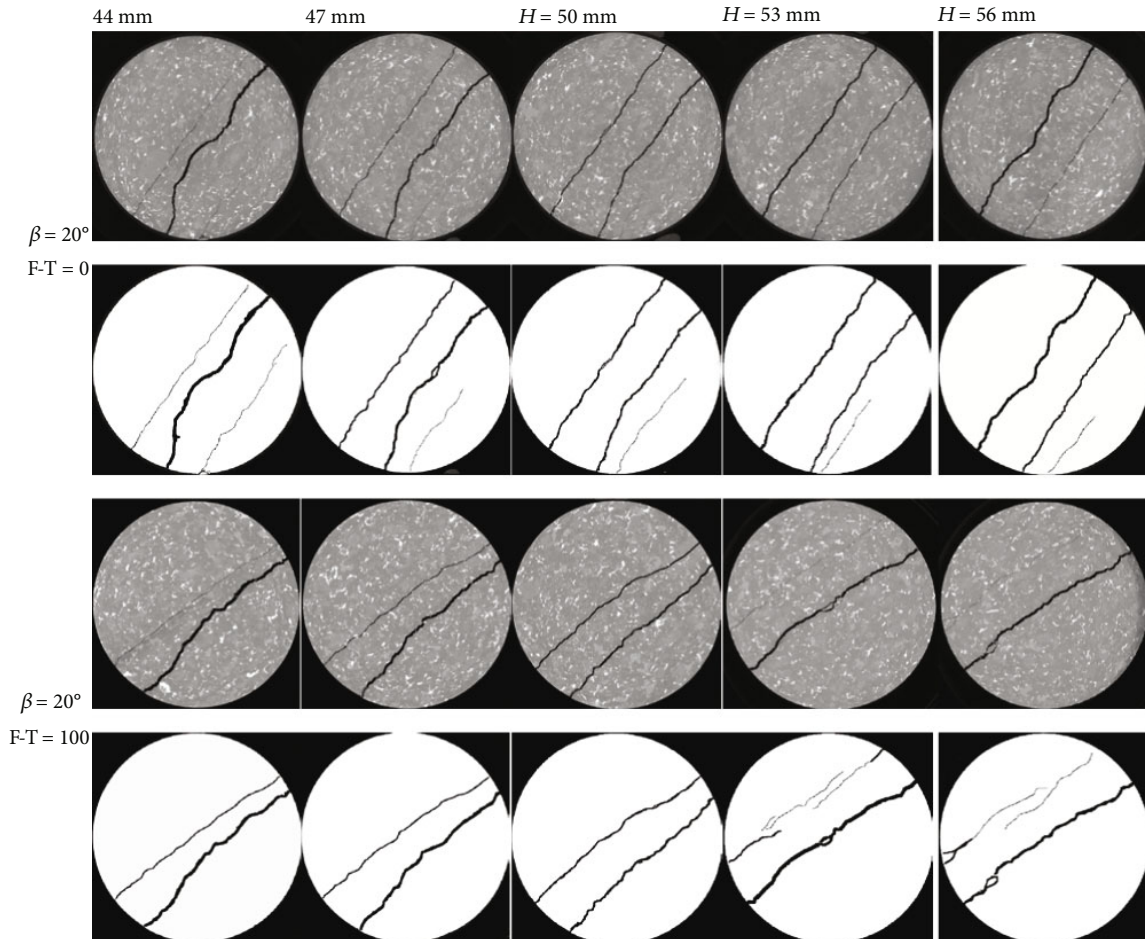
FIGURE 12: X-ray CT reconstruction images and crack pattern for the sample having an approach angle of 20° subjected to 0 and 100 cycles.

The reconstructed CT images are shown in Figures 12–14. In these images, low-density regions can be observed in response to cracks. It can be seen that the distribution of the low-density regions is affected by the flaw approach and also the F-T cycles. Taking the sample without F-T treatment, for example, crack scale increases with the increasing approach angle, two crack bands can be observed for the sample with an inclined angle 70° . However, the crack pattern is relatively simple for the sample with an inclined angle of 20° . Basing on the original CT images, we further extract the crack pattern by using a series of digital imaging methods [30–32]. The crack pattern at the rock bridge area is also shown in Figures 12–14. It can be clearly seen that the morphology of the crack network becomes simple for the samples subjected to 100 F-T cycles.

For the sample with an approach of 20° (Figure 12), three sets of cracks exist for the sample without F-T treatment; however, two sets of cracks can be observed for the sample subjected to 100 F-T cycles.

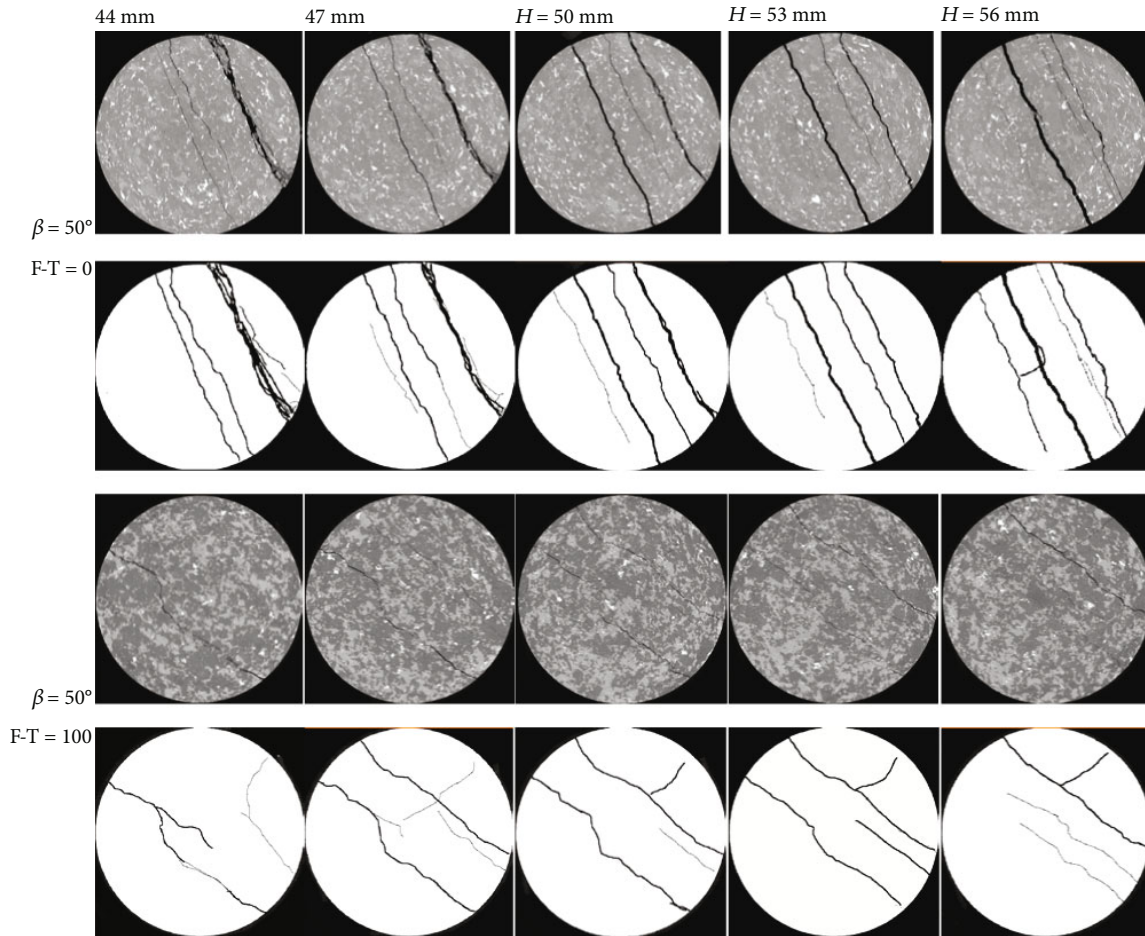
FIGURE 13: X-ray CT reconstruction images and crack pattern for the sample having approach an angle of 50° subjected to 0 and 100 cycles.

For the sample with an approach angle of 50° (Figure 13), a crack zone can be observed at the right of the sample for the sample without F-T treatment. Four parallel cracks with larger aperture are distributed on the sample. However, the crack network is simple and the crack aperture is relatively small for the sample subjected to 100 F-T cycles.

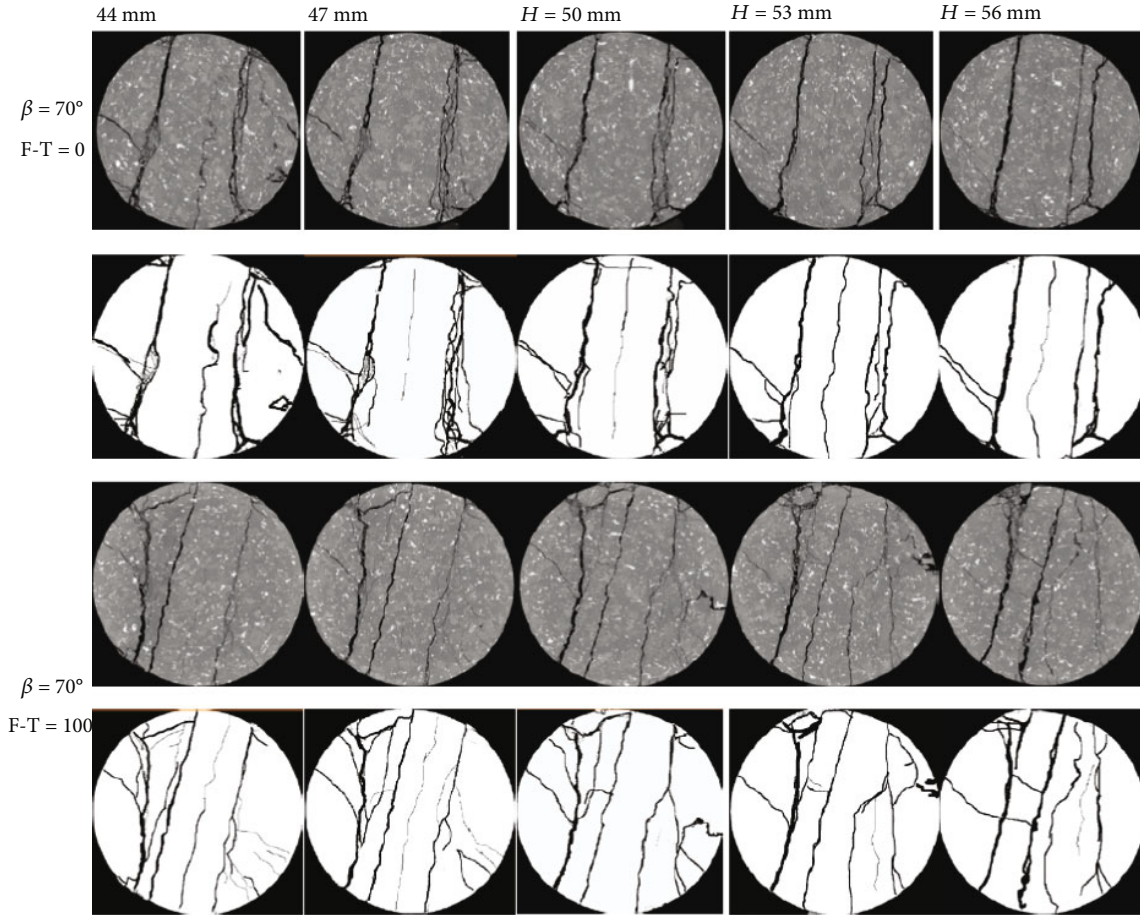
FIGURE 14: X-ray CT reconstruction images and crack pattern for the sample having an approach angle of 70° subjected to 0 and 100 cycles.

For the sample with a high approach angle of 70° and without F-T treatment (Figure 14), two crack zones can be observed at the left and right sides of the sample, many microcracks exist in the crack zone. This crack pattern indicates that fracture of the rock bridge is difficult, and much more energy is needed to communicate the preexisting upper inclined flaw and the horizontal flaw underneath. For the sample with 100 F-T treatment, due to the high approach angle of the two flaws, the complex crack network is easily stimulated at the rock bridge area. However, no crack zone exists at the rock bridge and fracturing of the sample needs less energy than the sample without F-T treatment. The rock bridge is eerily to be fractured for the sample subjected to high F-T cycles. To roughly reveal the impact of the F-T cycle on the fracturing of the rock bridge area, an index of fracture degree is defined as the ratio of the total crack area to the total section area of the CT images. In this work, because only five CT slices were obtained for each tested sample, the calculated index cannot reflect the fracture degree accurately; however, the change trend can be reflected using this method. Table 5 lists the fracture degree for the tested samples with approach angles of 20°, 50°, and 70°, respectively. It can be seen that the fracture degree is smaller for samples subjected to 100 F-T cycles.
