Research Article

Freeze-Thaw Stability Analysis of the High-Ice Content Soil-Rock Cutting Slope: A Case Study in Oroqen Autonomous Banner, North China

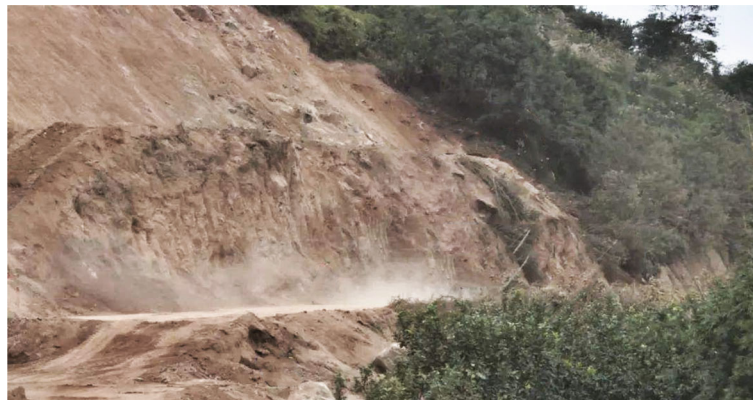
FIGURE 2: Real view of the slope.

The first- and third-grade slopes shown in Figures 2 and 3 are both 10 m high sunny soil-rock slopes, with angles of 45° and 35° , respectively. Volcanic breccia presents throughout the depth of the slopes. In the first-grade slope, when the depth is less than 6.8 m, all are strongly weathered brown-red-gray volcanic breccia. Besides, the structure appears fine-grained or massive, with fissures very developed, and the core is lumpy. In the slope, the depth between 1.2 m and 2.7 m is the soil-containing ice layer with ice content greater than 50%; the depth between 2.7 m and 5.9 m is the ice-rich frozen soil layer, with visible ice lenses and ice content of 20%-30%; the depth between 5.9 m and 6.8 m is the fertile frozen soil, with few visible ice crystals, little water seepage, and almost permanent structure after melting. According to the in situ test of Shi et al., Wang et al., and Feng et al.; the formulas of Ren et al. (2020) and Pan et al. (2020); the models of Xu et al. (2020) and Wang et al. (2020), the essential allowable value of the foundation bearing capacity [f_{a0}] and the standard amount of soil friction resistance on the pile side Q_{ik} are 900 kPa and 160 kPa, separately [19–27]. In the third-grade slope, when the depth is less than 7.5 m, all are strongly weathered brown-red-brown-gray volcanic breccia, and the structure is similar to that of the first-grade slope. Besides, the depth between 0.6 m and 2.2 m is a soil-containing ice layer with an ice content greater than 70%, which encloses a small amount of rock fragments; the depth between 2.8 m and 4.9 m is an ice-rich frozen soil layer; ice lenses and thin ice layers can be seen with an ice content of 20% to 30%.

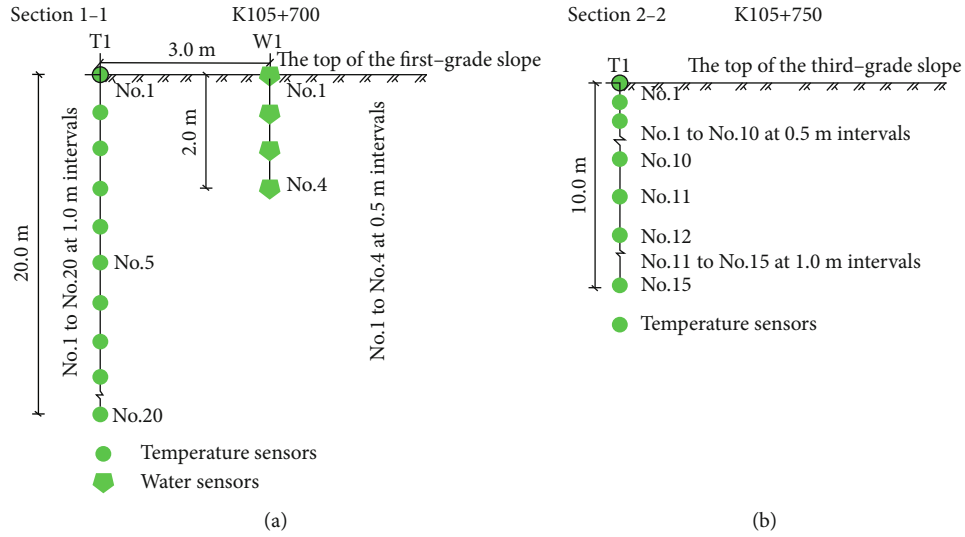
FIGURE 4: Layout of temperature and moisture sensors in cross-section 1-1 (a) and cross-section 2-2 (b).

perpendicular to the road at K105+700 and K105+750 in the research, as shown in Figures 4(a) and 4(b).

With reference to the construction practices of Chen et al., we set temperature sensors, moisture sensors, and slope landmarks on the first- and third-grade slopes [28]. To get temperature data in sections “1-1 and 2-2” of the slope, we drilled two temperature boreholes (denoted as T1 and T2) to place the 20 m long and 10 m long temperature sensors.

T1 lied at a horizontal distance of 3 m inside the top of the first-grade slope at K105+700, with a 20 m drilling depth, and we set the temperature sensors every 1 m. T2 is located on the

third-grade slope at K105+750, with a horizontal distance of 2 m from the top of the slope, the drilling depth was 10 m, and a temperature sensor was set every 0.5 m or 1 m before or after the 5 m extent, respectively, with a total of 15. We tied all temperature sensors together according to the depth. What is more, to prevent the temperature sensor probes from being stuck in the surrounding cable when putting into the borehole, the tape was fixed near each probe, as shown in Figure 5. Before burying the moisture sensors, a test pit (2 m × 2 m × 2 m) in section 1-1 was dug, and the horizontal distance between W1 and T1 was 2 m. The moisture sensor

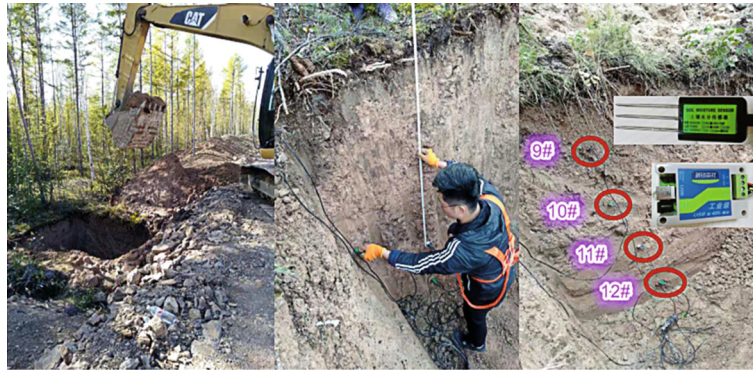
FIGURE 6: Construction glimpse of moisture sensors.

was embedded every 0.5 m along with the 2 m extent, with a total of 4, as shown in Figure 6. The probe of each moisture sensor is inserted vertically into the pit wall. We arranged nine landmarks uniformly on the first- and third-grade slopes in the section, with a total of eighteen. All the lenses were bound at the upper ends of the landmarks for convenient observation with a total station. When measuring data, these two drilling points were selected as reference points.

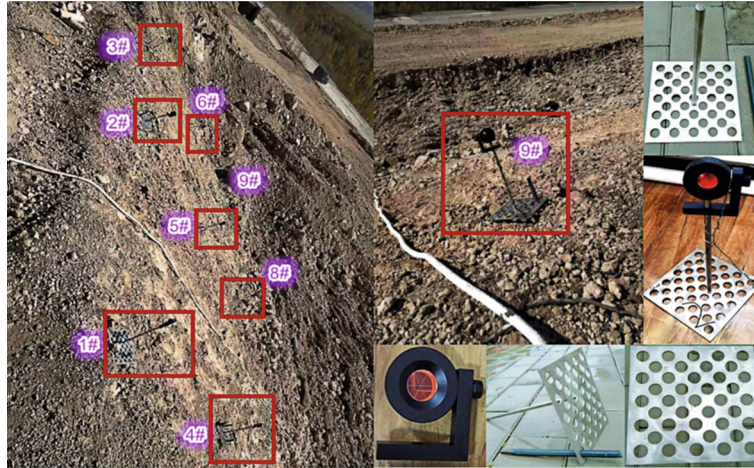
FIGURE 7: Layout of landmarks on the slope.

In order to obtain a full range of slope deformation under freeze-thaw cycles, we evenly arranged landmarks perpendicular to the slope on the upper, middle, and lower positions of the slope arranging in three rows and three columns, respectively. Each landmark was composed of a 304 stainless steel plate at the bottom, a steel rod fully welded on the stainless steel plate, a lens fixed on the steel rod, and a drill rod which

played the role of setting the four corners of the steel plate. Both the length and width of the steel plate were 200 mm, and the thickness was only 3 mm. There were 41 small holes in the steel plate, arranging in a plum blossom shape. The diameter of the small holes was 10 mm. At the center of the steel plate was a steel rod with a length of 300 mm and a diameter of 10 mm. We welded the bottom of the steel rod and the steel plate fully for binding the lens. The lens was used together with a steel rod. We inserted the steel rod into a circular hole with a diameter of 10.5 mm reserved on the lens. To prevent the lens from swinging randomly with the external factors such as wind speed, rain, snow, and wild animals, which would affect the measurement accuracy, we tied the lens and steel rod tightly using iron wires. The drill rod was 200 mm long and 10 mm in diameter. The lower part

of the steel rod was conical at three centimeters. We firmly fixed the four corners of each steel plate to the surface of the slope with a drill rod, as shown in Figure 7,

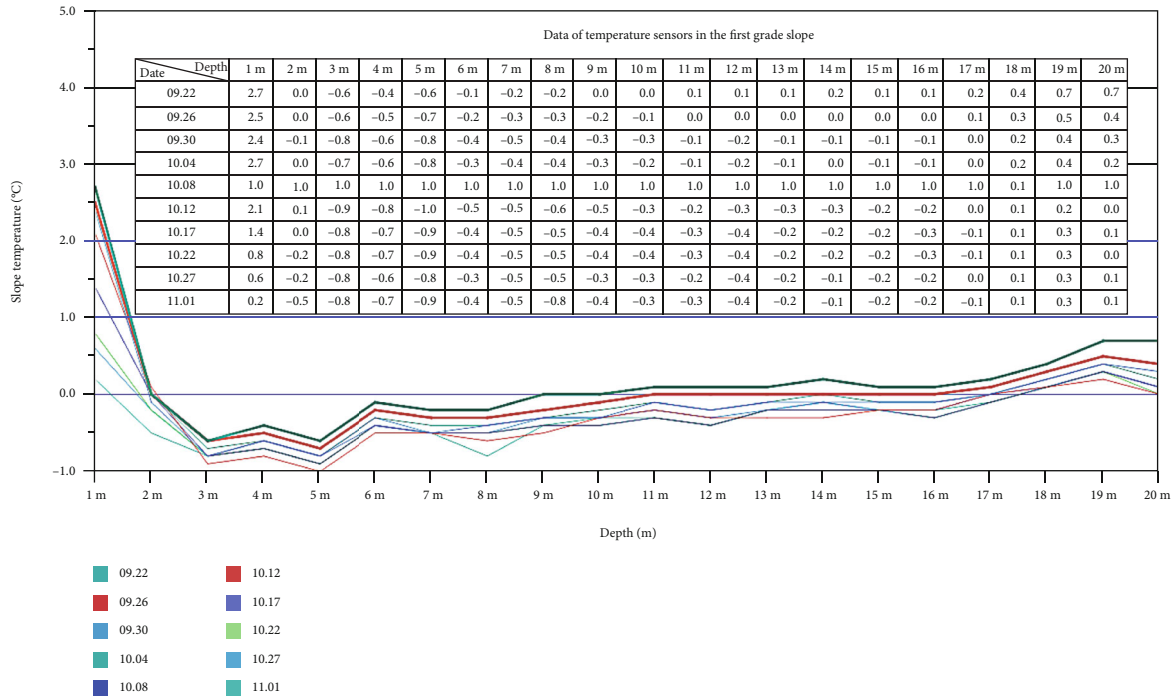
FIGURE 8: Temperature data diagram of section 1-1 in the first-grade slope.

3.1. Temperature Change Trend Graph of Sections 1-1 and 2-2. After a one-month commissioning period, we obtained the temperature data in September 2019. At this time, the weather just began to cool down, and it was far from reaching the freezing temperature. Therefore, the frozen soil or rock at this time was in the most primitive state. So, the measured data are the most accurate and favorable for construction. Figure 8 shows the slope temperature in section 1-1.

According to Figure 8, we can capture the following information:

- (1) The mean daily slope temperatures were all greater than or equal to -1.0°C before the heavy snow, with the minimum -1.0°C and the maximum 2.7°C
- (2) At the same burial depth, the winter temperature gradually decreased, so the temperature data measured by the temperature sensor also gradually decreased as the date continued. By the end of the observation period, the temperature reduction values of the temperature sensors 1#-9# at each buried depth were 2.5°C , 0.5°C , 0.2°C , 0.3°C , 0.3°C , 0.3°C , 0.3°C , 0.6°C , 0.4°C , 0.3°C , 0.4°C , 0.5°C , 0.3°C , 0.3°C , 0.3°C , 0.3°C , 0.4°C , and 0.6°C , respectively, and the maximum reduction rate was 92.0%

- (3) When the burial depth was 0 m-3 m, the temperature sensor data gradually decreased because the permafrost table was -0.7 m. The central part that affected the stability of the sunny slope was near the permafrost table and its top seasonal melting layer. The layer was active and influenced by external temperature, topography, landform, lithology, hydrogeology, vegetation, surface water, and other conditions. In September and October, the atmospheric temperature of Olunchun Autonomous Banner in Hulunbeier City was relatively high, and the slope composition was volcanic breccia. The surface layer was generally sloping gravel and filled

with fine-grained soil. The bottom layer was fully strongly weathered volcanic breccia with a small amount of bedrock fissure ice. Stone was a poor conductor of heat and had a relatively low thermal conductivity. According to the geological survey report, 1.2 m-2.7 m was a soil-containing ice layer with an ice content greater than 50%, and three noticeable ice vein traces were visible. Therefore, the temperature in this depth range showed a decreasing trend

- (4) When the burial depth was 3 m-19 m, the temperature sensor data gradually increased as the burial depth increased, which also shows that with the increase of the burial depth, the temperature in the ground increased little by little, which was in line with the change of ground temperature

- (5) When the burial depth was 19 m-20 m, the temperature did not follow the trend of increasing with depth, because when drilling into a stable stratum at 20 m, we placed twenty steel protective wall tubes binding with temperature sensors into the holes, which disturbed the stratum and increased the heat exchange with the outside world, causing the temperature to drop

- (6) After construction, the seasonal active layer was within a depth of 2 m, and the permafrost table had fallen by 1.3 m compared with the previous value 0.7 m. After drilling to a predetermined depth, it was necessary to fill fine sand into the protective wall tube and seal it for grouting before we buried temperature sensors. As a result of mechanized construction and the removal of surface vegetation, the fragile frozen soil environment was destroyed; the surface state and the frozen water balance state inside the soil were both changed. Therefore, hot melt lakes and depressions were generated; then, the surface water accumulated. What is more, the surface water had a high heat capacity. Its infiltration will input a large amount of thermal energy to the permafrost, which caused the melting of the permafrost to increase; that is, the seasonal melting depth increased, or the permafrost table decreased

- (1) The mean daily slope temperatures are all greater than or equal to -1.0°C and -0.9°C of the first- and third-grade slopes, with the maximum 2.7°C and 5.9°C , respectively. At the same burial depth, the temperature sensor data gradually decreases as the date continues, with the maximum reduction value of separately 2.5°C and 5.5°C . And the maximum rate of change is 111%. When the burial depth is 0 m–3 m and 19 m–20 m in the first-grade slope, the temperature sensor data gradually decreases due to the changed original equilibrium state, permafrost table, soil-containing ice layer, ice veins, and disturbed stratum, while at other depths, the temperature sensor data gradually increases, which is in line with the change of ground temperature. After construction, the seasonal active layer is within 2 m, and the permafrost table has fallen by 1.3 m compared with the previous value 0.7 m

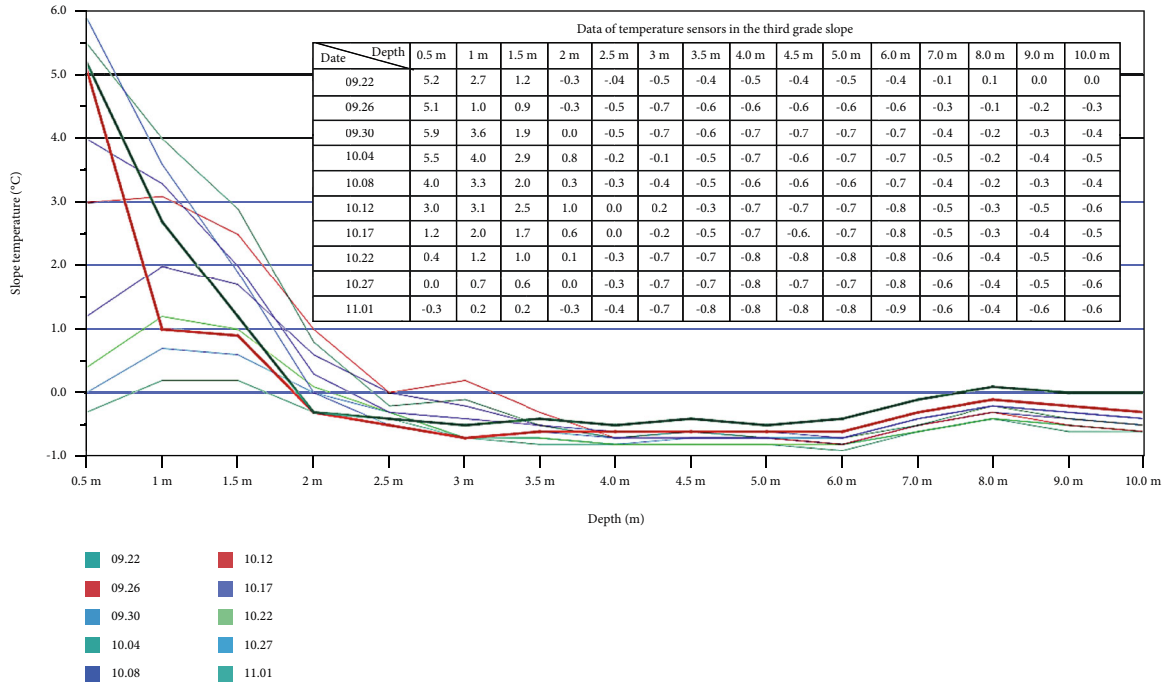
FIGURE 9: Temperature data diagram of section 2-2 in the third-grade slope.

Then, we analyzed the temperature data of section 2-2 in the third-grade slope, as shown in Figure 9. The third-grade

According to Figure 9, the temperature change law in the third-grade slope can be obtained:

- (1) The mean daily slope temperatures were all greater than or equal to -0.9°C before the heavy snow, with the minimum -0.9°C and the maximum 5.9°C . At

the same burial depth, the winter temperature gradually reduced, so the temperature data measured by the temperature sensors also gradually decreased as the date continued. By the end of the observation period, the temperature reduction values of temperature sensors 1#-9# at each buried depth were 5.5°C , 2.5°C , 1.0°C , 0.0°C , 0.0°C , -0.2°C , -0.4°C , -0.3°C , -0.4°C , -0.3°C , -0.5°C , -0.5°C , -0.6°C , and -0.6°C , respectively. And the largest rate of change is 111%

- (2) During the observation period, the average temperature of the region was 15.15°C , and the minimum temperature was -0.7°C . When the burial depth was below 1 m, the average temperature of the highest and lowest temperatures was 6.67°C and -6.76°C ,

respectively. The atmospheric temperature was relatively low to this extent, and the original equilibrium state changed because of significant disturbance, so the temperature sensor data increased. However, when the burial depth exceeded 1 m, the temperature gradually decreased owing to the influence of the ice-rich frozen soil layer

- (3) When the burial depth was below 6 m, the temperature sensor data gradually decreased with the increase of the burial depth due to the ice-rich frozen soil layer in this range according to the geological survey report, with visible ice lenses and ice content of 20%-30%. The situation was similar to the case of 8 m-10 m depth with ice content of 15%-30%

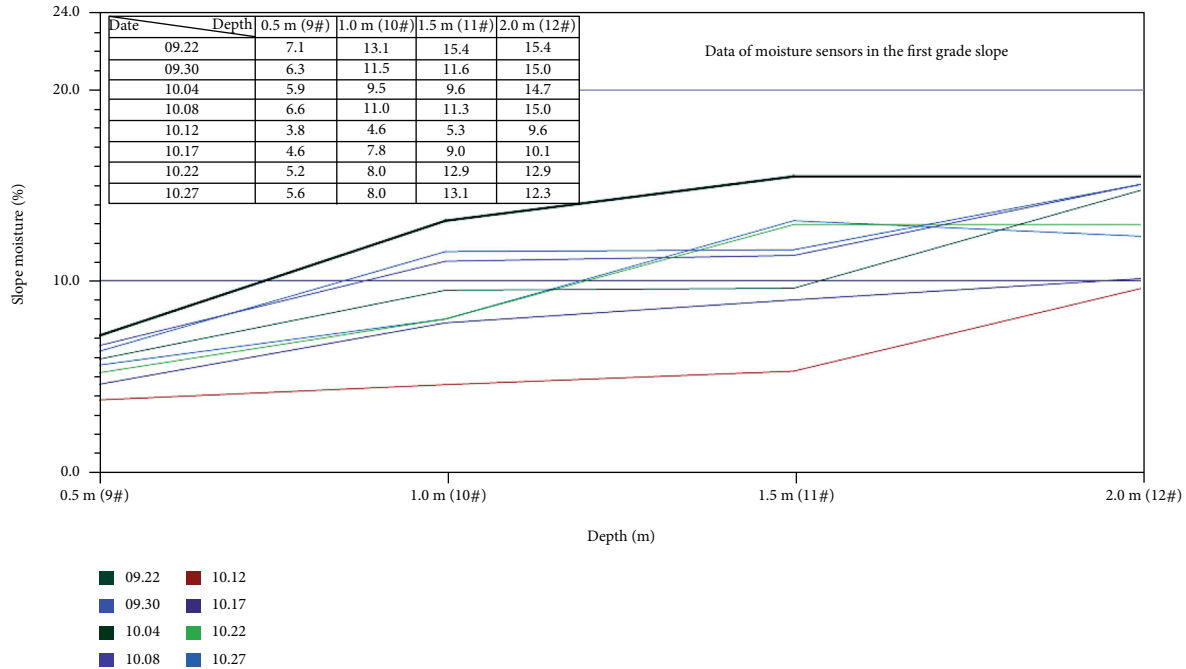
FIGURE 10: Moisture diagram of section 1-1 in the first-grade slope.

3.2. Moisture Change Trend Graph of Section 1-1 in the Slope. According to Figure 10, we can get the change rule of moisture in the slope:

- (1) Over time, the weather gradually dried with more water loss. The temperature and free water content decreased little by little, especially when the wind was keen on the first-grade slope, so the moisture sensor data accordingly reduced at the same burial depth between 2019.09.22 and 2019.10.04. The depth range where the water content fell the most was 0.5 m-1.5 m, where it was more affected by outside weather, geology, and hydrology than other places. At the end of the observation period, the water content of the moisture sensor 9#-12# separately decreased by 1.5%, 5.1%, 2.3%, and 3.1%, and the change rates were 21.13%, 38.93%, 14.94%, and 20.13% at each buried depth

- (2) At the same observation time, the observed data were different due to the different burial depths, and the closer to the bottom of the pit, the larger the water content due to being less affected by external vegetation, wind, temperature, and other external influences, then the better the water retention of the soil. At the same time, due to the aggregation effect and gravity, the water content became larger. The moisture sensors 9#-12# were measured eight times in total; the increase in water content at each observation from the top of the pit to the bottom was 8.3%, 8.7%, 8.8%, 8.4%, 5.8%, 5.5%, 7.7%, and 6.7%, in which the change rate of each time was 116.90%, 138.10%, 149.15%, 127.27%, 152.63%, 119.57%, 148.08%, and 119.64%.

- (3) At the same burial depth, the moisture sensor data increased between 2019.10.04 and 2019.10.08. The reason is that the pit was originally open-air, and then the backfilling carried out on 2019.10.04, causing the water retention of the soil in the hole to increase. Therefore, the water content rose. Then, the water content gradually decreased, affected by dry and windy weather at the same burial depth between 2019.10.08 and 2019.10.12. Due to the drops of rain, hail, blizzard, and other weathers, the data of the moisture sensor increased at the same buried depth between 2019.10.12 and 2019.10.27, indicating that the moisture content in the shallow layer of the slope was relatively affected by the outside world. Therefore, we should pay close attention to the change of water content in the superficial layer and slope protection during the entire life cycle of the slope

- (2) At the same observation time, the closer to the bottom of the pit, the larger the water content. The maximum value increase in water content of moisture sensors 9#–12# at each observation from the top of the pit to the bottom was 8.8%, in which the change rate was 149.15%. Furthermore, the moisture

decreases accordingly at the same burial depth on 2019.09.22 to 2019.10.04 and 2019.10.08 to 2019.10.12, owing to drier weather and stronger wind and the maximum water content reduction, and their rates are 5.1% and 38.93%, respectively. However, the data increased between 2019.10.04 and 2019.10.08 on account of the pit backfill. Besides, because of many drops of rain, hail, and blizzard, the water content increased between 2019.10.12 and 2019.10.27, indicating that the moisture content in the shallow layer of the slope is relatively affected by the outside world. Therefore, we should pay close attention to the change of water content in the shallow layer and adopt measures to protect the slope during the entire life cycle of the slope

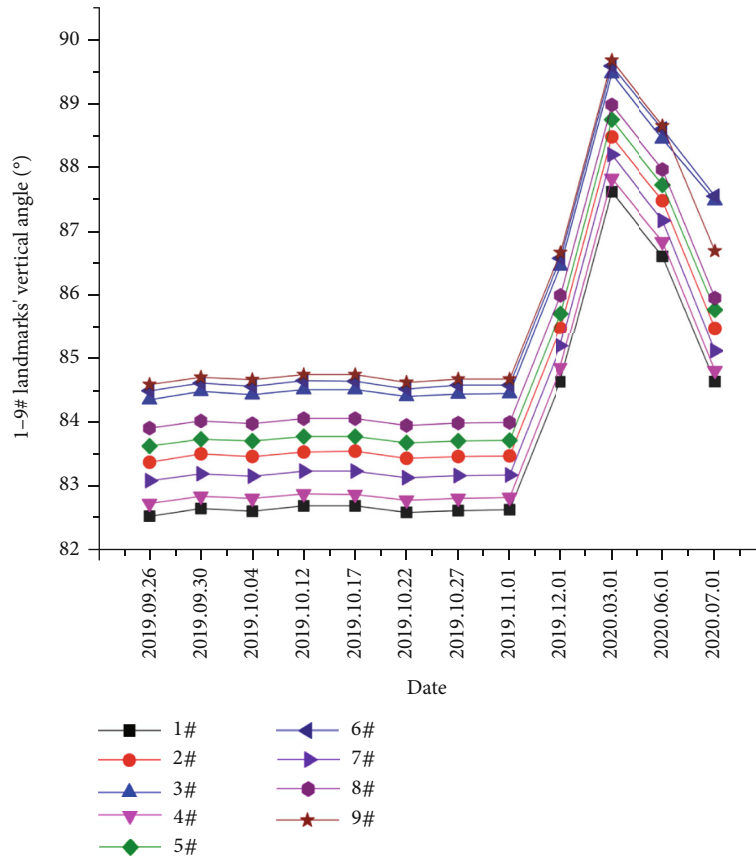
FIGURE 11: Vertical angle change charts of landmarks on the first-grade slope.

3.3.1. Changes in the Vertical Angle of Landmarks. The vertical angle, also known as the height angle, refers to the angle between the sightline and horizontal line. It is the vertical angle between the center axis of the instrument and the observation point. The tolerance of the difference in the vertical angle of the total station one measurement back is 12".

It can be seen from Figure 11 that before November, the vertical angle fluctuates periodically with the freeze-thaw cycle. After November, the slope has been in a state of negative temperature. The volume of the slope increases after the moisture in the slope is frozen, and the slope is uplifted by frost heave, causing the vertical angle to become larger and larger. The vertical angle has been increasing throughout the winter. After entering the spring thawing season, the slope begins to thaw, so the vertical angle begins to decrease until the next cycle of freeze-thaw. Therefore, the vertical angle is an important indicator to measure the degree of freeze-thaw of a slope, and it is often used in the calculation of the shallow slumping amount of a slope.

- (3) The vertical angles of landmarks 1#–9# on the first-grade periodically increase firstly and then decrease, with a floating amplitude of 0.15° , which exceeds the allowable error $12''$, indicating that the landmarks were in the cycle of periodic frost heaving and melting, corresponding to the changes in atmospheric temperature. Each height difference curve has an upward trend, indicating that when entering winter, frost heaving has been going on, especially during the period in the rainy and snowy seasons. After numerous freeze-thaw cycles, the landmarks on the slope moved down a distance along the slope, so we can combine the abovementioned traditional methods of slope protection with the new monitoring and early warning system to better serve slopes in permafrost regions

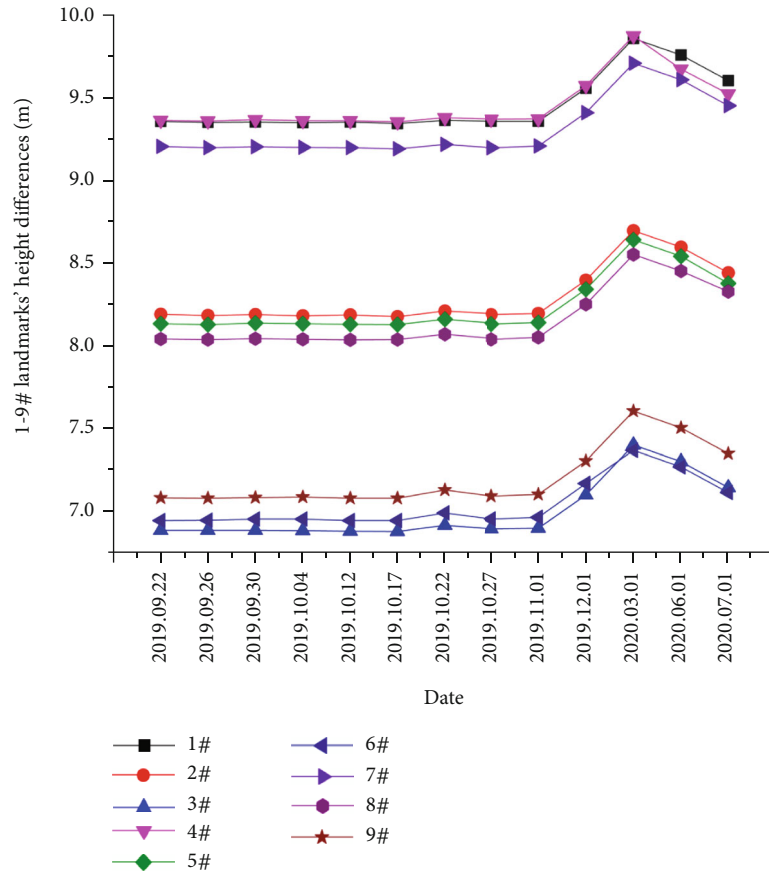
FIGURE 12: Height difference change charts of landmarks on the first-grade slope.

3.3.2. Changes in the Height Difference of Landmarks. The height difference was the difference in elevation between two points, that is, the end elevation minus the starting elevation. Firstly, select a surface as the reference surface and then measure the height of the two points relative to the reference surface. The difference between the two heights is the height difference.

According to Figure 12, we can get that the curve had a slight upward trend, indicating that when entering winter, frost heaving had been going on, especially during the period of 2019.10.17 to 2019.10.22, because there were sleet and

moderate snow during this period. And the weather gradually became colder due to multiple drops of rain and storms; then, frost heave was the most obvious at this time. After entering the summer, the slope was in a melting state, so the last part of the curve in the figure showed an upward trend.

It can be seen from Figure 12 that the slope has been in dynamic changes with the freeze-thaw cycles. After entering September, as time goes by, the temperature gradually decreases, and the frost heave of the slope gradually accumulates, causing the frost heave to be greater than the thaw settlement. Therefore, the slope is raised by frost heave, and the height difference between the reference point and the landmarks on the slope is getting larger and larger, so the height difference curve in Figure 12 has been showing an upward trend before entering the spring thaw period. On the contrary, the weather is warmer and the temperature gradually rises during the spring thaw period. As time goes by, the melting amount of the slope begins to be greater than the frost heave, causing the height difference between the landmarks on the slope and the reference point to become smaller and smaller, so the height difference curve in Figure 12 has been showing a downward trend during the spring melting period. Monitoring data shows that after the construction of the side slope of the cutting, the permafrost in the area has been in a degraded state and is irreversible. Therefore, during construction in permafrost areas, we must adhere to the principle of filling more and digging less.

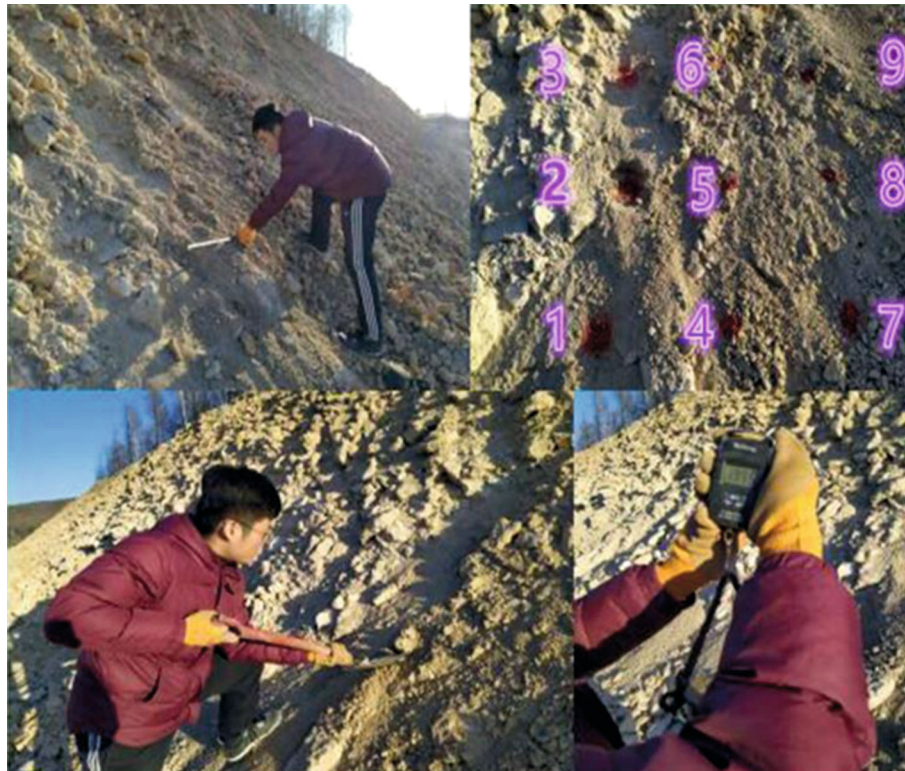
FIGURE 13: The soil-rock mixture sampling process.

3.3.3. Numerical Simulation of Slope Stability. According to the geological survey report, in the K105+700-K105+800 part of the high-ice content soil-rock slope, its composition was the same. A 1 m × 1 m × 1 m range was sampled to minimize

the disturbance to the slope, and then we weighed, sealed, and then transported them back to the laboratory for testing.

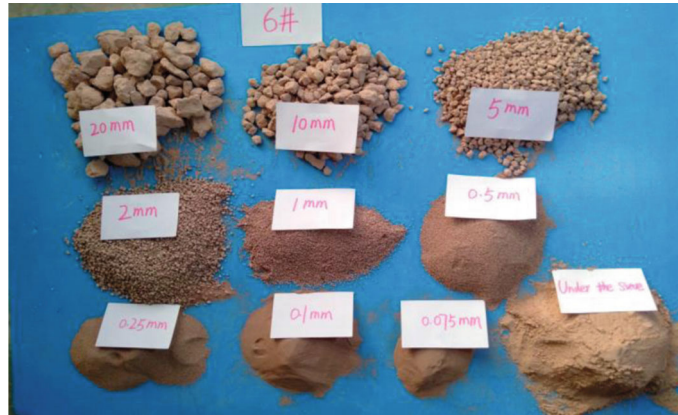
FIGURE 14: The screening test results of soil-rock mixture sample 6#.

Moreover, the slope soil-rock mixtures were collected and transported back to the laboratory for an indoor sieving analysis test. The test results showed that the mass and volume ratio of soil to stone in the slope were 55.04%:44.96% and 69.38%:30.62%, respectively, which are required parameters in ABAQUS numerical simulation.

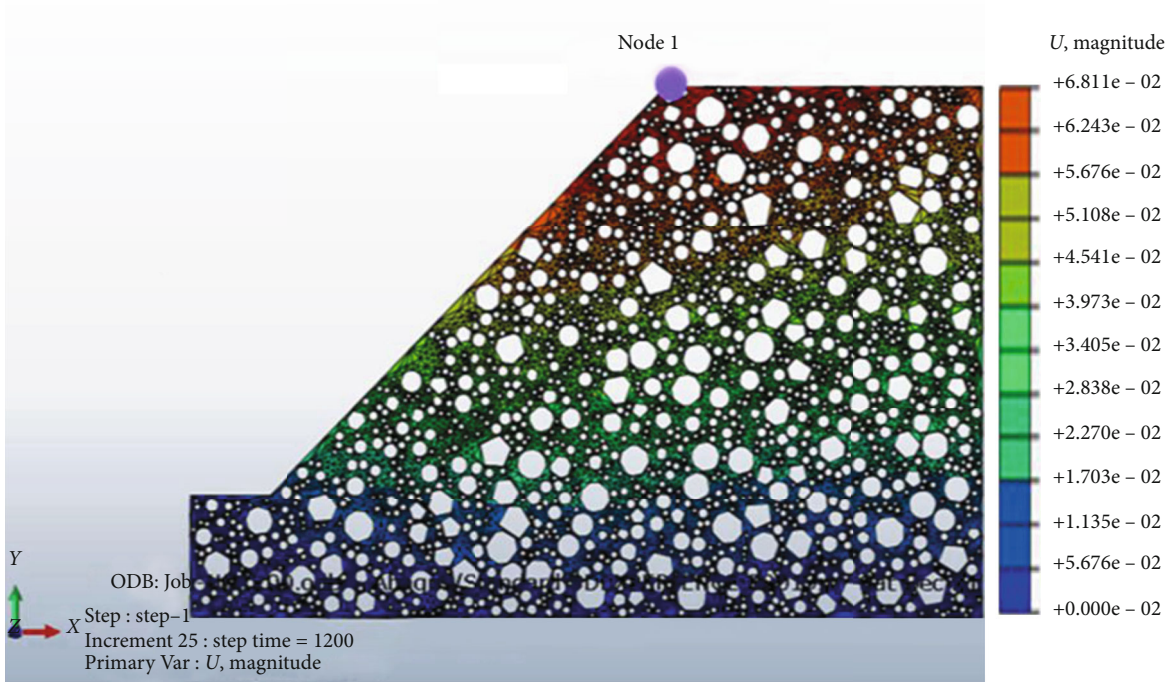
FIGURE 16: Displacement cloud map after two hundred freeze-thaw cycles.

of the slope is 0.997, and the slope has reached the limit equilibrium state. If slope protection measures are not taken, the consequences will be disastrous. Therefore, slope protection measures are very important. Moreover, in order to control the shallow slippage of the slope under freeze-thaw cycles in permafrost regions during the whole life cycle of the slope, slope protection measures must be taken seriously and strictly implemented from the beginning of the design stage to the end of the operation period.

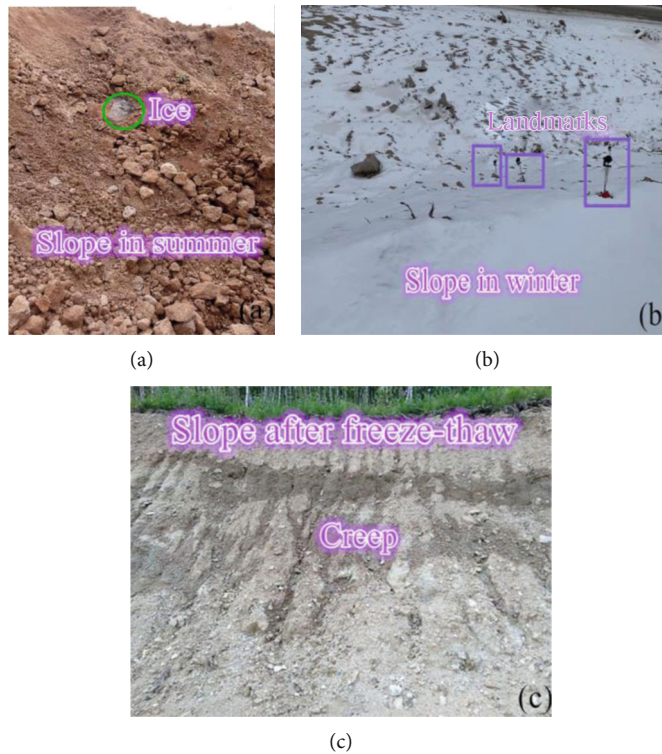
FIGURE 17: Physical map of the frozen soil-rock slope with high ice content.

We obtained temperature-moisture-displacement data of the high-ice content soil-rock slope in permafrost regions of the primary highway on National Highway 332 in Oroqen Autonomous Banner, Hulunbeier City, Inner Mongolia Autonomous, in the study. At the same time, we used the numerical simulation software ABAQUS to simulate the slope stability and proposed measures for slope protection. After each freeze-thaw cycle, the soil and rock particles on the slope move down a short distance along the hillside [30–34], and the more the freeze-thaw cycles, the greater the slip. This phenomenon is called the frost creep [35, 36]. Over time, the stability of the slope decreases, and even landslides occur, especially when the weather is warmer, after rain and snow, as shown in Figures 17(a)–17(c) below.

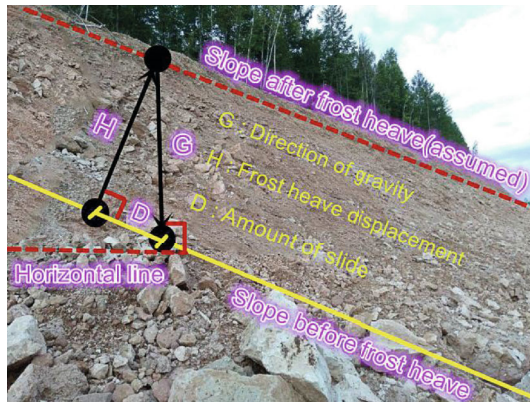
FIGURE 18: Creep schematic diagram of the soil-rock slope under freeze-thaw action.

2019, of which landmark 6# was the most obvious, which slid down about 1 cm, approximately equal to 10% of the slope height. This decline rate was huge. The same phenomenon occurred in the third-grade slope, and landmark 9# slid farthest with 8.5 mm by analysis, approximately 8.5% of the slope height. And there are many shallow trenches and cracks on the slope surface, which were traces left by the creep. The creep is a significant deformation feature of frozen soil, and freeze-thaw erosion is the leading cause of the creep, as shown in Figure 17(c). After many freeze-thaw cycles, the shallow sliding on the slope surface happens, which can be illustrated in Figure 18.

As shown in Figure 18, assuming that the solid yellow line represents the slope before the frost heave, the red

dashed line represents the slope after the frost heave, the letter H represents the amount of frost heave, G represents the direction of gravity, and D represents the amount of movement. When the slope is subject to frost heave, the pore water converts into ice, and the soil and rock particles on the slope uplift when the volume increases by about 9% along the H direction, which is perpendicular to the slope surface. And when melting, the particles affected by gravity and the slope angle fall straight in the G direction. After each freeze and thaw, the particles of the slope move down a short distance from the original position along the slope. Day after day, especially in the spring thaw season with freezing at night and melting at noon, we can capture the noticeable creep of the particles on the slope [10].
