Stability Monitoring and Analysis of High and Steep Slope of a Hydropower Station

Slope deformation and failure are major challenges for hydropower station engineering. Taking the left bank slope at the exit of the flood discharge tunnel of the Wudongde Hydropower Station in China as an example, the deformation mechanism of the high-steep rock slope was studied. The height of the slope is about 200 m, which is affected by slope excavation, rainfall, and atomized rain. The results of multipoint displacement meters, surface deformation monitoring, and anchoring stress meters showed that the deformation and deformation rate of the slope have increased dramatically. Through the comprehensive analysis of the slope, it is found that the overall lithology of the slope is poor, the excavation disturbance causes the redistribution of the stress in the slope, and the excavation surface is relatively steep, which provides space for the deformation of the slope rock mass. Unloading relaxation leads to a large number of new fissures in the slope rock mass. These new fissures and fault fracture zones provide convenient conditions for rainfall and atomized rain infiltration. The rainwater infilt

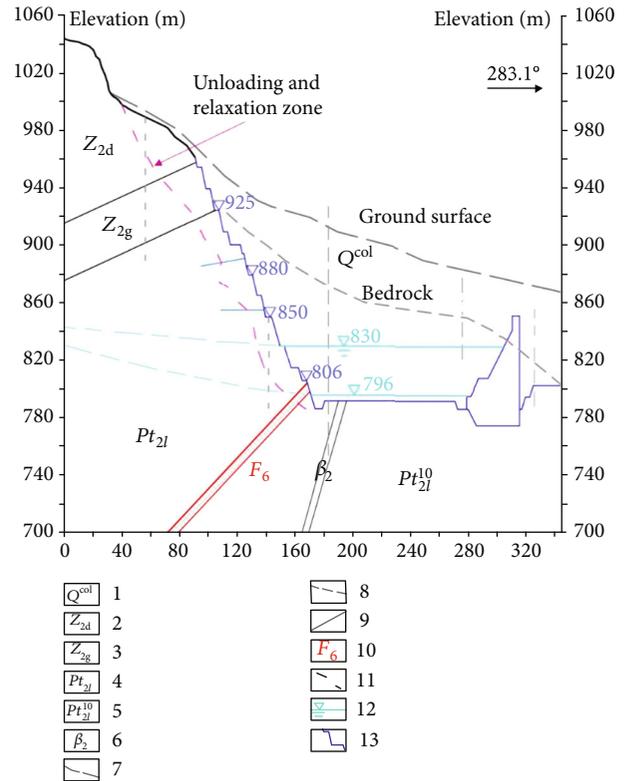
FIGURE 3: Engineering geology map of the slope. 1: collapse accumulation layer; 2: Dengying Formation grey to light grey thick dolomite; 3: Guanyinya group gray thin layer dolomite sandwich, ultrathin shale; 4: gray thin layer dolomite (specifically refers to the falling snow group stratum in the downstream of the Huashangou fault on the left bank); 5: gray interbedded with thin limestone; 6: diabase; 7: original terrain; 8: bedrock surface; 9: lithology boundary; 10: faults and numbers; 11: lower limit of relaxation zone of artificial slope; 12: groundwater level line; 13: designed excavation line.

2.2. Stratigraphic Structure and Lithology. The engineering slope and natural slope above 925 m elevation are sedimentary caprock strata. The strata trending NNW-SSE dipping at an angle of 30° toward E, and the angle between the strike of the stratum and the strike of the slope is about 3°~37°, forming a gently inclined reverse slope. The engineering slope below 925 m elevation consists of folded strata that trend SW-NE and dip about 80° toward S. The strike of left side slope of the exit of the flood discharge tunnel is 193°, and the angle between the strike of the rock stratum and the slope forms a steep, transverse slope of about 57°~83° (Figure 2). The strata exposed before the excavation are the quaternary Huashangou accumulation body and the folded basement snowfall group, the sedimentary caprock Guanyinya Formation, and the Dengying Formation (Figure 3).

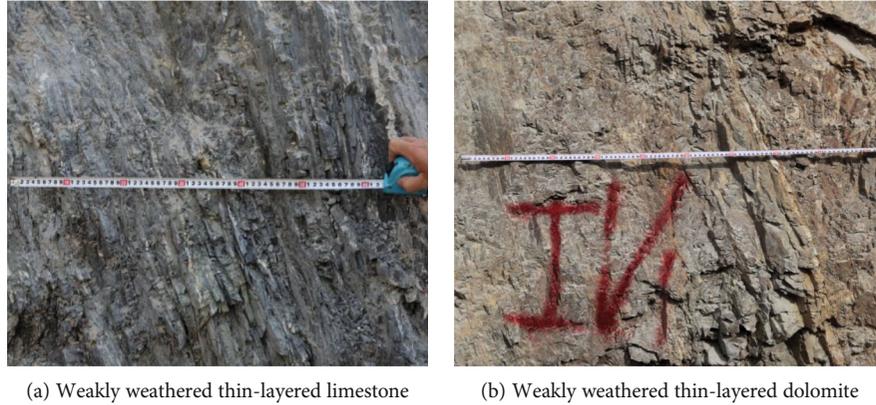
FIGURE 4: Typical rock mass of slope.

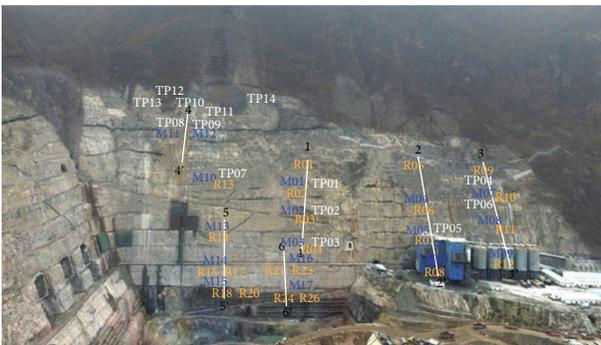
FIGURE 5: Distribution map of deformation monitoring points on the slope.

According to the different monitoring objects and monitoring depths, slope monitoring can be divided into appearance deformation monitoring, shallow deformation monitoring, and deep deformation monitoring. According to the characteristics of the project, six deformation monitoring sections (i.e., sections 1-1', 2-2', 3-3', 4-4', 5-5', and 6-6') were arranged on the slope. At the same time, 14 apparent monitoring piers, 17 sets of multipoint displacement meters, and 26 anchor stress meters were deployed (Figure 5).

system at 850 m elevation, and eight sets were at the rear edge slope (Figure 5).

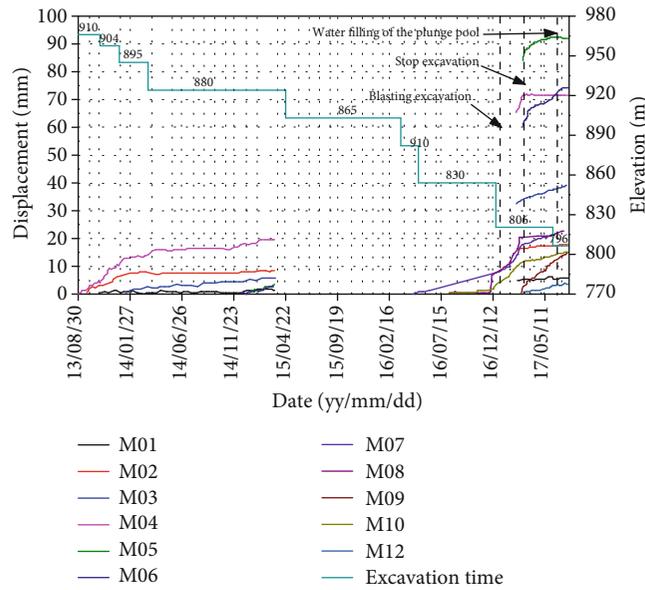
FIGURE 6: Relationship between the deformation of the multipoint displacement meter and the excavation process.

3.1. Monitoring Results of Multipoint Displacement Meter. Seventeen sets of multipoint displacement meters, numbered M01~M17, were arranged on the slope. They were all placed at the downstream of F_6 and divided into two monitoring areas according to the structural characteristics of the slope. Among them, 11 sets were arranged between F_6 and the rear edge slope of the concrete system of 850 m elevation. Six sets were placed at the rear edge slope of the concrete system with an elevation of 850 m. The monitoring depth was about 30 m. Figure 5 shows the layout location. The monitoring time of each multipoint displacement meter is different, and the earliest time is May 5, 2013. Due to factors such as instrument failure and on-site environment, some data are missing. The whole process monitoring curve of the cumulative displacement of the multipoint displacement meter and the orifice is shown in Figure 6 and Table 1.

3.1.1. Cumulative Deformation. According to the analysis of the monitoring data in Table 1 and Figure 6, as of August 10, 2017, the cumulative deformation of the orifices of 13 multipoint displacement meters is less than 25 mm, accounting for 76.5% of all monitoring points. The deformation of one monitoring point is 38.86 mm, and that of three monitoring points is above 71 mm. Among them, the monitoring point with the most considerable deformation is M11, at 986.8m elevation, and the deformation is 92.15 mm. The parts with large local deformation monitored by multipoint

3.1.2. Deformation Depth. From Figure 6 and Table 1, among the 17 multipoint displacement meters, except for M11 and M03, the multipoint displacement meters at these two monitoring points show that there is still a large deformation at a depth of 30 m horizontally (note that the deformation at the monitoring depth of 30 m at both points is more significant than that at 20 m, which are abnormal data). The data from the remaining 15 sensors prove that the slope rock mass at the distance of 30 m from the slope surface does not deform or deforms very little. Therefore, the excavation disturbance at the left side slope at the outlet of the spillway tunnel deforms the rock mass for a depth of about 20~30 m.

3.1.3. Deformation Rate. The deformation rate of the slope rock mass can be divided into three stages, namely, deformation intensification stage, deformation slowdown stage, and deformation convergence stage (Figure 6).

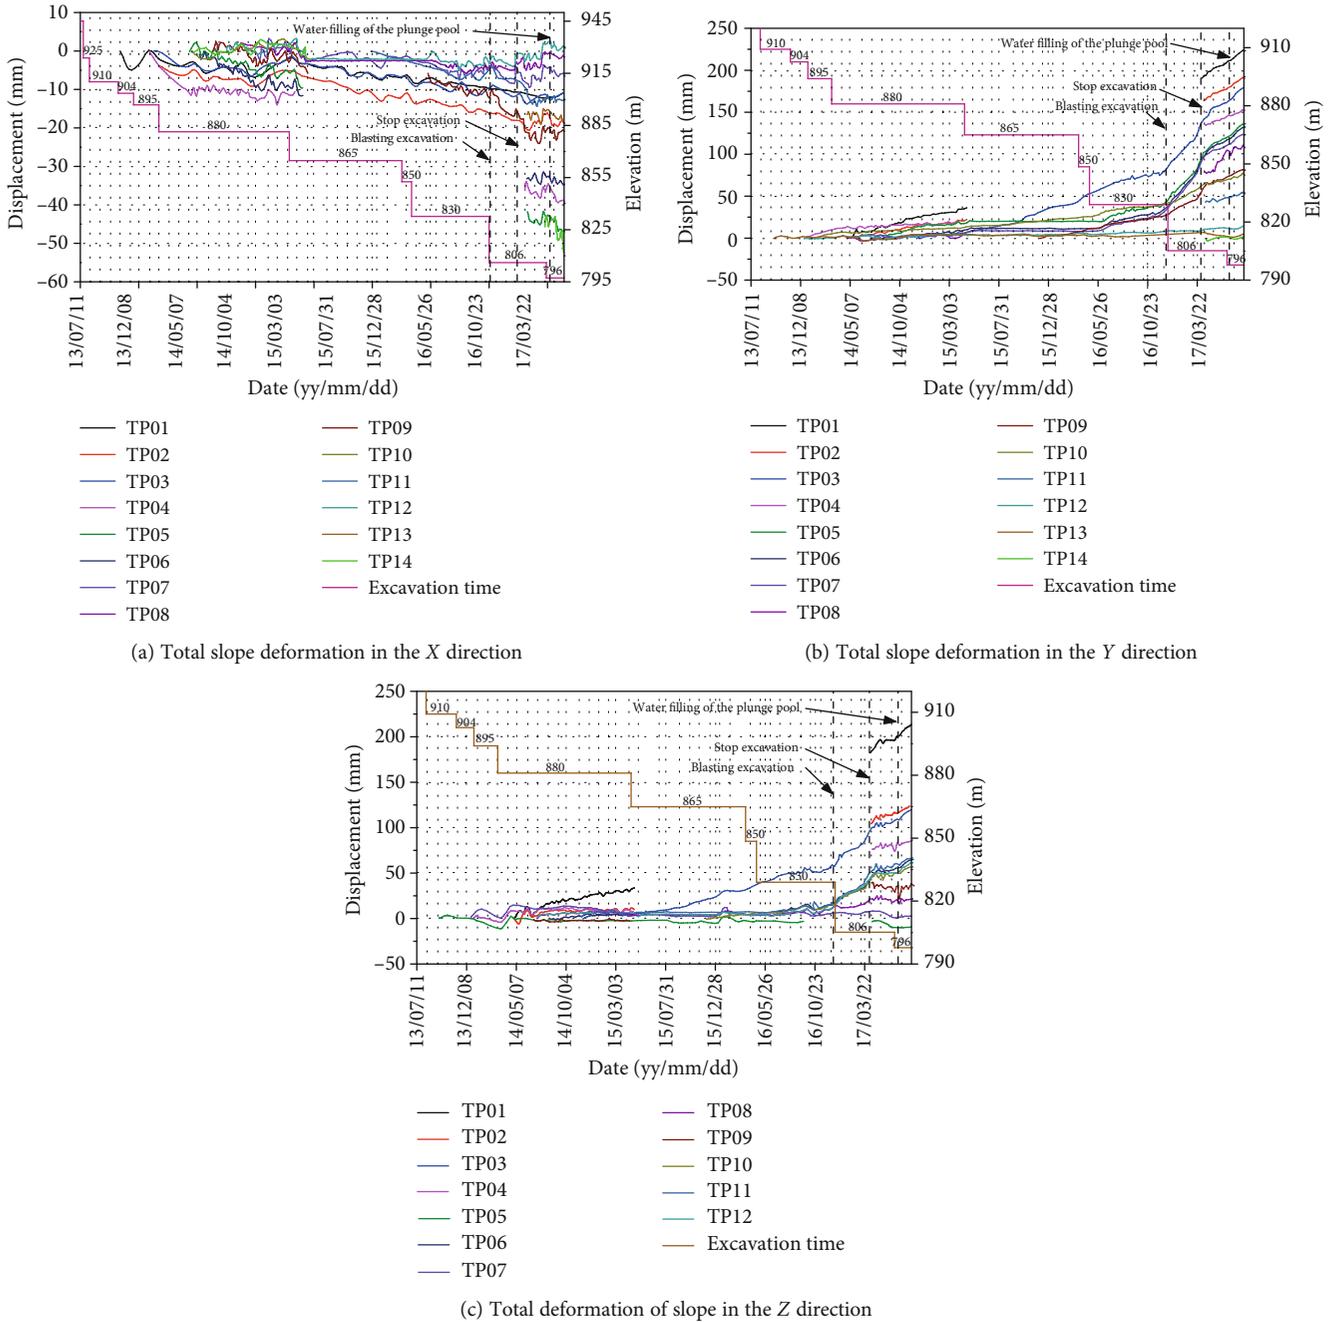
FIGURE 7: Comparison curve between the total deformation of apparent monitoring and the excavation process.

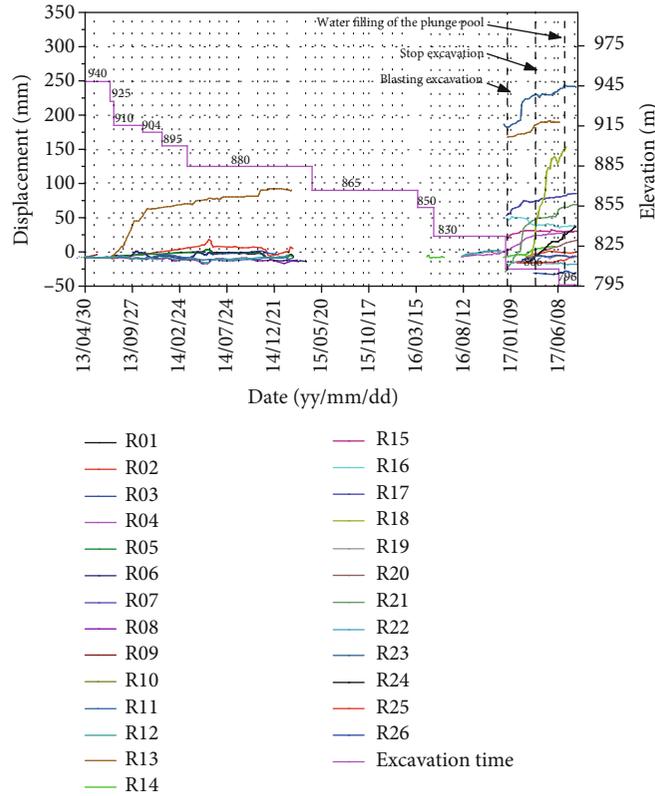
FIGURE 8: Comparison curve between the stress change of anchor stress meter and the excavation process.

Figure 8 shows the monitoring results of all anchor stress meters, as summarized in Table 3. According to the data analysis, as of August 10, 2017, three monitoring points exceed 150 MPa, and the monitoring point R23 of 849 m elevation detects the most significant stress change, i.e., an increase of 283.6 MPa. The measured stress of five anchors is within 150~30 MPa, while the variation of the remaining sensors is less than 30 MPa.

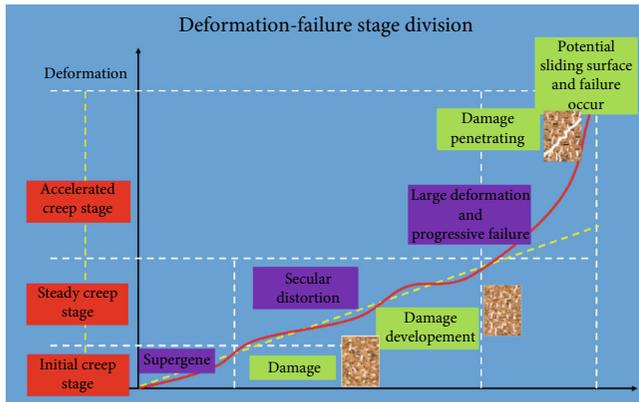
FIGURE 9: Deformation-failure evolution process of slope.

4.2. Disturbance of Engineering Activities. Although the engineering slope is a high-steep slope, before the excavation, the slope rock mass is in a relatively stable state. The excavation of the project redistributes the stress inside the rock mass. With the gradual expansion of the slope excavation, the rock mass on the slope is subjected to blasting dynamics to generate dynamic damage. On the other hand, the excavation changes the boundary conditions of the slope, and the rock mass undergoes unloading deformation. Part of the strain energy in the rock mass is released, and part of the strain energy is transferred to the deep part of the rock mass, resulting in stress redistribution. Moreover, the deformation of the slope body accompanies the redistribution causing the original structural plane in the rock mass to open and stagger, the expansion of the original joint fissure, or the generation of new cracks, especially in the vicinity of geological weak planes such as faults, soft rock areas, and strong unloading relaxation areas. The combination of new cracks and fault fracture zones generated in the unloading relaxation zone provides convenient conditions for rock mass seepage, and the slope rock mass seepage will vary with the degree of unloading (Figure 9).

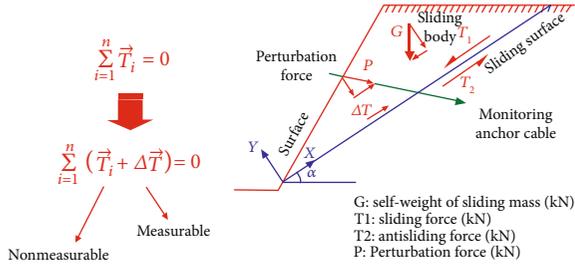
FIGURE 10: Schematic diagram of landslide measurable mechanical system.

5.1.1. Principle of Anchor Cable Force Remote Monitoring. The landslide will only occur if the sliding force is greater than the antisliding force. By considering the mechanical system of a natural landslide, three main forces are acting on it, i.e., sliding force (T_1), antisliding force (T_2), and self-weight of sliding mass (G). In the natural state, the sliding force and antisliding force on the sliding surface are in equilibrium, i.e., $T_1 \leq T_2$, and the slope is stable. However, when the external or internal factors affecting the slope stability change, the original equilibrium state breaks, and the stress in the landslide body redistributes. When $T_1 > T_2$, the slope is unstable. Therefore, it is only necessary to accurately measure T_1 and T_2 to judge the changing state of stress in the landslide body and predict the occurrence time and scale of landslide disaster in advance. In order to measure T_1 and T_2 , the magnitude of sliding force T_1 can be indirectly calculated through direct monitoring of disturbing force P after the artificial measurable force P is introduced. Figure 10 shows the complex mechanical system composed of the natural mechanical system and an artificial mechanical system.

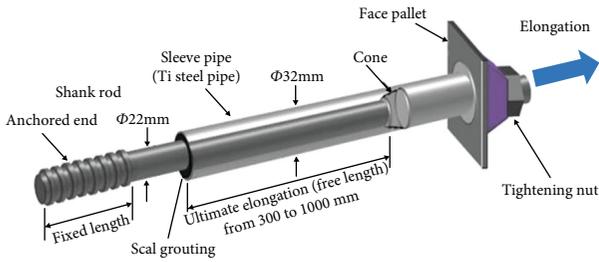
FIGURE 11: Structure diagram of CRLD cable.

5.1.2. Structure of Constant-Resistance Large-Deformation Anchor Cable and Working Principle. As a composite structure type stretchable anchor cable, the proposed Constant-Resistance Large-Deformation (CRLD) anchor cable mainly consists of rod body, constant resistance body, constant

resistance sleeve, pallet, and nut (Figure 11). The constant resistance body and the constant resistance sleeve together form a constant resistance device to provide constant support resistance for the anchor cable.

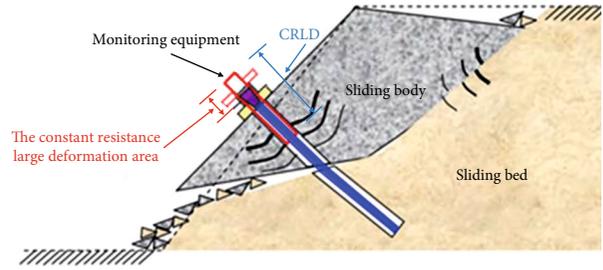
FIGURE 12: Reinforce and monitoring principle of CRLD cable.

When landslide occurs, with the slow release of deformation energy in the slope rock mass, the sliding body and sliding bed move relatively along the sliding surface. When the deformation energy of the rock mass exceeds the designed constant resistance, the constant resistance body frictionally slides along the inner wall of the constant resistance sleeve. The CRLD anchor cable stretches axially along with the large deformation of the slope rock mass and absorbs the energy generated by the slow landslide deformation (Figure 12). It avoids the failure of conventional monitoring anchor cable due to excessive deformation, meeting the targets of advanced monitoring and early warning for the landslide.

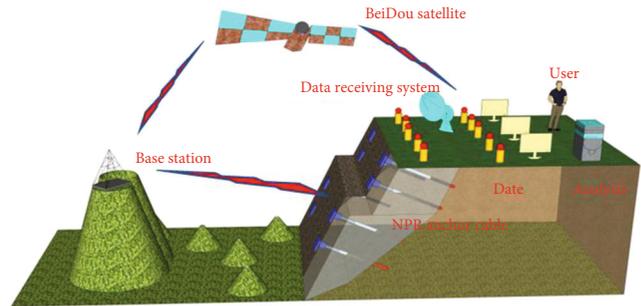
FIGURE 13: The principle of system operation.

5.1.3. Structure of the Landslide Remote Monitoring and Early Warning System. The landslide remote monitoring and early warning system consists of indoor and on-site equipment. The indoor monitoring equipment includes a data receiving-processing-analysis system, 3S maps of monitoring point target areas, a 3D monitoring engineering image search system, and some auxiliary analysis software. The on-site monitoring equipment consists of BeiDou satellite receiving equipment, data processing system, and information display system. Figure 13 shows the schematics of the system's working principle.

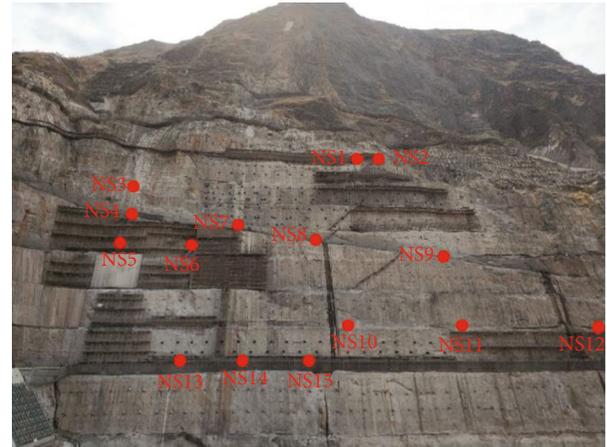
FIGURE 14: Layout of on-site monitoring points.

method, and schedule combined with the technical requirements of slope anchor cable force monitoring. A total of 15 monitoring points (NS1~NS15) were arranged within the scope of the engineering slope. The distribution of monitoring points is shown in Figure 14.

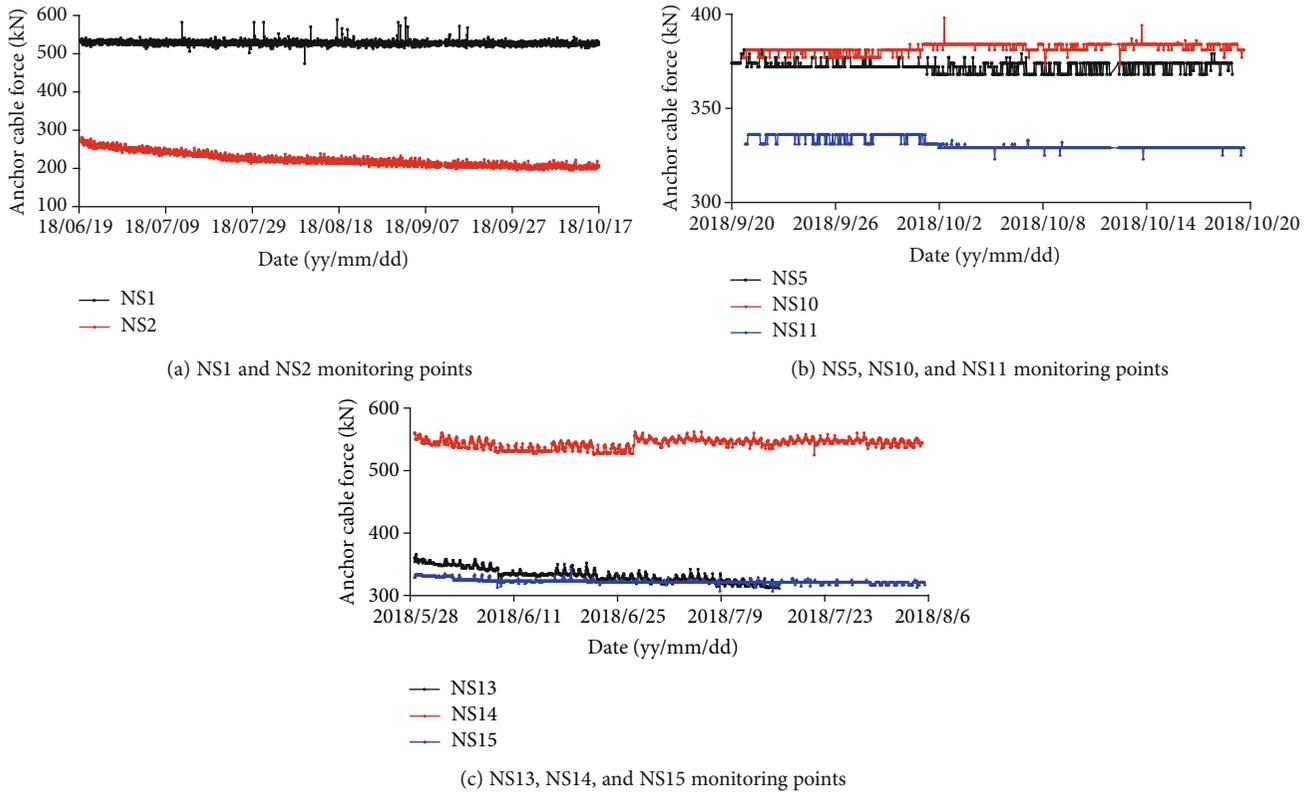
FIGURE 15: Curves of anchor cable force.

Through the analysis of the monitoring curve and monitoring data that have been received so far, 75% of the monitoring curve is in a horizontal state or an approximate horizontal state, indicating that the slope is in a stable state. Also, the NS1 monitoring curve contains some unstable data, while the NS2 curve has a slow downward trend, indicating that the top slope is currently in a relatively stable state.
