# Lessons from the Case History of a Massive Landslide Dam

A massive landslide created a natural dam on two tributaries of Jhelum River near the town of Hattian Bala in Kashmir in October 2005. The landslide was triggered by a 7.6  $M_w$  earthquake. The resulting unconsolidated dam and water impoundment upstream carried hazard potential of downstream damage to both infrastructure and population due to potential flooding caused by its breach. Comprehensive investigations and monitoring were implemented to analyse dam stability. Fresh topographic profiles were generated. Samples of the matrix materials were utilized in the laboratory investigations including grain-size analysis, laboratory electrical resistivity and permeability tests at varying densities and degrees of saturation, and sediment concentration assessment in the seepage discharge. A noninvasive geophysical method was employed together with new topographic information to develop transient subsurface pictures and to assess the advancement of seepage fronts within the dam body. Internal erosion/filtering potential of the matrix material was assessed by comparing grain size distributions with those of the earlier failed d

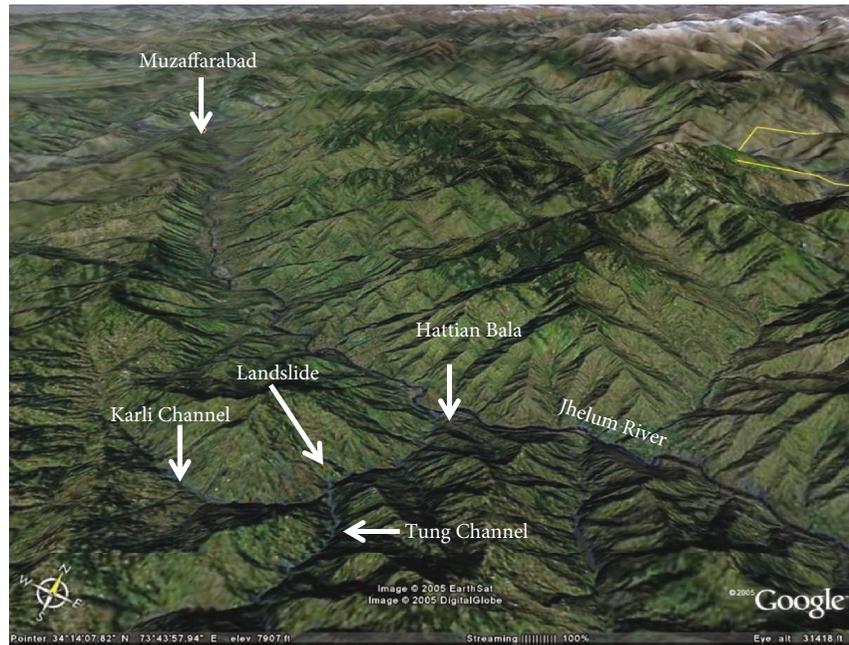
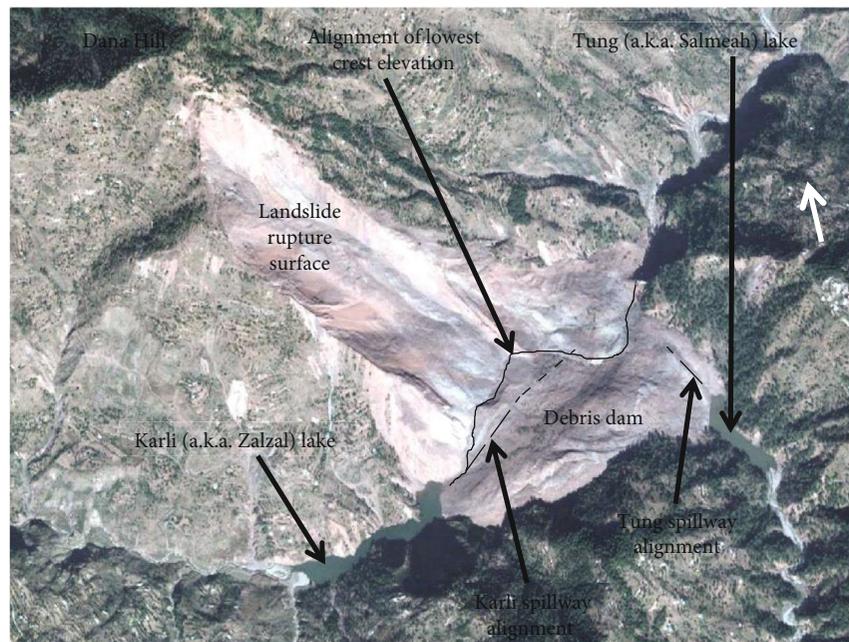
FIGURE 2: (a) 3D view of Hattian Bala landslide and surrounding area [7]; (b) satellite imagery of Hattian Bala landslide, dam, and lakes [5].

The most significant single landslide triggered due to this catastrophic event that caught the world's attention was the one located 3.5 km upstream of the confluence of the Jhelum river and Karli water channel near the town of Hattian Bala, AJK [5] (see Figure 2(a)). This landslide originated on Dana Hill (2080 m above sea level (AMSL),  $34^{\circ}09'N/73^{\circ}43'E$ ) [1] and carried a debris volume of around 85 million  $m^3$ , which blocked two tributaries of Jhelum River, namely, Karli (a.k.a. Zalzal) and Tung (a.k.a. Salmeah) water channels at their confluence (see Figure 2(b)). This blockage resulted in impoundment of water and creation of lakes on the upstream sides of the debris material (hereinafter referred to as a landslide dam). These lakes turned into a potential hazard for the downstream population and infrastructure, principally in the case of the Karli channel because of its higher inflow rate, significantly large impoundment capacity (i.e.,  $>60$  million  $m^3$

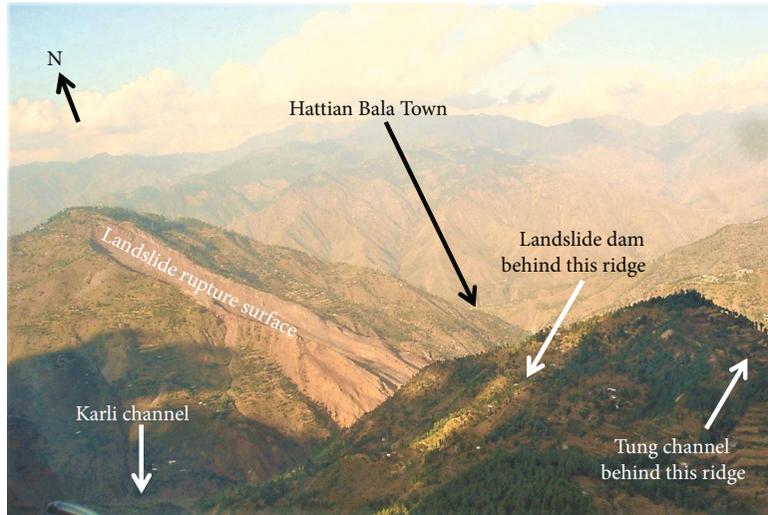
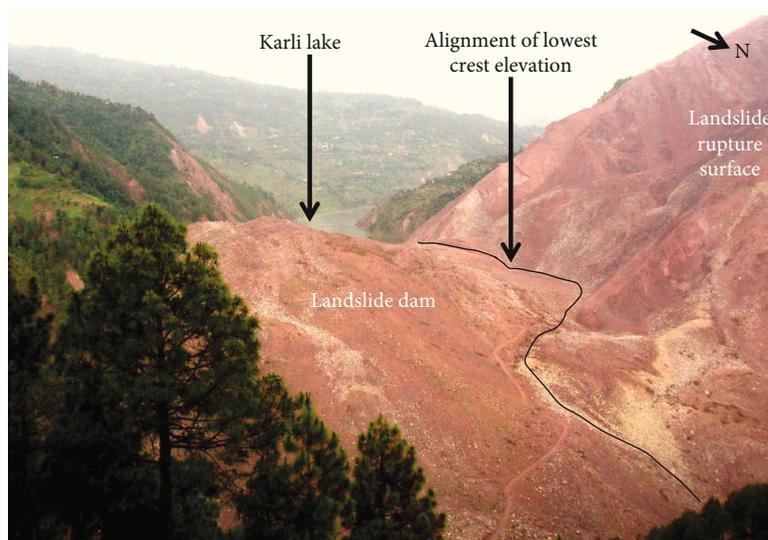
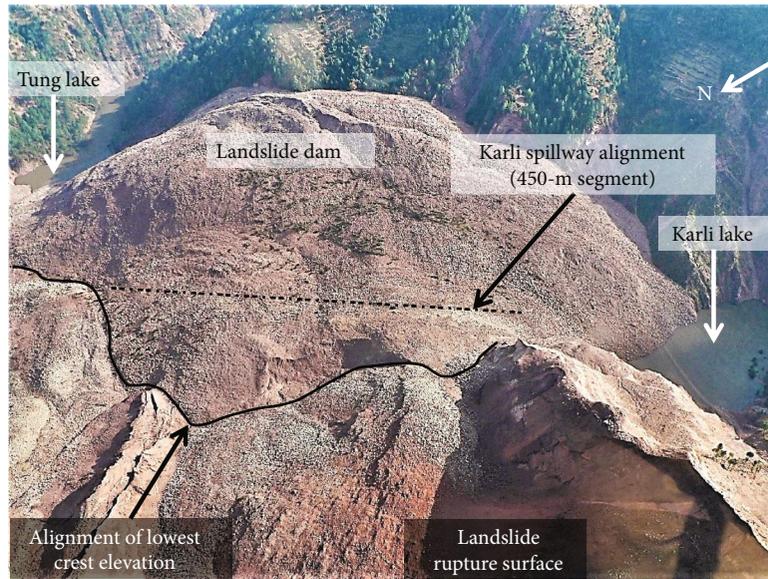
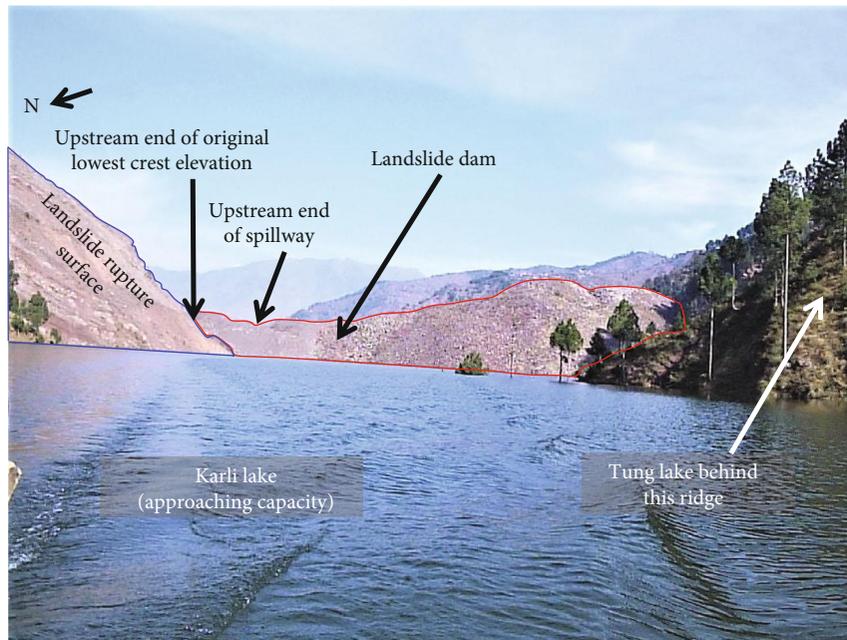
FIGURE 3: Pictures showing (a) landslide rupture surface and Karli water channel, taken from the upstream side of the dam facing eastward (November 2005); (b) landslide rupture surface, dam, Karli lake, and alignment of the original lowest crest elevation along the dam, taken from the downstream side of the dam facing westward (April 2006); (c) landslide rupture surface, landslide toe, dam, Karli and Tung lakes, and alignments of the original lowest crest elevation and the Karli spillway along the dam surface, taken from the top of the landslide (November 2005); (d) landslide rupture surface, dam, Karli lake, and upstream ends of the original lowest crest elevation and the Karli spillway, taken from Karli lake (December 2006).

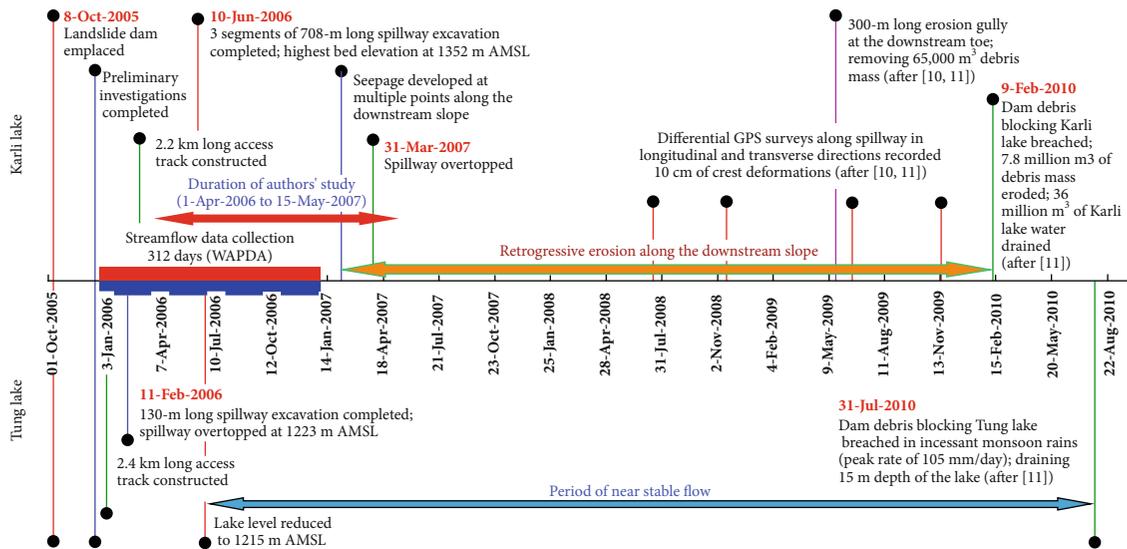
FIGURE 4: Chronology of events that occurred at the Hattian Bala landslide dam site from its creation to its breach (October 8, 2005, to July 31, 2010).

Due to the urgency against the danger of dam breach, recommendations from the investigations and studies summarized above were made to the authorities at the end of December 2005, although formal reports were finalized in a later time frame. The mitigation efforts commenced immediately. A chronology of significant events that took place at the site starting from placement of the landslide dam up to the breach of the dam portion in front of Tung lake in July 2010 is presented in Figure 4. These events include the following:

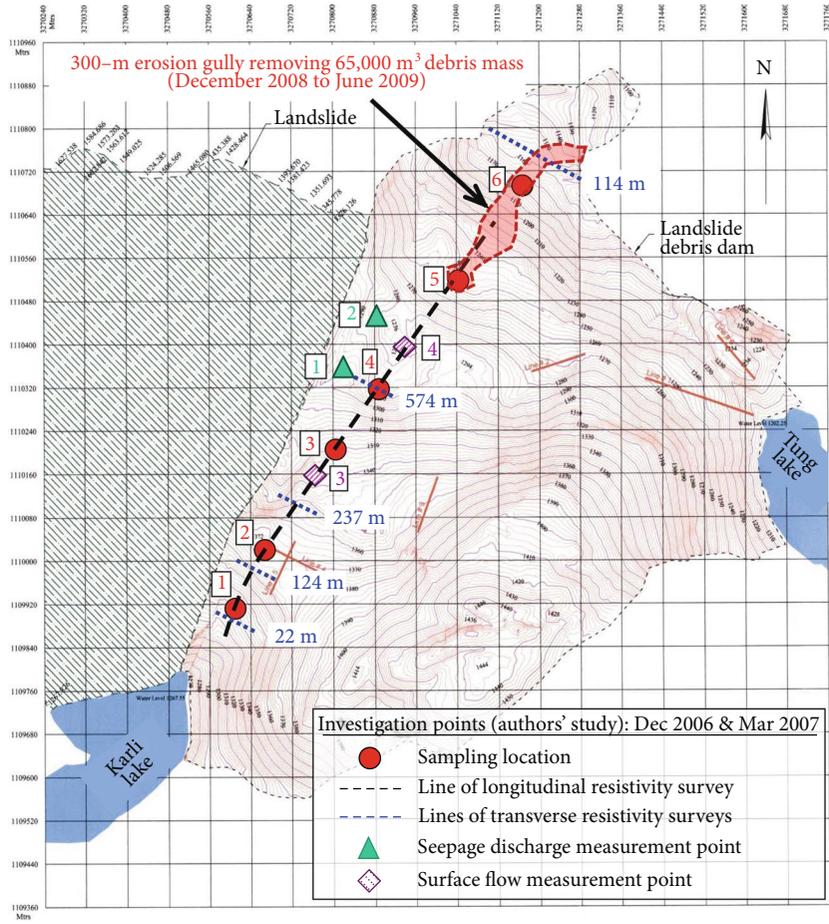
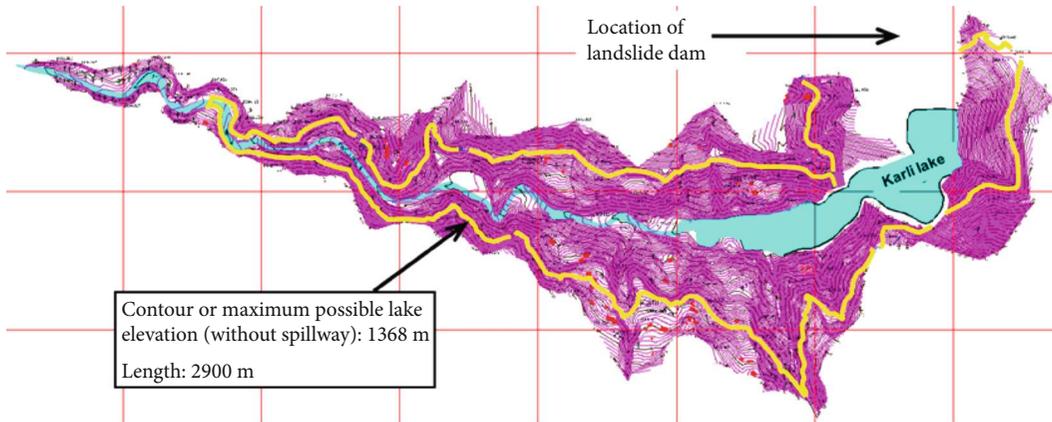
FIGURE 5: (a) 2 m contour interval topographical map of Hattian Bala landslide dam showing the field investigation points of the authors' study (measurements made in December 2006 and March 2007) and the rim of erosion gully (developed between December 2008 and June 2009); (b) 2 m contour interval topographical map of Karli lake area (adapted from [12]).

- (i) Fresh topographical surveys of the landslide, landslide dam, and Karli lake areas were completed, and 2 m contour interval maps were prepared by the end of December 2005 (see Figure 5). Figure 5(a) also shows the points of investigation of the authors' study conducted from April 2006 to May 2007 (details are elaborated in later sections of this paper) and the rim of 300 m long erosion gully that developed between December 2008 and June 2009 (as noted in [10, 11]). The thick contour (1368 m AMSL) in Figure 5(b) represents the minimum crest elevation of the landslide dam in its natural state (after Abeer [12]). Karli lake was expected to rise to this elevation without any corrective works

significant evolving hazard. The decision regarding the employment of investigation methods was taken based on their feasibility and reliability, vis-à-vis limitations of accessibility to the site, and the size and scale of the landslide dam. Investigations were aimed at determining the subsurface conditions including the stratigraphy, saturation levels, and seepage conditions affecting the dam stability. A flow chart explaining the investigation methodology adopted in this study is shown in Figure 11. The field investigations were done in two phases, with each phase spanning over a period of about 2 weeks (phase 1 in November/December 2006 and phase 2 in February/March 2007). The following is a summary of the investigations and analyses performed for this study and sets of information relevant to each method and testing approach adopted or analysis performed during this entire process (see Figure 5(a) for locations of field investigation points).

**4.1.2. Sampling.** For laboratory testing, bulk samples of matrix material were obtained from six locations along the bed of the open cut spillway (see Figure 5(a) for the locations). With such a large scale and quantity of the debris material, selective testing was a compulsion, rather than a choice. It was anticipated that under the static loading conditions, the overall deformations, in the dam body in short to medium term, would result from the seepage/piping and surface erosion, but not from the displacement of heavier and coarser fragments (i.e., boulders and cobbles), and that seepage would concentrate below the Karli spillway. Therefore, the laboratory investigations were focussed on the finer matrix collected from the spillway bed.

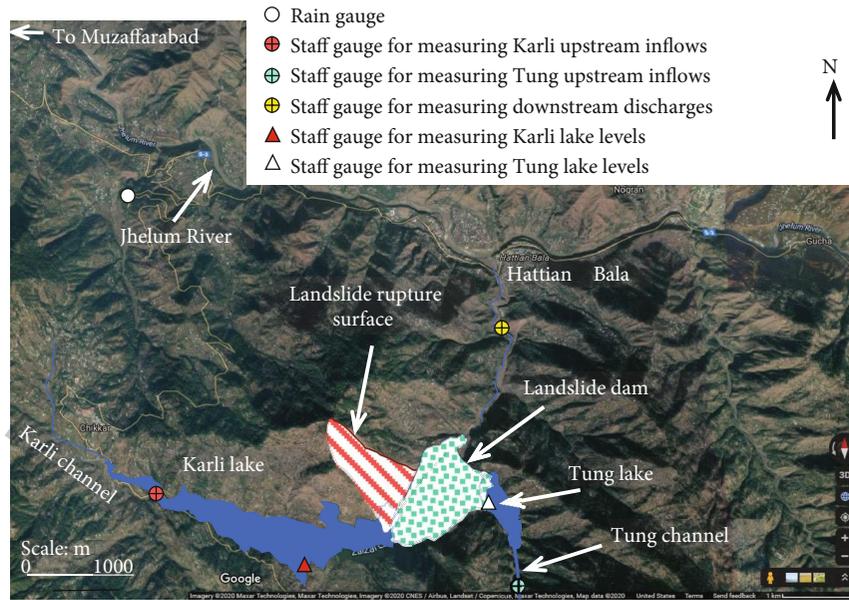
FIGURE 6: Hydrological data monitoring locations marked on the topographical map of the area (data collection period: December 26, 2005, to December 31, 2006) [13].

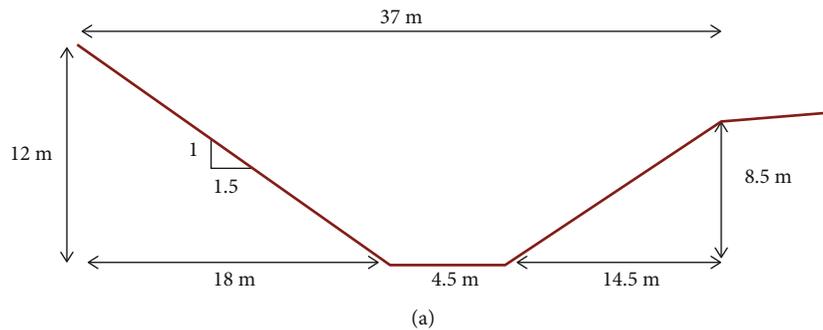
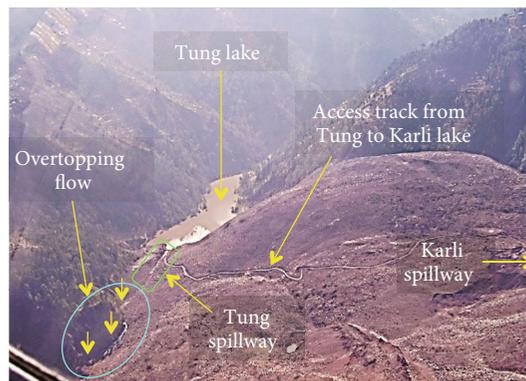
FIGURE 7: (a) Cross-section of the deepest spillway cut along the landslide dam portion blocking Tung lake; (b) photograph of Tung lake overflowing newly excavated spillway (February 12, 2006).

- (iv) A 130 m long spillway, 11.5 m deep with base width of 4.5 m and elevation of 1235 m AMSL, was excavated through the dam debris in front of Tung lake. The overflowing flow through the spillway began as soon as it was fully excavated on February 11, 2006. The overflow of the lake from Tung spillway and seepage through that part of the dam body caused washing out of the fines through surface erosion and piping over the next about 4 months. Resultantly, lake surface elevation was reduced to 1228 m AMSL by June 20, 2006. Figure 7 shows the cross-sectional dimensions of the Tung spillway at its deepest excavation point and a picture of the overflowing flow through Tung spillway. Although signs of seepage erosion were noticed later, Tung lake experienced a near steady flow across the dam over the next 4 years

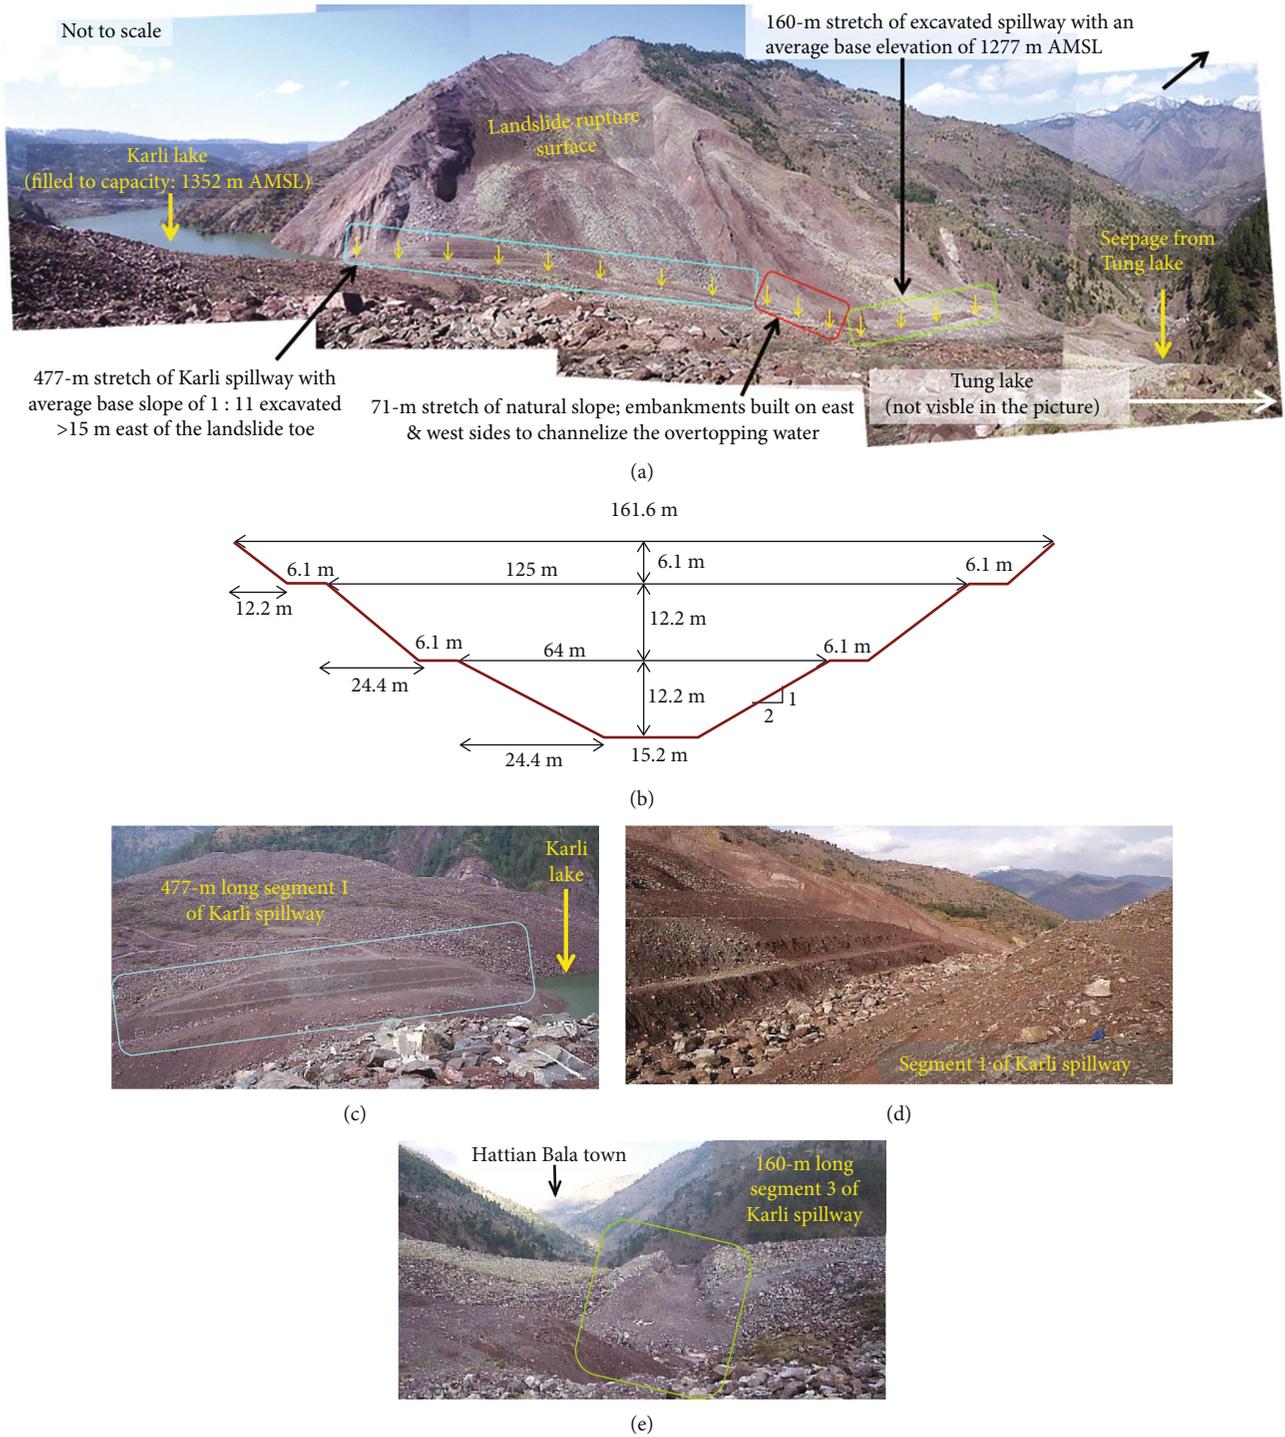
FIGURE 8: (a) Photomosaic showing complete view of the landslide rupture surface (scarp to toe), Karli lake, landslide dam portion blocking Karli channel, Karli spillway, and Tung lake seepage location (31 March 2007); (b) cross-section of segment 1 of the deepest spillway cut along the landslide dam portion blocking Karli lake; (c) photograph showing a complete view of segment 1 of Karli spillway (May 2006); (d) photograph showing bed treatment of Karli spillway segment 1 (May 2006); (e) photograph showing segment 3 of Karli spillway (December 2006).

- (v) A 708 m long spillway, with three distinct segments, was excavated through the dam debris blocking the Karli channel (see Figure 8(a)). The first 477 m long segment was excavated at least 15 m east of toe of the main landslide with a maximum base elevation of 1352 m AMSL and an average base slope of 1:11. The cross-section of maximum cut location along this segment is shown in Figure 8(b), and photographs of the same section are shown in Figures 8(c)

and 8(d). In particular, Figure 8(d) shows the spillway bed treatment of this segment by placing boulder- and cobble-sized sandstone rocks from the site. This was done to control rapid surface erosion, especially during a flash flood event. Part of the dam debris excavated from this segment was dumped on the west side in the natural low-

sides of this middle segment from part of the excavated dam debris. The third segment was relatively flat, excavated to the average base elevation of 1277 m AMSL (see Figure 8(e)). A total of about 1.1 million m<sup>3</sup> of debris material was excavated during the construction of this spillway

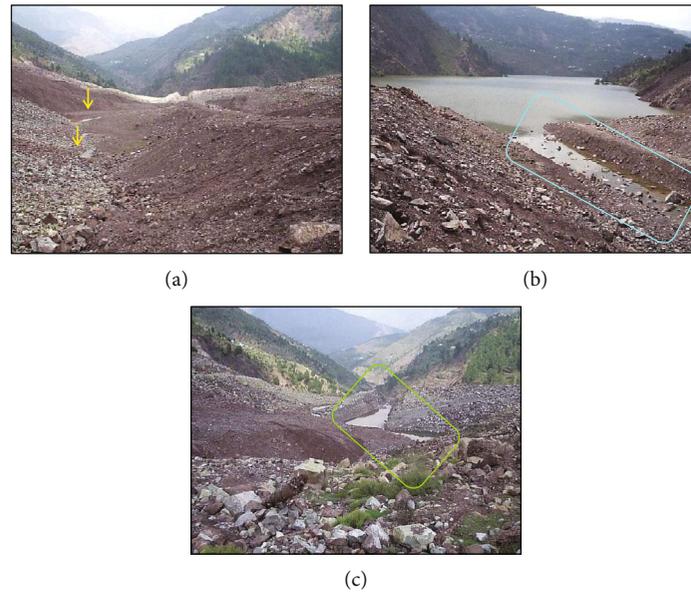
FIGURE 9: Photographs showing (a) locations of seepage points along the downstream slope of the dam (February 2007); (b) Karli lake filled to its capacity overtopping through segment 1 of Karli spillway (April 2007); (c) overtopping water from Karli lake flowing through segment 3 of Karli spillway (April 2007).

(vi) While Karli lake continued to fill to its capacity, multiple seepage points along the downstream slope of the dam developed in early February of 2007 (see Figures 5(a) and 9). Karli lake filled to its capacity and started overflowing through the spillway on March 31, 2007 (see Figure 9)

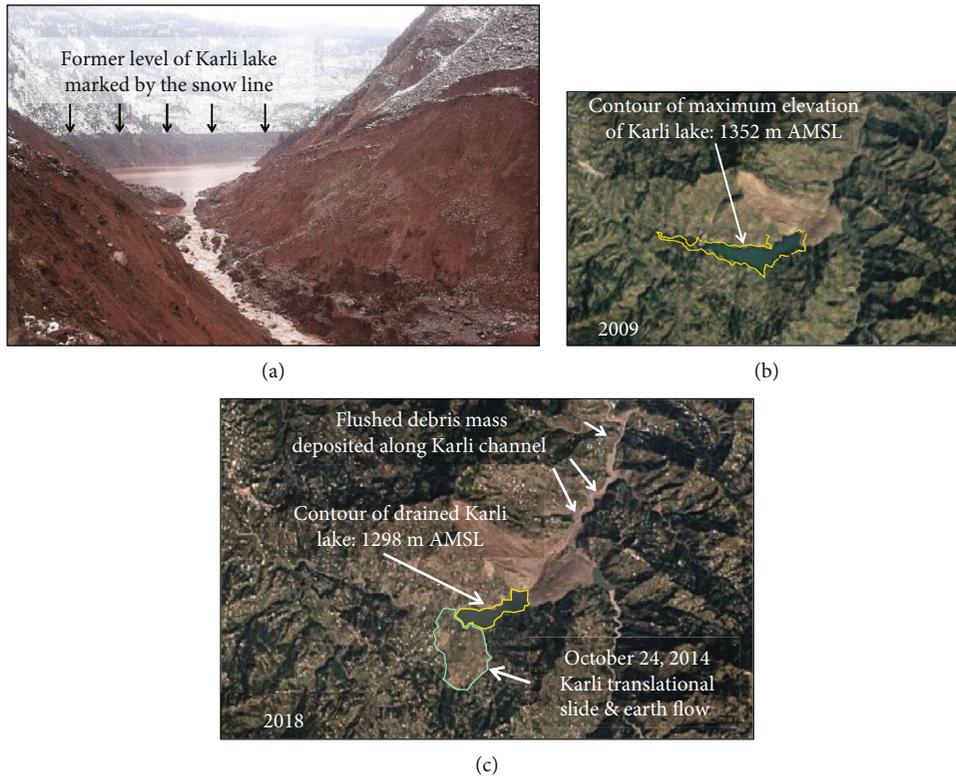
FIGURE 10: (a) Photograph showing the breached landslide dam in front of Karli lake (after [17]; photo courtesy of Dr. Kausar from GSP, dated February 10, 2010); (b, c) Google Earth Timelapse imageries of the Hattian Bala landslide area (year 2009, before landslide dam breaching, and year 2018, most recent available) [16, 18].

- (ix) Due to incessant rains in early February of 2010, the water of the Karli lake breached the landslide dam on February 9, 2010, eroding  $7.78 \text{ million m}^3$  of debris mass and immediately draining about  $36 \text{ million m}^3$  of water from Karli lake (see Figure 10). The flushed debris mass was deposited along the downstream stretch of Karli channel [11]. This breach caused the loss of one life and two dozen houses on the downstream stretch of Karli channel [10]. The lake ultimately reduced to a surface elevation of about 1298 m AMSL over the next decade

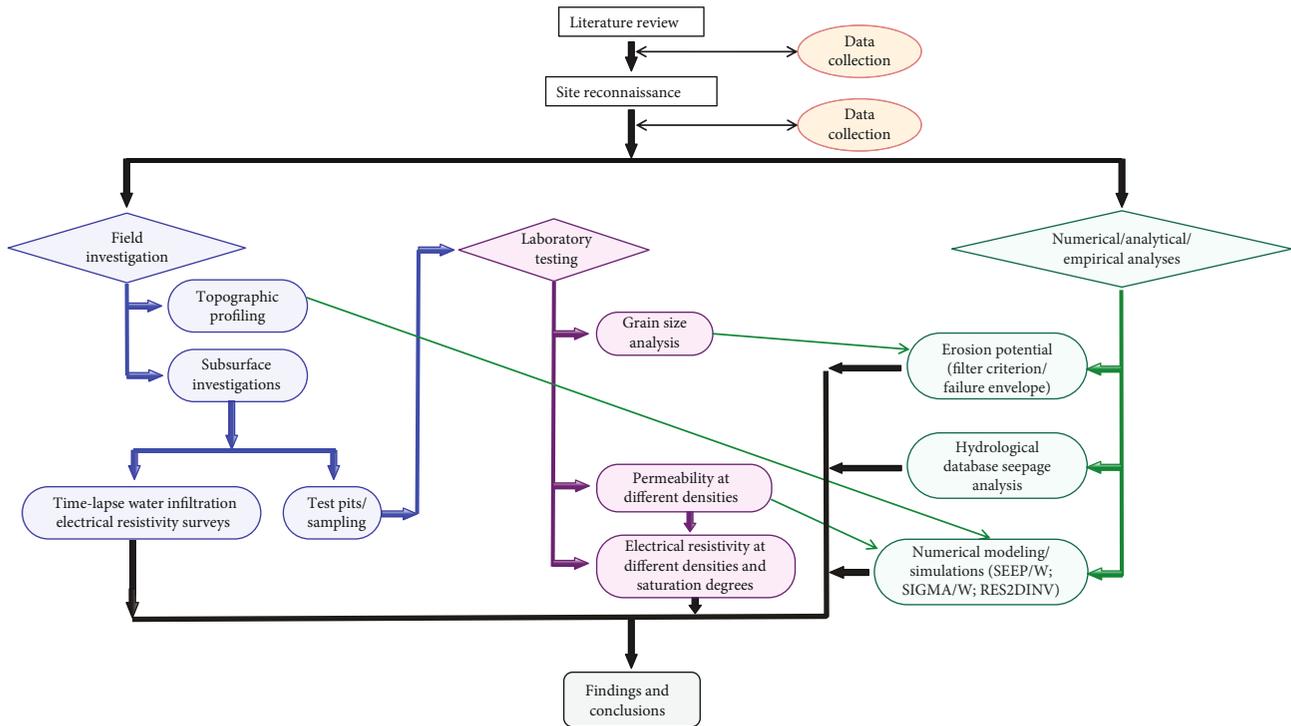
FIGURE 11: Flow chart of the authors' investigations for Hattian Bala landslide dam.

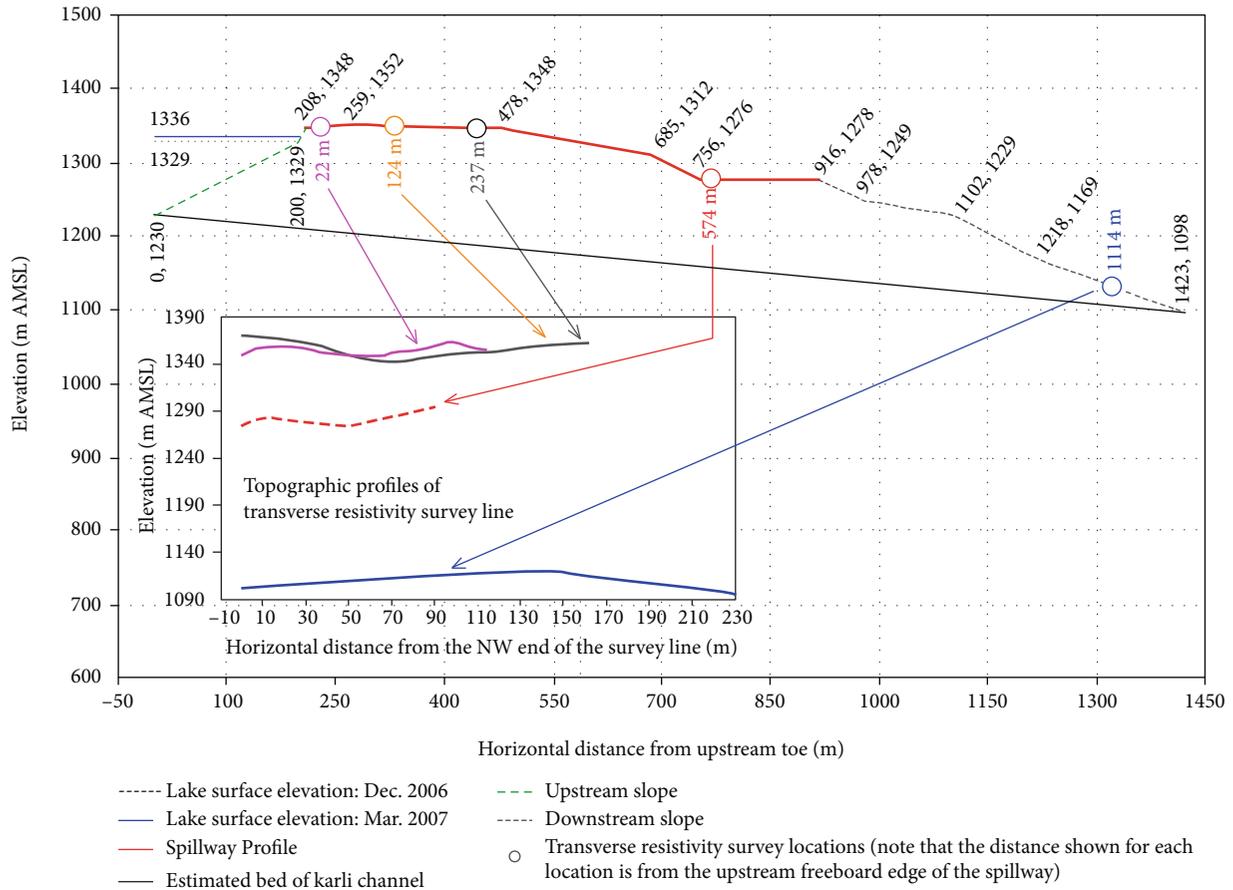
FIGURE 12: Surface topographic profiles of the lines for electrical resistivity surveys; the longitudinal survey line along the Karli spillway and the transverse resistivity locations are shown in the main graph, while the transverse survey lines at 22 m, 124 m, 237 m, 574 m, and 1114 m from the start point of the spillway are shown in the inserted graph.

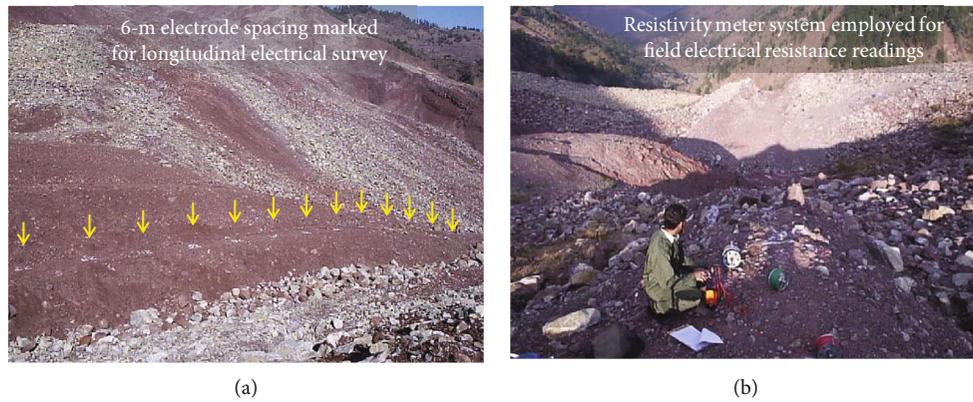
FIGURE 13: Field electrical resistivity survey in progress along the longitudinal survey line of the Karli spillway. The pictures illustrate (a) the marking of the electrode locations and (b) the resistivity system.

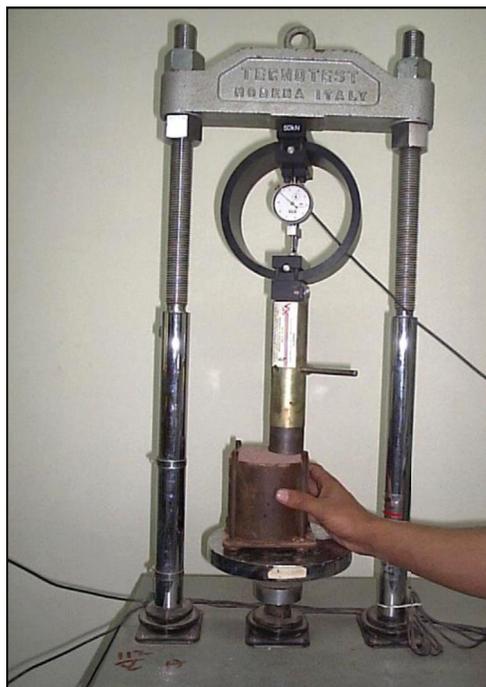
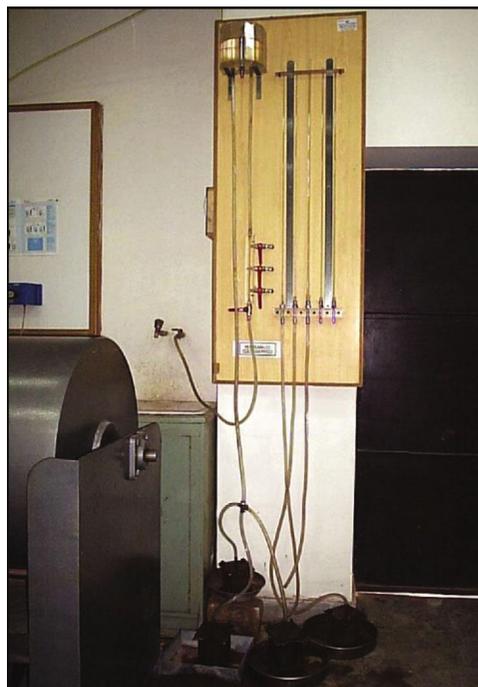
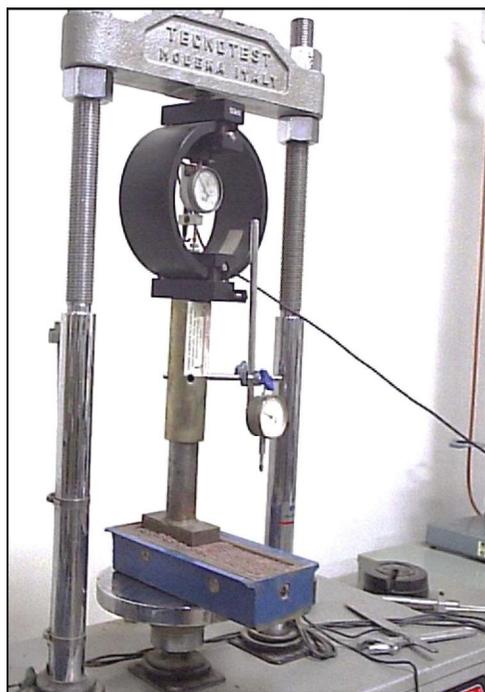
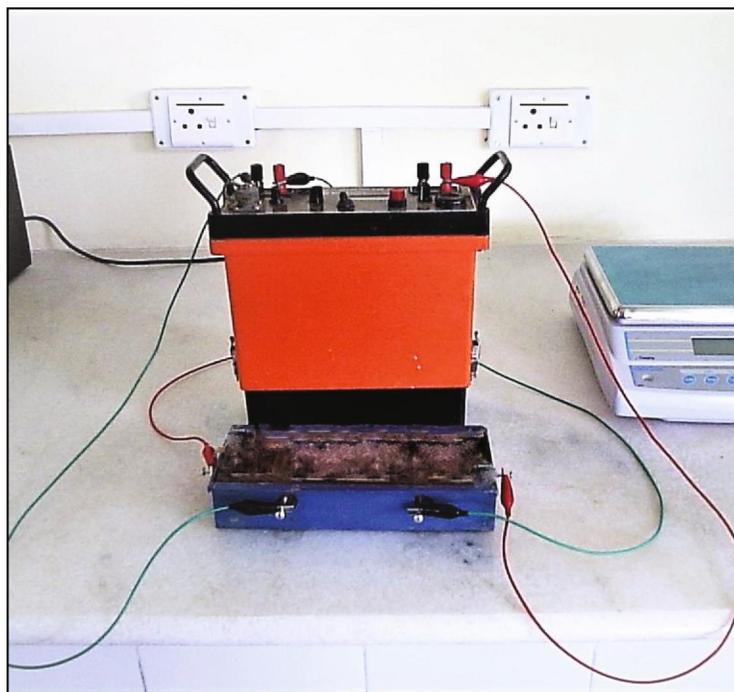
FIGURE 14: Selected laboratory tests on matrix material: (a) sample being compacted to the desired density in compaction-mold permeameter; (b) permeability test in progress on multiple samples; (c) sample being compacted to the desired density in the resistivity box; (d) resistivity box and sample connected to the resistivity meter with current and potential electrodes embedded in the sample.

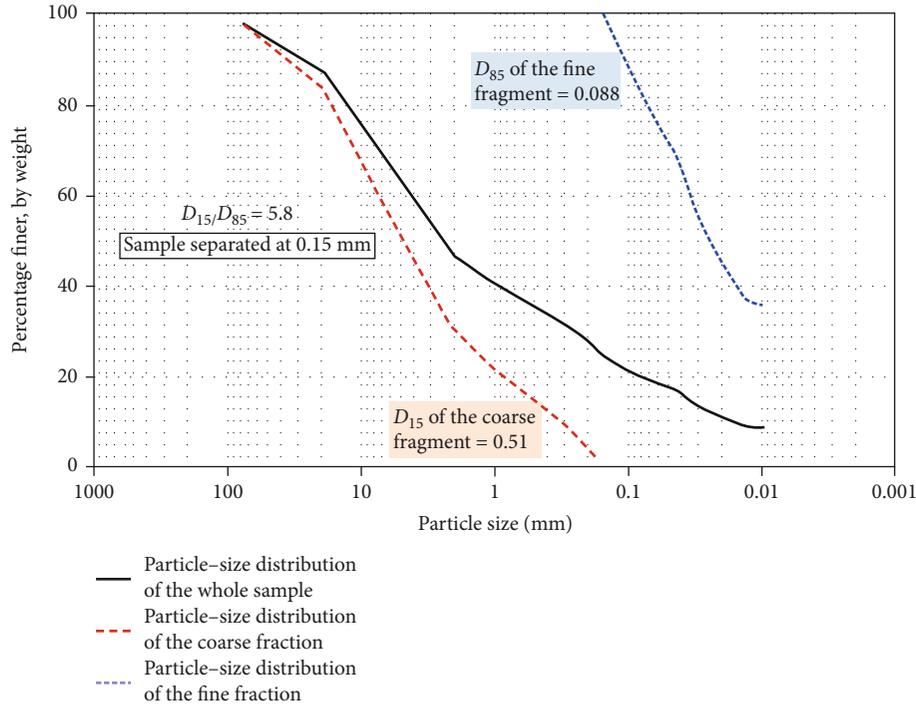
FIGURE 15: Illustration that shows the determination of  $D_{15}/D_{85}$  of matrix sample material from the Hattian Bala landslide dam from its grain size distribution separated at 0.15 mm particle size.

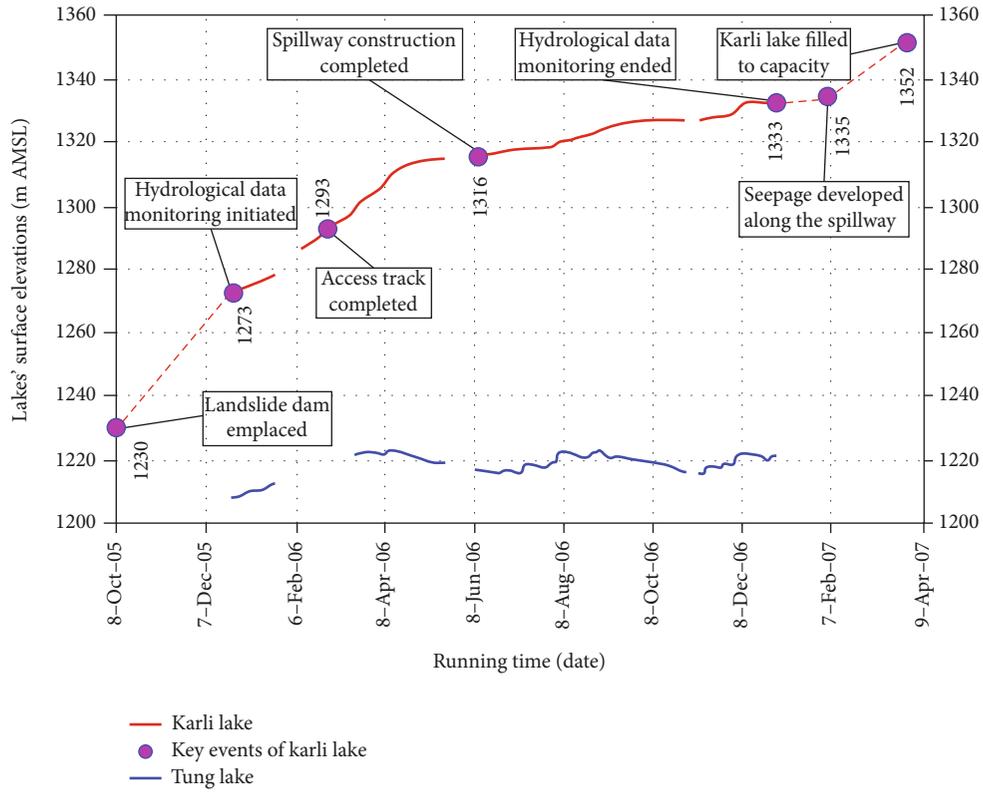
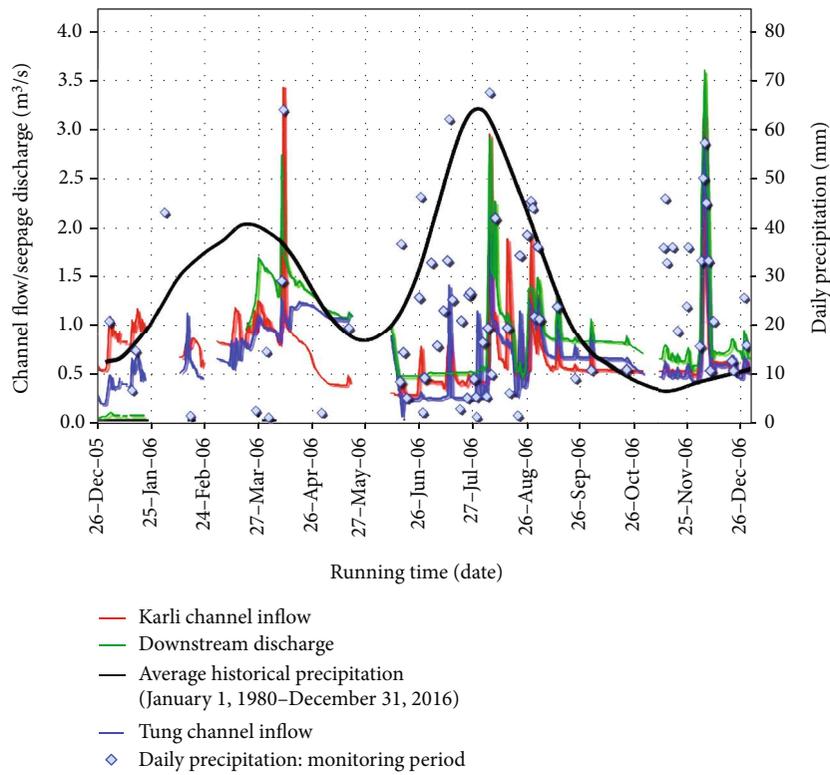
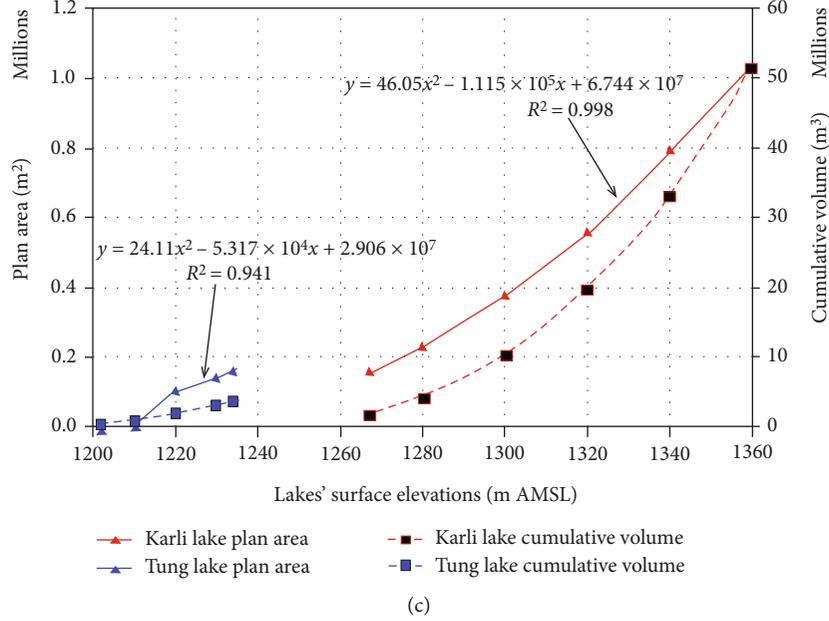
FIGURE 16: (a) Filling curves and lake periodic surface elevations for Karli and Tung lakes (significant events related to Karli lake are also shown): October 08, 2005, to March 31, 2007; (b) hydrological data including inflows of the two lakes and the downstream discharge from Hattian Bala landslide dam, daily precipitation in Hattian Bala area, and the average historical precipitation from NOAA [31]: December 26, 2005, to December 31, 2006; (c) plan area and corresponding cumulative volume vs. lake surface elevation for Karli and Tung lakes calculated from the contour maps.

- (xiii) The daily precipitation recorded for the duration of the data was noted to be less than the historical average shown in Figure 16(b) (except for November and December of 2006). Any future rainfall at or higher than the average could result in an increased rate of surface erosion as well as seepage forces due to the runoff from the adjoining slopes/catchment and the rainwater percolating into the dam surface

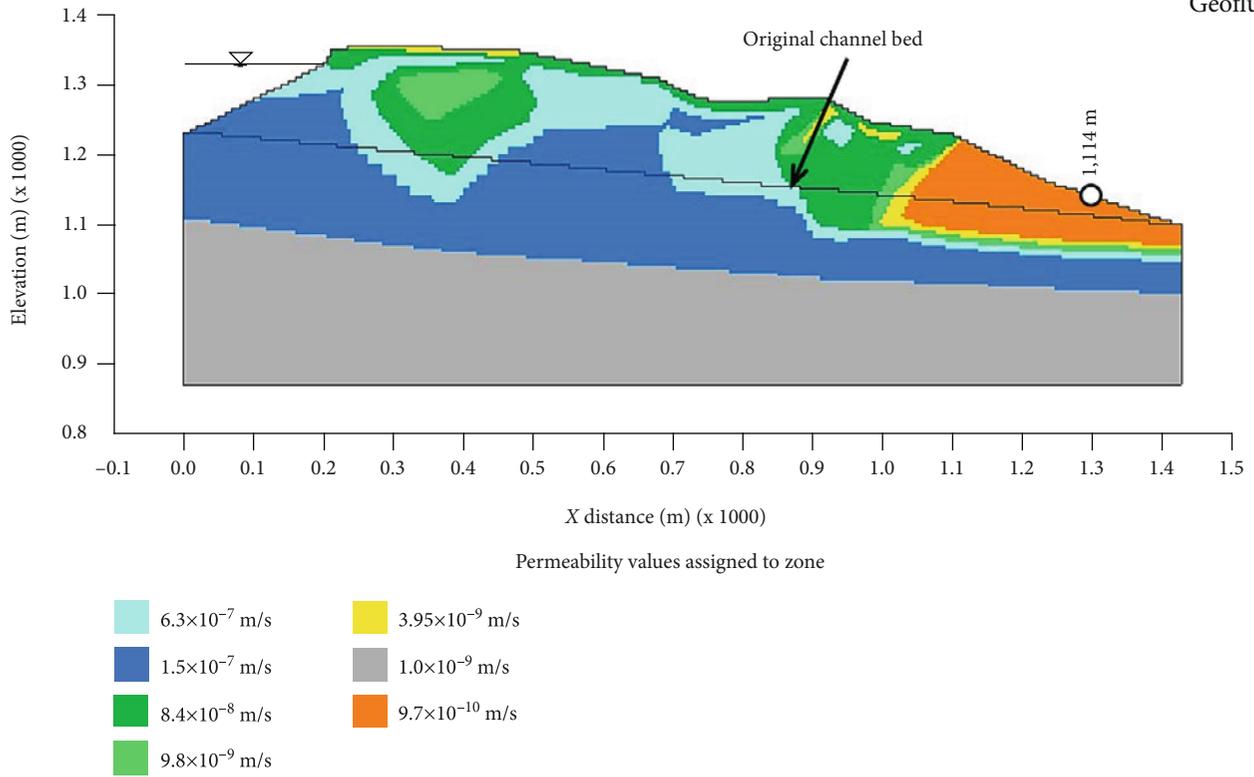
FIGURE 17: Finite element model used in SEEP/W for seepage analyses of the landslide dam section along the longitudinal survey line.

The finite element model of the subsurface developed in SEEP/W was replicated from the pseudosection obtained from the RES2DINV resistivity program. The model consisted of 22,690 elements and 23,074 nodes. Different zones within this model were assigned  $k$  values based on the calibrations performed during the laboratory investigations between  $k$ ,  $\rho$ , and  $\rho_d$  values and comparing those with the RES2DINV pseudosection. Simulations were run for likely combinations of the boundary conditions. Effort was made to conceptualize various threshold combinations of conditions and parameters, which could generate instability in the dam. The SEEP/W model prepared for these simulations along with the permeability values assigned to various zones is shown in Figure 17. It can be noticed that the zone at the toe of the landslide dam (orange) was assigned a very low permeability value. This zone consisted mainly of boulder- and cobble-sized particles in which longitudinal electrical

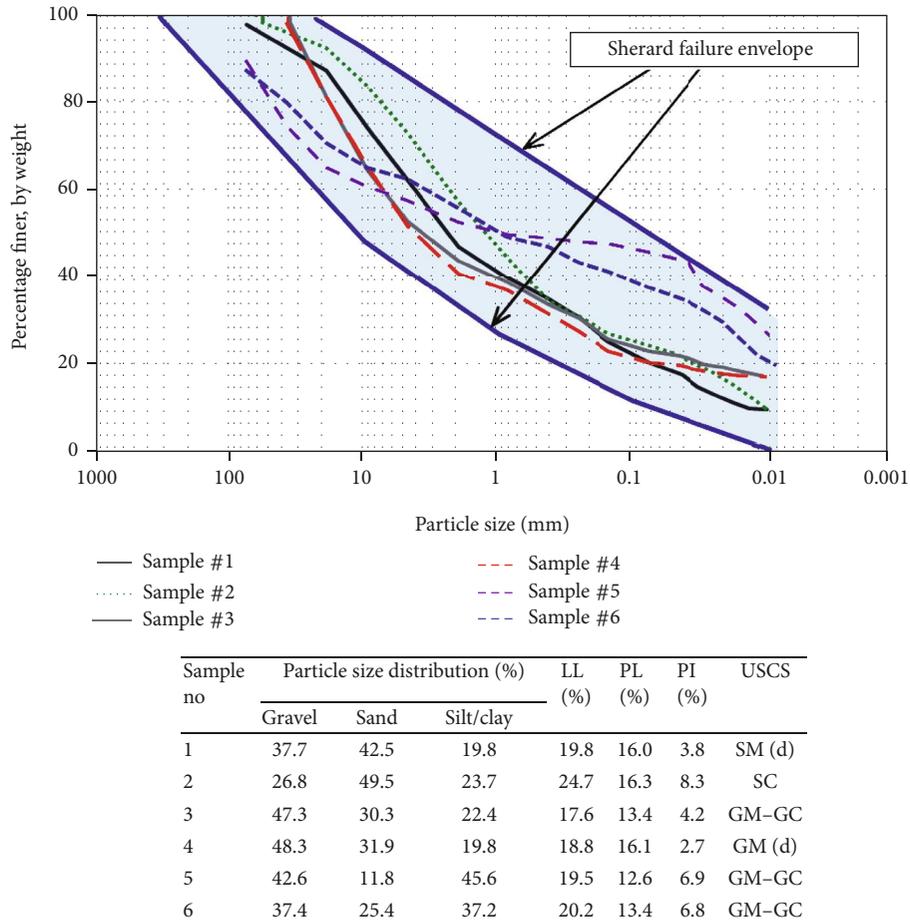
FIGURE 18: Grain size distribution curves, Atterberg limits, and the USCS classification of matrix samples from Karli spillway.

*4.2.2. Erosion Potential.* Results from the comparison of the grain size distribution curves with that of the Sherard failure envelope [29] (see Figure 18) indicated that the dam material was significantly susceptible to internal erosion due to the seepage forces. However, since the material in the subsurface was a random assemblage of coarse and fine fragments of the crushed source rock, piping could not develop or advance in its classical sense. Instead, it was expected to be a slow process, extended over months and possibly years.

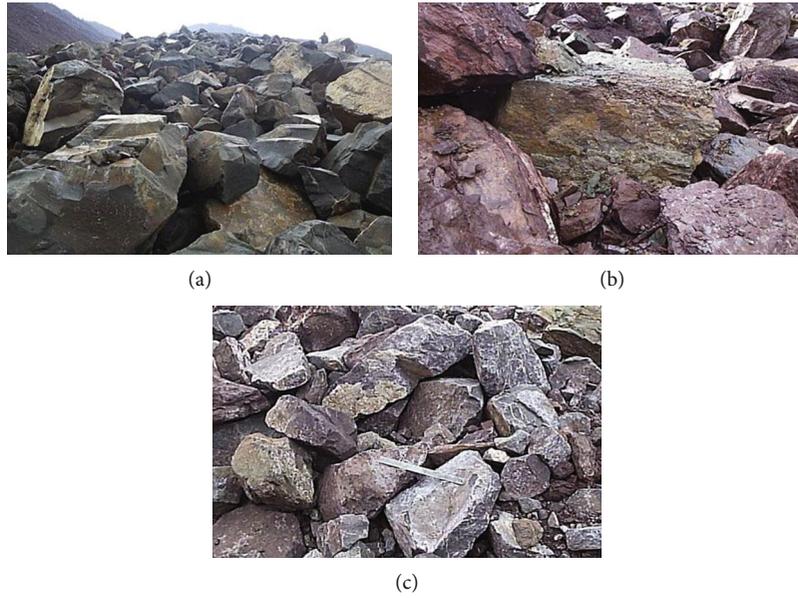
FIGURE 19: Examples of coarse materials from Hattian Bala landslide dam: (a) grey sandstone; (b) purple to reddish-brown mudstone (shale); (c) sandstone (used as a scale is a 12" stainless steel ruler).

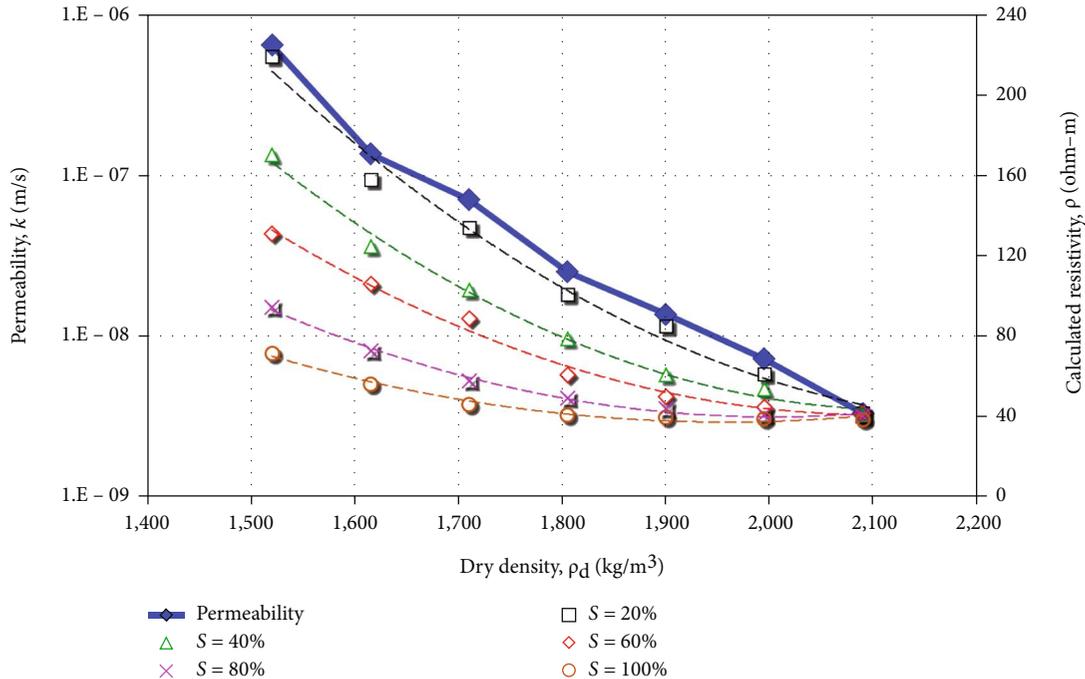
FIGURE 20: Results of laboratory tests on samples of matrix material from the Hattian Bala landslide dam, including permeability tests at different densities (plotted on a semilogarithmic scale on the primary vertical axis), and resistivity at different densities and degrees of saturation (on the arithmetic scale on the secondary vertical axes).
