# Lessons from the Case History of a Massive Landslide Dam

A massive landslide created a natural dam on two tributaries of Jhelum River near the town of Hattian Bala in Kashmir in October 2005. The landslide was triggered by a 7.6  $M_w$  earthquake. The resulting unconsolidated dam and water impoundment upstream carried hazard potential of downstream damage to both infrastructure and population due to potential flooding caused by its breach. Comprehensive investigations and monitoring were implemented to analyse dam stability. Fresh topographic profiles were generated. Samples of the matrix materials were utilized in the laboratory investigations including grain-size analysis, laboratory electrical resistivity and permeability tests at varying densities and degrees of saturation, and sediment concentration assessment in the seepage discharge. A noninvasive geophysical method was employed together with new topographic information to develop transient subsurface pictures and to assess the advancement of seepage fronts within the dam body. Internal erosion/filtering potential of the matrix material was assessed by comparing grain size distributions with those of the earlier failed d

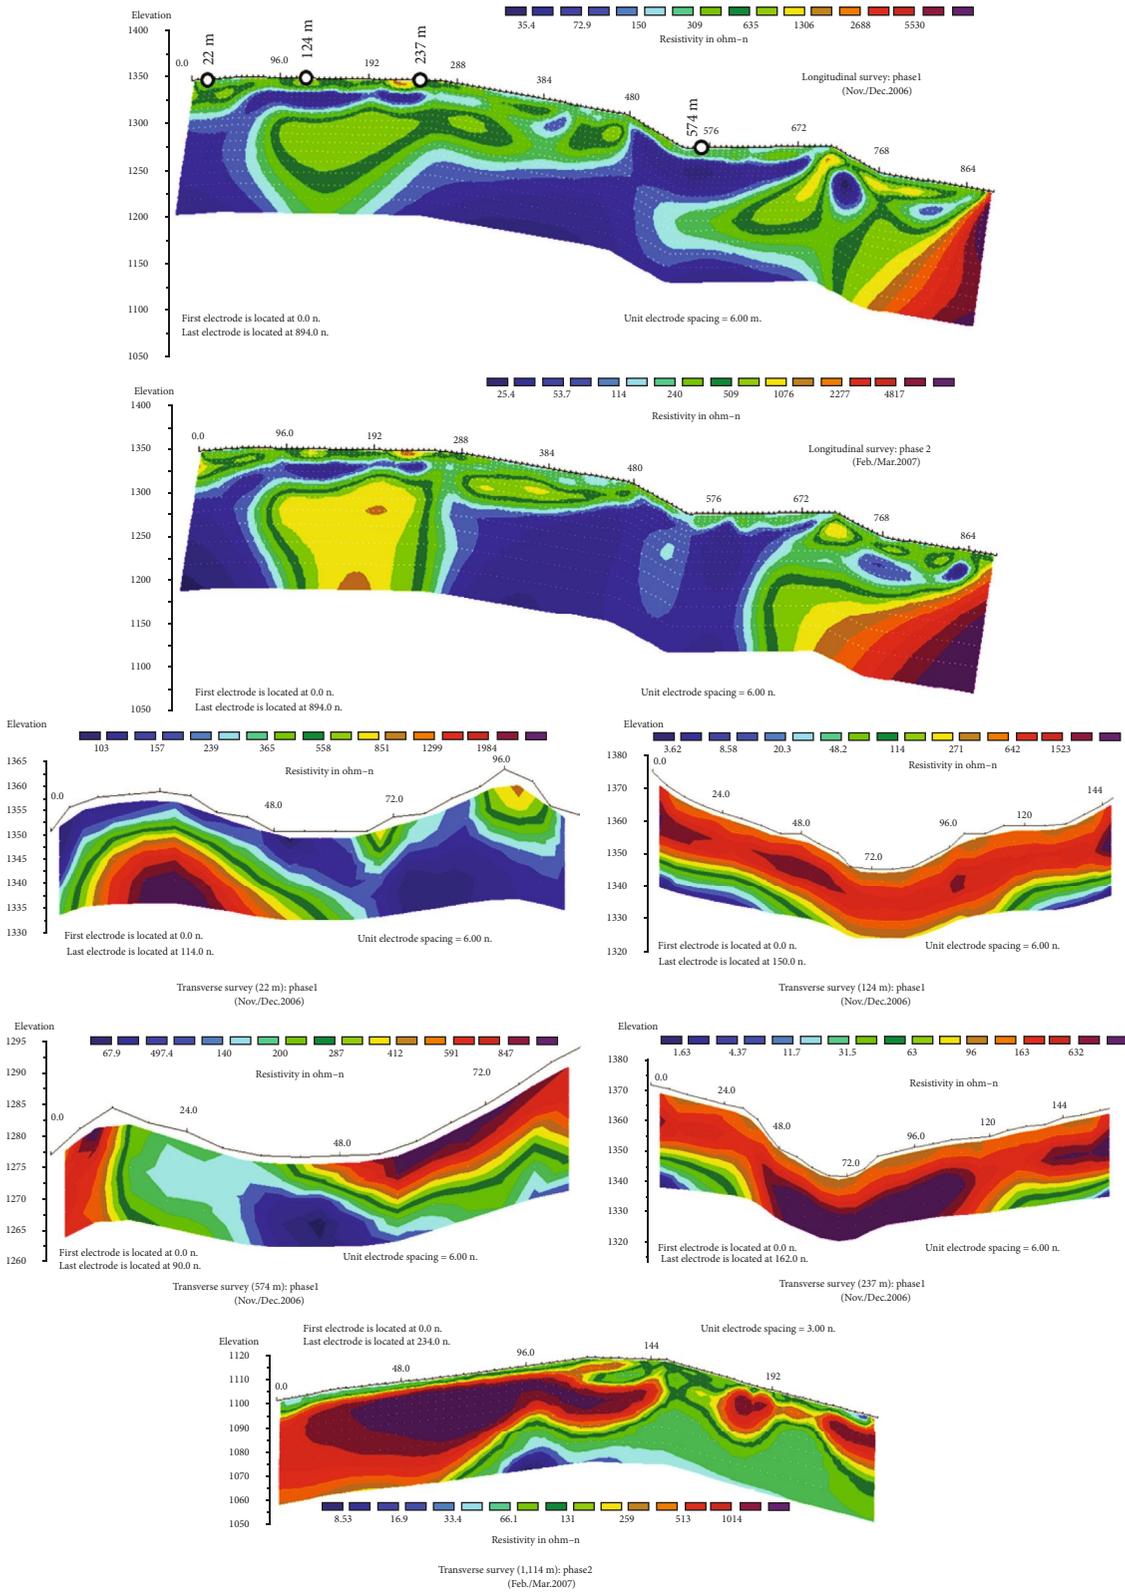
- (i) *Phase 1 Longitudinal Survey*. This model indicated two low resistivity (interpreted as highly saturated) zones in the dam body. The limits of the first zone adjacent to the upstream toe of the dam were compatible with the Karli lake surface elevation of 1329 m AMSL, noted at that time. From the depth perspective, this zone extended below the original Karli channel bed level, whereas its longitudinal dimension was about 100 m. The second zone extended horizontally from approximately 260 m up to 685 m from the upstream edge of the spillway (freeboard edge), and its depth varied from near the surface to below the original Karli channel bed. A part of this zone also relates to the lowest point along segment 2 of the spillway where seepage water reappeared on the surface at two locations in February 2007. A medium resistivity (interpreted as intermediate density and permeability) zone was sandwiched between the two low resistivity saturated zones, which could hinder the development of smooth flow paths and thus impede the flow of water. A zone characterized by extremely high resistivity values (representing very high density and low permeability) was found in the subsurface towards

- (ii) *Phase 1 Transverse Resistivity Surveys*. The four transverse resistivity profiles of phase 1 are shown in Figure 21. As mentioned above, these additional surveys were conducted to verify the profile obtained from the longitudinal survey. Since the longitudinal survey was conducted along the spillway bed, the main portions of interest from the transverse survey profiles were those below their lowest crest elevations (these elevations correspond to the spillway bed). The maximum depths of investigations for the transverse resistivity surveys at 22 m, 124 m, 237 m, and 574 m extended vertically up to 20 m, 26 m, 28 m, and 16 m below the spillway bed, respectively. The resistivity values of the 22 m transverse survey profile indicated an increase from 175 ohm-m at the spillway bed to 800 ohm-m at 20 m depth, whereas those of the 124 m transverse survey profile increased from 350 ohm-m at the spill bed to about 1000 ohm-m at 12 m depth and then decreased down to about 150 ohm-m at 26 m. For the third transverse resistivity survey at 237 m, the values varied between 95 ohm-m and about 1000 ohm-m

FIGURE 21: Longitudinal and transverse resistivity profiles of Karli spillway from RES2DINV modelling integrating data from two phases on field investigations.

within the 28 m depth zone, whereas for the transverse survey at 574 m, the value decreased from about 300 ohm-m at the spillway bed to about 60 ohm-m at 16 m depth. Interestingly, these resistivity values obtained from the transverse profiles are in general agreement with the values of the longitudinal profile of that phase, thus validating the subsurface inversion model and the interpreted conditions.

- (iii) *Phase 2 Longitudinal Survey.* The time-lapse water infiltration longitudinal resistivity surveys, conducted during the phase 2 field investigations in February/-March 2007, exhibited a general increase in the extents of low resistivity (high saturation) zones. This increase could be attributed to (1) rise in the Karli lake surface elevation by 7 m from December 2006 to March 2007 and (2) excessive rainfall (401.5 mm total) during a time-lapse of three months between the two phases of the surveys (Surface Water Hydrology Project, Water and Power Development Authority Pakistan, personal communication, unpublished data, March 2007). The surface runoff from the rainwater accumulated and percolated into the dam body, particularly at the lowest point along segment 2 of the spillway. The decrease in the resistivity values was maximum in the subsurface below that location.

- (iv) *Phase 2 Transverse Resistivity Survey.* The only transverse resistivity survey of phase 2 was performed near the toe end of the dam (at 1114 m from the upstream end of the spillway). Accordingly, this survey line was located 220 m towards the downstream side from the end point of the longitudinal survey line of the two phases (also see Figure 12). Because of that distance, the results from this survey could not be used to validate directly any part of the longitudinal profile. However, it was conducted to investigate whether the extremely high resistivity zone observed near the end of the two longitudinal surveys further extended towards the downstream toe end. The profile developed from this 234 m long survey extended 41 m deep below the surface (see Figure 21). The reduced electrode spacing provided higher resolution. The results indicated variation of the resistivity values between 150 ohm-m and 1500 ohm-m within the top 25 m. The values were much lower than those observed in the end segment of the longitudinal surveys of both phases. It was interpreted that the extremely high resistivity zone found below the 780 m to 894 m stretch of the longitudinal survey gradually decreased in values towards the toe end of the dam. In the lower 15 m of the profile, the resistivity values decreased to less than 20 ohm-m. This low resistivity (interpreted as a highly saturated zone) corresponds to depths below the original channel bed. This particular observation hinted to a possible connection with the second low-resistivity saturated zone of the longitudinal surveys through the deeper strata.

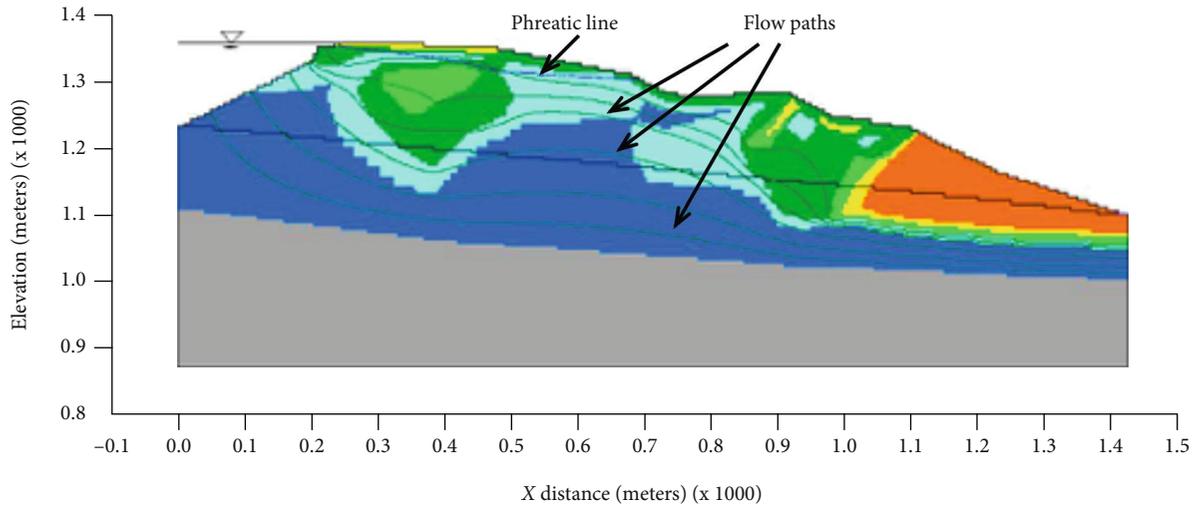
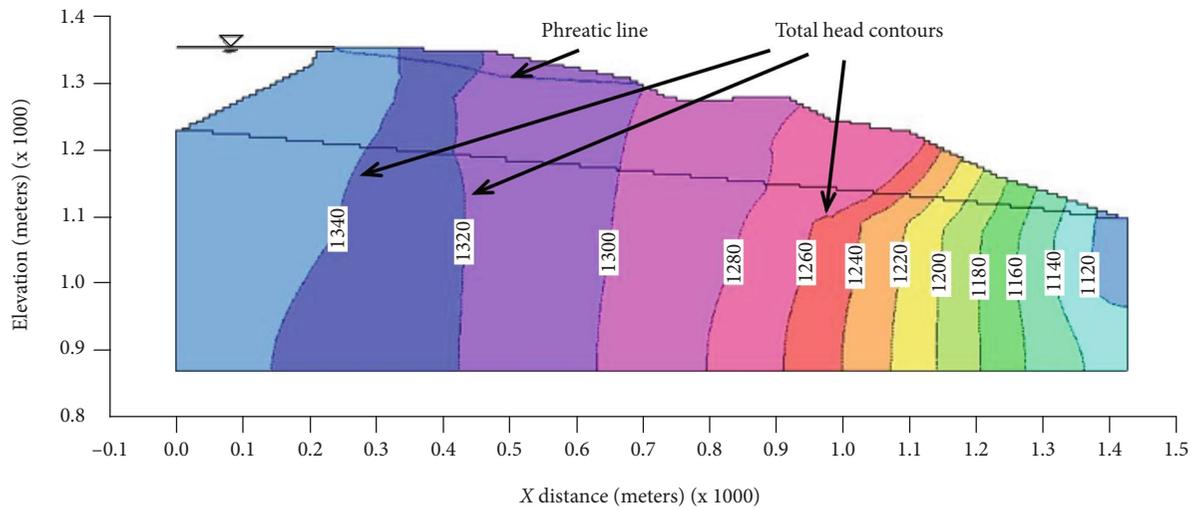
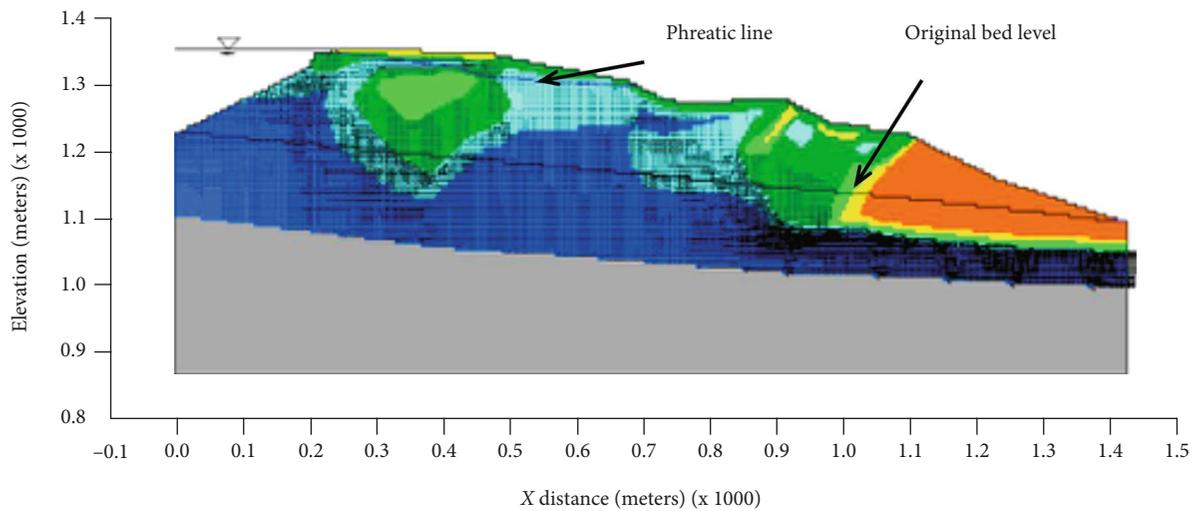
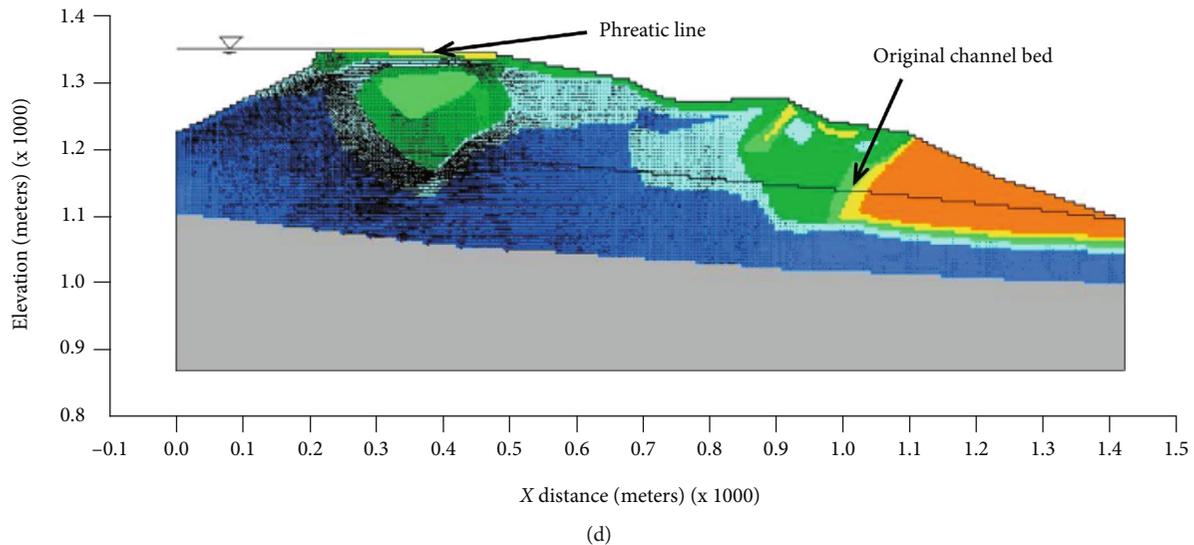
FIGURE 22: SEEP/W simulation results for Karli spillway (lake level at 1352 m AMSL): (a–c) flow paths, total head contours, and velocity vectors, respectively, for the head at the downstream toe end equal to the original channel bed, and (d) velocity vectors for zero flux at the downstream toe end.

- (i) In the simulations modelled for three pondage levels with zero flux condition at the downstream toe end, the phreatic line daylights on the spillway surface very close to the upstream face of the dam (see Figure 22(d)). However, no such signs were observed during any phase of the site investigations or visits. It implied the possible use of incorrect downstream boundary conditions and/or a transient state of the actual seepage under the spillway in contrast to the steady-state model for which the analyses were run

- (ii) The phreatic line, generated in the simulations with the downstream head at the same elevation as the original channel bed, daylights on the spillway surface near the lowest elevation point of its segment 2 (see Figure 22). As mentioned earlier, the two seepage points, initiated in February 2007, were located adjacent to this spot. Thus, this combination of boundary conditions and simulation seemed to be closer to the actual site conditions
