Seepage in Water-Rich Loess Tunnel Excavating Process and Grouting Control Effect

The background of this paper is a seepage collapse accident in a loess tunnel in Qingyang City, Gansu Province. Firstly, the general situation of the project is introduced, and then the accident of collapse and roof collapse and the treatment measures are described systematically, and the square reason of seepage collapse is analyzed. On this basis, the design and construction methods of basement grouting and curtain grouting are introduced, and the effect of grouting reinforcement is evaluated in detail through on-site monitoring, in order to provide a practical basis for the safety construction and deformation control of a water-rich loess tunnel and the provide reference for similar engineering design.

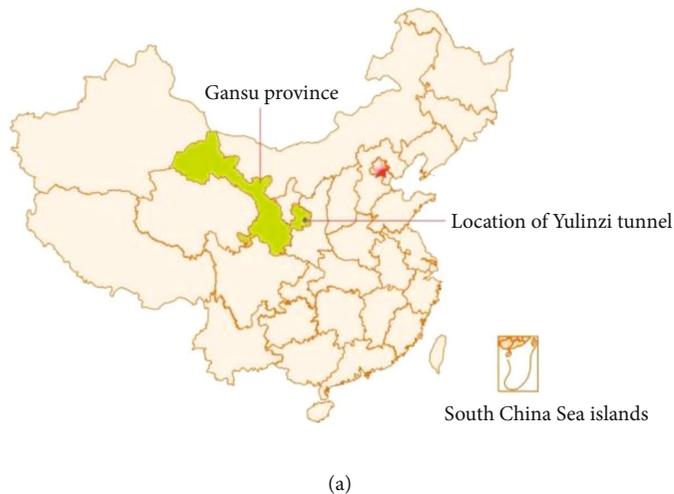
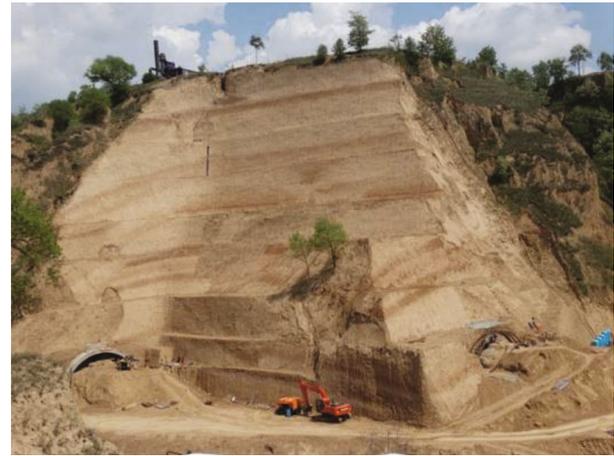
FIGURE 1: Location and surrounding geological conditions of Yulinzi tunnel.

2.1. Background of the Yulinzi Tunnel. Qingyang City is located in the southeast of Gansu Province, China. The Yulinzi tunnel is a part of the Yin-Bai Expressway Project in Qingyang City. The tunnel is located 2200 m west of Yulinzi Town, Zhengning County, Qingyang City, as shown in Figure 1(a). The total length of the tunnel project is about 1970 m, which is a single hole and double track tunnel. The elevation of the tunnel is 1170.00–1294.00 m, and the relative height difference is 124.00 m. There are loess gullies developed at the entrance and exit, and the gullies are narrow, and the slope is steep. The maximum buried depth is 113 m, as shown in Figure 1(b). The lithology of the tunneling site is the Quaternary Upper Pleistocene (Q_3^{eol}) Malan loess and Middle Pleistocene (Q_2^{eol}) Lishi loess with multiple layers of paleosol.

The stratum through which the tunnel passes is the Longdong Loess Plateau, the largest loess region in the world, which is characterized by a simple regional geological structure, the development of vertical loess joints, and the development of irregular tensile joints locally. The width of the fissure is large, more than 1 cm, and it is a channel for the infiltration of meteoric water. In fact, dense vegetation can

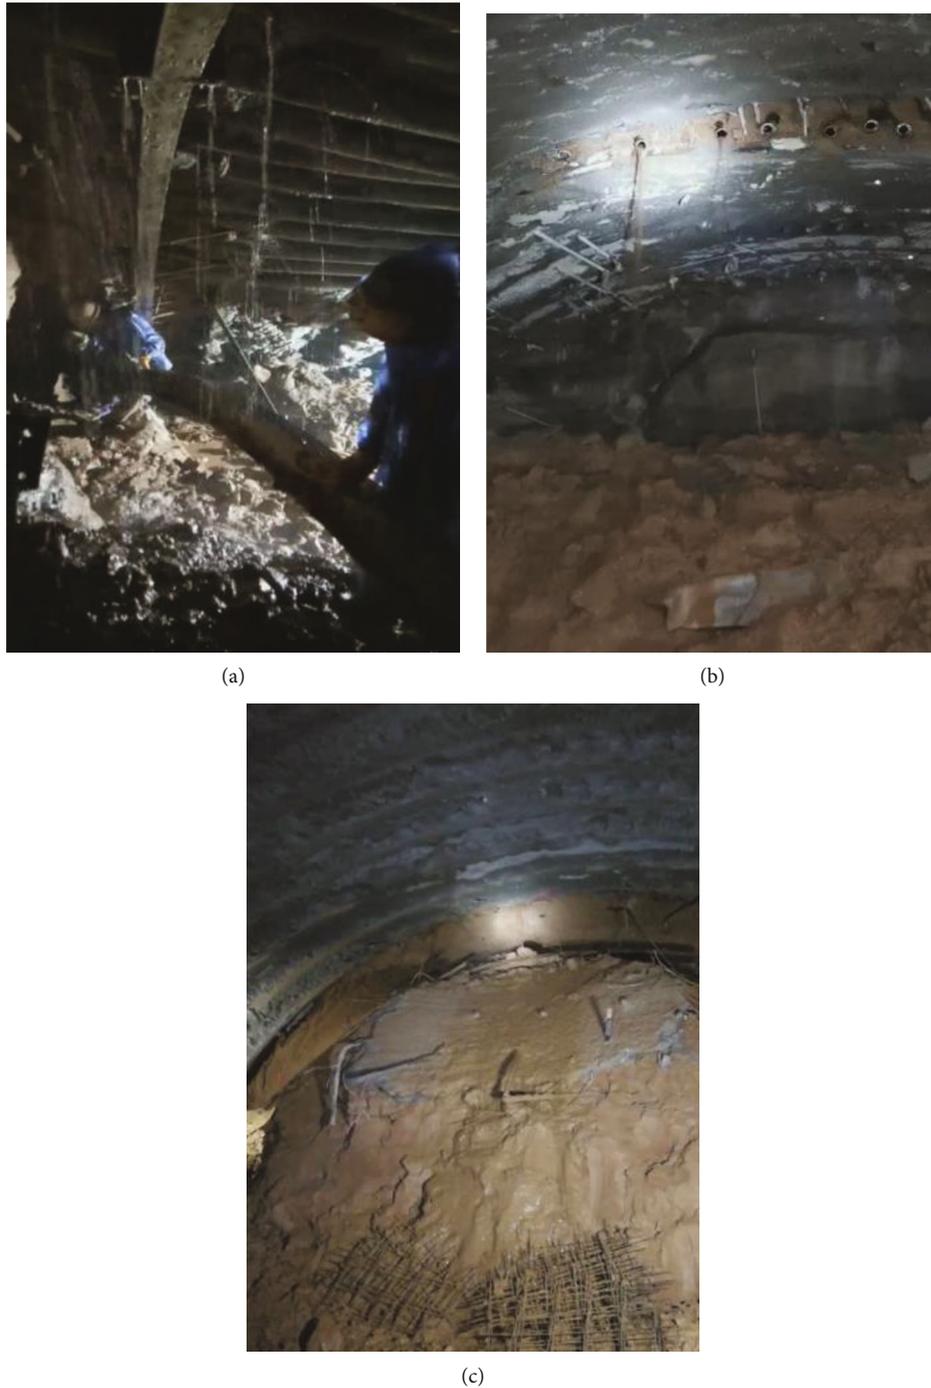
FIGURE 2: Water gushing and mud inrush at tunnel face: (a) tunnel water gushing; (b) water inrush from advance pipe shed; (c) mud burst on tunnel face.

2.2. Collapse Accident. On the evening of December 19, 2019, the arch of YK280+596.8 at the right exit of the Yulinzi tunnel collapsed, and then the upper and middle steps of YK280+596.8 to YK280+617.6 on the tunnel face collapsed after the initial support failure. After the collapse, the soil gushing out caused the sections of YK280+617.6 to YK280+630.8 to collapse without the construction of secondary lining filling and pushed the secondary lining trolley and the waterproof plate working trolley to the direction of the entrance for about 15 m, as shown in Figure 4. The tunnel in this section is buried to about 95 m. At the surface of YK280+600 corresponding to the tunnel collapse is a surface pit with a diameter of about 38 m, with a peripheral staggered platform of about 2 m and central depth of about 8 m (see Figure 5). After the collapse occurred, the construction personnel and machinery in the tunnel were evacuated in time, and the corresponding position of the roof was set up with warning lines to ensure the safety of construction. According to the situation of the site, the preliminary disposal scheme is put forward.

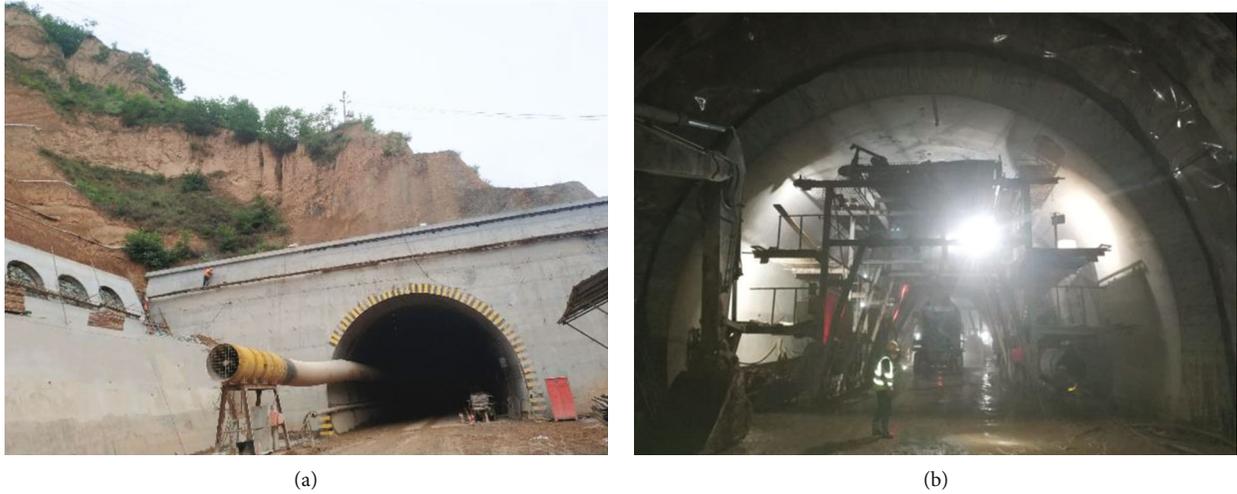
FIGURE 3: Construction situation (a) outside and (b) inside the tunnel before the incident.

be observed on the surface of the tunnel in this area. More importantly, the groundwater in the tunnel site area is pore water of loose rock, and the tunnel is located below the underground water level. The water content of the surrounding rock in the construction section is too high, the water seepage at the face of the tunnel is serious, and there is a water gushing and mud gushing phenomenon, which usually hampers the construction of the tunnel (see Figure 2). Considering the influence of groundwater seepage, in order to ensure the construction safety, the New Austrian Tunneling Method excavation is adopted in the process of tunnel construction, and drainage measures are strengthened. However, the seepage collapse accident occurred at the tunnel face 1893 m away from the opening of the portal (see Figure 3).

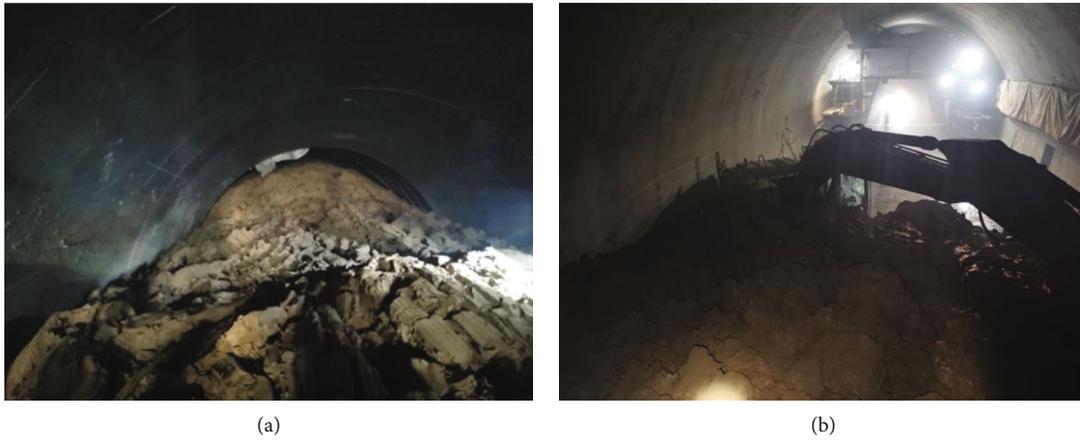
FIGURE 4: Accident scene: (a) collapse and mud bursting in tunnel; (b) excavator flushed away by inrush mud.

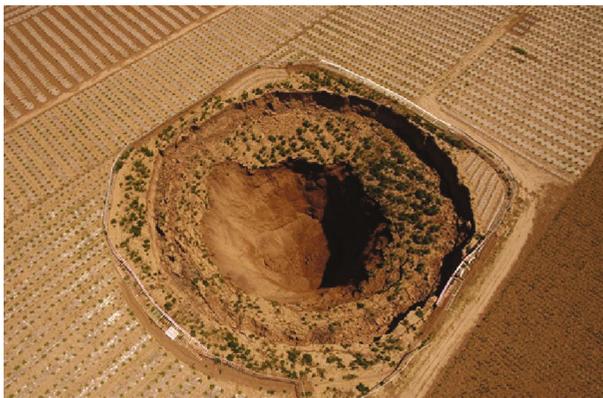
FIGURE 5: Large scale surface subsidence occurred.

2.3. Disposal Measures. Subsequent collapse treatment measures are as follows: (1) For the pit at the bottom of the surface, 5% lime soil is used for backfilling, leveling, and compaction, and the compaction degree reaches more than

90%. Then, the surface is backfilled with 1 m thick planting soil, and the soil body is slightly higher than the surrounding surface after backfilling, so as to prevent the infiltration of surface water. (2) The collapsed soil mass flowing into the constructed secondary lining section is repaired, a wall for grouting and a 20 m long drain hole are set up, and the collapsed section of YK280+625-YK280+617.6 is timely backfilled with back pressure to prevent further expansion of collapse. (3) Surface well point precipitation is adopted for this section to reduce water content of surrounding rock and groundwater level in the tunnel. (4) Construction of grouting small conduit on the section of the collapse in the cave to reinforce the collapse in the cave. After the completion of the grouting, the collapse is repaired and the construction platform is gradually completed. (5) After the repair and reinforcement of the cave collapse, a 2 m thick cast-in-place concrete wall for grouting was built at YK280+628 and YK280+611, and the collapse was reinforced by advanced high-pressure grouting. (6) Temporary reinforced arches were added at the end of the lining, and the ring grouting was carried out to reinforce the surrounding rock. The whole process of rescue was tracked and monitored.

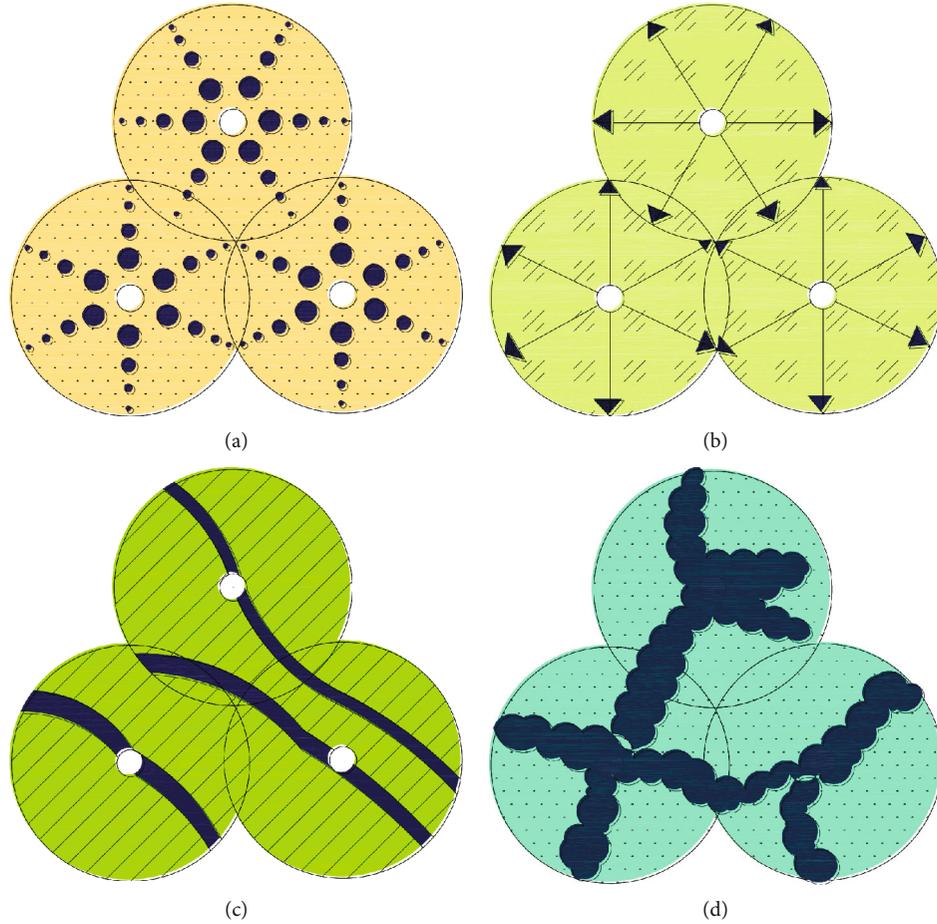
FIGURE 6: Diffusion mechanism model of grouting in stratum: (a) permeation diffusion; (b) splitting diffusion; (c) fissure filling; (d) disturbance displacement compaction.

3.1. Grouting Mechanism. In the process of tunnel engineering grouting construction, due to the different geological conditions, geological media, and grouting materials, the grouting may show different diffusion mechanisms in the formation reinforcement and water plugging, which are mainly manifested in four kinds: permeation diffusion, splitting diffusion, fissure filling, and disturbance displacement compaction [32], as shown in Figure 6.

water will soften and partially dissolve the cements at the contact parts of particles, weaken the structural connection, and significantly reduce the mechanical strength of soil, and then collapse accident occurs [33]. By the grouting amount of pore water in the loess, the grouting pressure exceeds the limit of the soft loess strata shearing resistance, the soft loess stratum splits apart, and the grout along the cleavage surface infiltration and formation compaction forms a mesh split pulse, to strengthen the mechanical properties and impervious soil and achieve the goal of grouting reinforcement and water plugging. Therefore, the grouting mechanism of the loess stratum belongs to splitting diffusion.

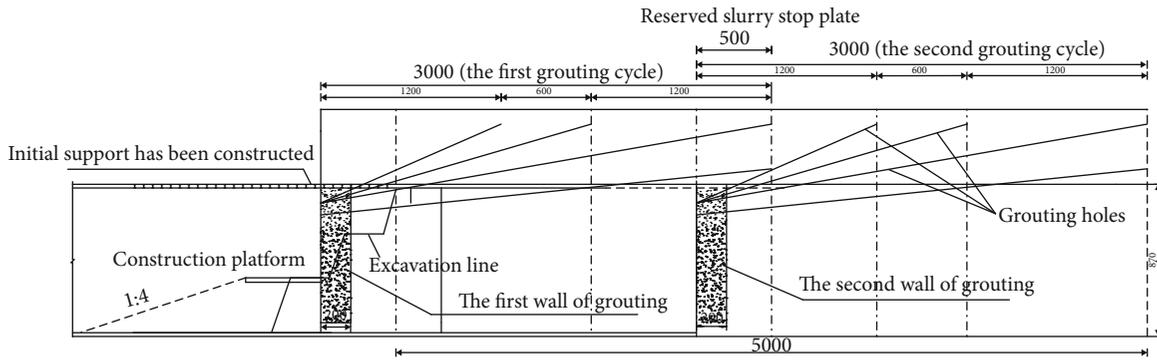
FIGURE 9: Vertical section of grouting (units: cm).

3.2.1. Basement Grouting Reinforcement Scheme. The tunnel basement grouting is usually arranged on the surface of the invert or the filling layer, and the rigid grouting pipe is installed in the grouting hole. The grouting steel pipe can also form the composite foundation of the steel pipe pile with the reinforced stratum. The advantages of the tunnel basement

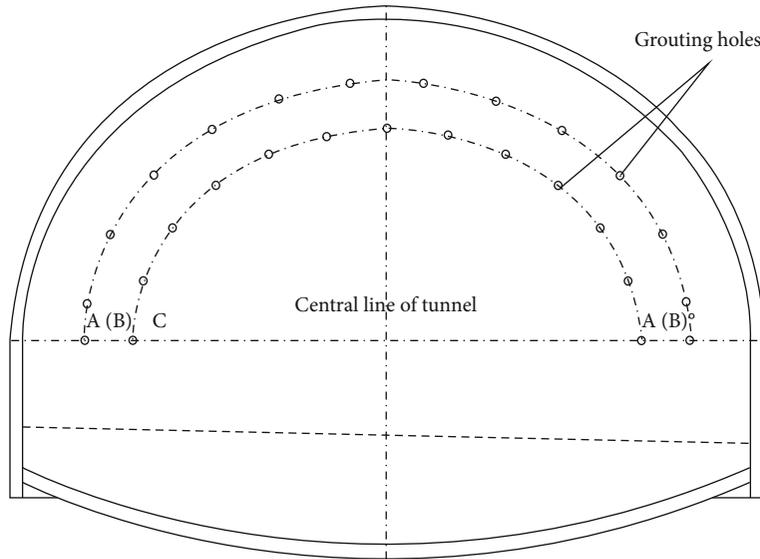
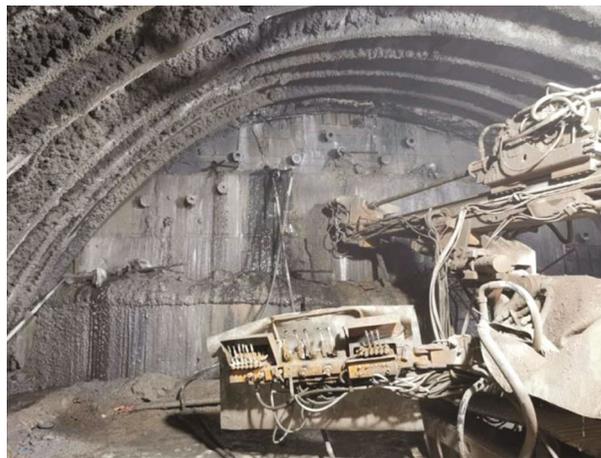
FIGURE 10: Curtain grouting construction: (a) layout of grouting hole; (b) construction site of curtain grouting.

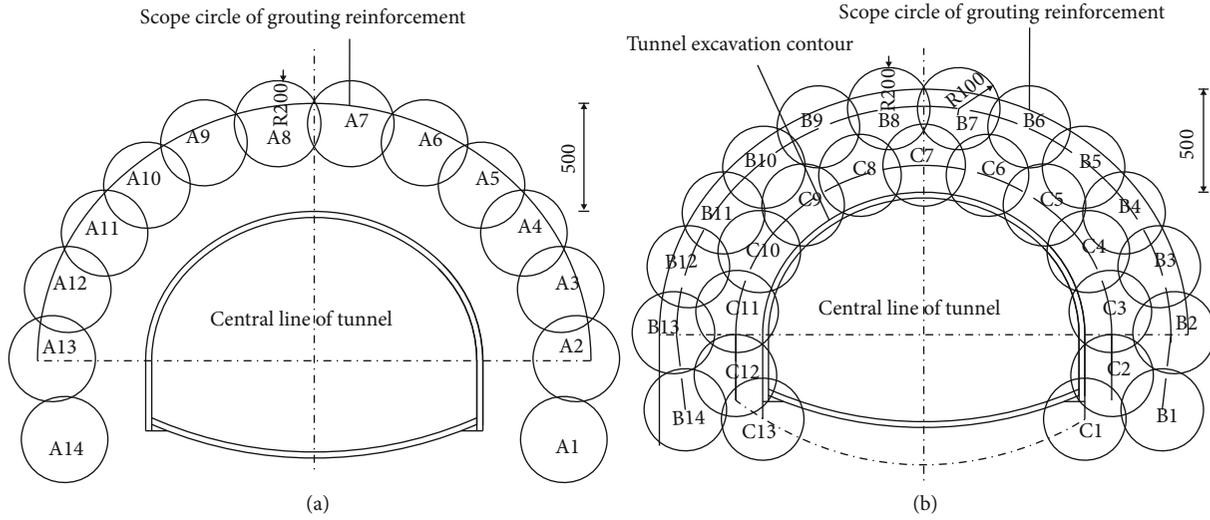
FIGURE 11: Schematic diagram of hole cross-circle: (a) the middle section; (b) the final section (units: cm).

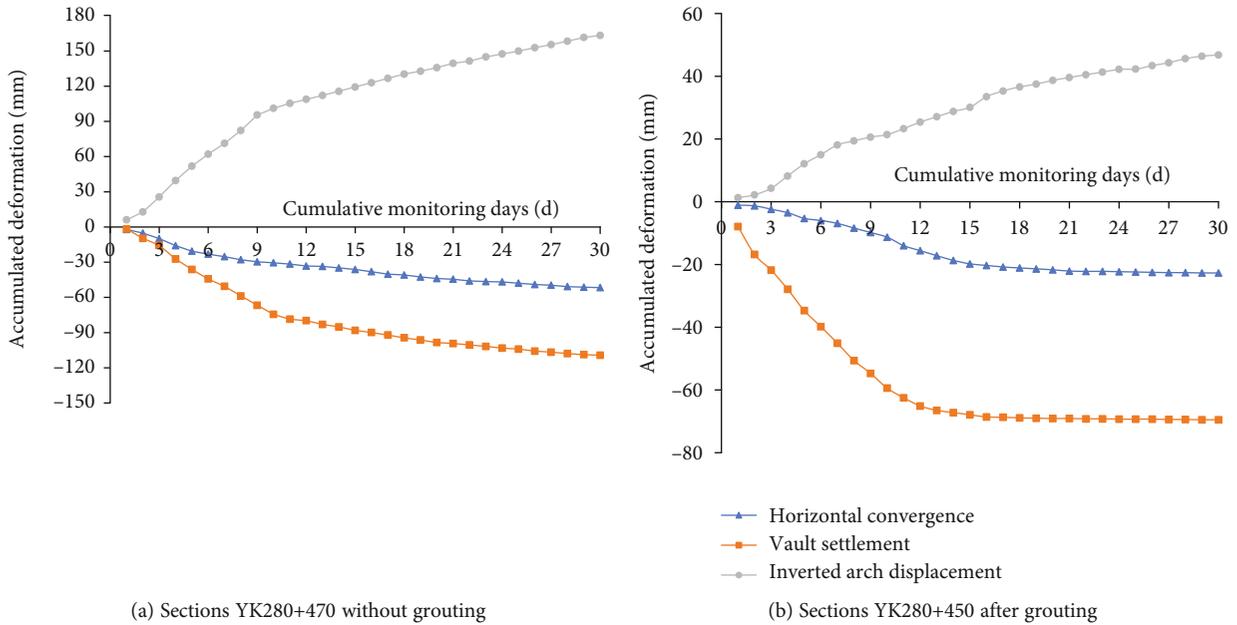
FIGURE 12: Deformation aging diagram of surrounding rock of adjacent sections before and after grouting.

continued to increase nonlinearly. After 30 days, the maximum values of the three are 109.3 mm, 51.7 mm, and 163.3 mm, respectively. According to the relevant provisions of the code [34], the deformation amount has exceeded the

allowable value of the displacement control benchmark, and deformation control measures should be taken.

However, for the sections YK280+450 reinforced by basement grouting combined with curtain grouting, the vault

settlement, horizontal convergence, and inverted arch displacement reached 67.2 mm, 18.7 mm, and 28.8 mm, respectively, after the excavation of the upper step for about 14 days. At this time, the deformation tended to be stable, and the deformation rate gradually decreased. After 22 days, the deformation of surrounding rock is basically stable. After 30 days, the maximum values of vault settlement, horizontal convergence, and inverted arch displacement are 69.5 mm, 22.7 mm, and 46.8 mm, respectively, which fully meet the code deformation requirements. After basement grouting and curtain grouting, the maximum values of vault settlement, horizontal convergence, and inverted arch displacement decrease by 36%, 56%, and 71%, respectively, and the time to reach the stable stage is advanced to the 22nd day after tunnel excavation. Obviously, after grouting, the change of surrounding rock displacement field is significantly

reduced, which plays a great role in limiting the deformation of the vault and the invert, effectively avoiding the collapse of the vault surrounding rock and the floor heave phenomenon of the invert surrounding rock, and ensuring the construction safety.

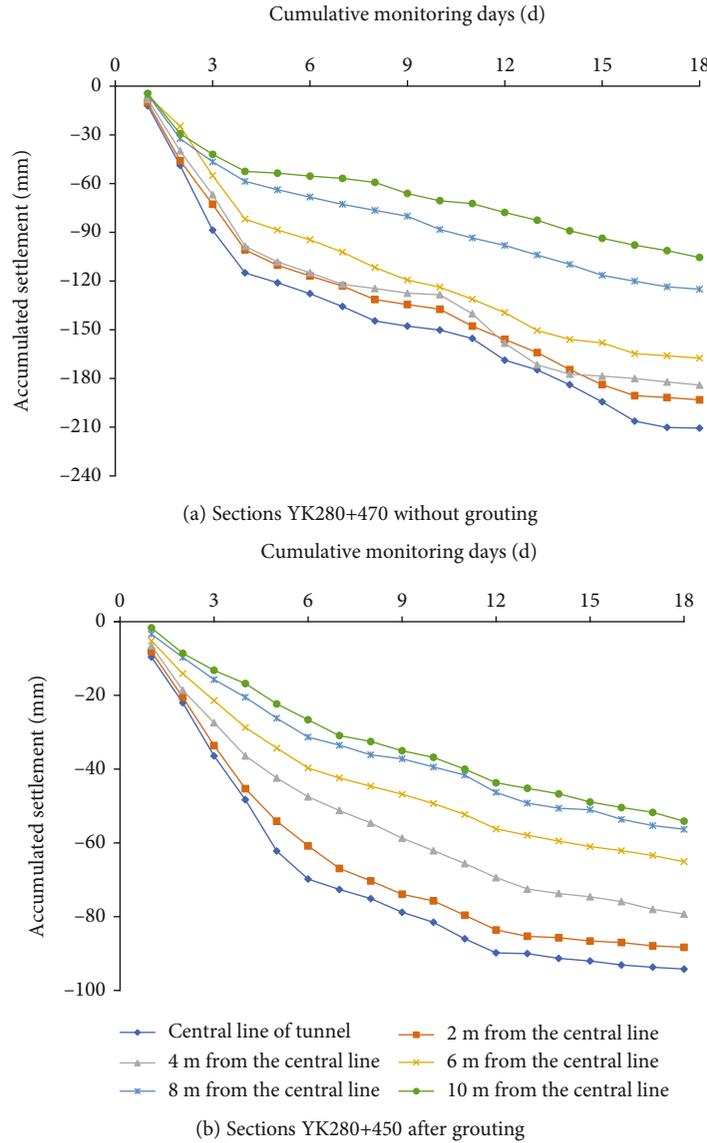
FIGURE 13: Surface settlement aging diagram of adjacent sections before and after grouting.

4.2. Analysis of Surface Subsidence Deformation. Figure 13 shows the comparison curve of surface settlement deformation before and after basement grouting combined with curtain grouting at adjacent different sections. Obviously, the surface settlement of nongrout sections YK280+470 is huge after excavation, in which the accumulated surface settlement of the center line of the tunnel reaches 115 mm after 4 days, and the accumulated surface settlement of 4 m away from the center line of the tunnel reaches 98.6 mm. This continues to increase, and then the deformation after 18 days in

the tunnel central line cumulative settlement is 210.6 mm, and the surface from tunnel center line 6 m in the surface of the cumulative settlement is 167.5 mm, which is far greater than the allowable value of surface deformation specified in the code [34]. Therefore, it is necessary to take corresponding measures to control the surface settlement after tunnel excavation to prevent surface cracks or collapse disasters.

However, after the excavation of the sections YK280+450 reinforced by basement grouting and curtain grouting, the surface settlement in the affected area of the tunnel is significantly reduced. The accumulated surface settlement of the tunnel center line is reduced to 94.2 mm, which is only 45% of the accumulated settlement before grouting. Moreover, the surface settlement tends to be stable within 6 m from the tunnel center line. Basement grouting and curtain grouting can effectively control the surface subsidence of water-rich loess tunnel and reduce or avoid the risk of surface cracks and roof fall.

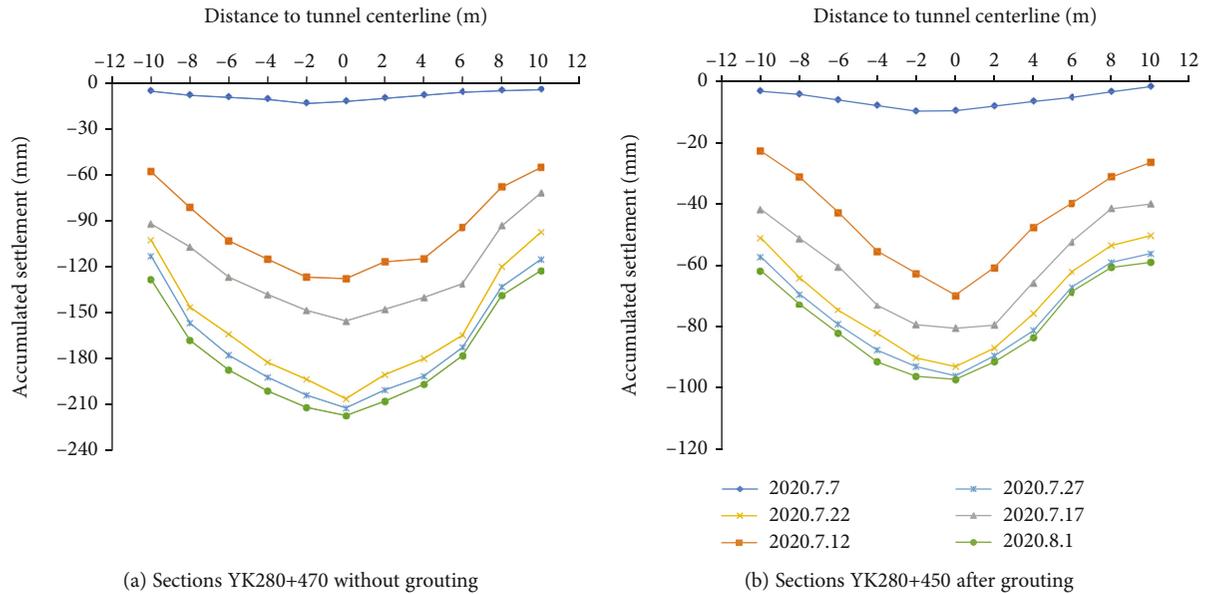
FIGURE 14: Development diagram of surface transverse settlement of adjacent sections before and after grouting.

4.3. Analysis of Surface Transverse Settlement. The development trend of the surface transverse settlement is shown in Figure 14. The surface settlement changes regularly with the construction period. The surface transverse settlement deformation increases sharply within 5 days after excavation of the tunnel face and tends to increase slowly after 15 days. As can be seen from the nongroutings sections YK280+470 in Figure 14(a), with the continuous seepage of groundwater, the surface subsidence of the overlying strata within the tunnel span is obvious. After 5 days of excavation at the tunnel face, the accumulated surface settlement in the tunnel center line reached 127.8 mm, and the maximum value reached 217.3 mm after 25 days.

Compared with the nongroutings sections, in Figure 14(b), after grouting sections YK280+450, although the overburden strata of the tunnel also presents an overall subsidence phenomenon, due to the reinforcement effect of basement grouting and curtain grouting, the overburden

strata load was effectively dispersed to both sides of the tunnel, and the overburden strata settlement was relatively small within the span of the tunnel. After 5 days of excavation at the tunnel face, the accumulated surface settlement in the middle line is only 69.8 mm. After the surface settlement enters the convergence stage, the influence of tunnel excavation stress release on formation deformation disappears, and the groundwater seepage is not obvious. The cumulative surface subsidence at the center of the tunnel is 97.3 mm, which is about 55% less than that of the non-grouting sections.

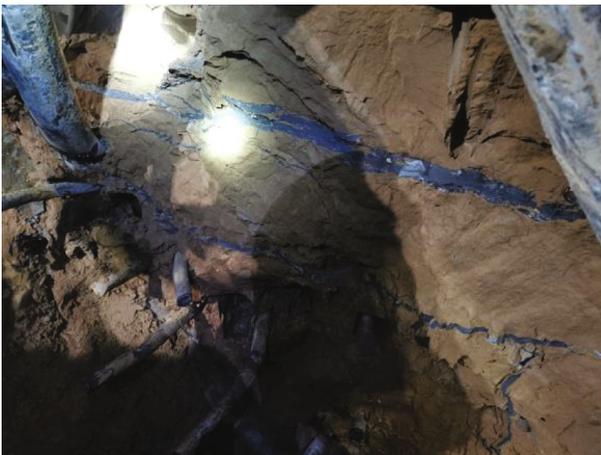
FIGURE 15: Grouting pulp veins.

4.4. Field Observation of Grouting Effect. For the soil after grouting reinforcement, after excavation, the slurry diffusion, slurry consolidation, and surrounding rock seepage are observed, so as to effectively evaluate the grouting reinforcement effect and provide important reference for the next cycle grouting design and construction. According

to the actual sections of the YK280+450 excavation face, as shown in Figure 15, the soil slurry veins are clearly distributed after excavation, and the slurry is diffused to the whole face. The consolidation strength of the slurry stones is high and hard plastic, the face is dry and has no water seepage, the surrounding rock has no collapse or falling blocks, and the overall stability is good. Curtain grouting technique is effective in strengthening the loess stratum with high moisture content and meets the requirements of tunnel construction.
