Research Article

Study on Failure Mechanism and Control Technology of Roadway Surrounding Rock under Complex Occurrence Coal Seam

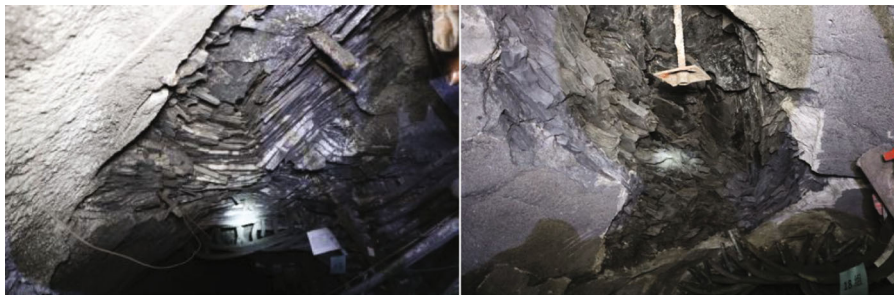
FIGURE 2: Bending deformation of roadway roof.

3.1. Analysis of Surface Failure Characteristics of Roadway Surrounding Rock. Under the original support scheme of the 2254 east floor roadway, the roof bends and sinks seriously, the local shotcrete layer falls off, the layered surrounding rock is broken, and the separation layer between the surrounding rock layers is common, and the anchor bolt is suspended, as shown in Figure 2.

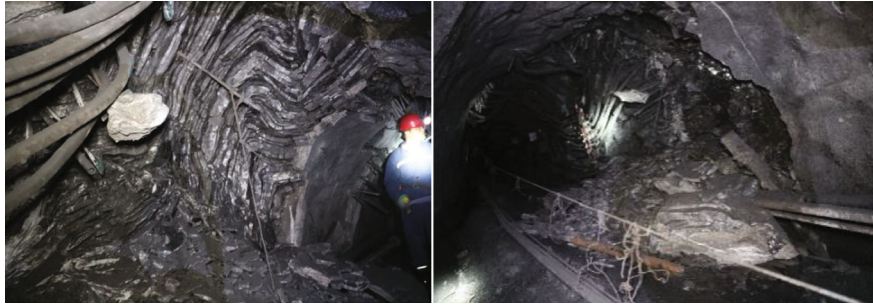
FIGURE 3: Rib deformation of roadway.

The two sides of the roadway are asymmetrically deformed, the left side of the roadway is relatively stable, and the right side of the roadway shows serious intrusion, chipping, cracking, and other phenomena. As shown in

Figure 3, the “S”-shaped extrusion and bending deformation occurred in the surrounding rock, which led to the collapse of the right side roadway and the exposed bolts, which seriously affected the normal passage of the roadway.

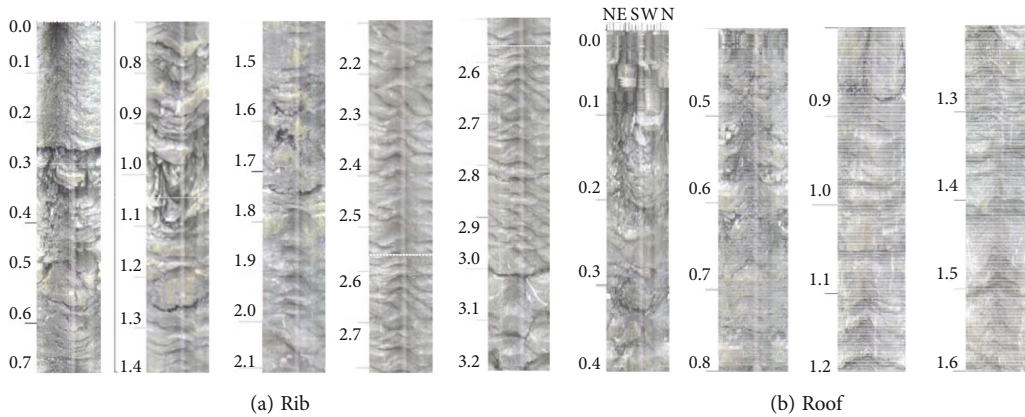
FIGURE 4: Peek view of borehole roadway surrounding rock.

3.2. Analysis of the Development of Fissures in Road Surrounding Rock. A borehole peeping instrument is used to record the internal damage of the roadway roof and the surrounding rock of the side. The peeping results of the surrounding rock at the side of the roadway show that (Figure 4(a)) there are obviously broken zones of surrounding rock within two ranges of 0.3 m-0.4 m and 0.8 m-1.1 m

from the surface of the roadway side. Single cracks developed at 0.5 m and 1.3 m. There is a cavity at 1.6 m-1.7 m, the whole is continuous at 1.8 m-3.0 m, and cracks develop at 3.0 m-3.2 m.

When the tunnel roof was drilled and peeped, there was a broken rock zone at 1.6 m of the drilling position, so only the surrounding rock data within 1.6 m of the roof was obtained (Figure 4(b)). The results show that there are a lot of cracks in the surrounding rock at 0.1 m~0.6 m. The vertical and horizontal cracks can be seen at 0.8 m~0.9 m, the integrity of the surrounding rock within 0.9 m~1.1 m is good, and there are cracks at 1.2 m, 1.4 m, and 1.5 m.

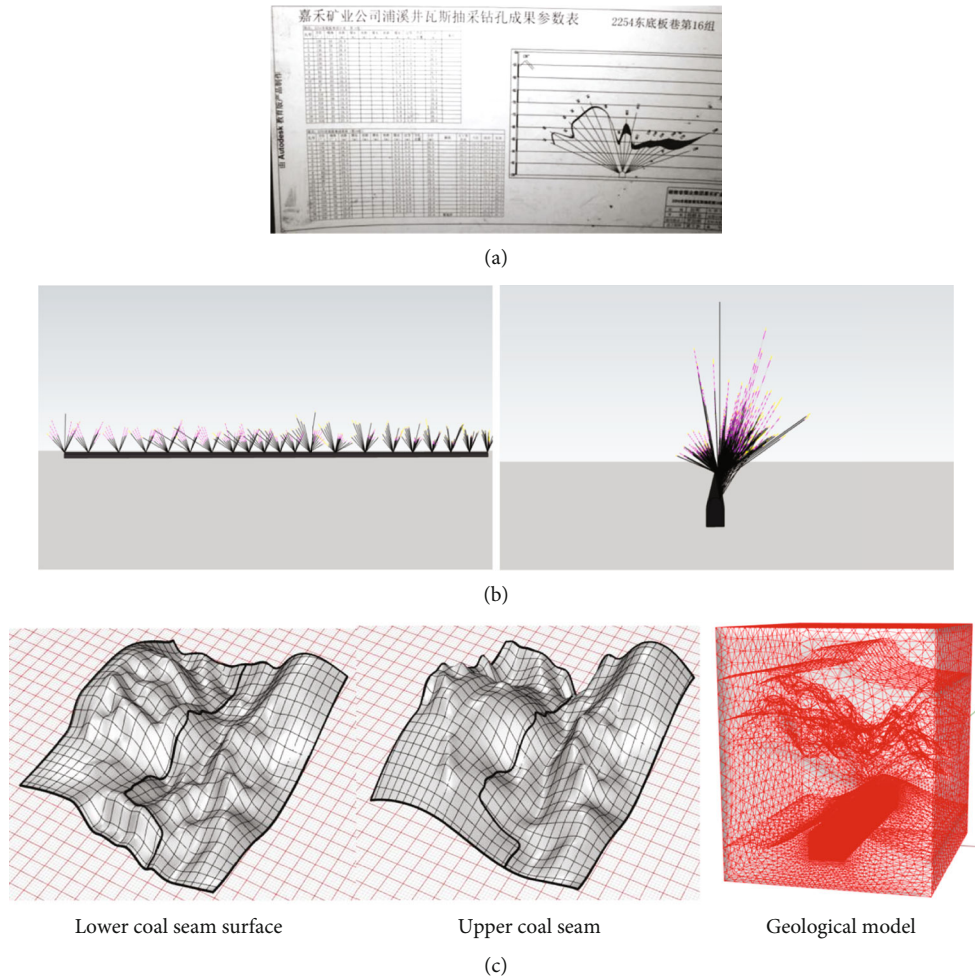
FIGURE 5: (a) Gas drainage drilling results of 15 groups in the 2254 east floor roadway. (b) Each borehole rock mass and coal seam foundation model. (c) Coal seam fitting surface and geological model.

4.1. Building the Geological Model. In order to grasp the occurrence of the coal seam above the 2254 east floor roadway, using the parameter map of the gas drainage drilling results in the roadway (Figure 5(a)), and using SketchUp combined with Rhino software, the coal seam fitting lower surface and upper surface were established.

Firstly, the SketchUp software is used to determine the drilling angle according to the azimuth and inclination in each group of extraction drilling holes. Then, use the black curve, the red dotted line, and the yellow curve to draw the length of the rock mass, coal seam, and overtop, respectively, at the drilling position, so as to construct the rock mass and coal seam foundation model of each drilling hole above the roadway, as shown in Figure 5(b).

The coal length curves made by different hole numbers of each borehole are connected to establish the coal seam profile above each group of borehole roadways. Import the basic model built by SketchUp into Rhino, determine the relative position and unit of the imported model, and fit all the lower and upper surface points to the lower surface and upper surface of the coal seam. In order to make the surface closer to the point cloud, try to let the fitted surface pass more feature points, and set the most suitable fitting parameters through continuous debugging, so as to obtain the final model, as shown in Figure 5(c).

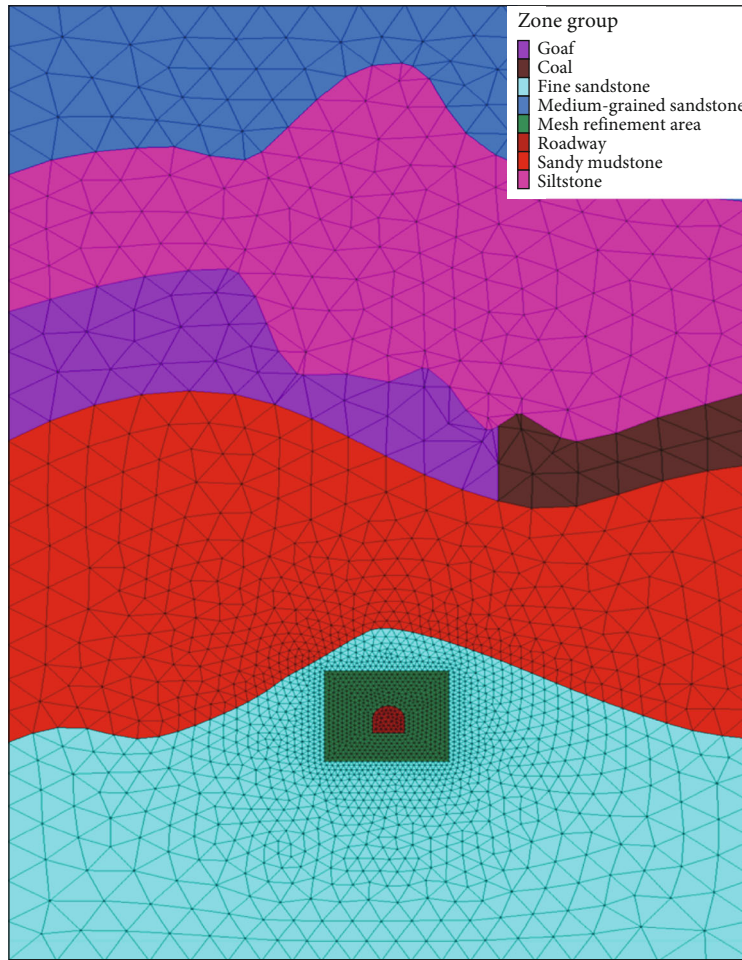
FIGURE 6: Numerical simulation model.

seams was analyzed. According to the geological structure obtained from field exploration, the model is divided into six layers from top to bottom: medium-grained sandstone, siltstone, coal, sandy mudstone, roadway, and argillaceous sandstone. The dimension of the straight wall semicircular arch roadway is 2600 mm \times 2700 mm (width \times height). The roadway was originally supported by anchors, nets, and spray. The anchor rod is $\Phi 16 \times 1800$ mm full-threaded steel, and the anchor rod is anchored by a resin coil. The model adopts the Cartesian coordinate system, and the generated mesh is divided into 670,020 elements and 114,705 nodes. At the same time, to ensure more accurate simulation, the surrounding rock within 6 m around the roadway is encrypted, as shown in Figure 6.

Model boundary conditions: lower boundary: displacement is zero; left, right, front, and rear boundaries: horizontal displacement is zero; upper boundary: free boundary, vertical stress 6 MPa; model lateral pressure coefficient is set to 2. The model adopts the Mohr-Coulomb yield criterion. The mechanical parameters of the surrounding rock are shown in Table 2.

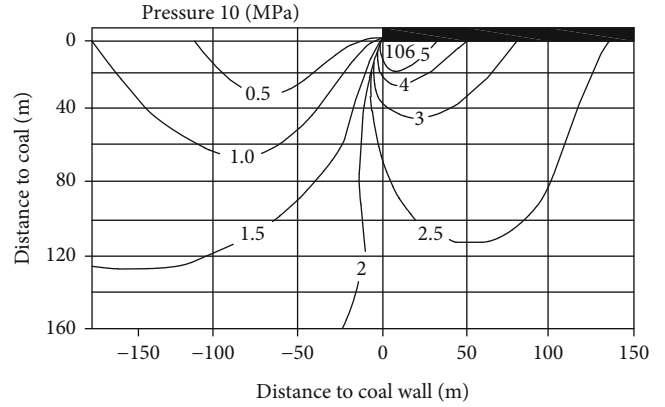
FIGURE 7: Contour map of maximum principal stress distribution of floor rock stratum.

of working face mining, we must first understand the distribution and transmission law of lateral support pressure on the working face floor. By referring to the literature [26], the maximum principal stress transfer law of the working face was obtained, and the contour map of the maximum principal stress distribution of the floor strata was obtained, as shown in Figure 7.

Mining of the coal seam above the floor roadway leads to a regular transfer of the maximum principal stress of the rock formation. The main influencing factors include the vertical distance between the roadway and the upper working face and the horizontal distance between the coal wall edge of the roadway working face. Therefore, after the floor roadway is mined in complex coal seams, the stress distribution of the floor strata in the working face is closely related to the deployment position of the roadway. The difference in the spatial position between the goaf and the roadway makes the stress increase coefficient of the floor roadway vary greatly. According to the elastic mechanics' analysis, the transfer law of the stress generated during the mining of the working face in the floor rock can be obtained.

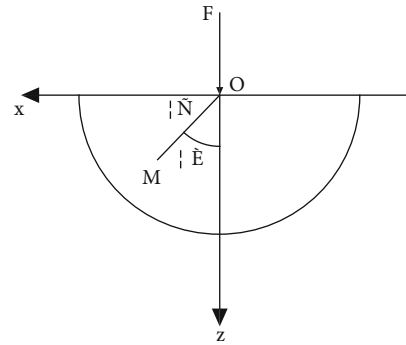
FIGURE 8: Semi-infinite planar body of floor rock under the action of load F .

As shown in Figure 8, the floor rock formation at the boundary of the gob is regarded as a semi-infinite plane body. Under the action of the concentrated load F along the positive direction of Z in the figure, the polar coordinate

Based on the above analysis, it can be concluded that the maximum vertical stress generated by mining is distributed on the lower axis of the load center, which is negatively related to the depth of the rock mass, that is, the smaller the depth, the greater the stress. At the same time, the closer

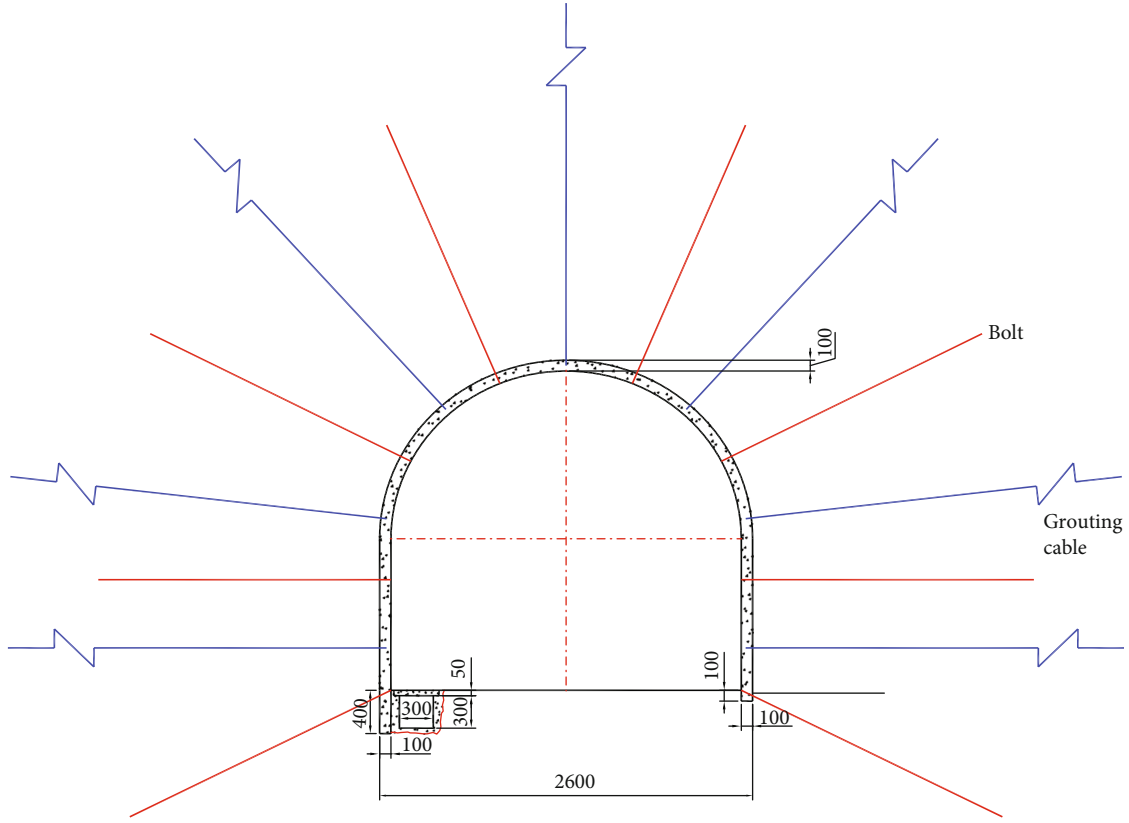
FIGURE 11: Anchor cable support section view.

As shown in Figure 11, the anchor rod is made of BHRB500 $\Phi 22\text{mm} \times 2200\text{mm}$ left-handed rebar without longitudinal reinforcement. Each anchor uses 2 rolls of K2330 resin anchoring agent, the anchoring force is not less than 70 kN, the row spacing between the anchors is 700 mm \times 700 mm, the metal mesh is $\Phi 6\text{mm}$, the grid is 100 \times 100 mm, and the specification is 1000 mm \times 800 mm. There must be anchors where the metal mesh joins the stubble and is close to the rock surface, and the length of the stubble between the meshes is not less than 100 mm. The thickness of sprayed concrete is 100 mm, and the strength is C20. Using a steel plate tray, it is made into a square with a side length of 150 mm and a thickness of 8 mm.

The anchor cable adopts a grouting anchor cable with $\Phi 21\text{mm} \times 6100\text{mm}$, and the distance and discharge are 1200 \times 1400 mm. The end of the anchor is anchoring the resin, and the length of the anchor is 1500 mm. Each anchor cable uses 5 rolls of Z2850 resin rolls, and the anchoring power is not less than 100 kN. The anchor tray uses a compressed pad device, which is superimposed from two pads. The specifications are 350 mm \times 350 mm \times 10 mm and 150 mm \times 150 mm \times 10 mm square pads. The large pads are inside and the small pads are outside.

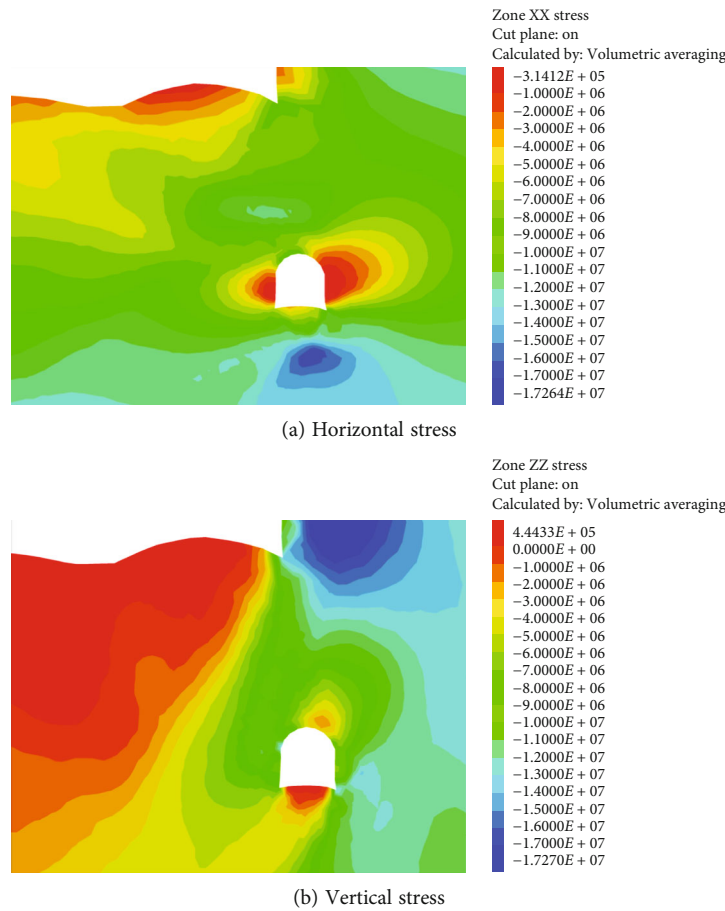
FIGURE 12: Optimize the horizontal stress and vertical stress distribution cloud chart after the optimization of the roadway.

As shown in Figure 12, after the optimization support scheme is adopted, the peak stress peak of the surrounding rock level X is reduced compared with the original scheme. The distribution of horizontal stress on the sides of the surrounding rock is still asymmetric. The right side of the lane road is still greater than the left. The distribution of vertical stress is still the deformation stress release area on the right side of the top plate. In general, the stress peak value has a certain decrease than the original plan, which improves the overall stability of the surrounding rock.

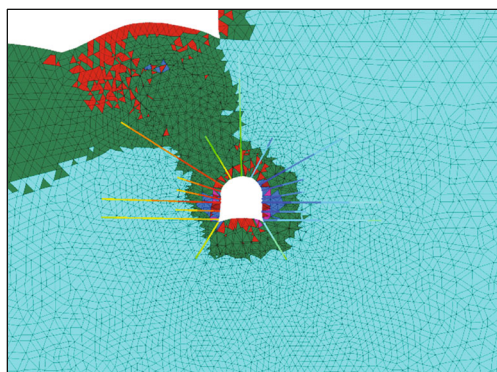
FIGURE 13: Distribution of plastic zone of the roadway under optimization scheme.

It can be seen from Figure 13 that after the optimization scheme is adopted, the degree of asymmetric distribution of the plastic zone of the roadway surrounding rock is reduced. Among them, the width of the surrounding rock plastic zone on the right side of the roadway is reduced to 2.1 m, and the depth of the bottom plastic zone is reduced to 1.85 m. At the same time, in the improved support scheme, the length of the bolt is increased to 2200 mm, and the anchoring sections of the bolt and the cable are located in the elastic zone of the surrounding rock outside the plastic zone of the surrounding rock.

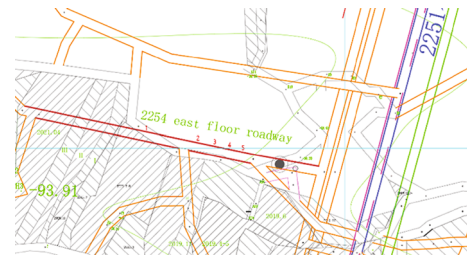
FIGURE 14: Construction layout of the new scheme.

The new scheme was adopted for construction in 2254 east floor roadway. The construction layout is shown in Figure 14. Observation points for the surface displacement of the roadway surrounding rock are set up within and outside the construction scope for data observation.

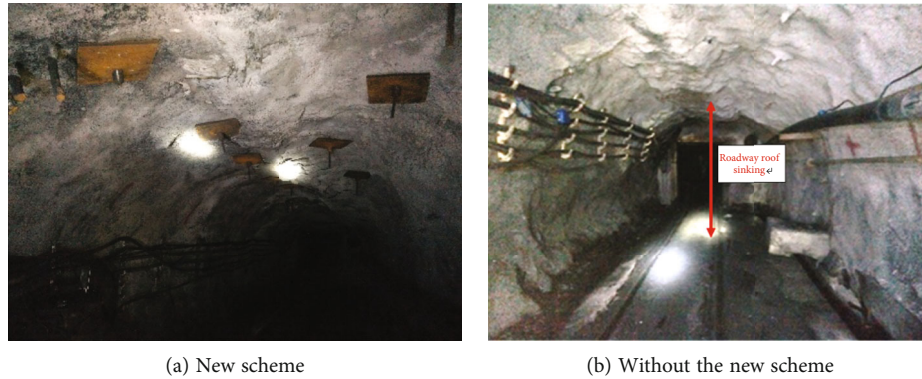
FIGURE 15: Comparison picture of deformation of roadway.

5.1. Observation Effect Analysis. The deformation of the roadway surrounding rock (the height of the roof and the floor and the width of the two sides) has been observed for one year. Figure 15(a) is the roadway diagram after the construction of the new scheme, and Figure 15(b) is the roadway deformation diagram without the implementation of the new scheme.

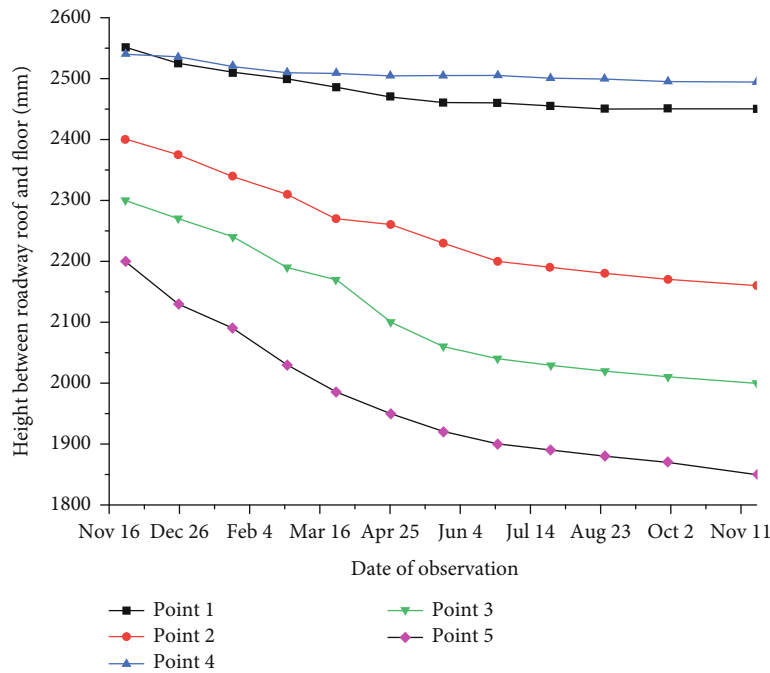
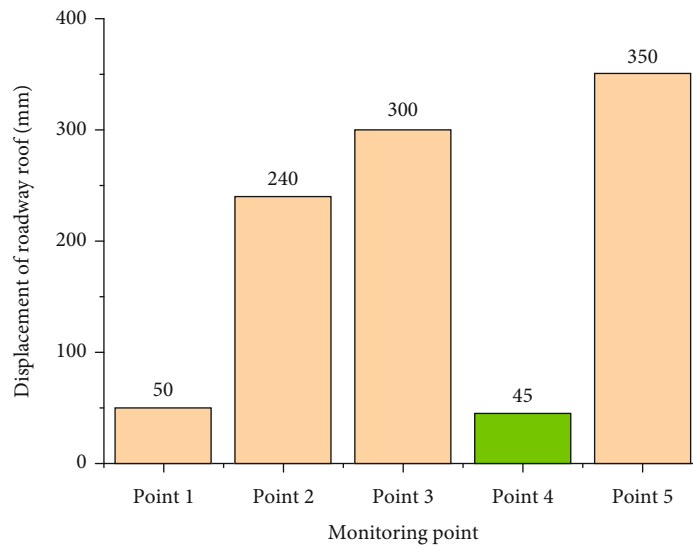
Figures 16(a) and 16(b) show that under the impact of mining, the top board of different observations has a certain degree of sinking. Point 4 (the construction section of the new plan) has the smallest sinking volume, and the height of the top board drops from the original 2540 mm to 2495 mm, a decrease of 45 mm. Point 5 (old plan construction section): the height of the top board dropped from the original 2200 mm to 1850 mm, the largest sinking volume, reaching 350 mm. The height of the top board of point 3 (the construction section of the old plan) dropped from 2300 mm to 2000 mm, sinking 300 mm. Point 2 (old plan

FIGURE 16: (a) Line chart of roadway roof and floor height change. (b) Column chart of roadway roof subsidence at different monitoring points.

construction section): top plate height dropped from 2400 mm to 2160 mm, sinking 240 mm. The height of the roadway at points 3 and 5 can no longer meet the normal walking needs. Pedestrians need to bow their heads to prevent head-butting. In addition, the roof height of no. 1 point (construction section of the old scheme, which is also located in the bottom plate of the goaf) is relatively small, from the original 2550 to 2450 mm, and the subsidence height is only 100 mm. Therefore, the support parameters should be further optimized for the roadway roof surrounding rock, especially the observation points 3 and 5.

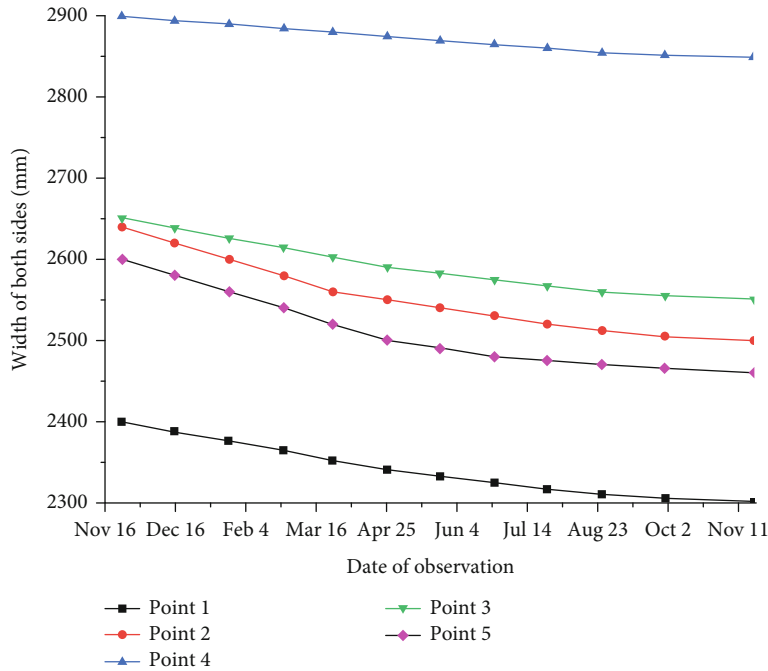
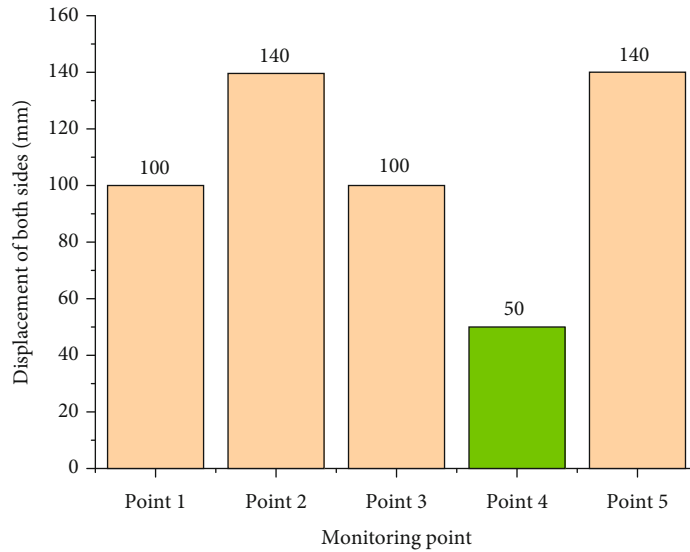
5.2. Analysis of Observation Effect on Both Sides of the Roadway. The monitoring data (Figure 17) show that, under the influence of mining stress, the width on both sides of different monitoring points decreases to a certain extent. Point 4 (the construction section of the new scheme) has the smallest reduction in the width on both sides, from the original 2900 mm to 2850 mm, a reduction of 50 mm. Point 5 (construction section of the old scheme) was reduced from the original 2600 mm to 2460 mm, a reduction of 140 mm. Point 2 (construction section of the old scheme) has been reduced from the original 2640 mm to 2500 mm, a reduction of

FIGURE 17: (a) Line chart of the height change of the two sides of the roadway. (b) The bar chart of the height change of the two sides of the roadway.

140 mm. The no. 1 point (the construction section of the old scheme, which is also located in the bottom plate of the goaf) has been reduced from the original 2400 mm to 2300 mm, a reduction of 100 mm. No. 3 (the construction section of the old scheme): the width of the two gangs has been reduced from the original 2650 mm to 2550 mm, a reduction of 100 mm. Observation data show that the height of the top and bottom plates and the width of both sides of the roadway are significantly reduced after the new scheme is adopted, indicating that the new scheme can effectively control the deformation of the roadway.
